Subject: 2016 Annual Site Inspection and Monitoring Report for Uranium Mill Tailings
Radiation Control Act Title II Disposal Sites

2016 Annual Site Inspection and Monitoring Report for Uranium Mill Tailings Radiation Control Act Title II Disposal Sites

November 2016

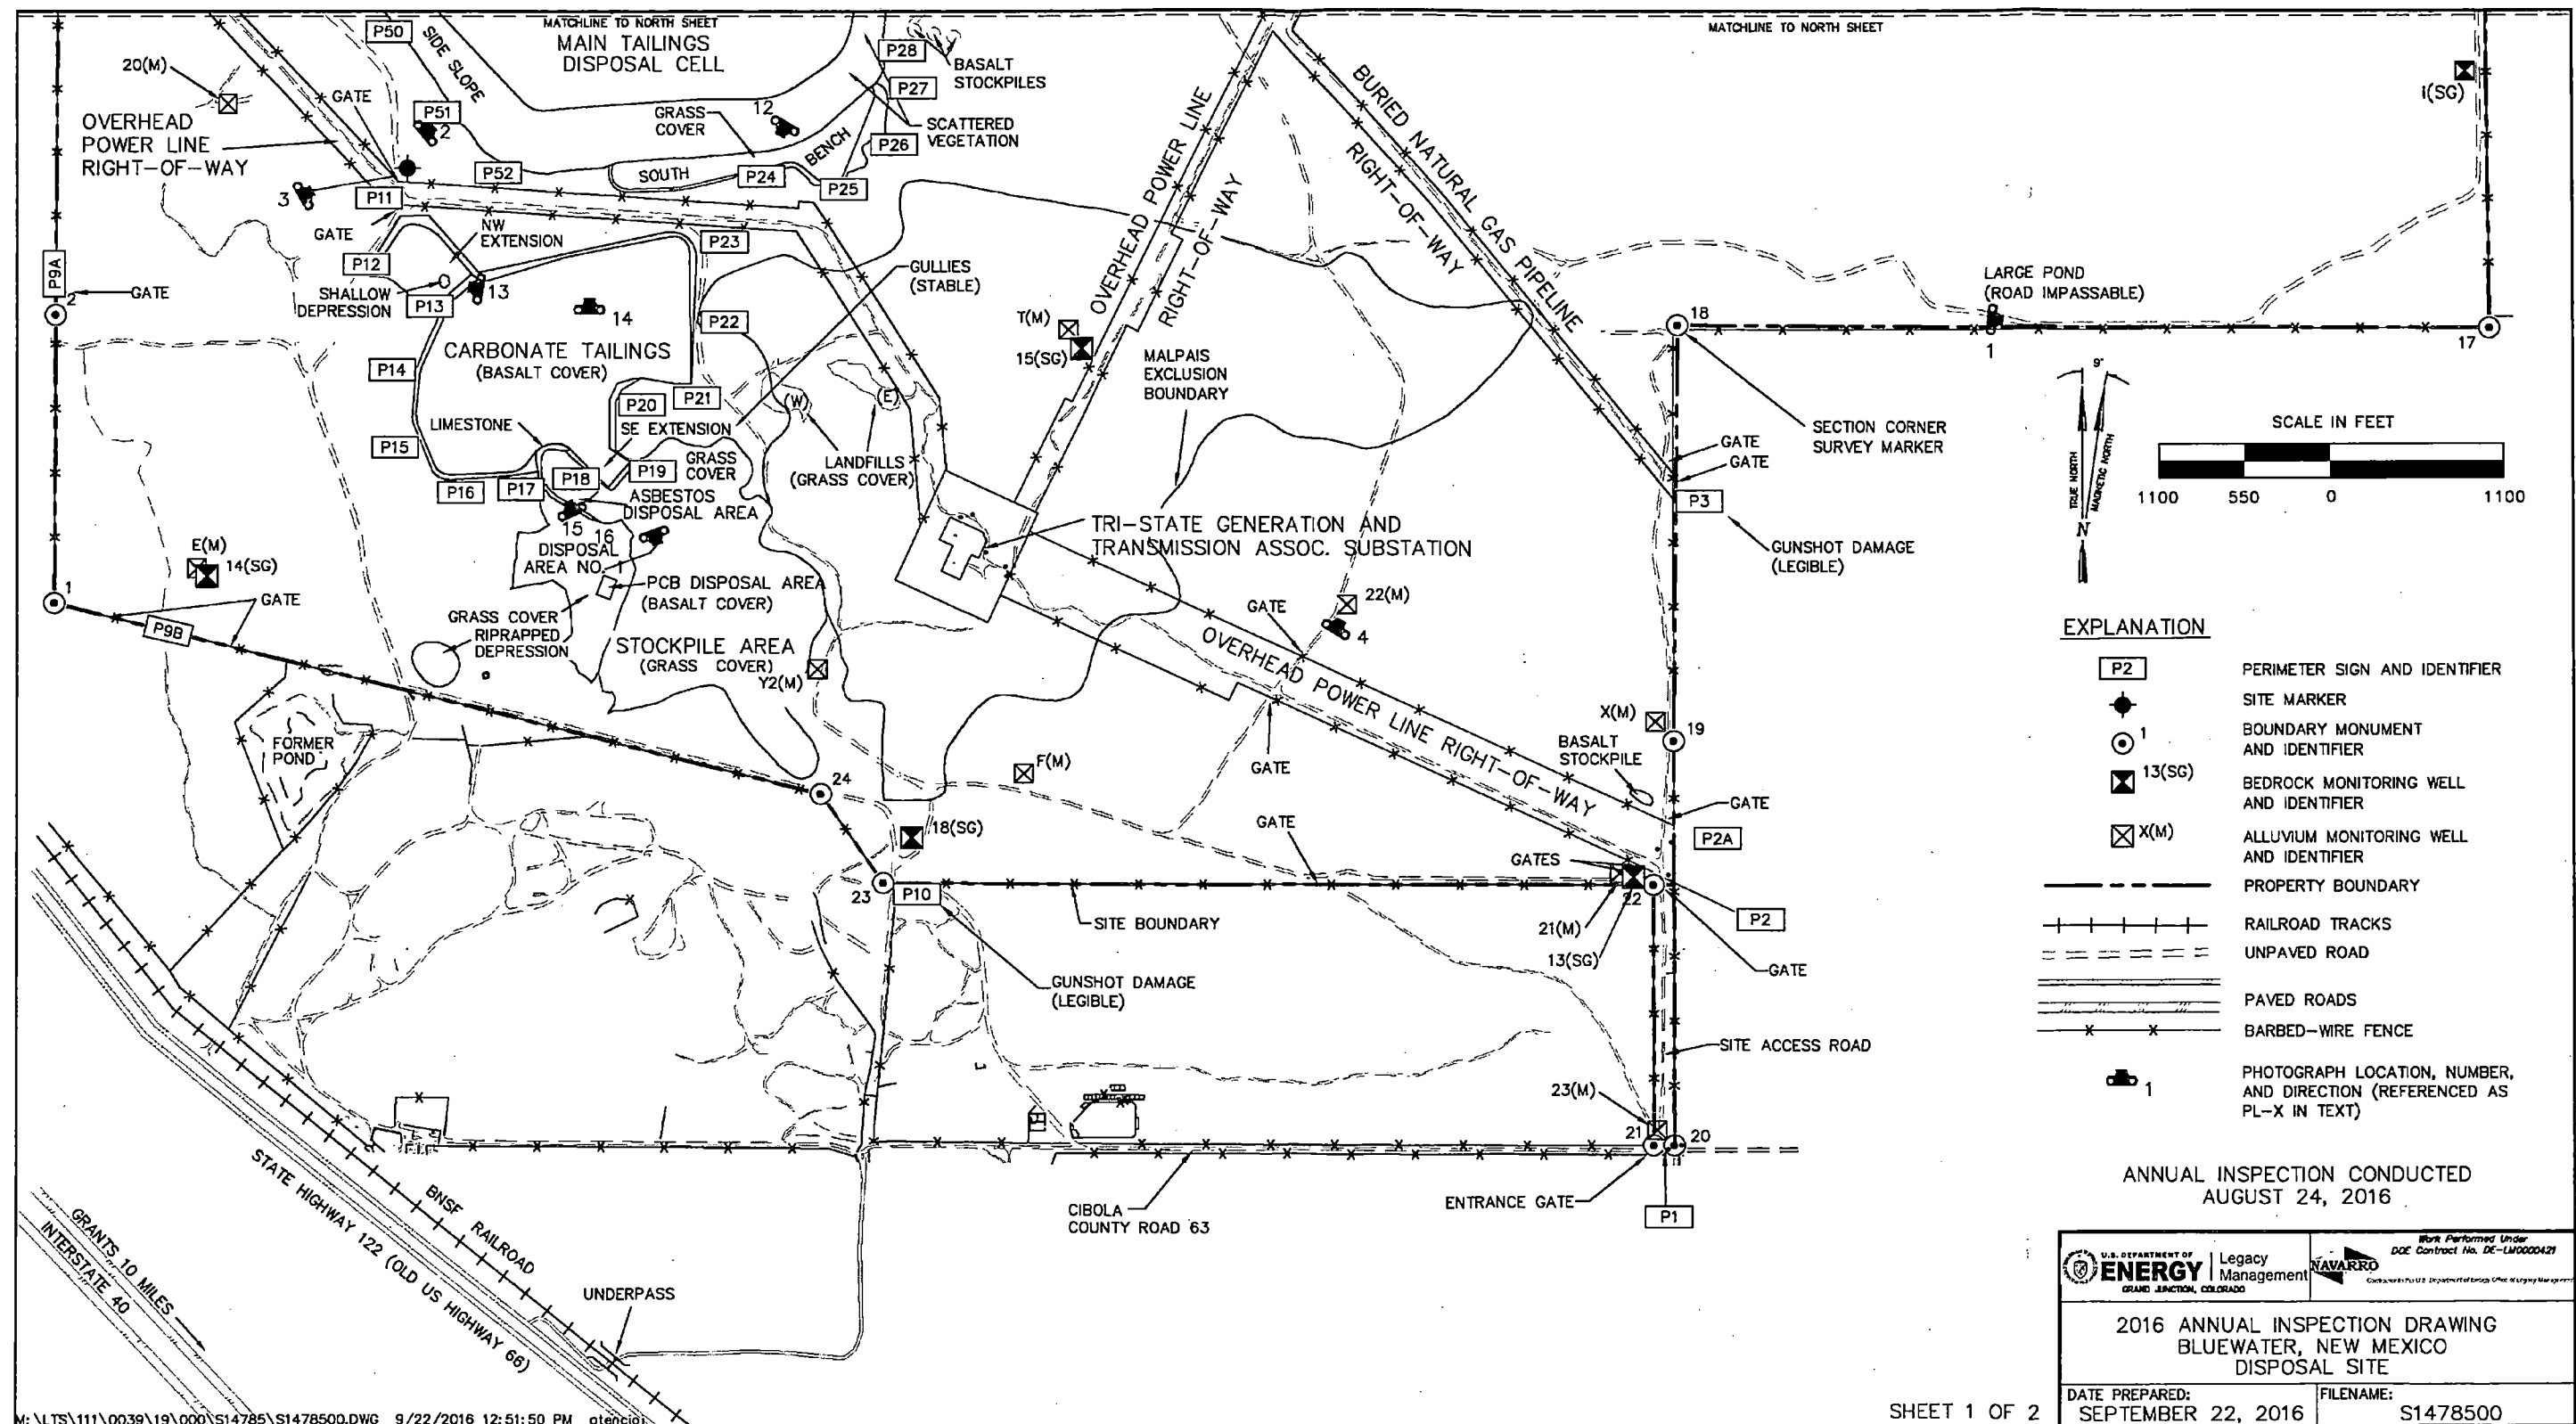
Figure 1-1. 2016 Annual Inspection Drawing for the Bluewater, New Mexico, Disposal Site (South Area)

Interior tertiary roads used to access DOE assets consist of a dirt track covered at places with crushed basalt. The roads are susceptible to erosion and are repaired when they become impassable. All roads were passable except for a location that was covered by a large ephemeral pond (PL-1).

Fifty-five perimeter signs (warning and no-trespassing signs) are mounted on steel posts along the site boundary and around the main and carbonate tailings disposal cells (PL-2). Perimeter signs P3 and P10 have gunshot damage but are still legible. No maintenance needs were identified.

A granite site marker is between the southwest corner of the main tailings disposal cell and the northwest corner of the carbonate tailings disposal cell (PL-3). No maintenance needs were identified.

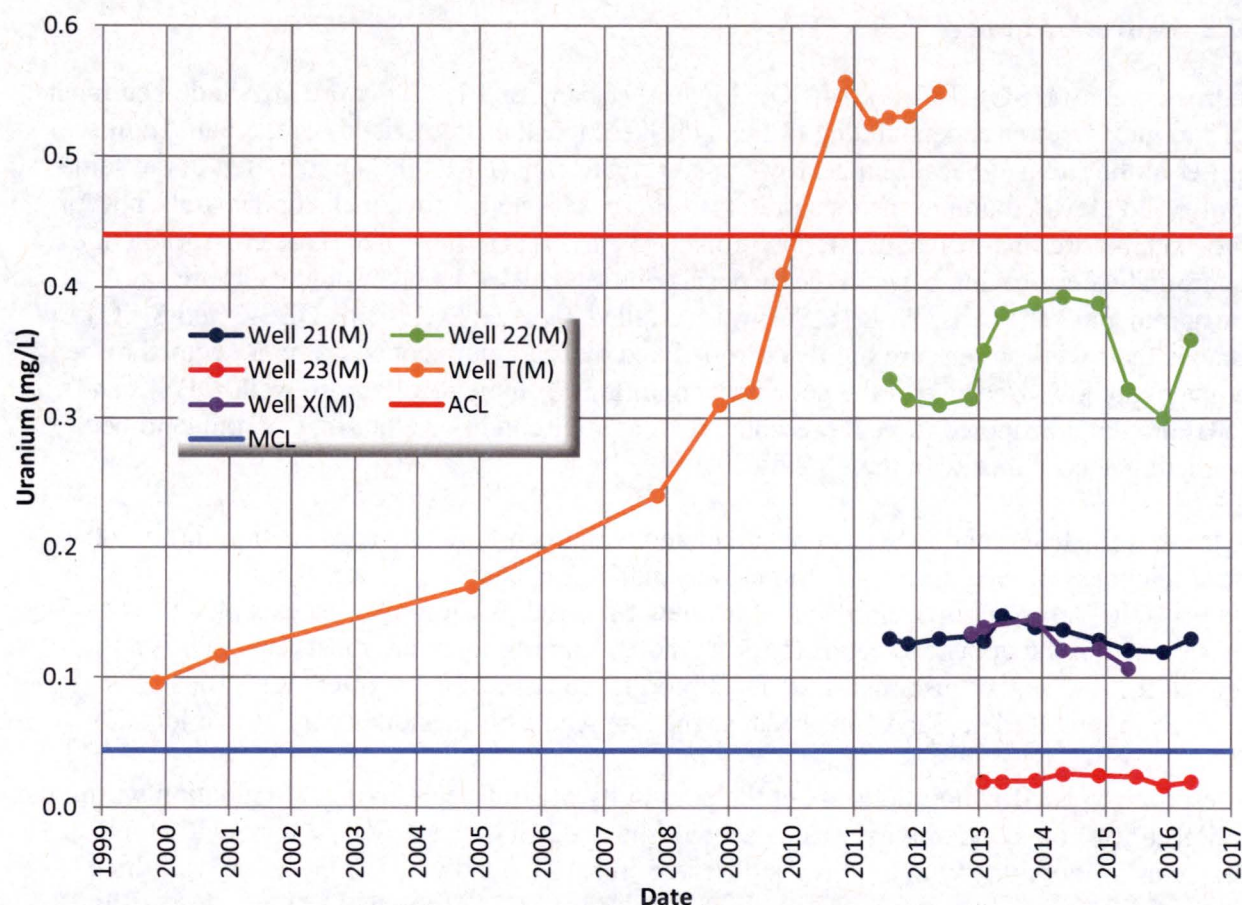
Figure 1-3. Uranium Concentrations in Alluvial Aquifer POC Well T(M) and Downgradient Wells at the Bluewater, New Mexico, Disposal Site

Alluvium well 21(M), installed in 2011, is adjacent to the southern site boundary, where the estimated deepest part of the ancestral Rio San Jose channel coursed before being buried by basalt lava flows. Alluvium well 22(M), also installed in 2011, is approximately halfway between POC well T(M) and well 21(M). The uranium concentrations in these two newer wells are less than the ACL (Table 1-4). However, the uranium concentrations in both wells, shown on

Figure 1-3, continue to exceed the UMTRCA MCL of 0.044 mg/L (40 CFR 192, Table 1) and the State of New Mexico drinking water standard of 0.03 mg/L. The elevated uranium concentrations in well 21(M) and POE well X(M) indicate that alluvial groundwater with uranium concentrations exceeding the drinking water standard is leaving the site.

NRC requested that DOE evaluate the performance of the main tailings disposal cell to see if there is a correlation between cell performance and the elevated uranium concentrations in POC well T(M) (see Figure 1-3). A cell cover and water balance evaluation of the disposal cell (including the 2013 radon study referred to in Section 1.4.2.1) concluded that the increase in uranium concentrations in well T(M) cannot be attributed to a reduction in disposal cell performance; no surge of tailings fluids from the cell has occurred since it was closed (DOE 2014). The increase in uranium concentration is apparently related to the declining water level at the well location and the influence of groundwater from contaminated weathered Chinle Formation material at the bottom of the well screen.

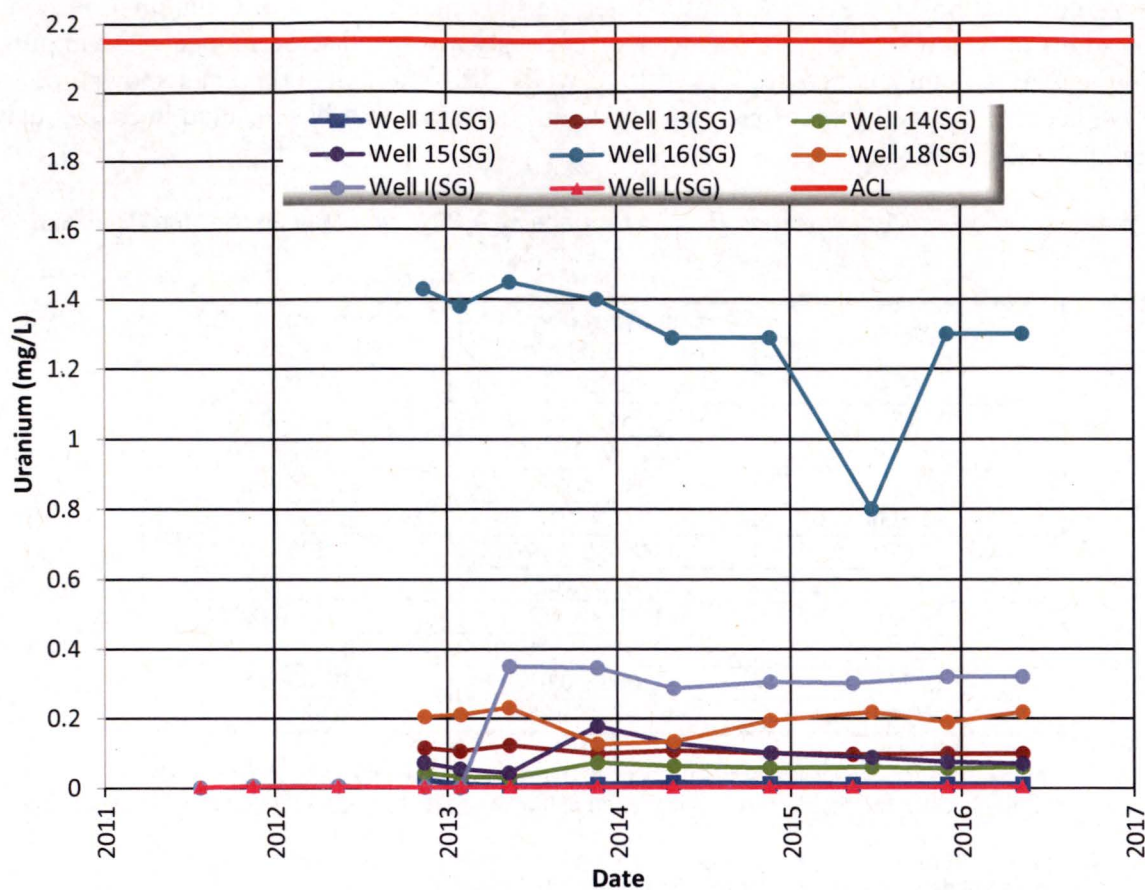
Figure 1-4. Uranium Concentrations in the San Andres Aquifer at the Bluewater, New Mexico, Disposal Site

Uranium concentrations in the San Andres aquifer are shown on Figure 1-4. Uranium concentrations in well I(SG) before 2013 were erroneously low because of an incorrect sampling depth in the well. Uranium concentrations at POC wells OBS-3 and S(SG) are not shown in Figure 1-4 because the well screens are encrusted with iron scale that has resulted in erroneously low uranium concentrations.

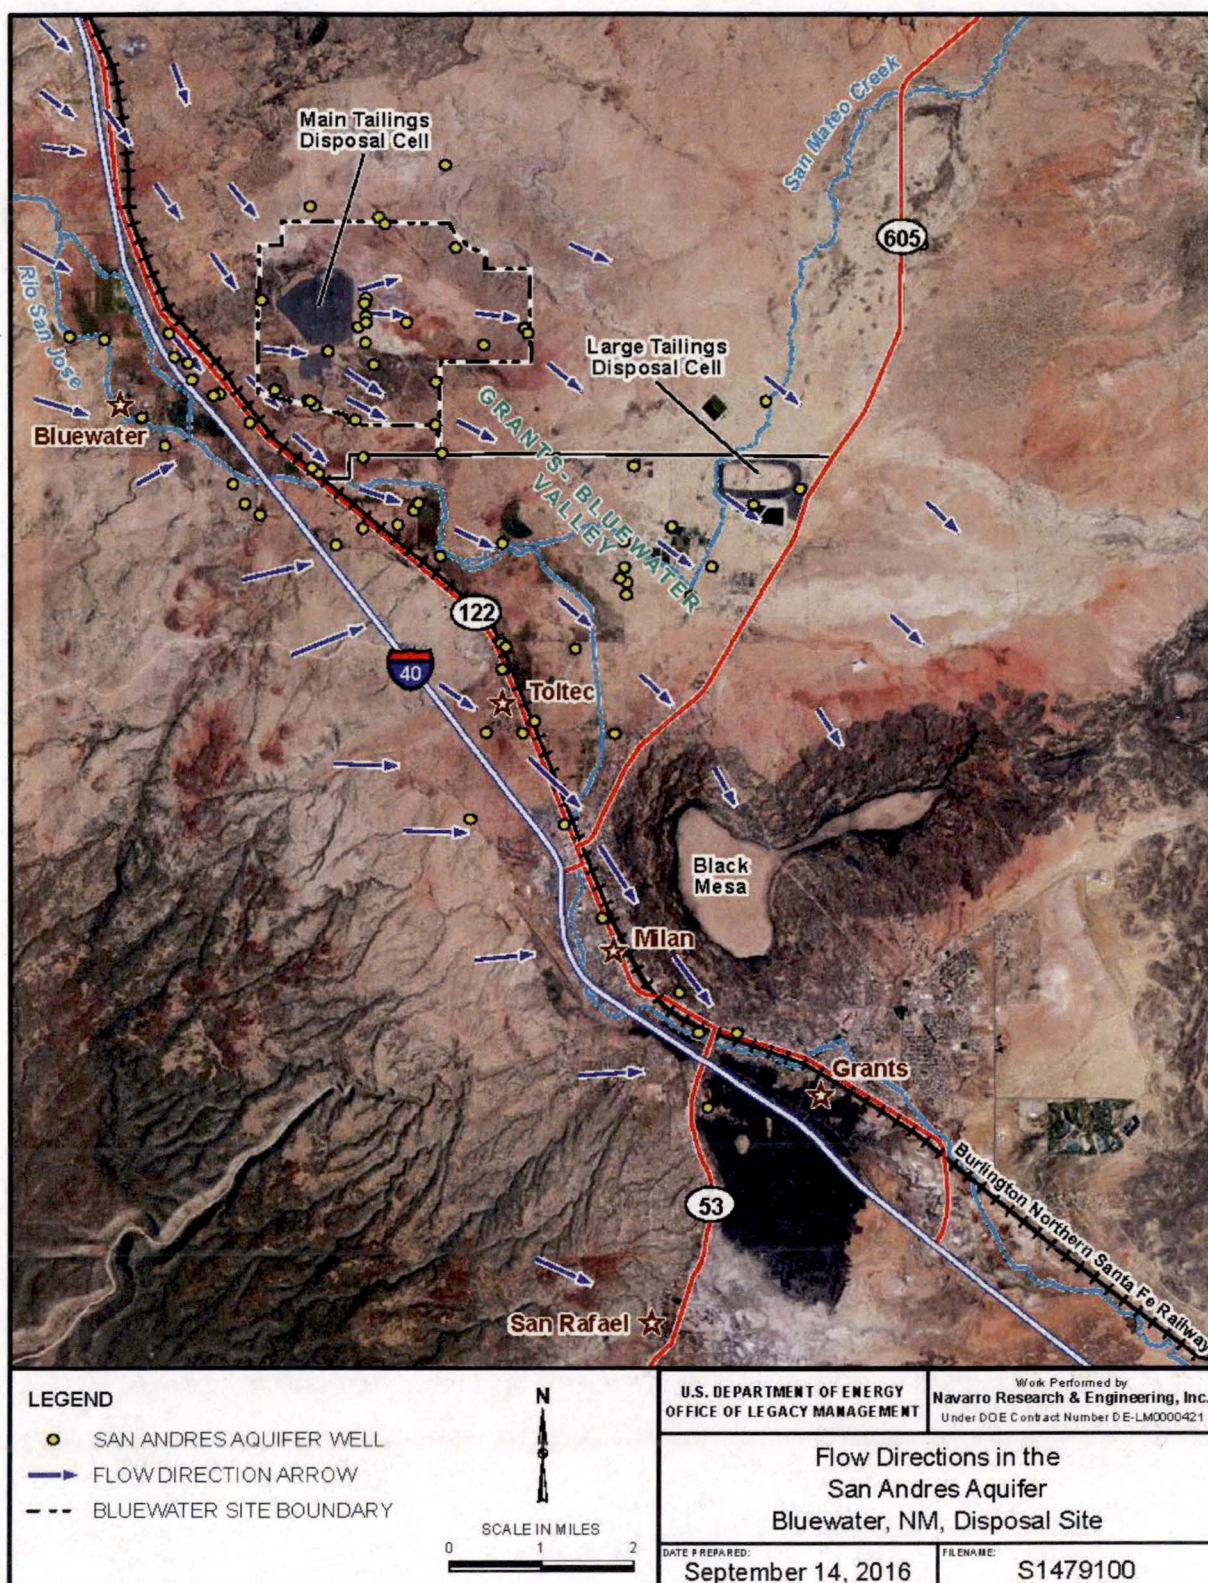
Figure 1-5. Groundwater Flow Directions in the San Andres Aquifer at the Bluewater, New Mexico, Disposal Site

The extent of uranium contamination in the San Andres aquifer and the potential risk to downgradient groundwater users was evaluated in DOE's groundwater conceptual model. Evaluation of previous groundwater studies in the region and available groundwater data indicated that the flow path of the aquifer from the Bluewater site is in the east-southeast direction. The groundwater from the site passes under the Homestake mill site and continues through an area north of the community of Grants. The flow path from the Bluewater site is substantially north of the Milan and Grants municipal wells (Figure 1-5).

The uranium plume follows the groundwater flow path, and the leading portion is in the vicinity of the Homestake site. Groundwater monitoring results obtained by various entities over the last several decades indicate that uranium contamination from Bluewater mill operations reached the Homestake site by 1980 and that the plume has essentially stabilized. Uranium concentrations attenuate with distance from the Bluewater site primarily through dispersion. No known drinking water wells are completed within the uranium plume, and Bluewater site-derived uranium contamination in the San Andres aquifer is not expected to impact the Milan or Grants municipal water supplies.

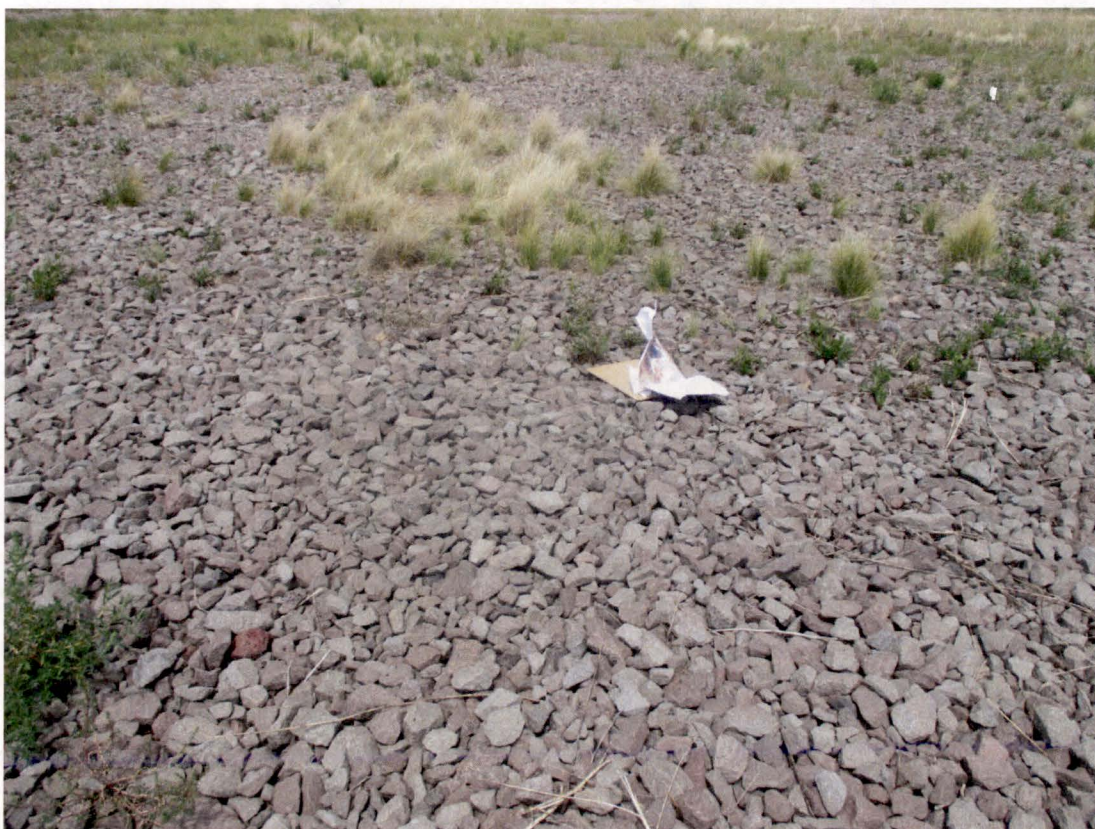
PL-14. Reclaimed Test Pit 7

Two test pits were dug and sampled on the top slope of the carbonate tailings disposal cell as part of the NRC/DOE radon study. The test pits were reclaimed after completion of field investigations, and the locations were observed and photographed during the annual inspection. Reclamation appeared to be successful at both test pit locations; no settlement or erosion was visible (PL-14).

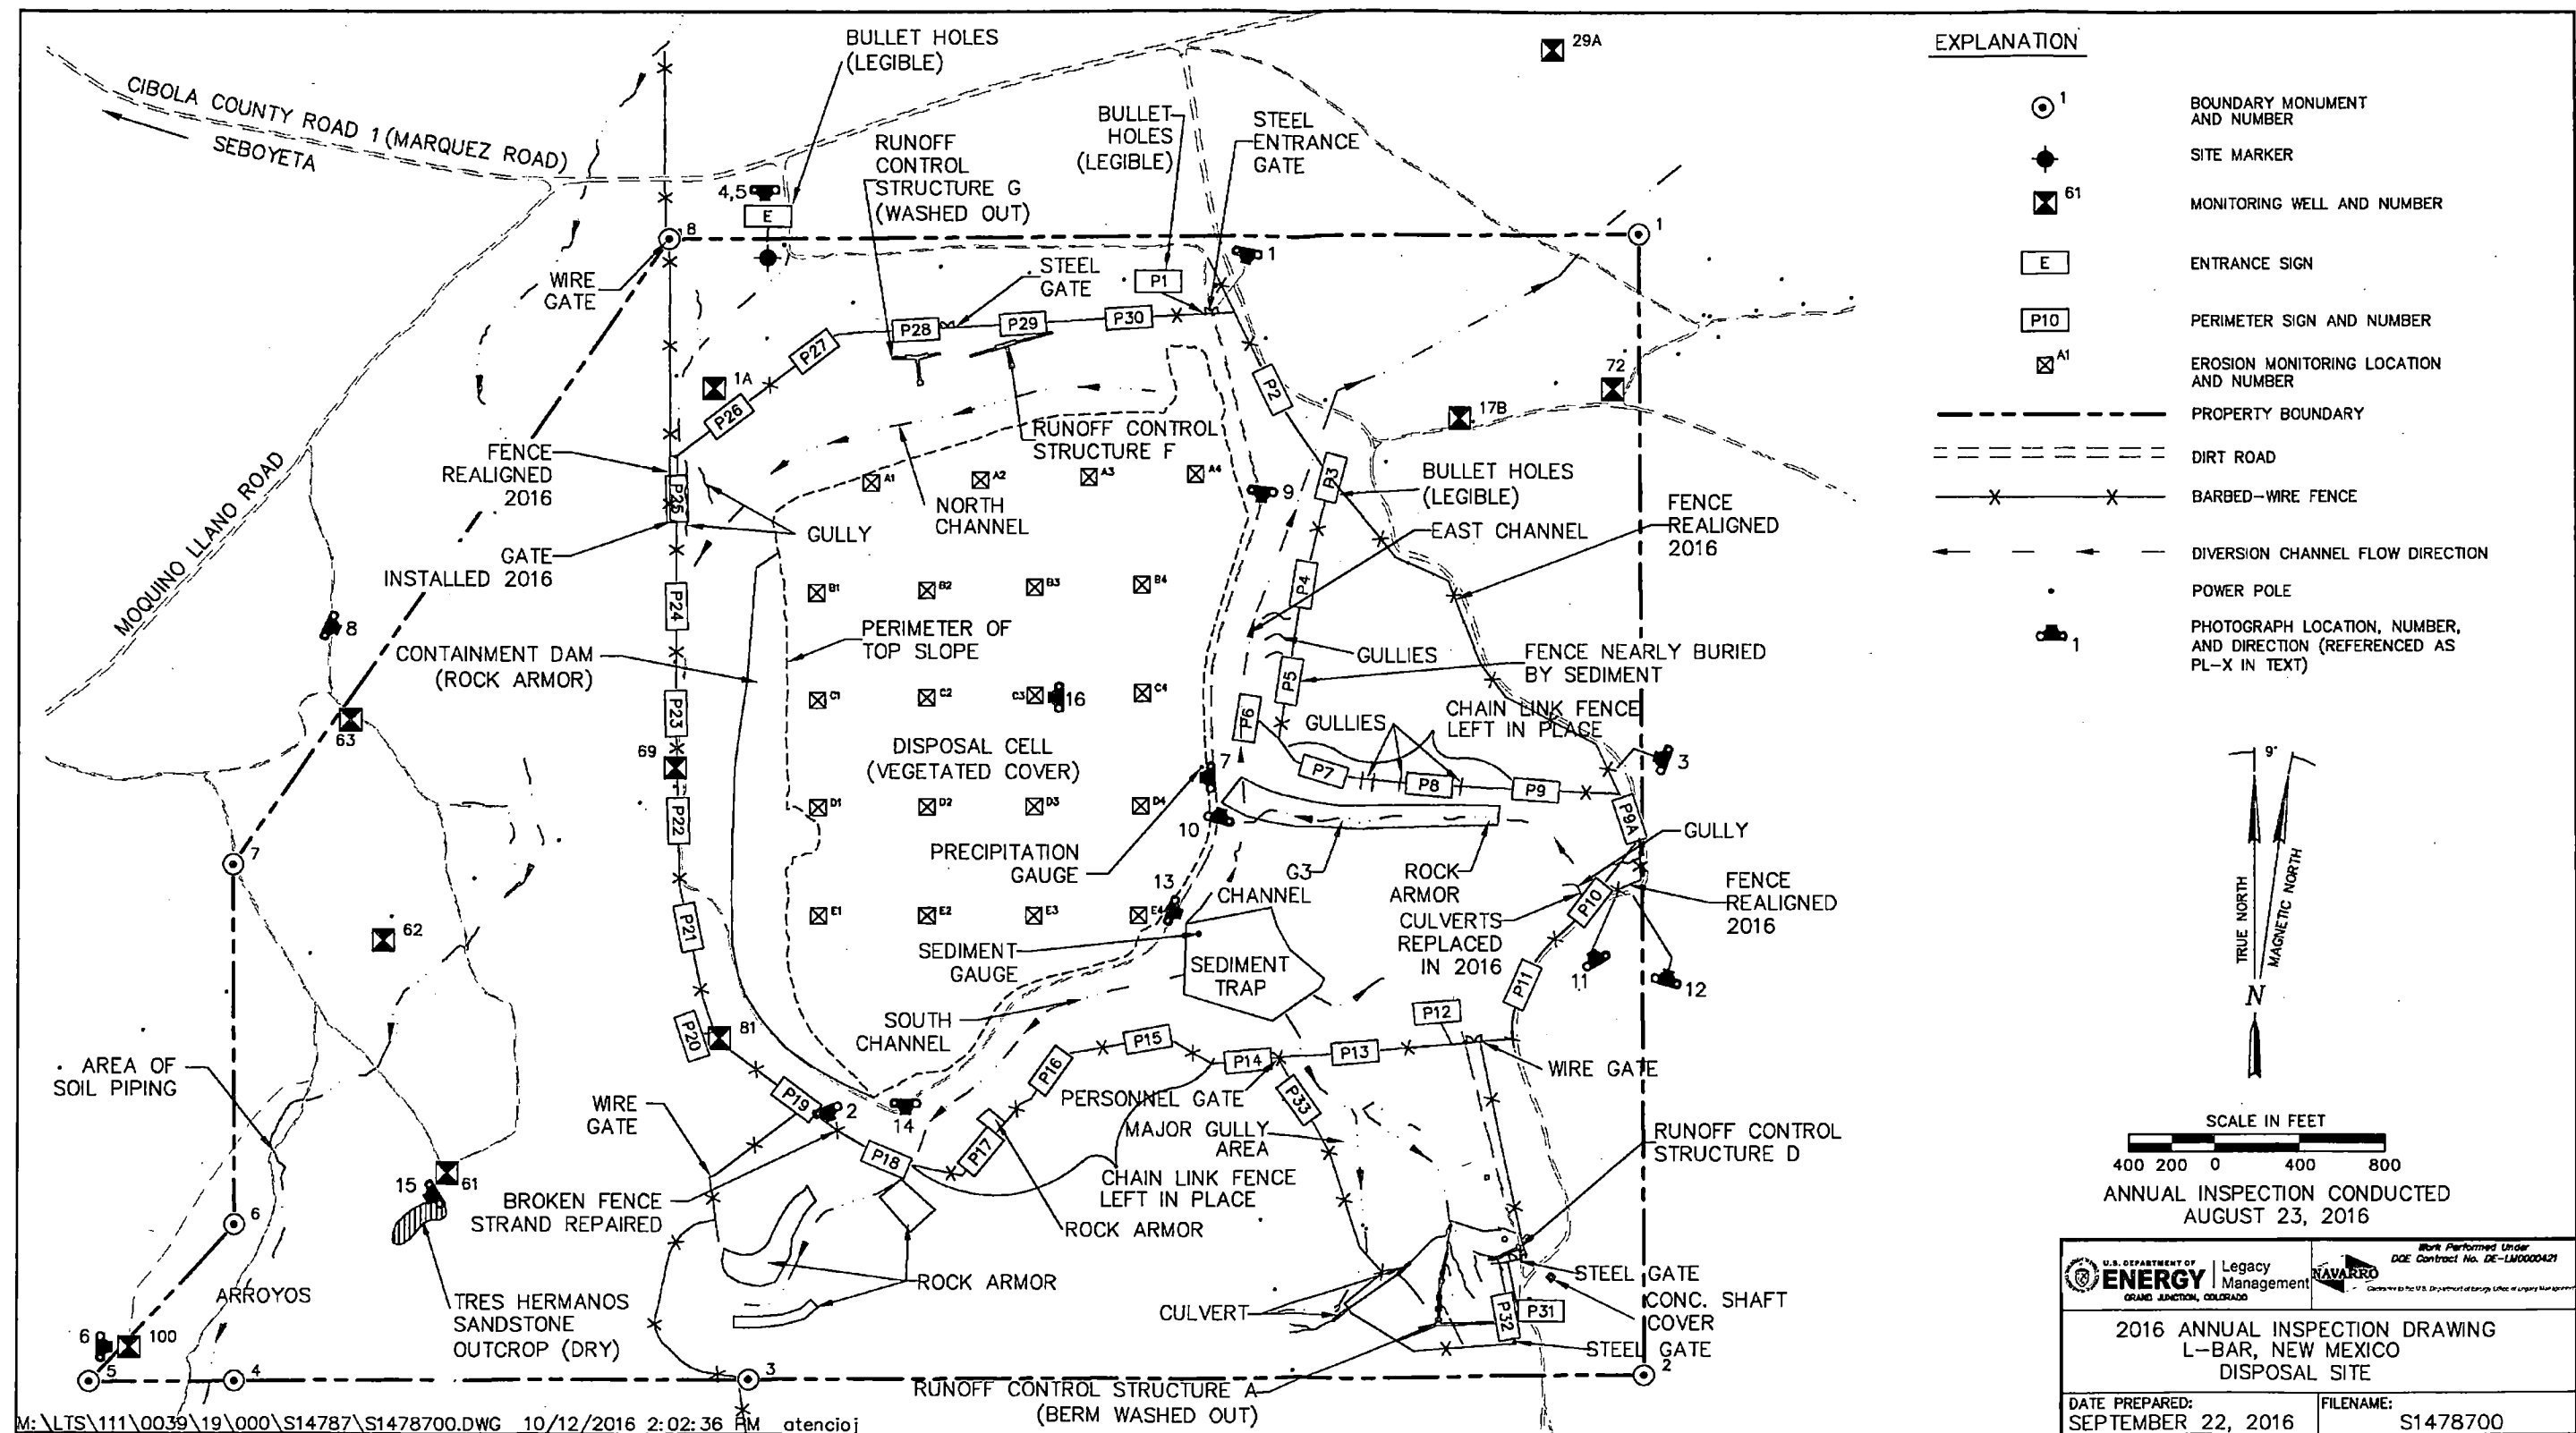
Figure 3-1. 2016 Annual Inspection Drawing for the L-Bar, New Mexico, Disposal Site

In accordance with the EMP, the former licensee installed a grid of 20 evenly spaced monitoring locations on the cover in November 2003. These locations are shown on Figure 3-1. The locations were initially measured in December 2003 to establish a baseline data set.

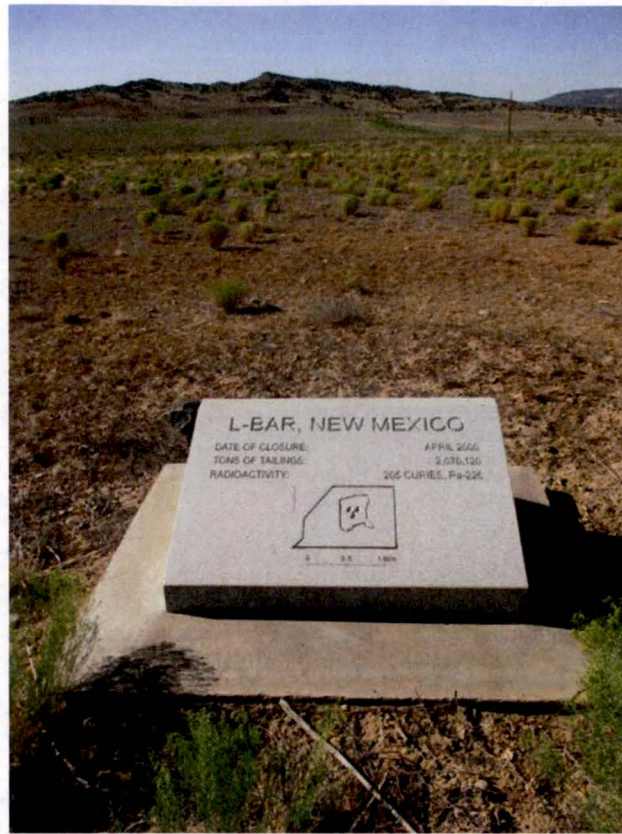
PL-5. Site Marker

The site has one granite site marker, which is located north of the disposal cell adjacent to the site access road (PL-5). No maintenance needs were identified.

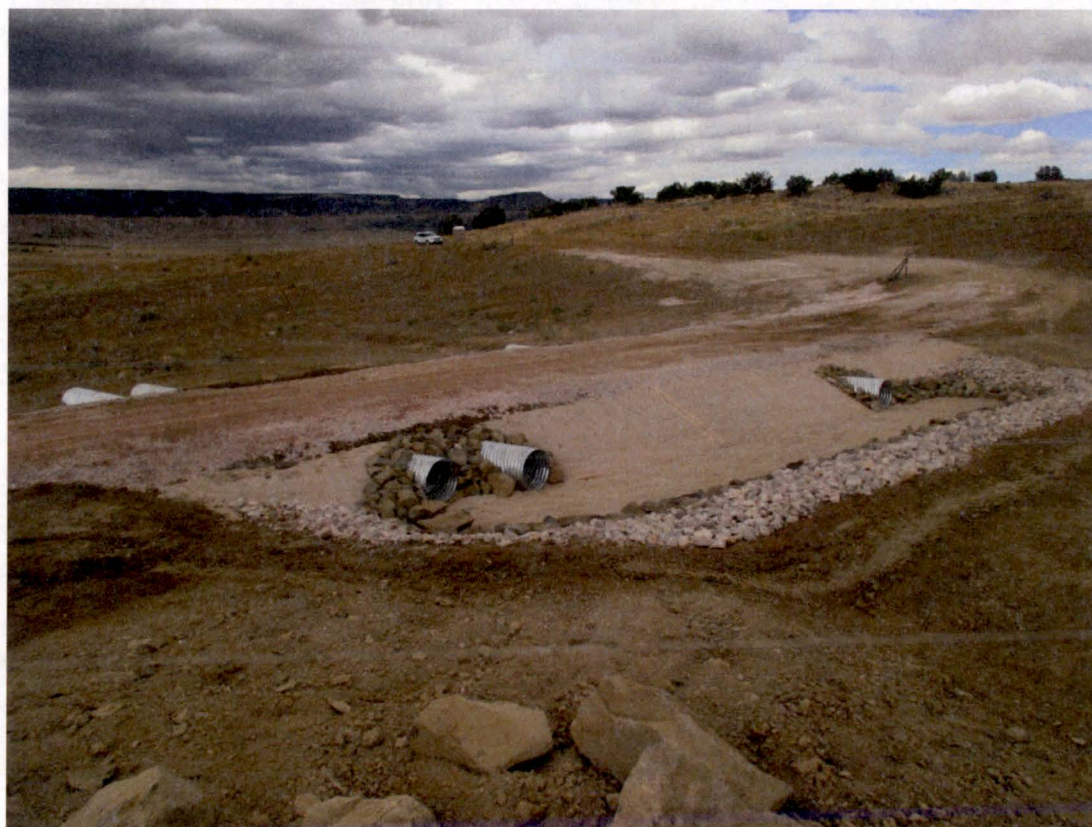
PL-12. New Culvert Across East Site Access Road

- **L-Bar, New Mexico:** Culvert installation was completed at a site access road to prevent further damage from an erosional gully. The section of fence along the east site access road was re-aligned to address impacts from erosion.
- **Sherwood, Washington:** An erosion feature is present at the toe of the tailings dam, and a forest fire on August 2016 impacted portions of the site. A follow-up inspection is planned for late 2016.
- **Shirley Basin South, Wyoming:** Concentrations of radium-226 and radium-228 continued to exceed their respective alternate concentration limits at three wells. NRC concluded that there is no current risk to human health and the environment. Groundwater monitoring will continue in accordance with the LTSP.

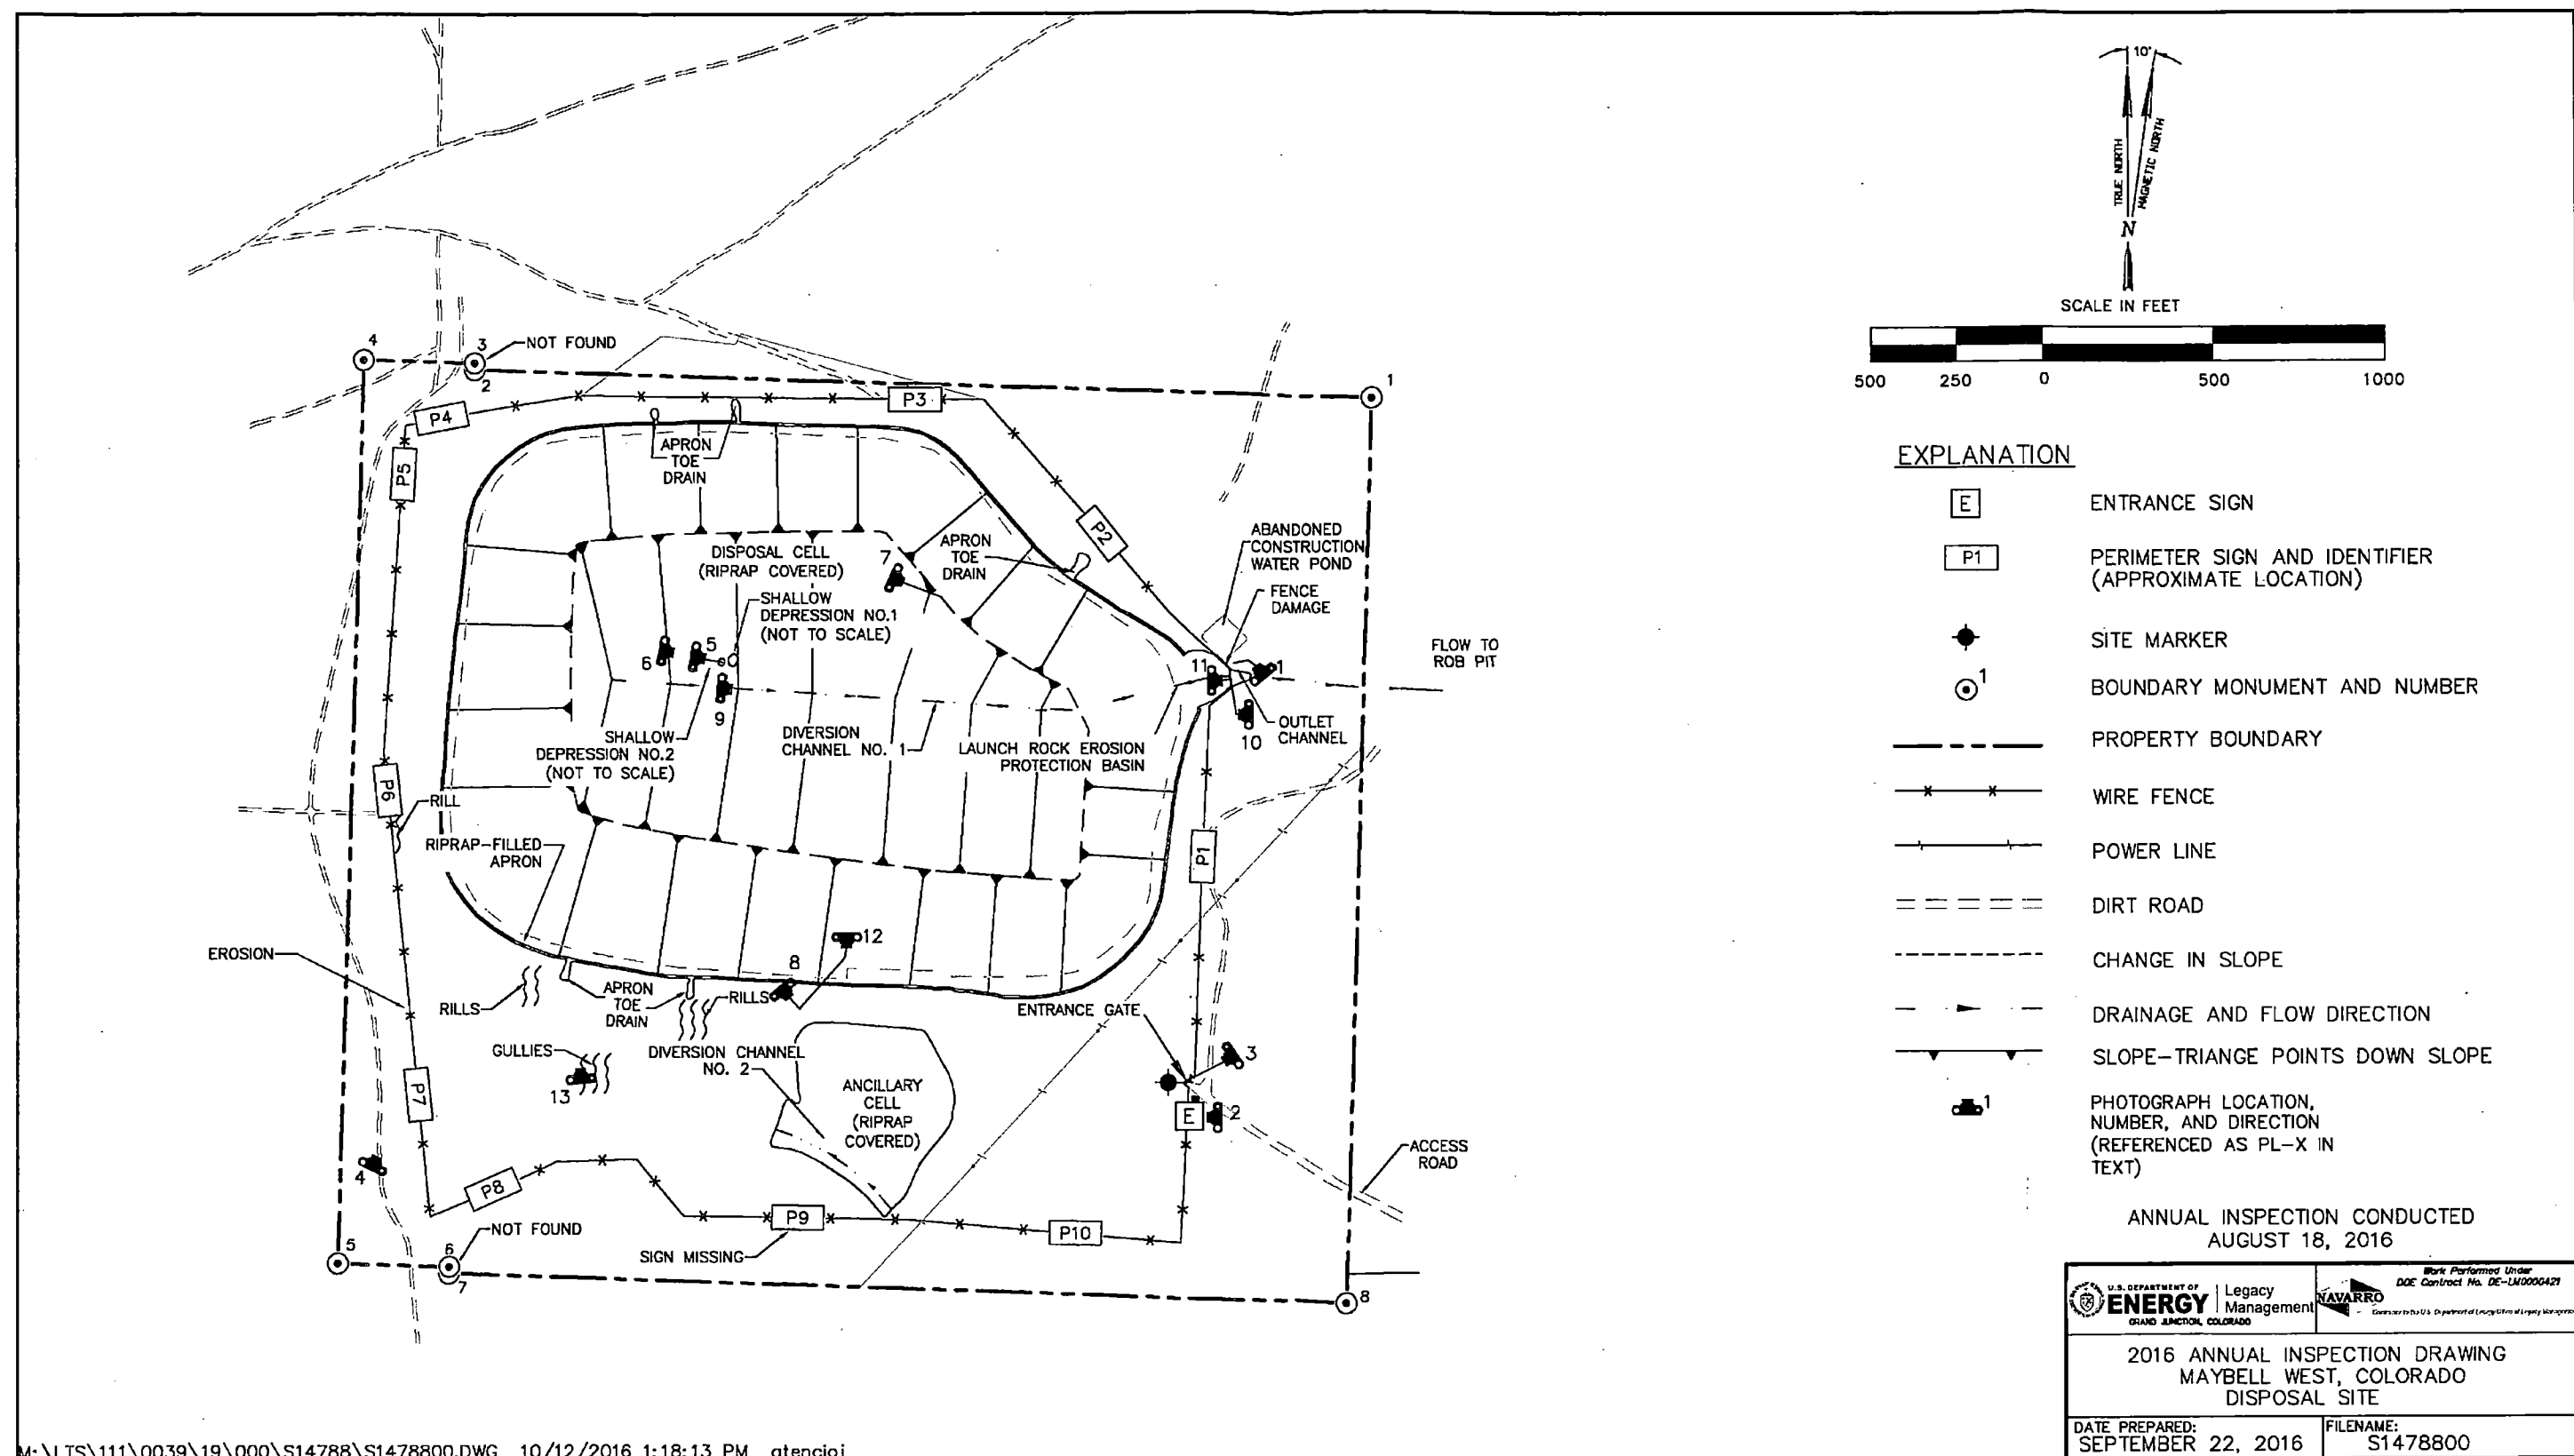
Figure 4-1. 2016 Annual Inspection Drawing for the Maybell West, Colorado, Disposal Site

A standard four-strand barbed-wire stock fence surrounds the disposal cell, the ancillary cell, the drainage structures, and much of the site. The fence facilitates land management by DOE, because the site is in wintering grounds frequented by big game animals (primarily pronghorn, deer, and elk) and is also surrounded by open range land used for cattle grazing. With the exceptions of a damaged fence post and the associated loose fence strands (PL-1) and erosion occurring along a short portion of the fence line, no maintenance needs were identified. Those fence repairs will be made when more significant repairs are needed; the fence remained functional. The entrance sign is mounted on a perimeter fence metal t-post directly south of the entrance gate (PL-2). The entrance sign remains legible. Ten warning or perimeter signs are mounted on perimeter fence metal t-posts around the site. Perimeter sign 9 was missing and will be replaced. The remaining perimeter signs remain legible.

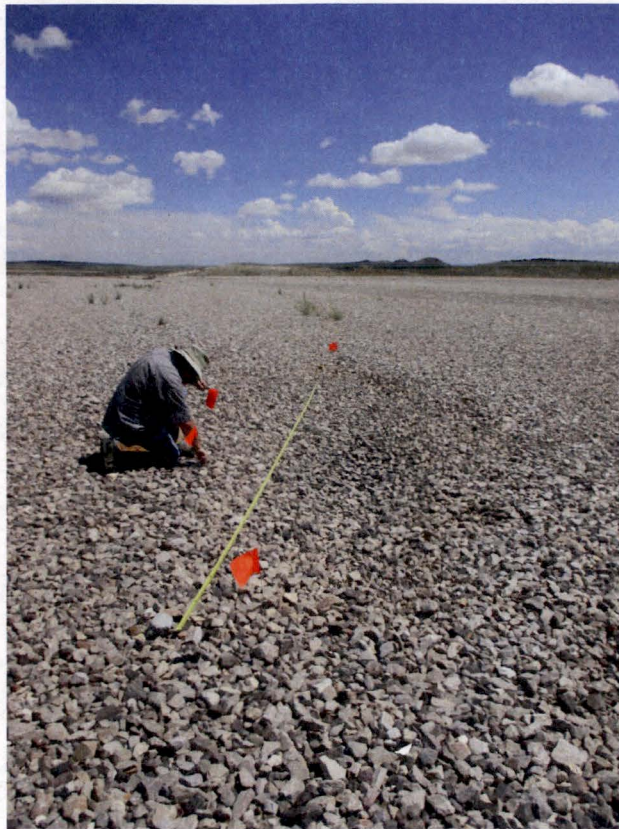
PL-5. Measuring Depression No. 1

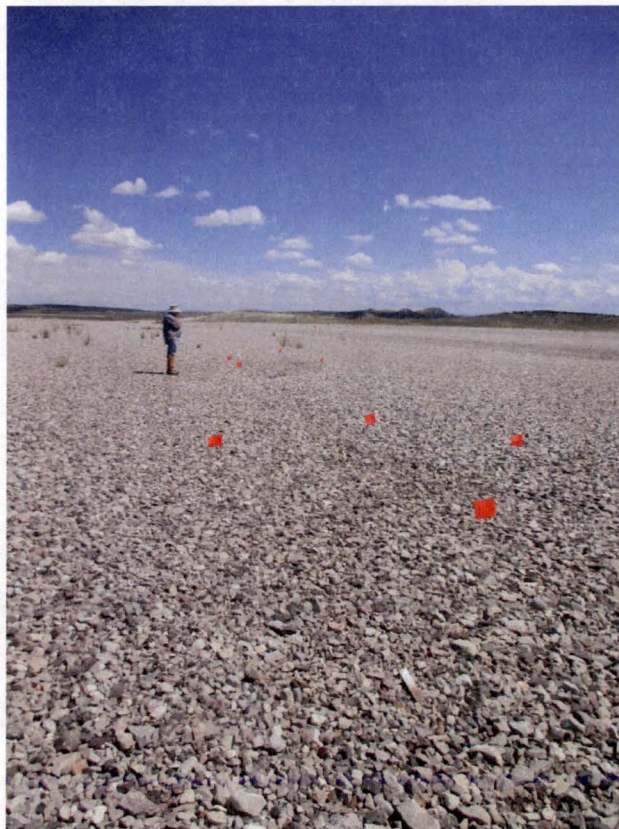
PL-6. Depression No. 1 and No. 2 Marked by Pin Flags

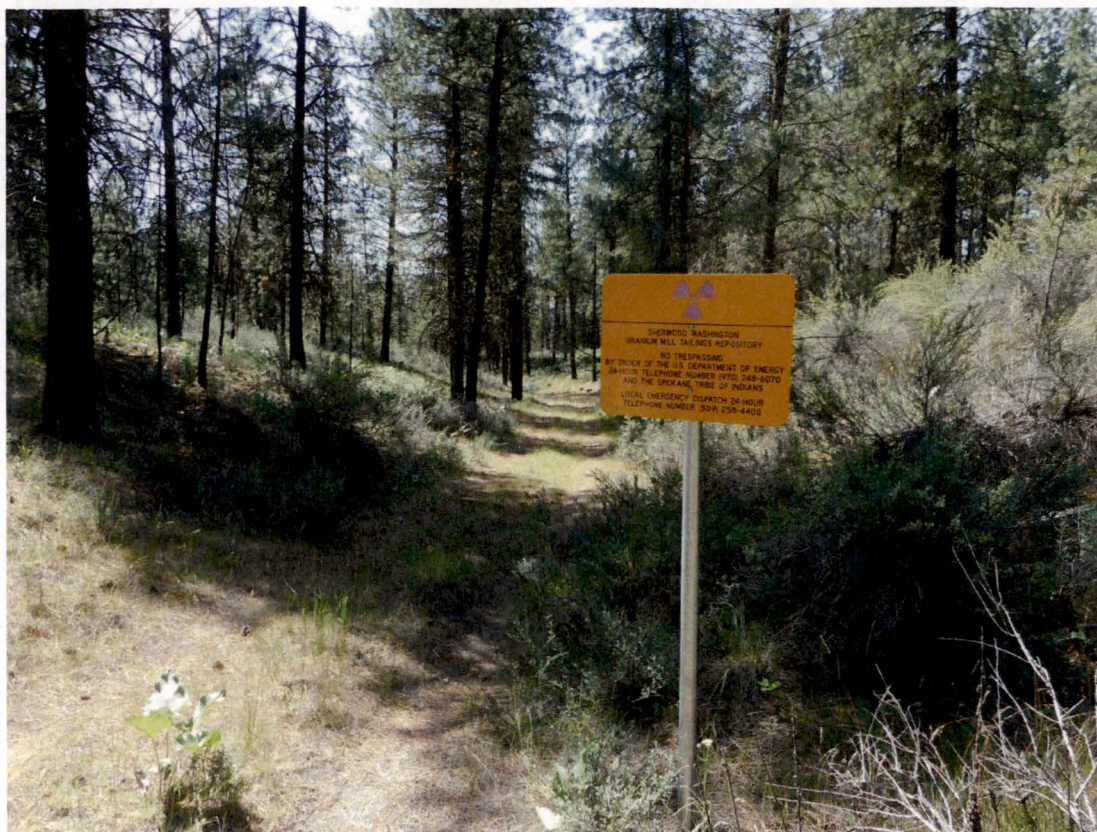
Six warning or perimeter signs, designated P1 through P6, are along the site boundary at likely access points around the site. The signs are attached to steel posts set in concrete. Vandalism of signs commonly occurs, including removal of signs or bullet damage. Text on signs may become illegible due to fading or bullet damage. Missing or illegible signs are replaced as necessary. All of the signs were present and legible, and no maintenance needs were identified (PL-1).

PL-1. Perimeter Sign P4

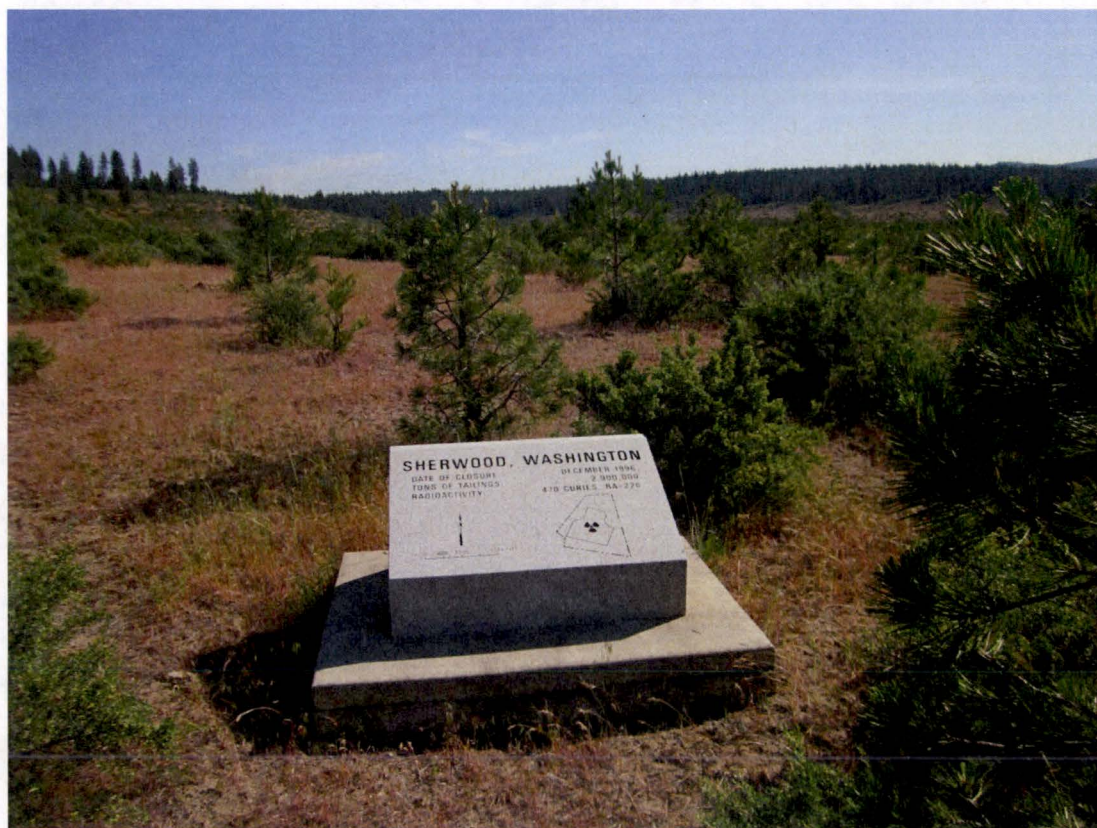
One granite site marker is present on the southwest side of the site where the access road lies closest to the site boundary. Site marker was stable and legible. No maintenance needs were identified (PL-2).

PL-2. Granite Site Marker
