Subject: 2016 Annual Site Inspection and Monitoring Report for Uranium Mill Tailings
Radiation Control Act Title II Disposal Sites

2016 Annual Site Inspection and Monitoring Report for Uranium Mill Tailings Radiation Control Act Title II Disposal Sites

November 2016

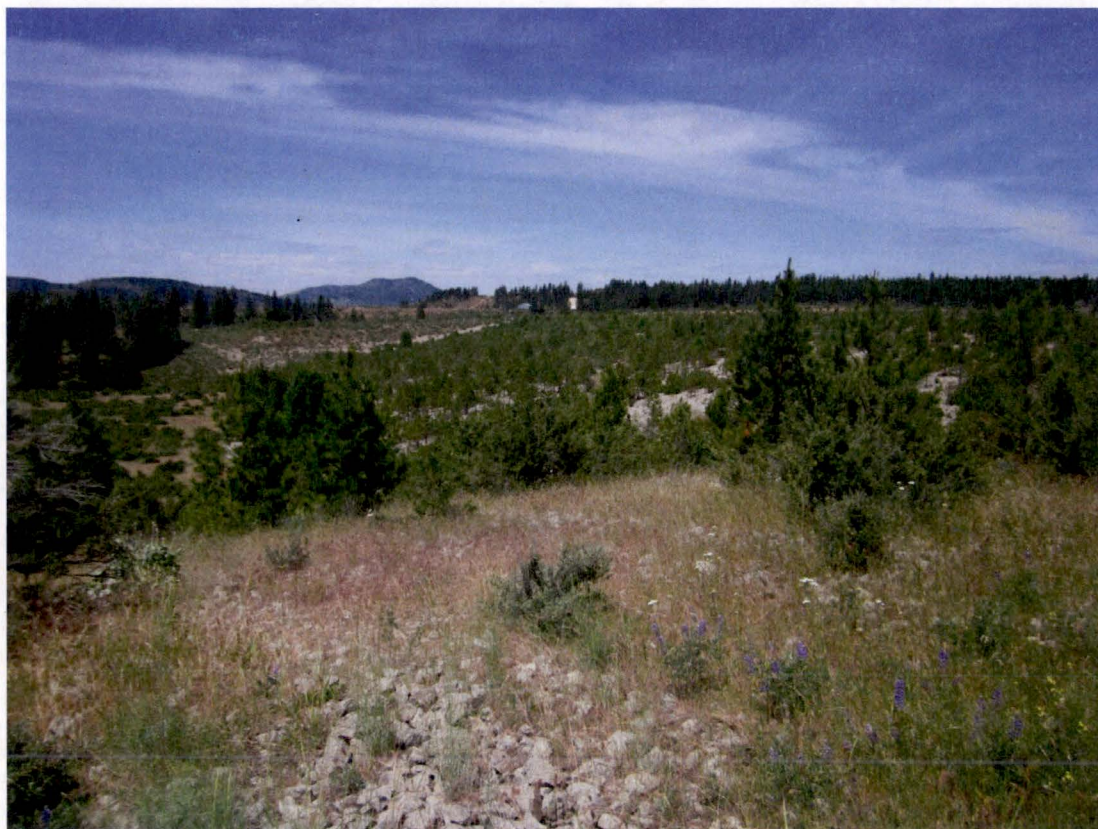
The tailings dam face has a rock cover consisting primarily of highly durable quartz monzonite. The face was designed to allow a vegetated cover, including mature trees, to establish and stabilize the surface and prevent erosion. Consequently, the presence of this vegetation does not harm the function of the dam, and the dam will not be compromised if the rock cover eventually degrades. The dam face is thickly vegetated (PL-6).

PL-6. Face of Tailings Dam, View to West

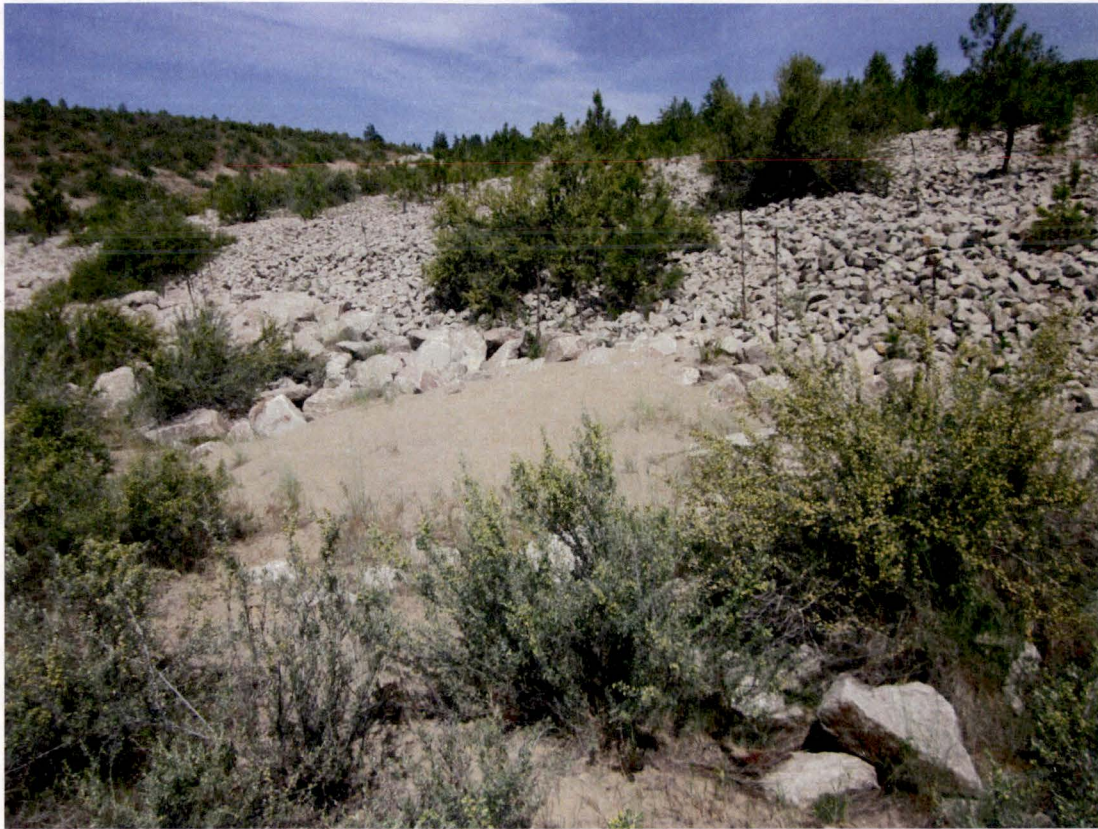
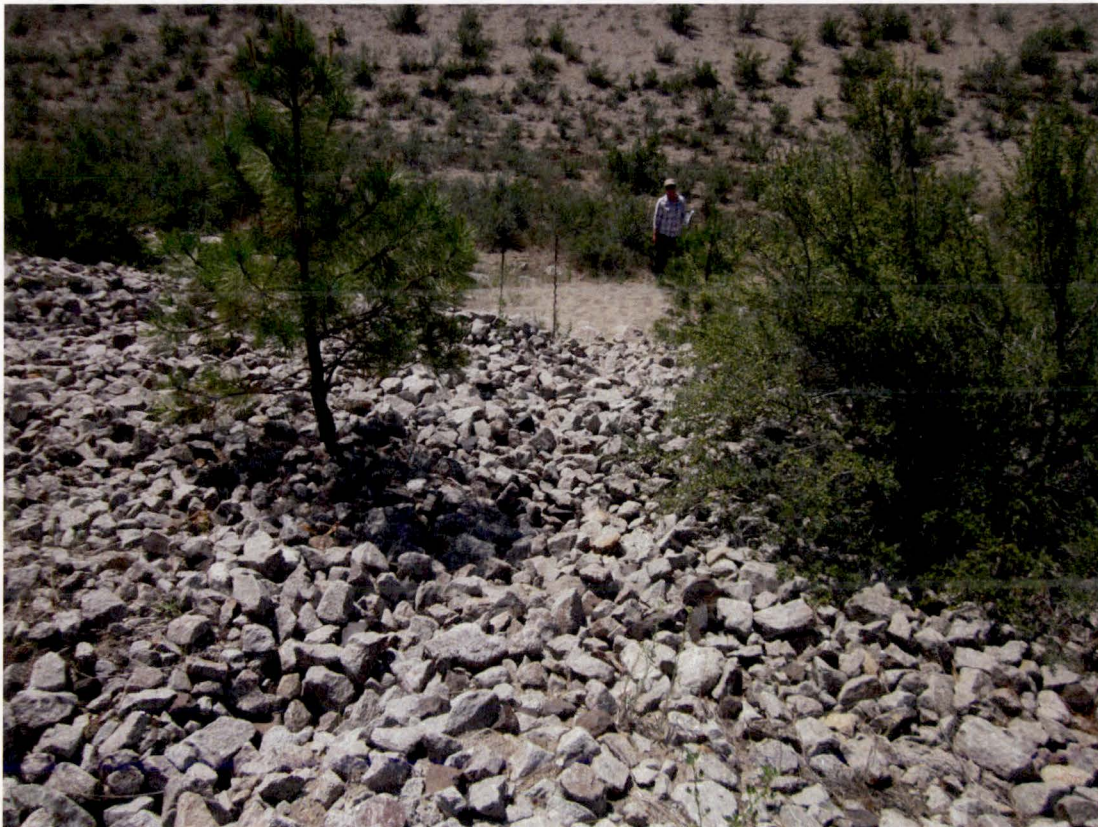
During the 2016 annual inspection, one area at the base of the rock-covered dam face was found to have a fan of sand that had washed out from underneath the rock cover (PL-7, PL-8). A small rill could be traced from the dam base up approximately 50 feet under the cover. The rill ranged from 1 to 2 feet wide and 8 to 12 inches deep. A return visit to the site was performed on October 4 and 5 to evaluate the cause, extent, and repair of the erosion, if required. A report will be transmitted to the NRC upon completion of the engineering evaluation.

DOE conducted a follow-up inspection with engineering staff on October 4 and 5, 2016, to evaluate the sand washout erosional feature. The tailings closest to the washout are approximately 800 feet away. This engineering evaluation by specialists was required to provide information needed to select a remedy. An engineering evaluation report is being completed and will be transmitted to the NRC detailing the summary of findings and if required, the proposed remedy for NRC approval. DOE also assessed impact from the August 22 forest fire which burned over portions of the southeast section of the site. The fire did not burn over the disposal cell and the only damage observed was a scorched perimeter sign which remained legible.

PL-7. Erosion at Base of Dam, View to Northwest

PL-8. Erosion at Base of Dam, View to Southwest

Was evidence of significant erosion observed on the dam? *Yes*
If yes discuss in report: *Sand is washing out from under the rock armored face of the cell at one location (see photos PL-7 and PL-8 in report). A small gully can be followed 50 feet back up the face and is from 8" to 12 deep, approximately 1 1/2 to 2 feet wide. The closest tailings are some 800 feet away in the cell. A second trip to the site will be made to determine the cause, extent, and possible remedy.*

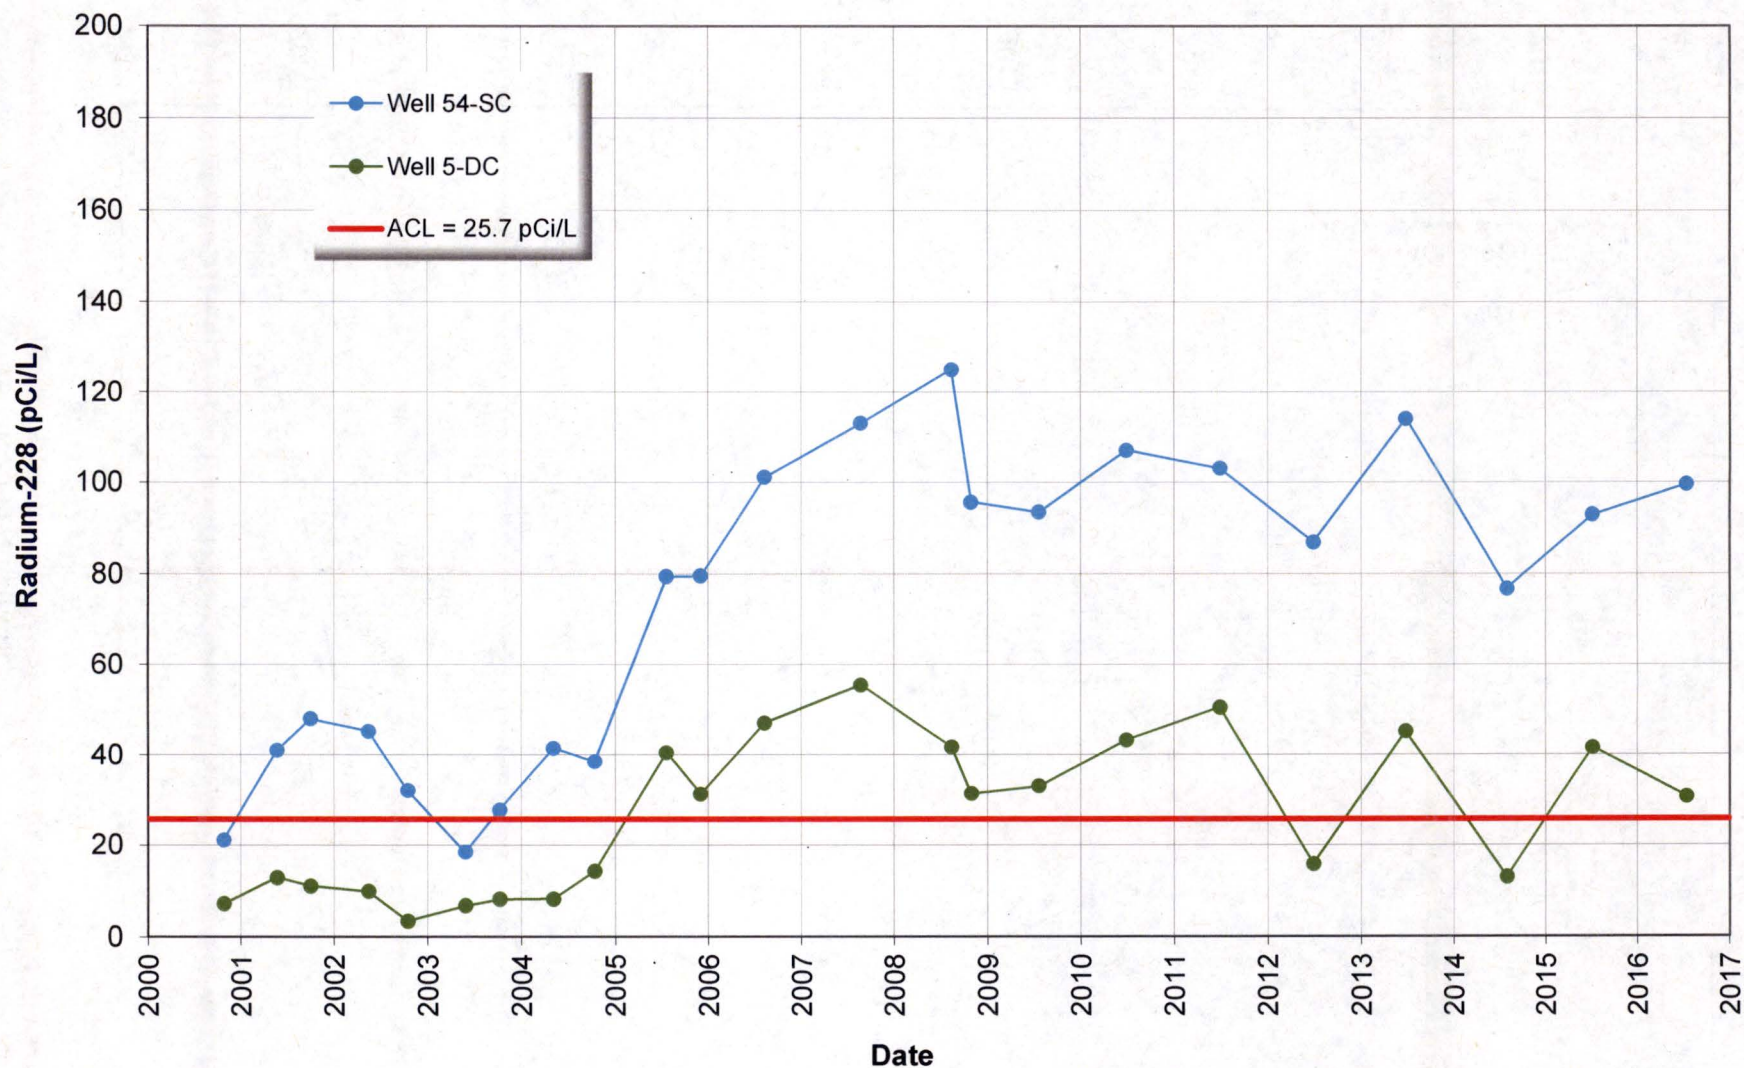
The concentration of cadmium in well 5-SC remained less than the ACL as it has since 2005. Radium-228 continued to exceed the ACL in both wells 54-SC and well 5-DC (Figure 6-2). Additionally, the ACL for radium-226 continues to be exceeded in well 110-DC (Figure 6-3).

Figure 6-2. Radium-228 Concentrations in Wells 5-DC and 54-SC Since Completion of the Disposal Cell at the Shirley Basin South, Wyoming, Disposal Site

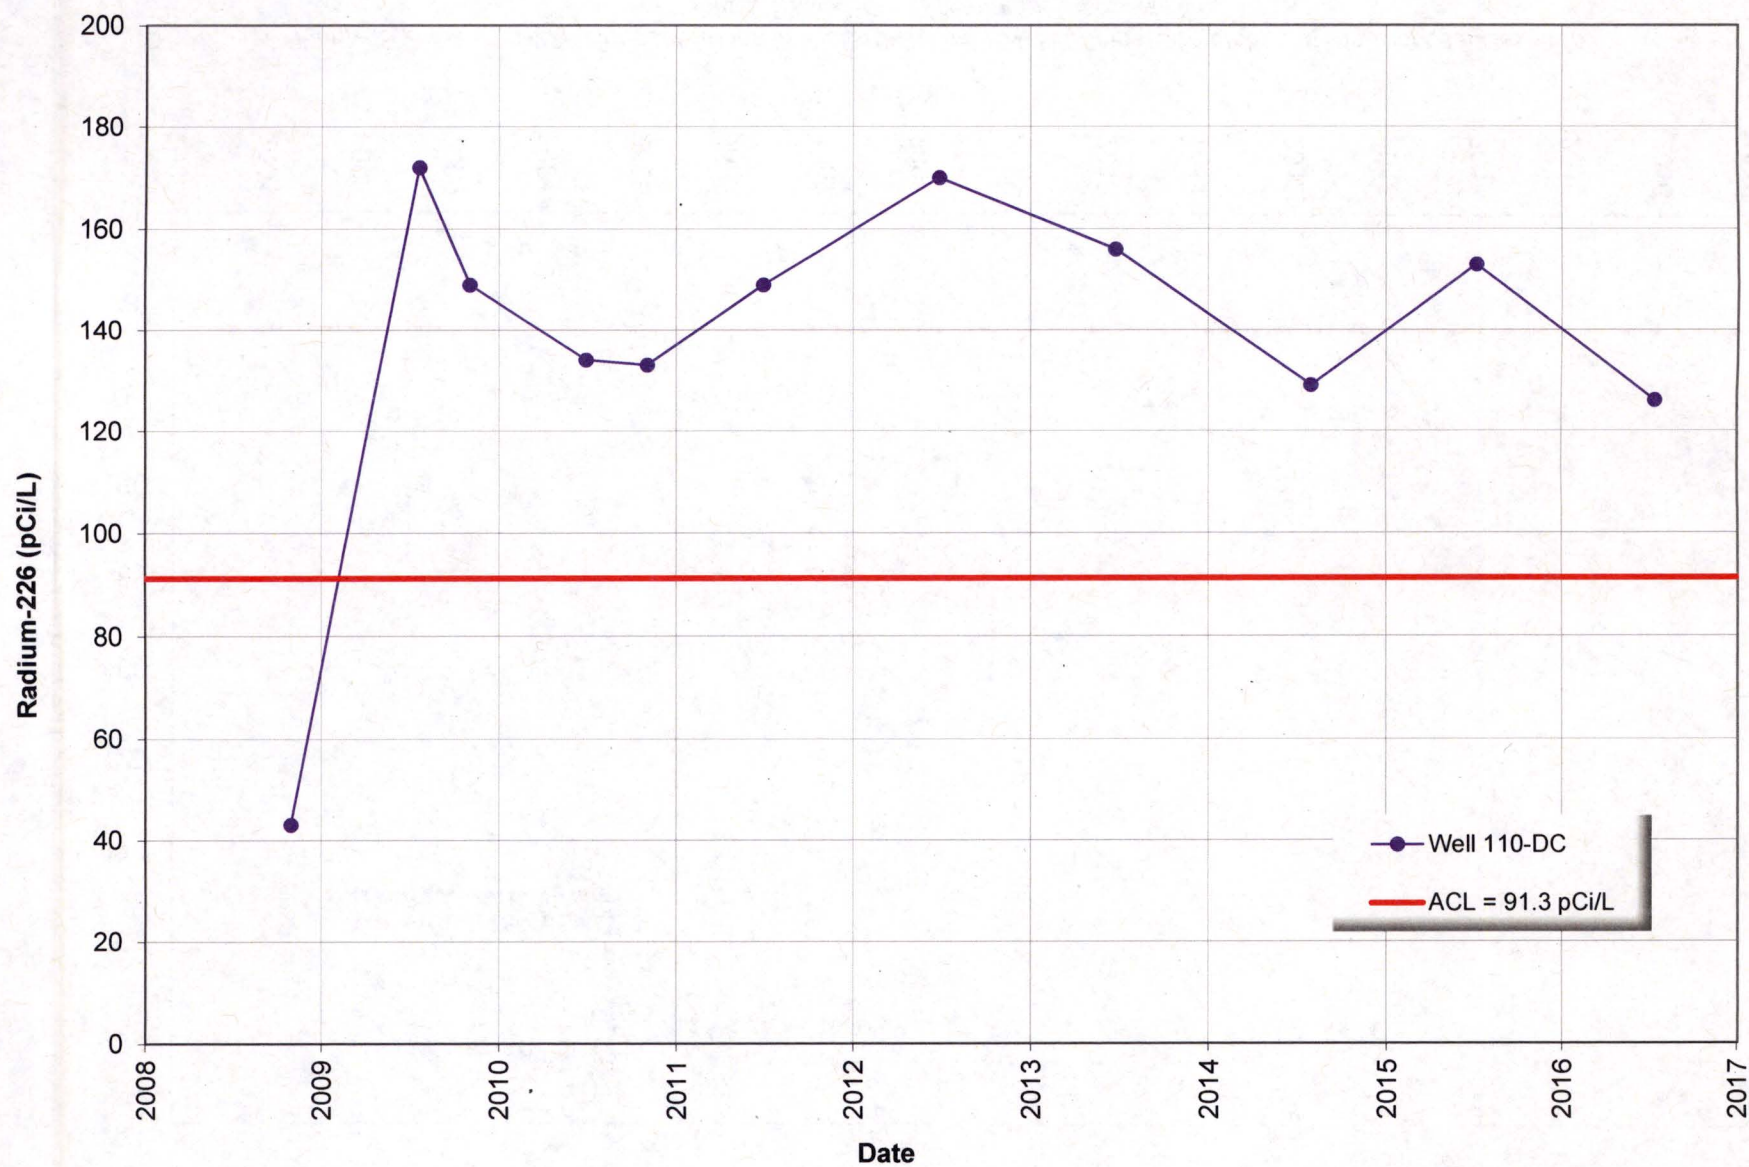
Wyoming Class III groundwater protection standards (applicable only to chloride, sulfate, and TDS) apply to water quality at the site boundary. The standards were met at the downgradient site boundary wells (100-SC, 102-SC, 110-DC, 112-DC, and 113-DC). The standards were exceeded for sulfate and TDS in wells 5-SC, 54-SC, and 5-DC; for radium-228 in wells 54-SC and 5-DC; and for radium-226 in well 110-DC. The 2016 results were within the range of historical measurements for these wells. The exceedances are found in wells near the disposal cell except for the radium-226 exceedance at well 110-DC. Well 110-DC is near a uranium ore deposit and the radium-226 concentration is around 17 times that of the upgradient POC well 5-DC. Therefore, the radium-226 in well 110-DC is probably naturally occurring.

Figure 6-3. Radium-226 Concentrations in Well 110-DC at the Shirley Basin South, Wyoming, Disposal Site

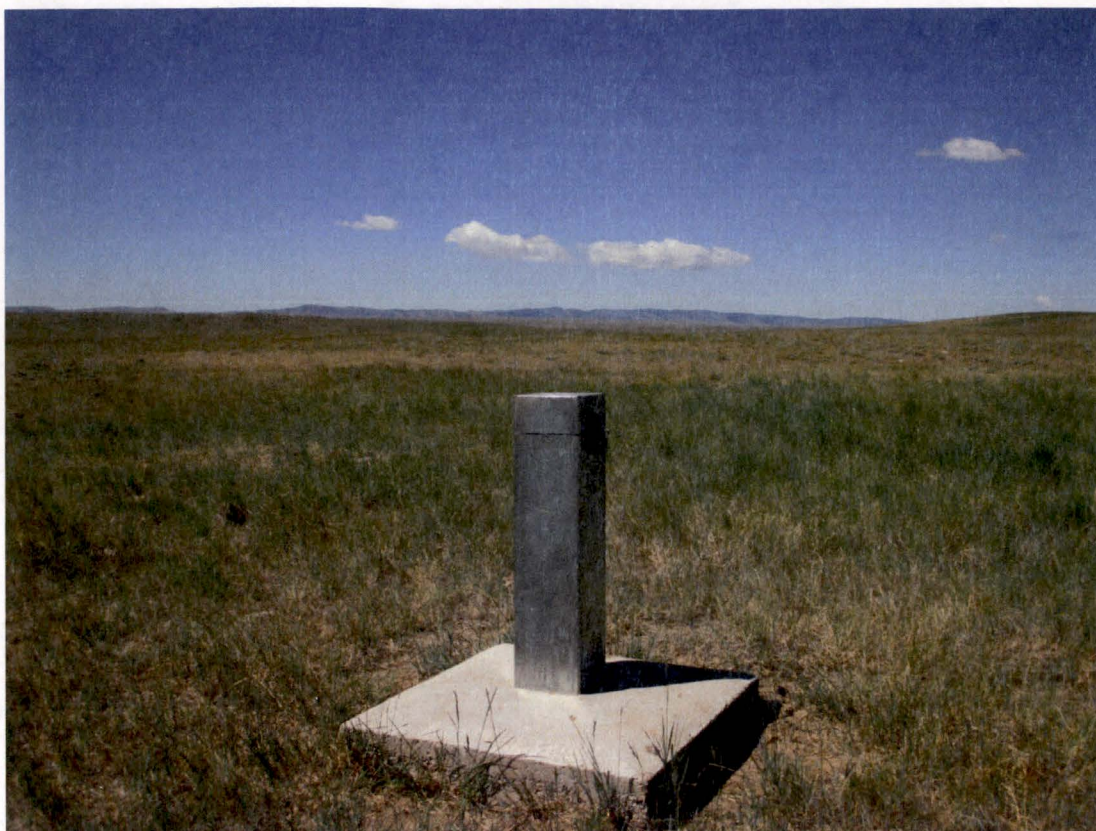
The site groundwater monitoring network consists of 14 wells; six of these wells were installed downgradient of the disposal cell in the fall of 2008. The wellhead protectors were undamaged and locked (PL-5). No maintenance needs were identified.

PL-5. Monitoring Well 113-DC

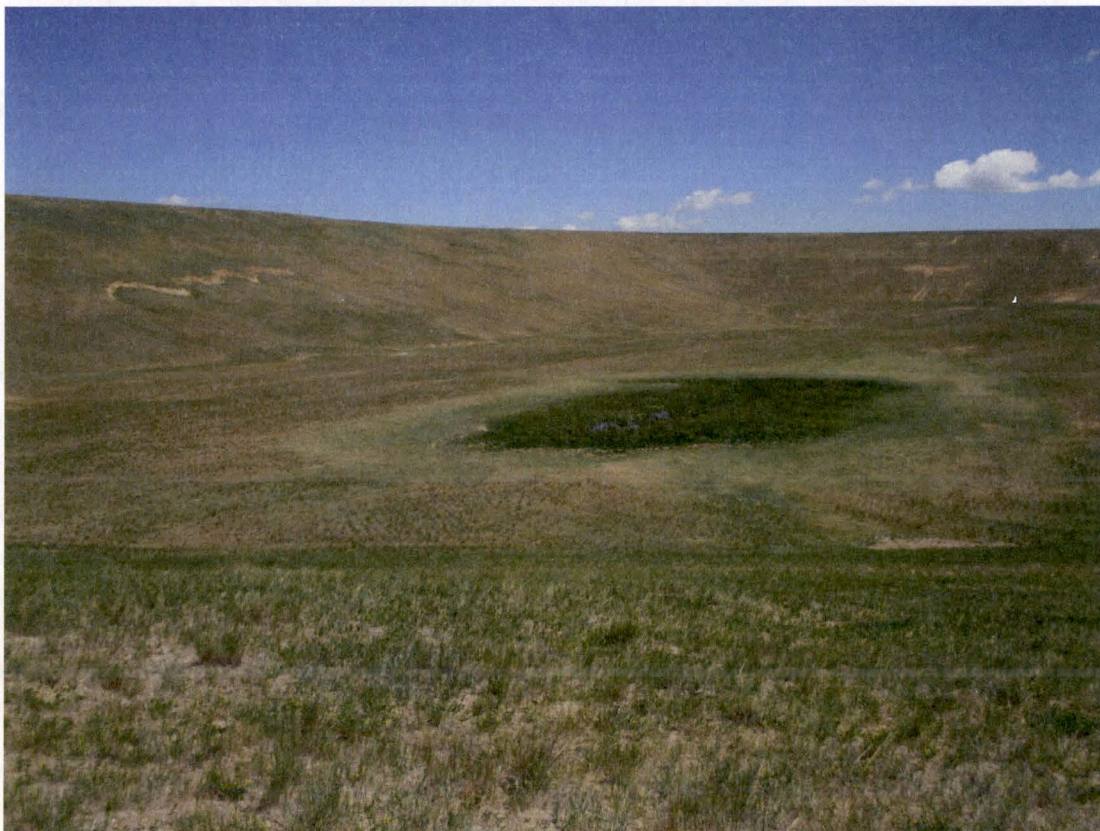
PL-12. Wetland Area at Bottom of Pit 4

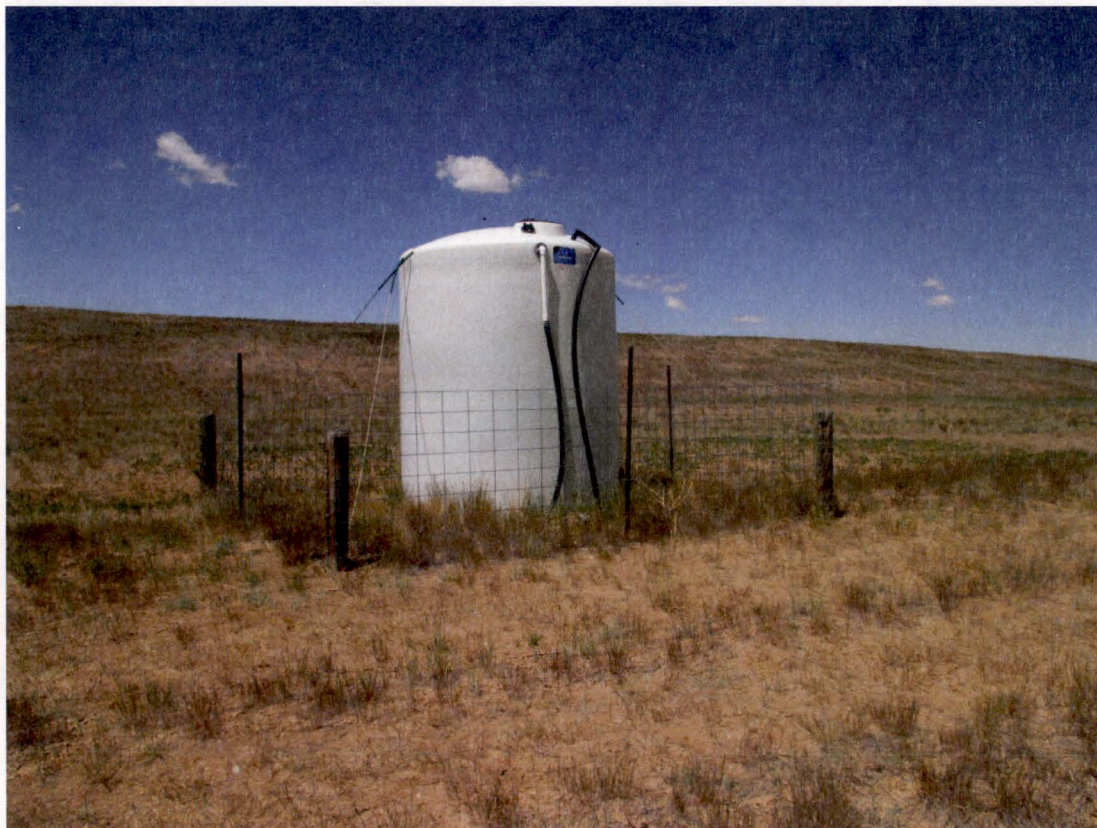
PL-14. Stock Water Holding Tank (Water from Well K.G.S. #3)
