Alloy 152/52-LAS Dilution Zone and Interface/Fusion Line PWSCC Testing

***Mychailo Toloczko, Matt Olszta,
Nicole Overman, and Steve Bruemmer***
Pacific Northwest National Laboratory

EPRI 690/ 152/ 52 PWSCC Research Collaboration Meeting
Nov 29 to Dec 1 • Tampa, FL

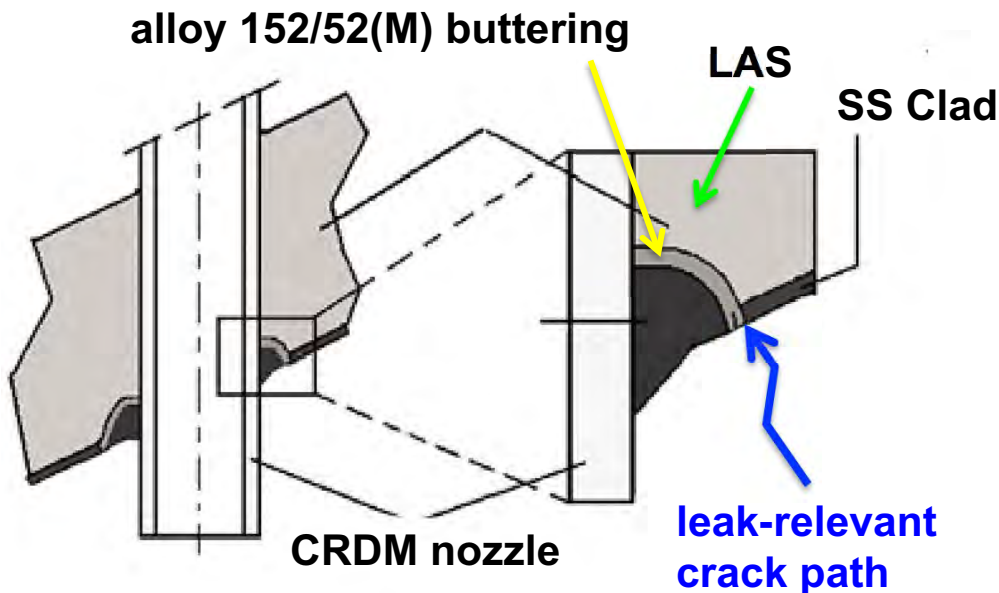
CRDM Nozzle J-Groove Weld

- ▶ Greatest concern is dilution zone against low alloy steel (LAS).
- ▶ Potential continuous dilution leak paths do exist for both CRDM welds and DMW nozzle welds.
- ▶ Must first crack through alloy 152/52-SS dilution in some welds.

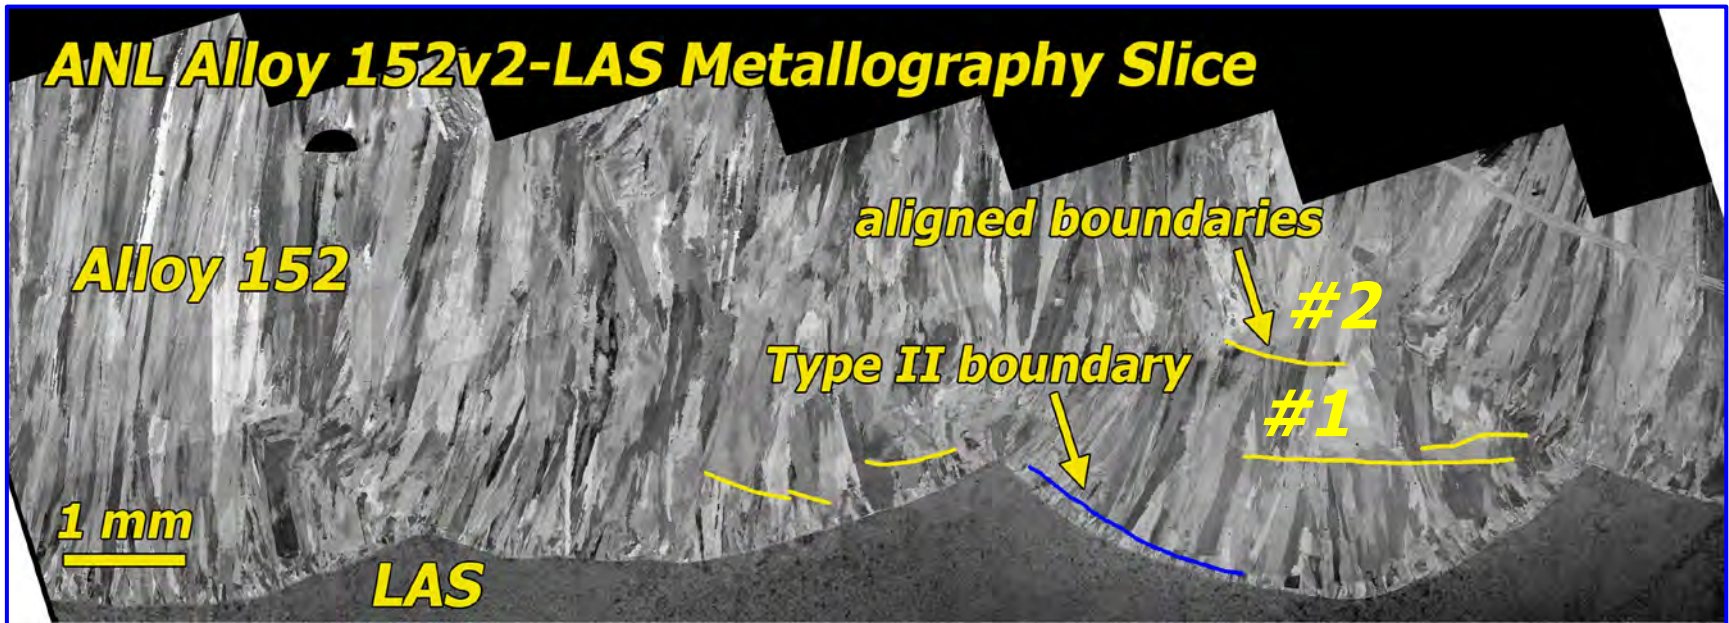
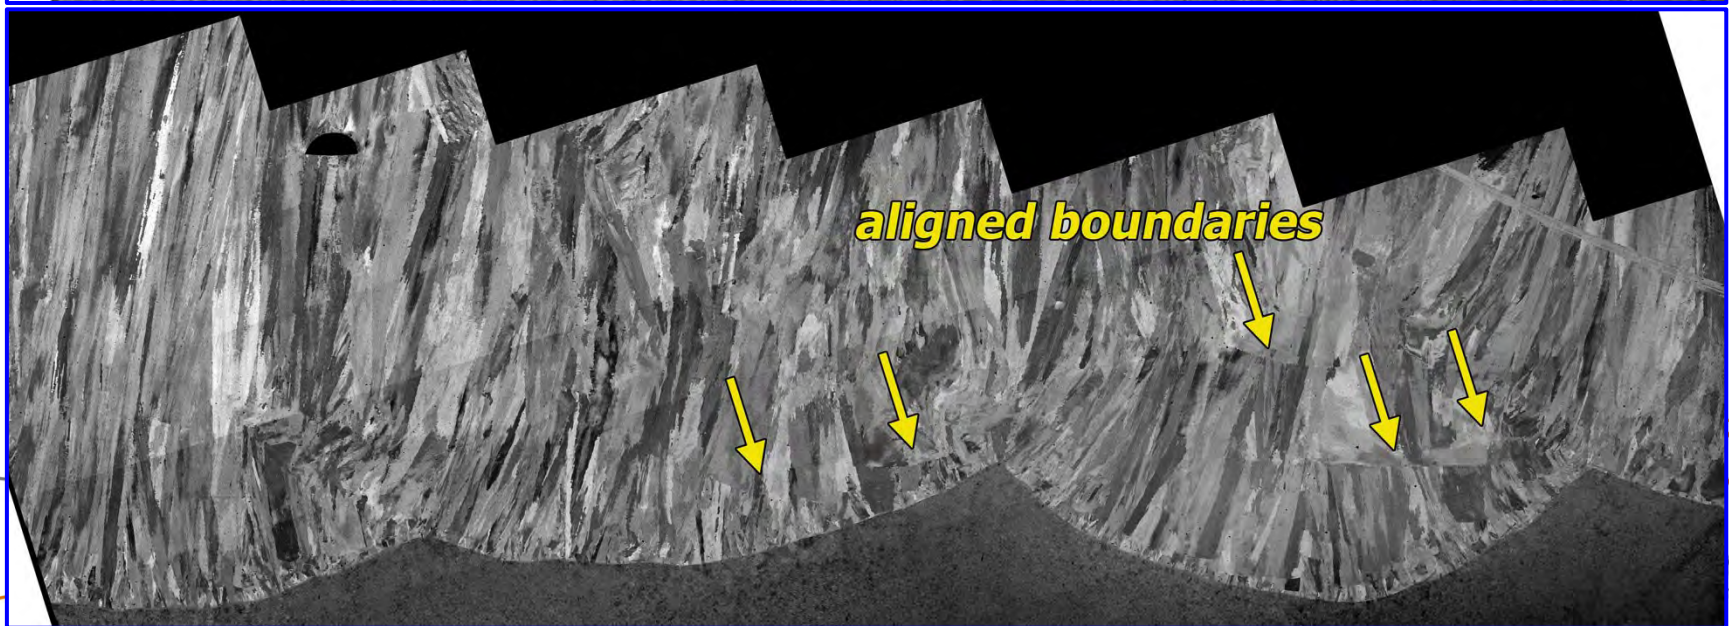
Favorably Aligned Boundaries in ANL Alloy 152v2-LAS Metallography Slice

- ▶ Weld grains are predominantly needle-shaped with long axis parallel to the weld-LAS interface normal, $\sim 300\ \mu\text{m}$ dia. $\times \sim 0.5\text{-}3\ \text{mm}$.
- ▶ Leak-relevant crack path (parallel to fusion line) is not aligned to the needle orientation.
 - Unfavorable for IG cracking along these typical weld grain boundaries.
- ▶ Low density of favorably aligned boundaries have been observed.
 - Can be $>1\ \text{mm}$ from the fusion line. Much further from the fusion line than typical Type II boundaries.
 - SCC growth on these boundaries has been observed.

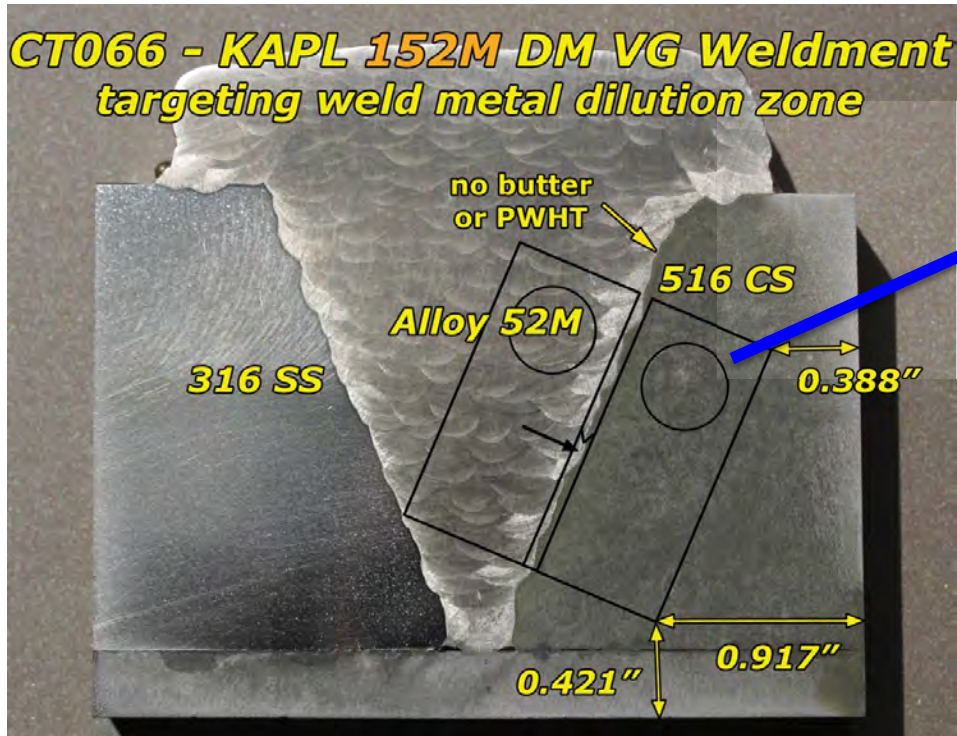
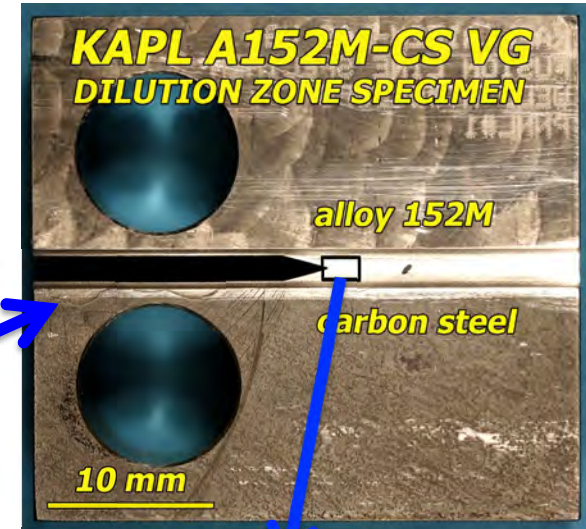
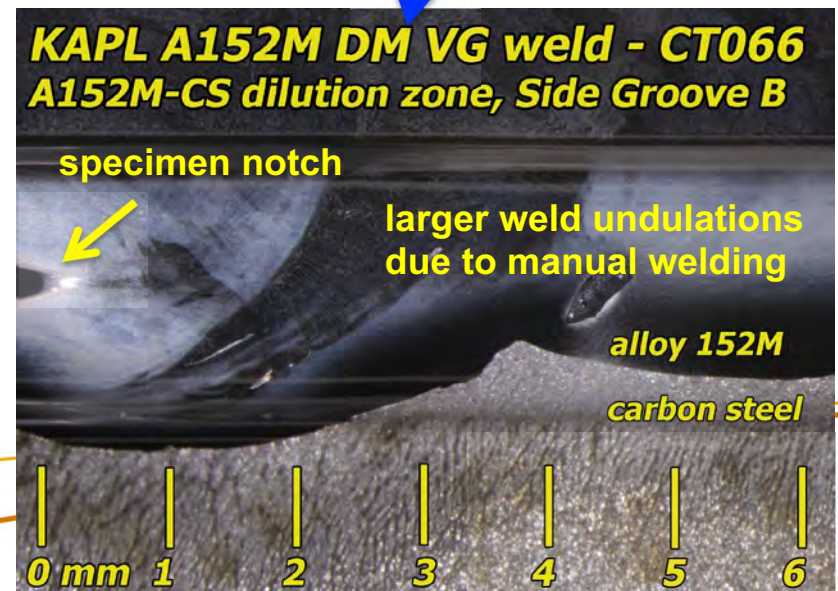
KAPL Alloy 152M weldment

Goal was to measure weld dilution zone response ~0.5-1 mm from fusion line.

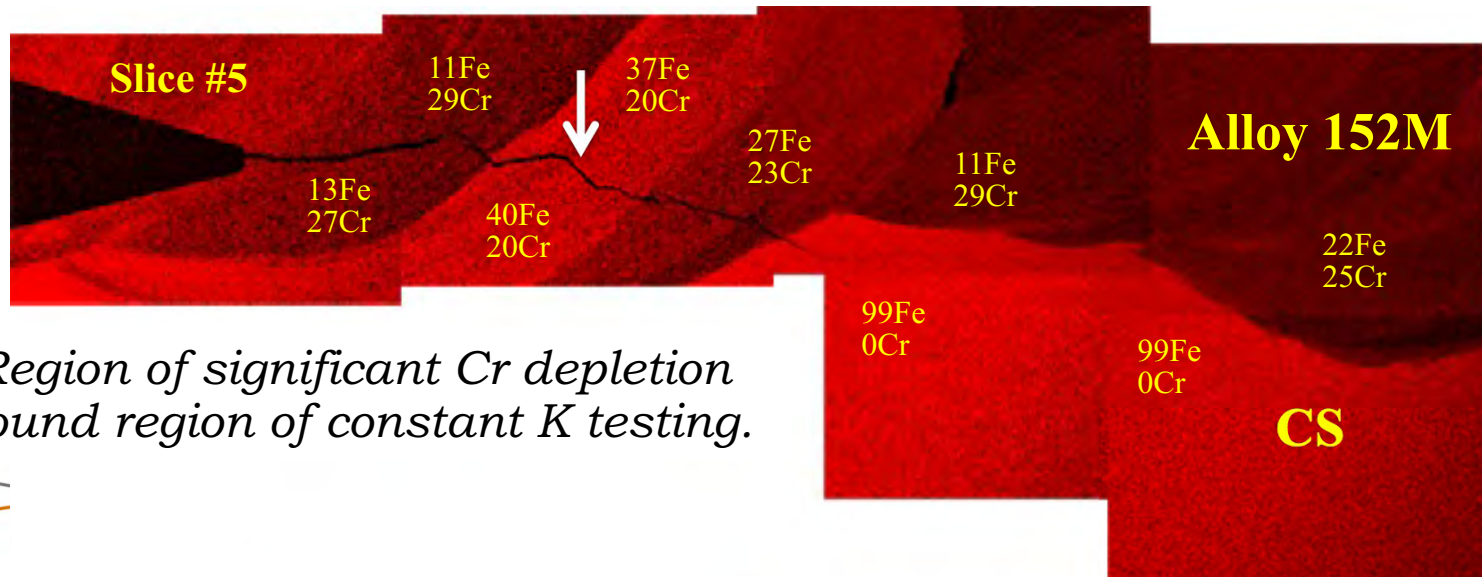
Companion
SEM Fe-K
EDS Map

- Low constant K CGR.
- Typical grain boundaries are not oriented for IG growth.
- Exams of crack profile and crack surface showed predominately TG cracking.

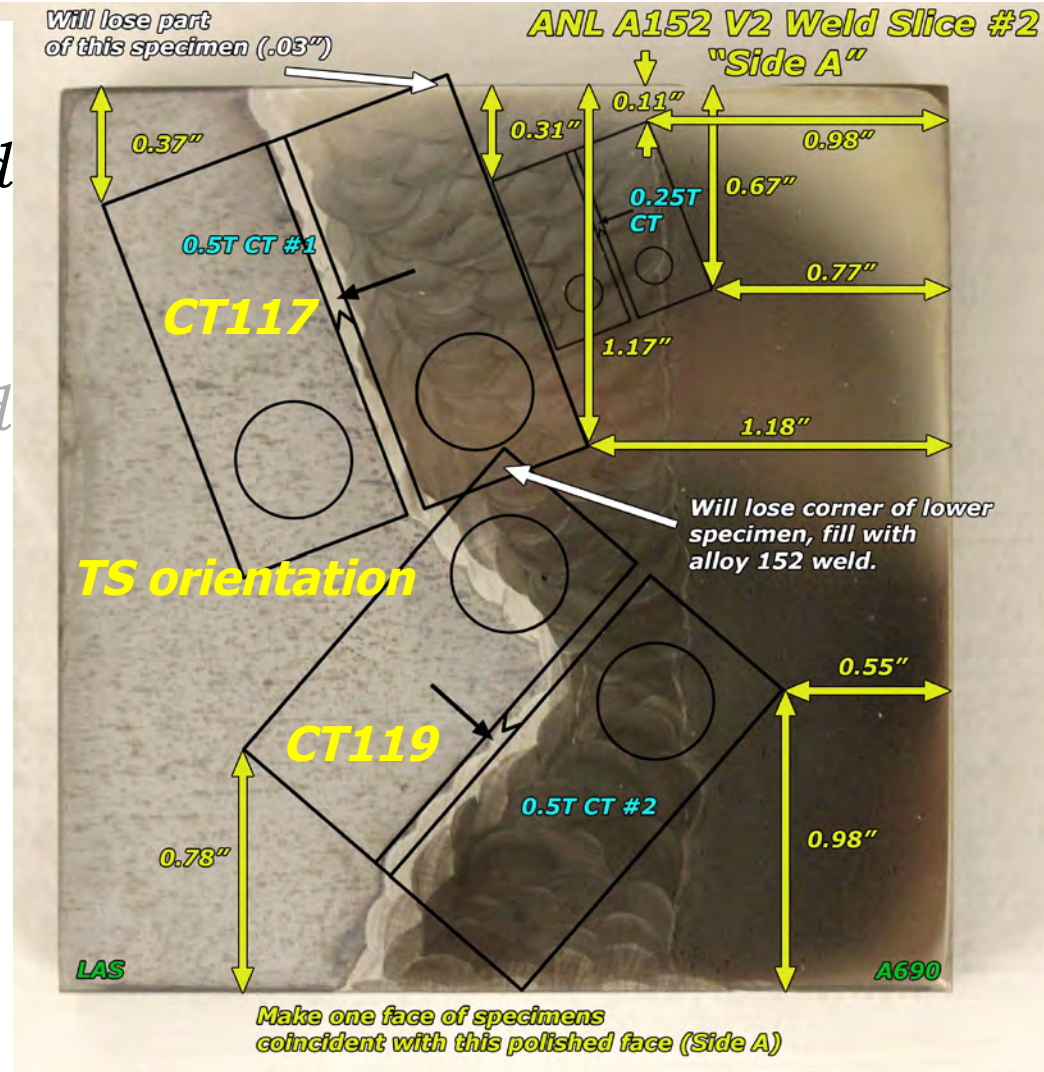
A152v2-LAS DZ PNNL #1 (CT117) and #2 (CT119)

- ▶ Targeted dilution zone
- ▶ CT117 and **CT119** tested separately.
- ▶ Cut from same weldment as ANL N152-LAS-11 and N152-LAS-1 specimens where high high SCC CGRs were observed by tests at ANL.

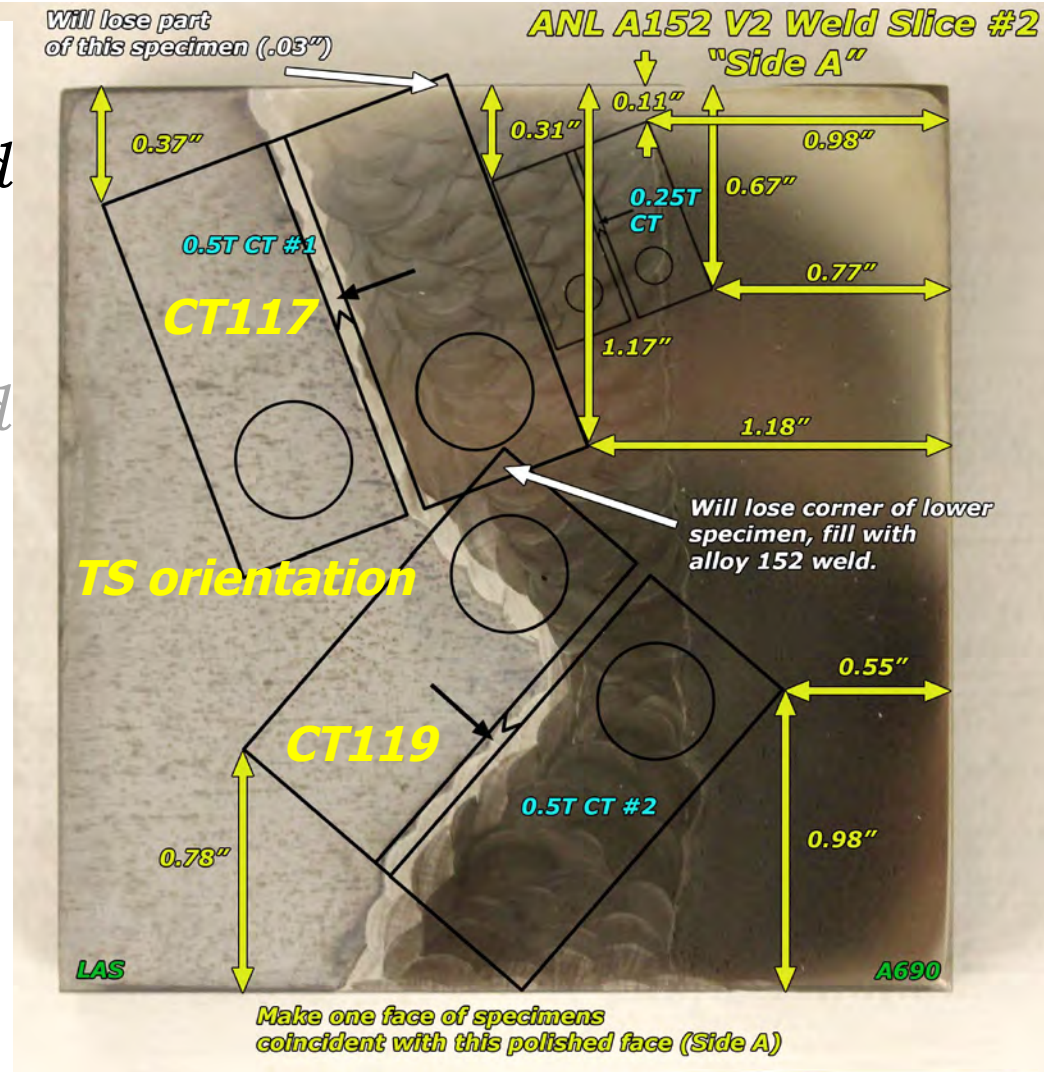
A152v2-LAS DZ PNNL #1 (CT117) and #2 (CT119)

- ▶ Targeted dilution zone
- ▶ **CT117** and CT119 tested separately.
- ▶ Cut from same weldment as ANL N152-LAS-11 and N152-LAS-1 specimens where high high SCC CGRs were observed by tests at ANL.

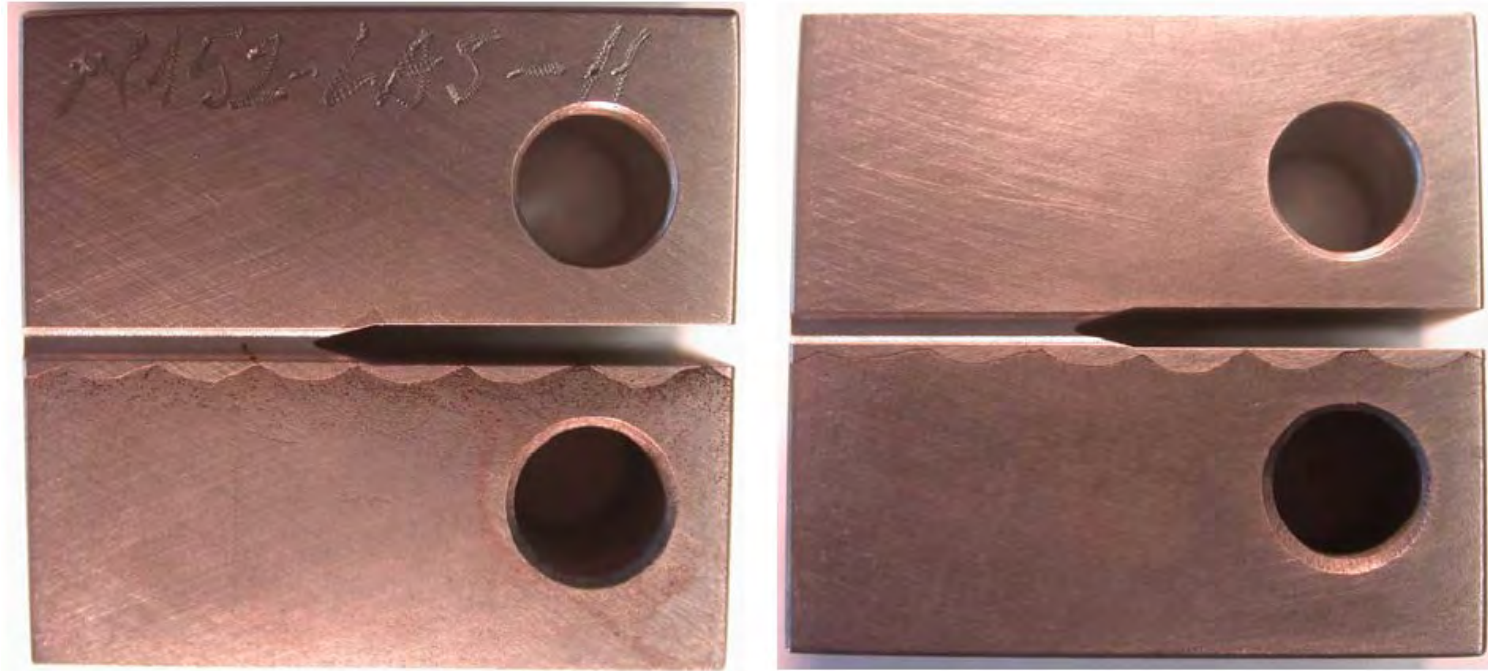
Both sides of the specimen

- ▶ *N152-LAS-11 is well aligned to potential dilution zone regions.*

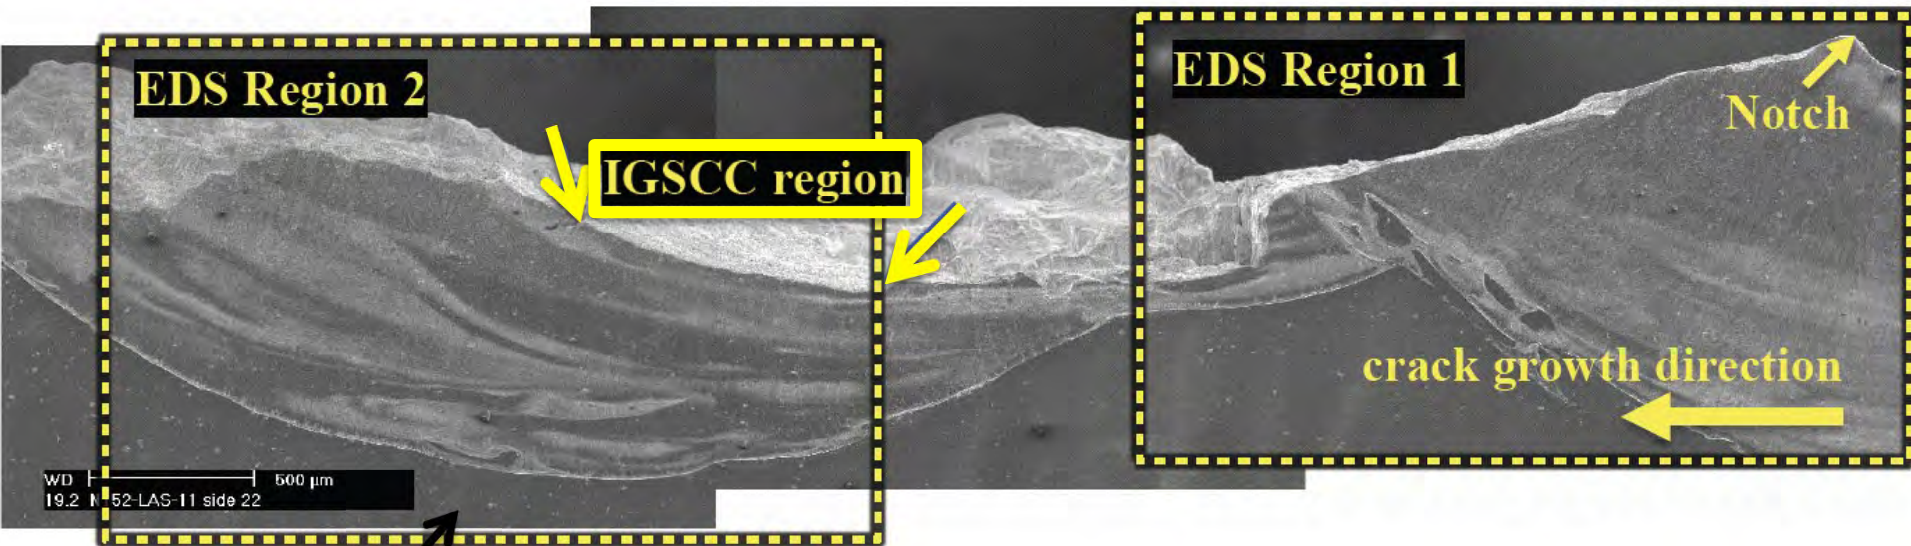
ANL N152-LAS-11 Specimen Cross-Section Observations

- ▶ *Specimen was fractured - one side of the specimen was cross-sectioned after fracture.*

Region of interest near that contains constant load crack extension
