RE: Event Notice #52453

RE: Nuclear Gauge incident s/n 38373

SEALED RADIOACTIVE SOURCE LEAK TEST REPORT

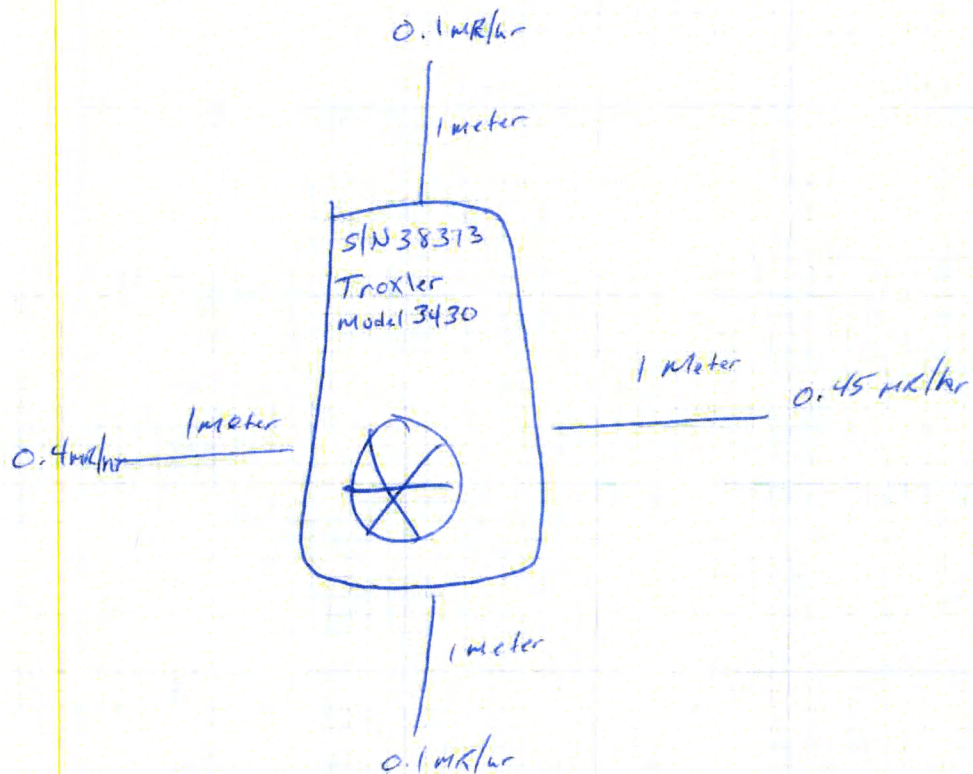
PROJECT: Gauge Incident Reading Page 1 of 1
 JOB NO. _____ Date 12/21/16 Comp. By MD CHECKED BY: _____

Upon my arrival, the gauge and equipment were as expected from the picture. I proceeded to survey the area outside the paint to find the readings were 0 mR/hr. Once I had determined it was as safe as could be, I approached the source from the west, using the roller as a barrier. Once near the gauge, I determined that the source rod appeared intact, with no damage and proceeded to take several readings around the gauge and roller. The readings at one meter were as expected (no higher than 0.5 mR/hr) and contact readings were also normal with the highest reading being 10 mR/hr. I also surveyed the path that the roller took after coming off the gauge, and the tire, to check for radiation, and none was present.
