Subject: 10CFR21 Reporting of Defects and Non-Compliance -
Engine Systems, Inc. Report No. 10CFR21-0114, Rev. 0

Subcover Assembly, P/N 1A-7846

10CFR21 REPORTING OF DEFECTS AND NON-COMPLIANCE

SYSTEM: Emergency Diesel Generator

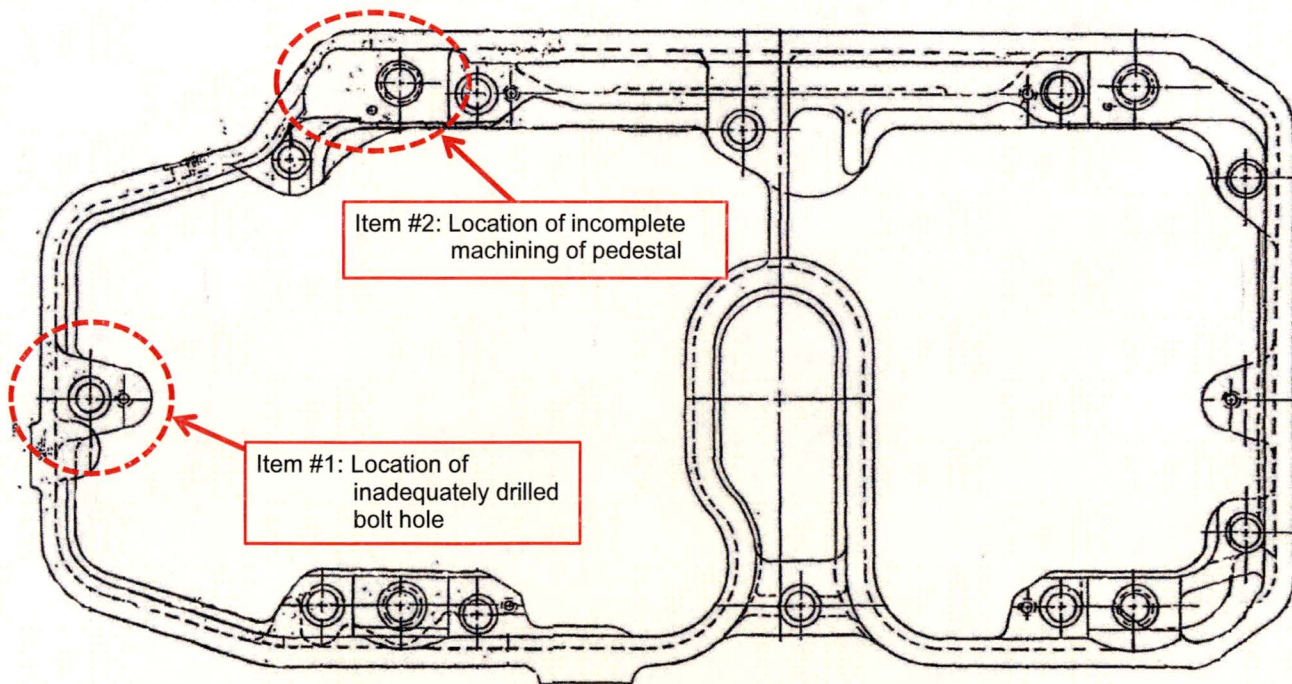
Figure 1: Outline Drawing of Subcover

Engine Systems Inc. (ESI) began a 10CFR21 evaluation on November 18, 2016 upon notification of an issue with a subcover assembly at Perry Nuclear Plant. Attempts to install the subcover on their Enterprise diesel engine revealed two issues that prevented successful installation. First, one of the bolt holes was not fully machined through the entire depth of the subcover. Though the bolt could be inserted into the top of its corresponding hole, it would not pass completely through. The second issue was an interference between the rocker arm shaft and its mating pedestal. It was found that incomplete machining of the pedestal prevented the shaft from sitting flat on the pedestal.

The evaluation was concluded on 12/21/16 and it was determined that this issue is a reportable defect as defined by 10CFR21. The figures and photos below and on the following page provide visual detail of the deficiencies.

The root cause analysis determined the cause to be machining errors that were not detected during ESI's dedication activities. As subcovers are returned, they will be re-machined at the vendor's facility, inspected by ESI, and returned to customers within 60 days of receipt. ESI will also incorporate revisions to the dedication report prior to the supply of any new or reworked subcovers to further clarify the inspection of these features during the dedication process, thereby preventing reoccurrence.
