Oct. 13, 2016 — Day 27

Team continues work on reactor head

The Emergent Issues Team (EIT) is continuing to work through a plan for addressing the reactor vessel head following the leak on the core exit thermocouple nozzle assembly (CETNA). The plan includes removing 14 control rod drive mechanism coil stacks and 13 dummy cans to remove boron accumulation and install canopy seal weld clamps.

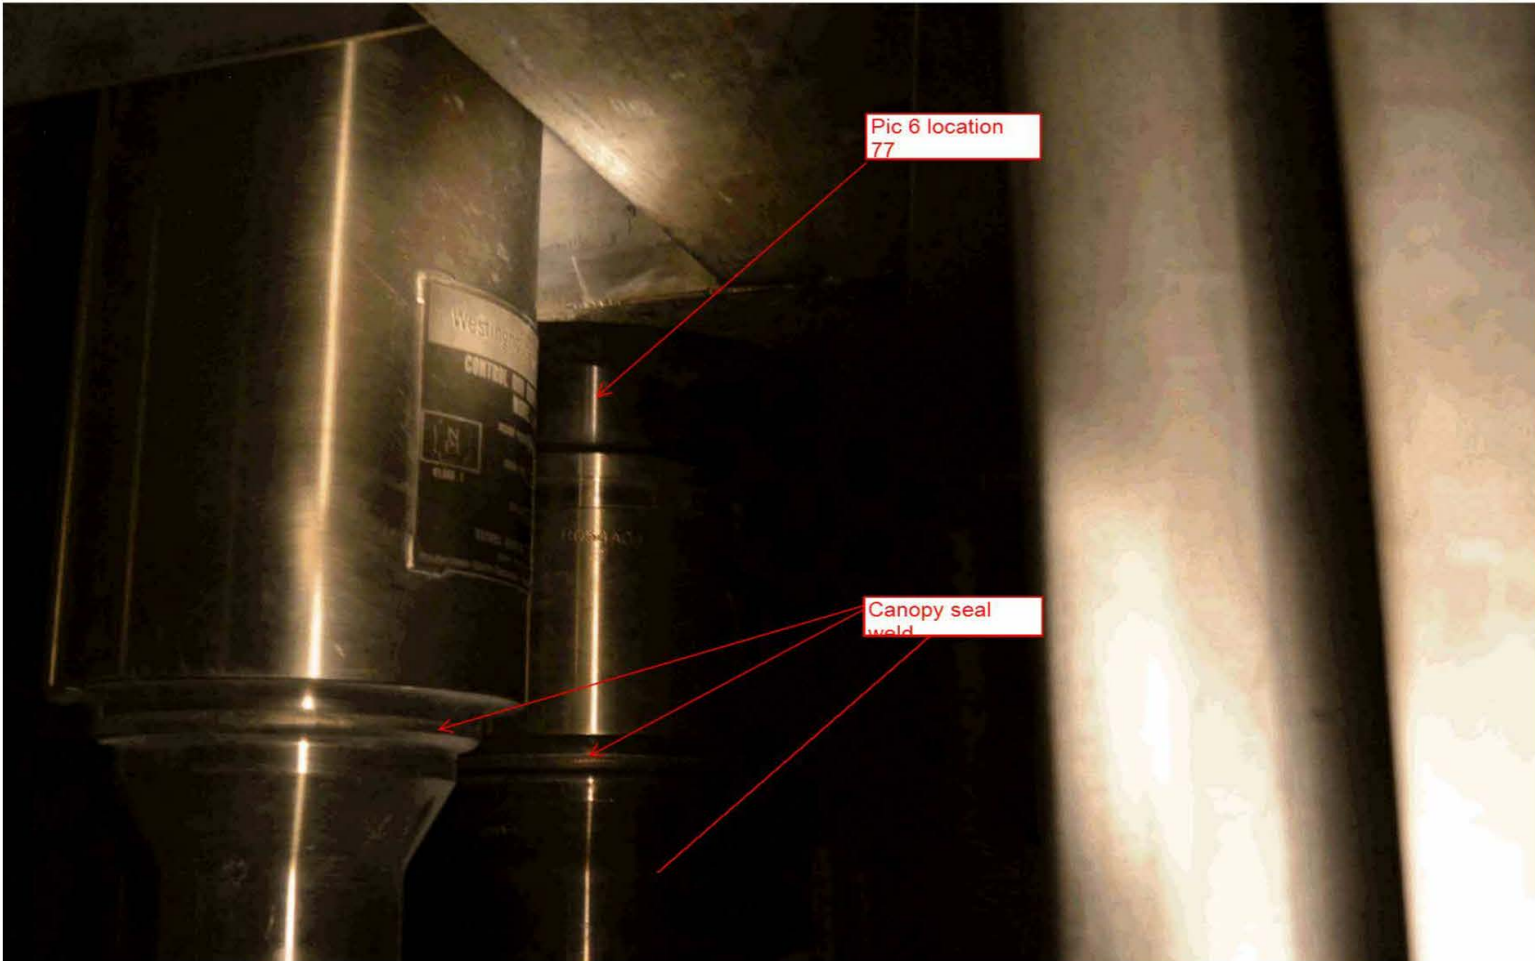
Pic 6 location
77

Canopy seal
weld

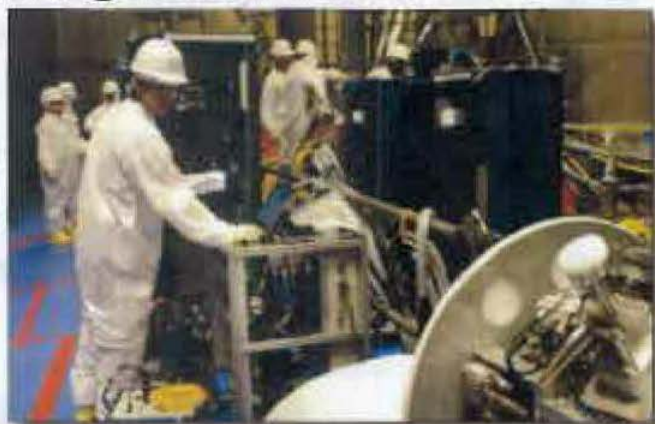
On the reactor head, canopy seal clamps were installed on penetrations #12 and #26. The control rod drive mechanism at penetration #16 was removed. Boric acid removal continues.

The team has worked through issues with the water jet peening tools and is now making steady progress with peening the reactor vessel and bottom nozzles.

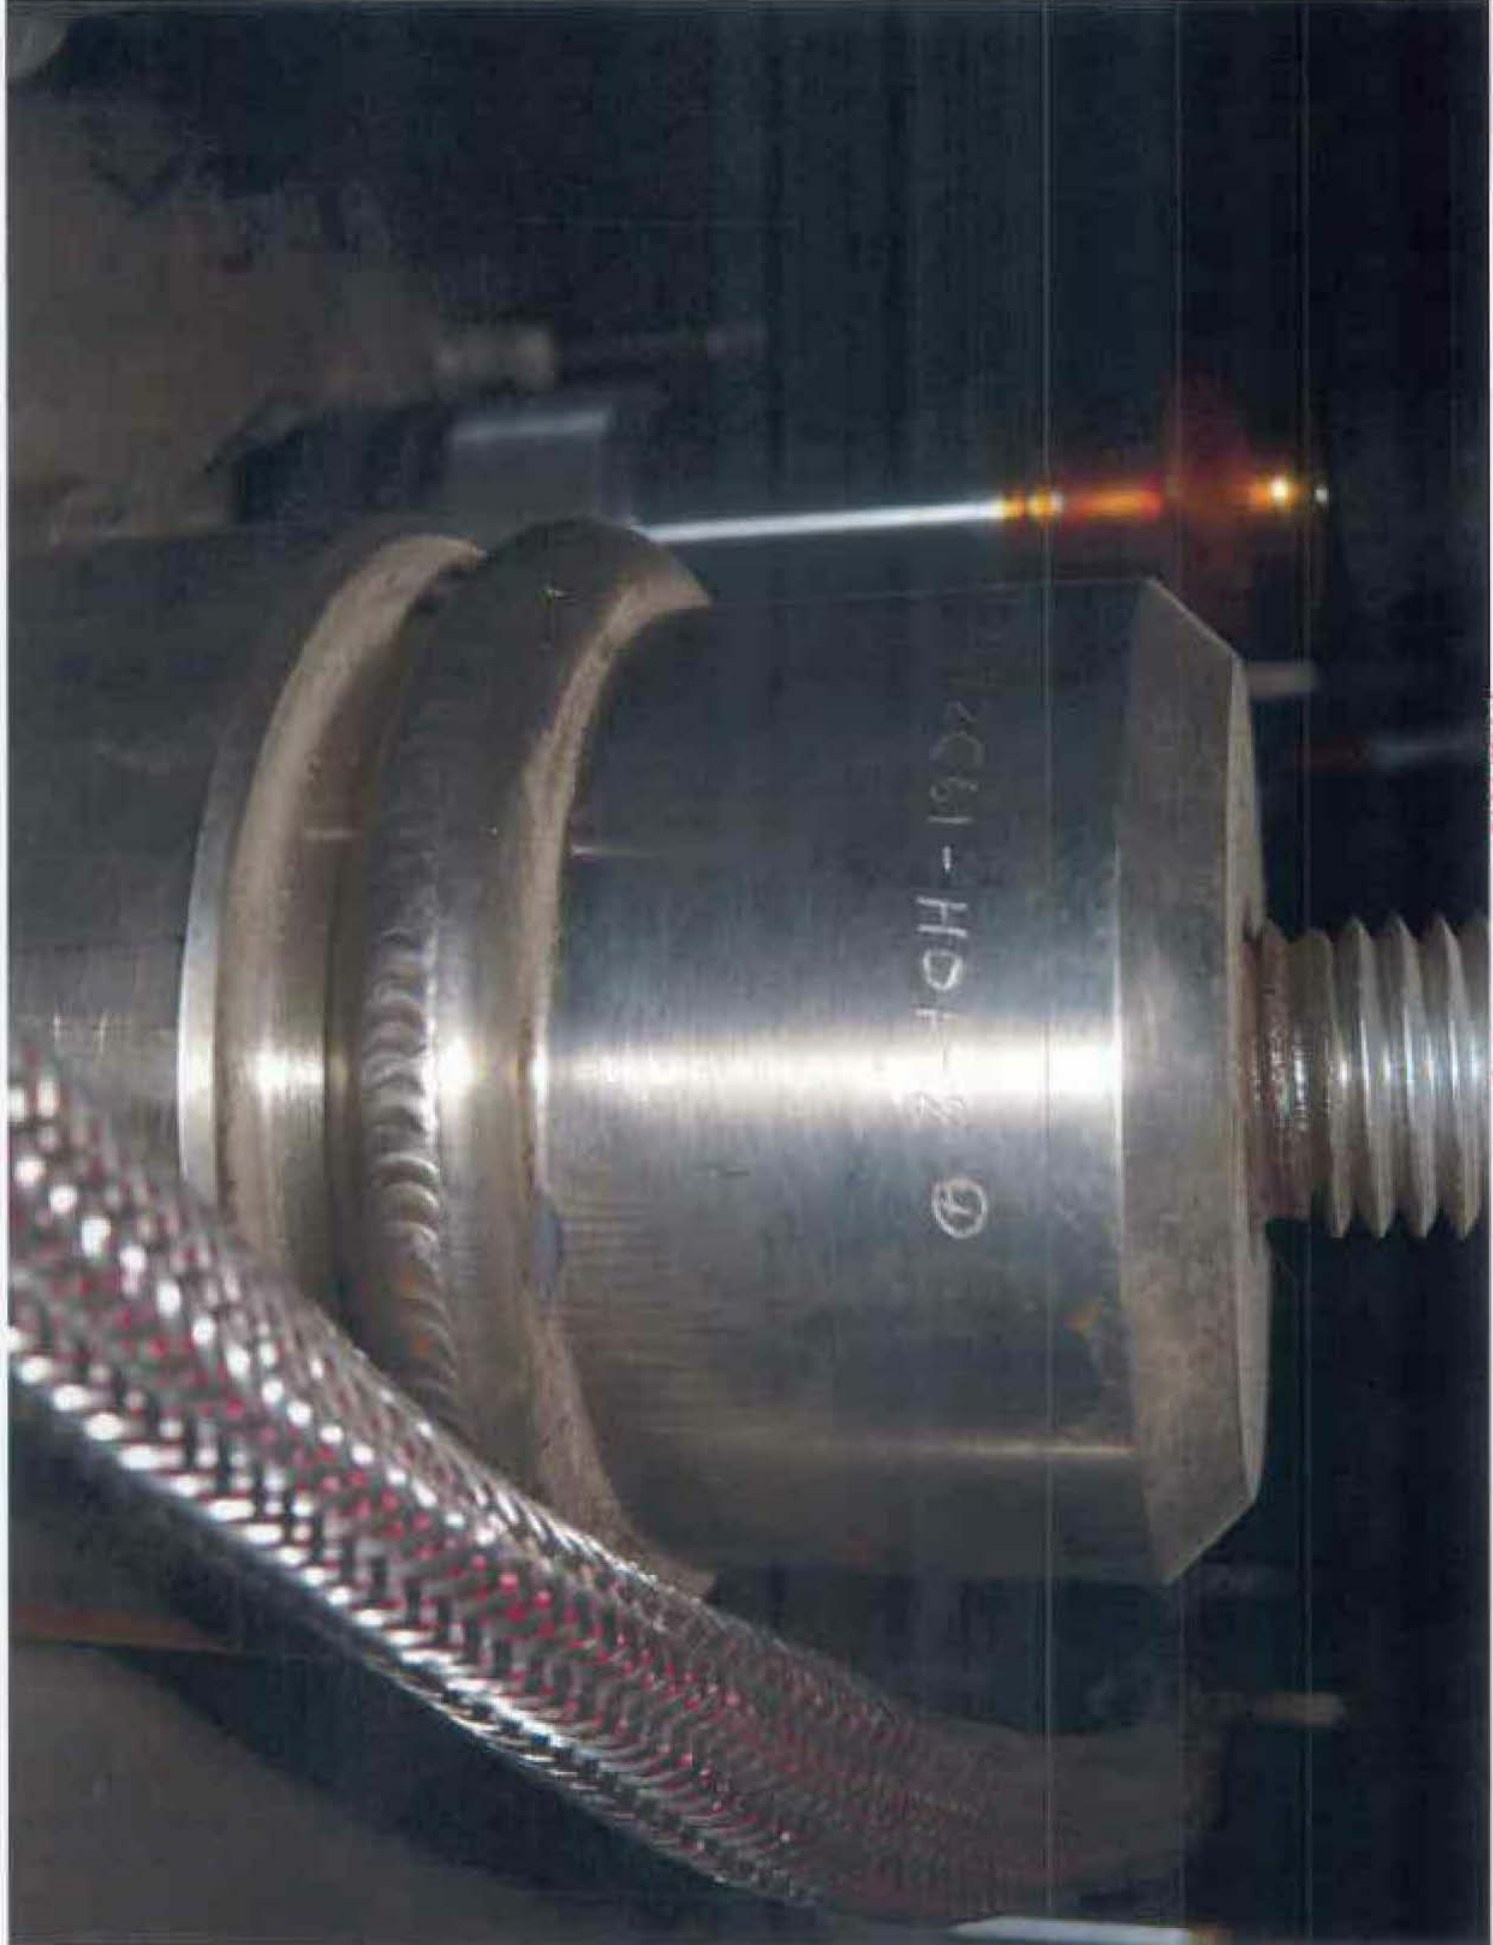
6-5

Description: During visual inspection under 15-402215-001, rust was identified at the lifting lug to CRDM thread interface. Wastage on grid locations C5 (CRDM 49) and K2 (CRDM 59) was noted for approximately 3-4 threads. There were no signs indicative of boron leakage. A review of RF17 pictures indicates at a minimum that K2 was an existing condition at the time. Pictures stored at K:\Data\NDE\Photos\CRDM Platform and vent plugs and seismic plates. Recommend this CR be issued to engineering for evaluation
