August 9, 2017
17-063

Subject: 60-Day Written Report for Event Notification Number 52840

60-Day Written Report for Event Notification #52840 - July 4, 2017**Event Description:**

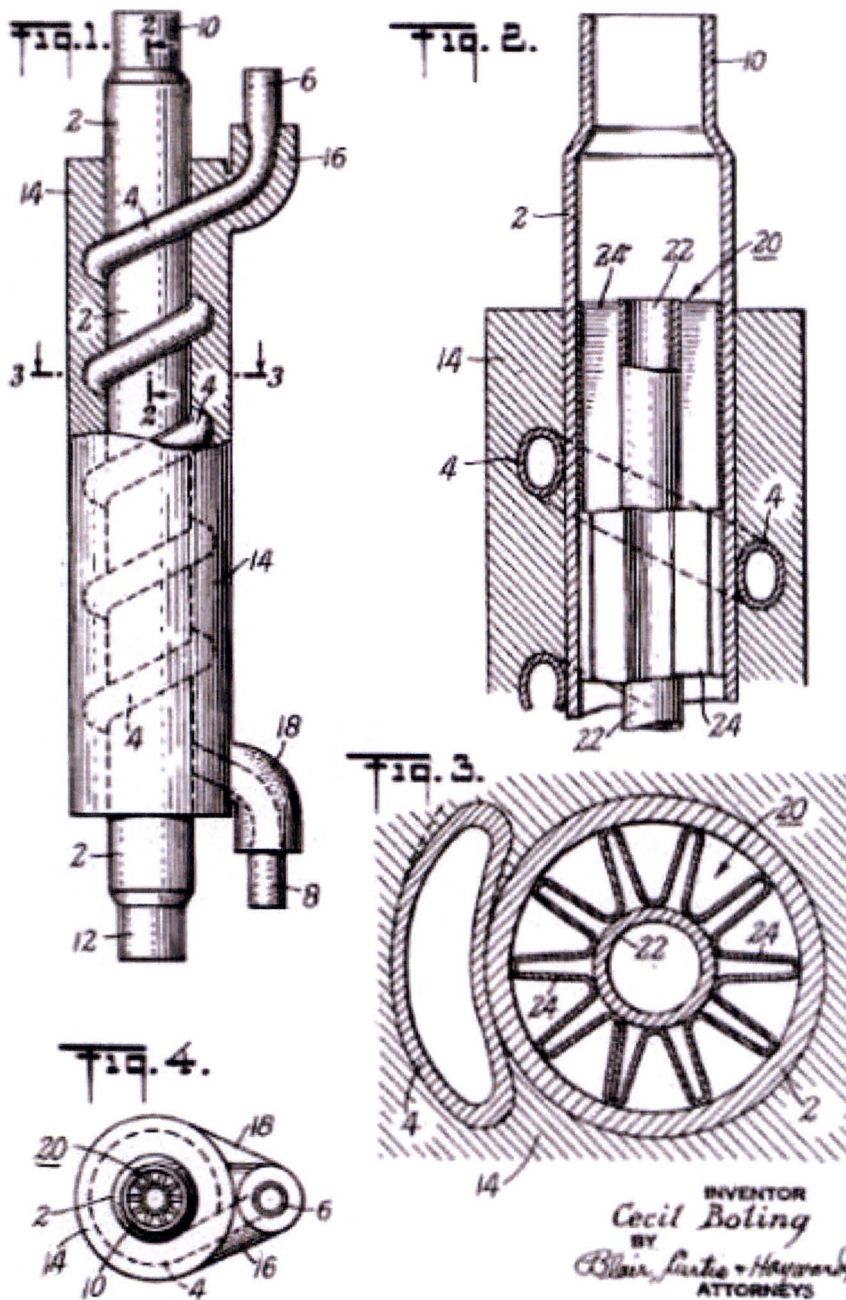
Figure 5 - Patented Heat Exchanger Design
(reference patent number 2,611,585)

The heat exchanger is an un-credited passive engineered control (Figure 4). The design of the heat exchanger provides an extremely high degree of reliability and protection from a coolant leak (Figure 5). The glovebox atmosphere passes through the larger diameter tube of the heat exchanger. Heat is conducted to the tube wall by a heat exchange assembly which is formed by a central expanded tube and a fin construction. Water flowing through an external cooling coil encircling the larger tube provides a source of coolant to the heat exchanger. The heat exchangers were leak tested to verify the integrity of the tubing. No leaks were identified. X-ray evaluation of the heat exchangers confirmed the interior configuration and detected no signs of degradation in

the tube walls (Figure 6). For water to enter the gas stream, the wall of the water line and the gas line must fail simultaneously at adjacent points. The probability of this combination of failures is extremely remote.

An Effectiveness of Protection score of "3" is assigned to the moderation control provided by the design of the heat exchanger. For water to enter the desiccant containers, the wall of the cooling water line and the gas line must fail simultaneously at adjacent points. The heat exchanger is an un-credited safety control. It has the reliability and availability qualities of a passive engineered control combined with an extremely low rate of failure rate. There are no known failures of at least hundreds, if not thousands of these heat exchangers in its 40 yrs of use in Dri-Train and similar purification systems.
