**Assessment of Hydrogeologic Conditions and
Need for Long-Term Groundwater Monitoring
at the Former Durita Uranium Mill, Naturita, Colorado**

Gene Peters and Randall Fedors

1. Purpose and scope of assessment

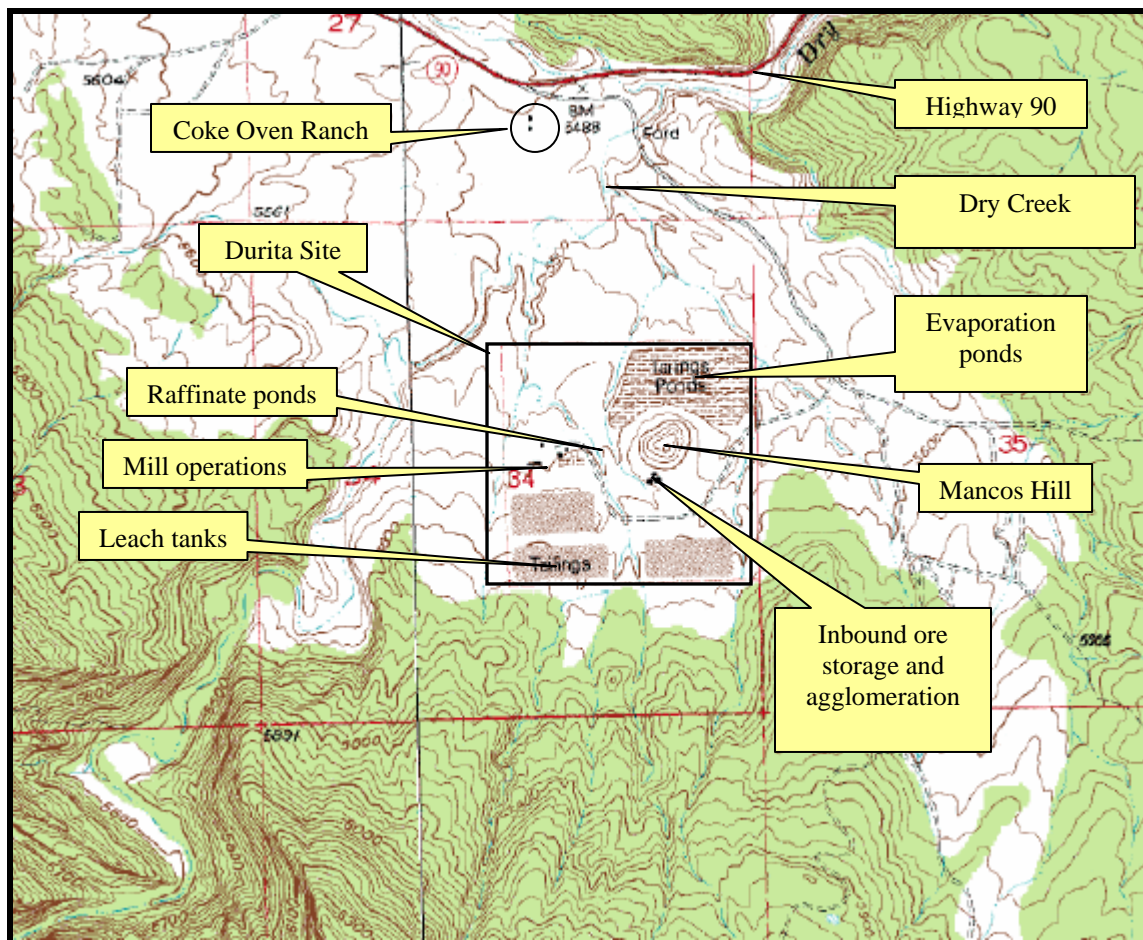
Figure 2 . Annotated Topographic Map of Durita Site at 1:50,000 Scale. Modification of Downloaded File Obtained from Topozone™ on 07/17/2006.

dilute sulfuric acid. The sulfuric acid solubilized labile uranium and other metals and the pregnant solution was captured in an underdrain system in the leach tanks, which reportedly were lined. The pregnant solution was conveyed to the mill area in the western portion of the Site (Figure 2) through a system of subgrade pipes. After a series of chemical processing steps, the solution was stored temporarily in four, synthetic-lined raffinate ponds for re-use. Once the leach solution was chemically exhausted, it was transferred to a series of six clay-lined evaporation ponds in the northern portion of the Site (Figure 2).

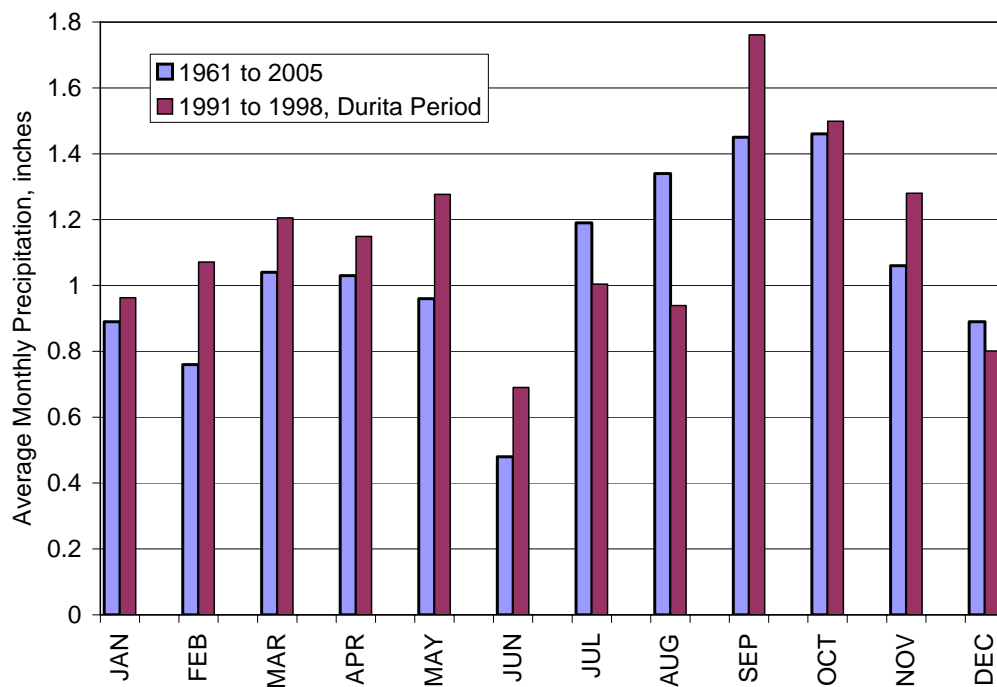
Figure 5. Average precipitation for entire period of record for Uravan and for period of water level monitoring at Durita (1991 to 1998)

Monthly values (**Figure 5**) suggest that precipitation occurs throughout the year, though June is moderately drier and late summer into early winter is moderately wetter than the other months. The presence of fall and winter precipitation is generally important in semiarid climates because evapotranspiration rates are reduced during these seasons, thus leading to the most prominent period for recharge. In the groundwater section, we will describe our search for indications of a seasonal signal in recharge as recorded in water levels in monitoring wells.

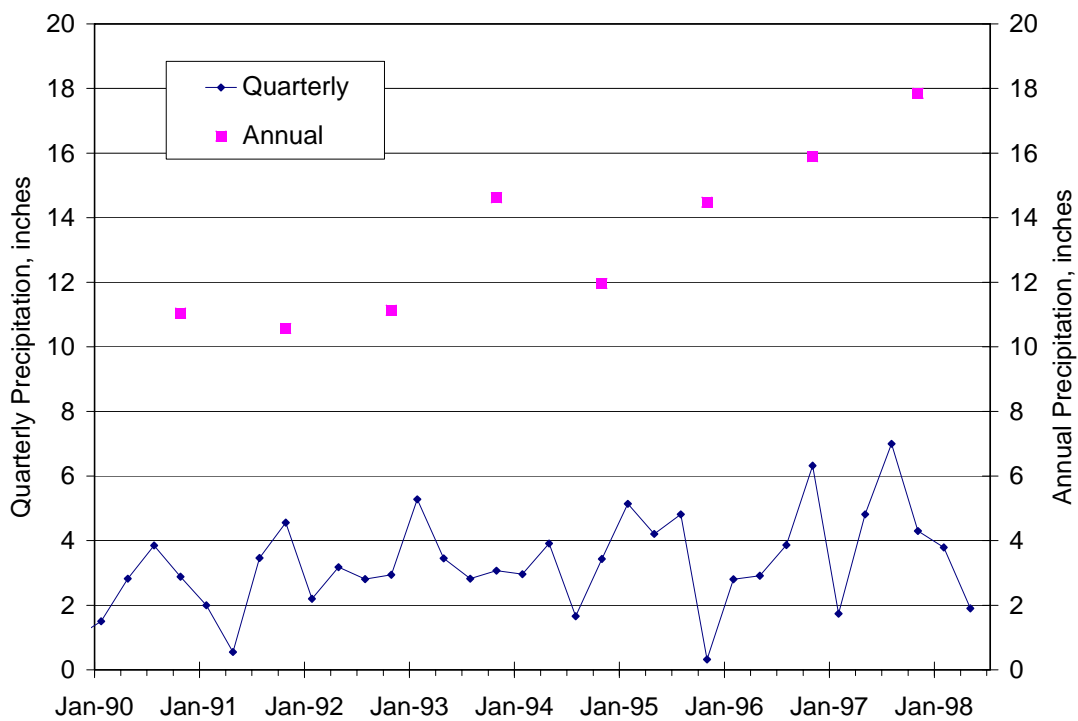
Figure 6. Quarterly and Annual Precipitation Data from Uravan NOAA Meteorological Station for the Period of Interest for Durita

Annual and quarterly values of precipitation at Uravan, our analog for Durita weather, are plotted in **Figure 6**. A prominent feature illustrated by the annual values, though difficult to distinguish in the quarterly data, is the trend of increasing precipitation for the later part of the period (1995 through 1998). In the groundwater section, we will also describe our search for indications of an increasing trend for recharge as recorded in water levels in monitoring wells for the 1995 through 1998.

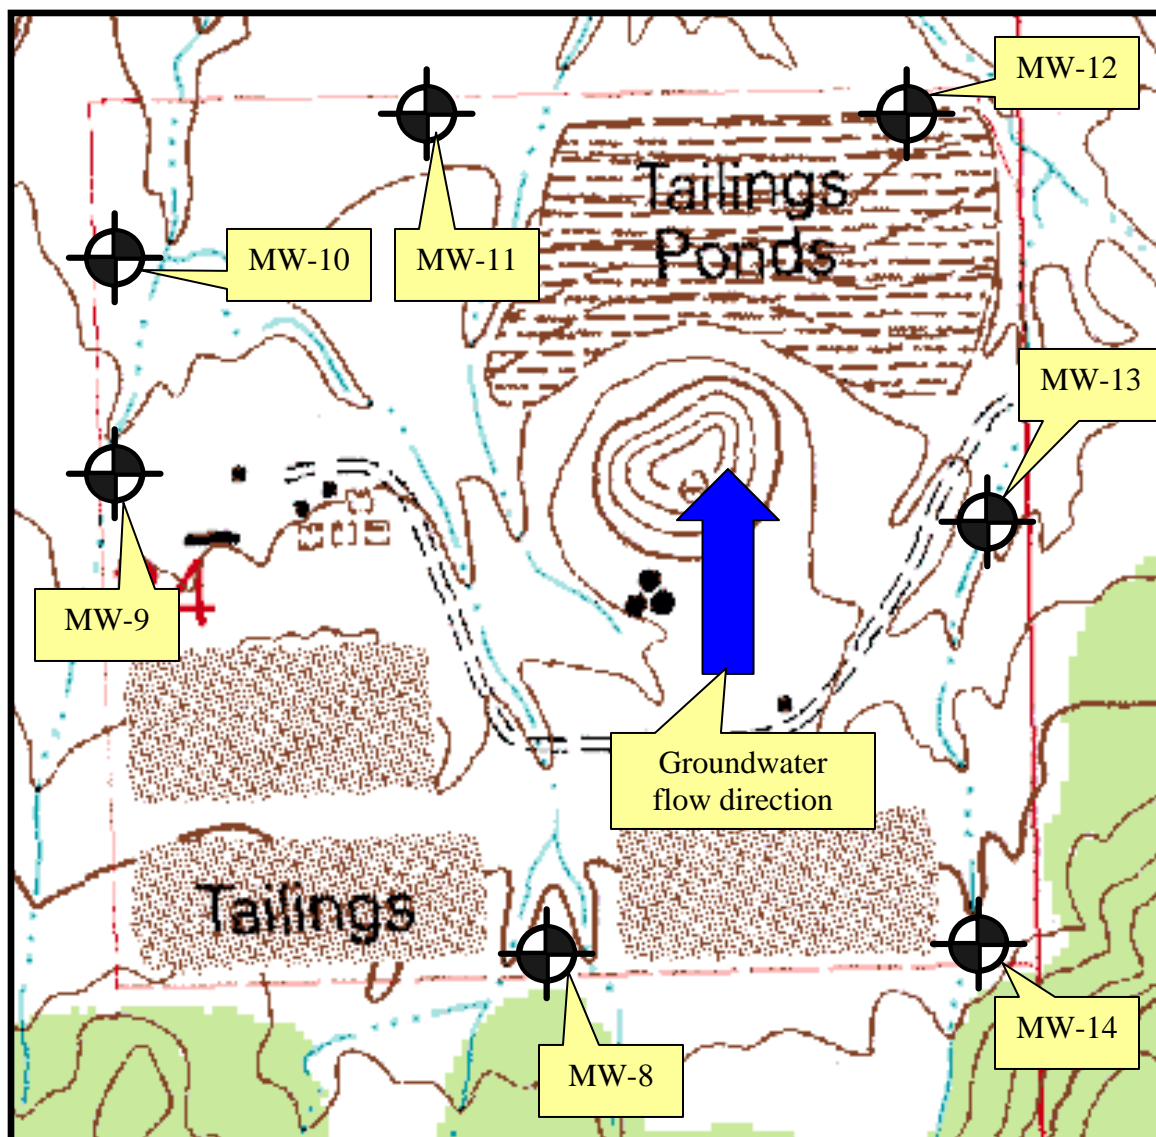
Figure 7. Topographic Map of Durita Site Showing Monitoring Wells. Modification of Downloaded File Obtained from Topozone™ on 07/17/2006.

The gradient of the water table is northward towards Dry Creek, but is ill-constrained because it is only defined by seven wells installed along the property boundaries. The seven boreholes outlining the permit area (Figure 7) were drilled into the uppermost aquifer, cased, and screened for monitoring purposes. The monitoring wells are labeled MW-8 through MW-14. The screened intervals intersect the sand layers in the lower portion of the Mancos Formation. Wells MW-1 through 7, mentioned in Fox (1982), were completed during leaching operations in the late 1970s. These wells, however, were improperly completed; thus no data were reported in the available documents.

Groundwater quality at the Site boundaries was monitored from 1977 (pre-development) to 1998 with a series of seven monitoring wells (Figure 7) screened in the shallow Mancos groundwater. Groundwater samples were analyzed for relevant radionuclides and selected wet chemistry parameters that might also indicated releases (e.g., pH excursions from released acids). These seven wells include three downgradient monitoring wells (MW-10, -11, and -12; although only MW-11 and -12 were designated as compliance wells), two cross-gradient wells (MW-9, -13) that could also intercept released contaminants depending on variations in flow direction and proximity to sources, and two upgradient monitoring wells along the southern Site boundary (MW-8, -14). No releases that adversely affected groundwater quality were evident from the available groundwater data.

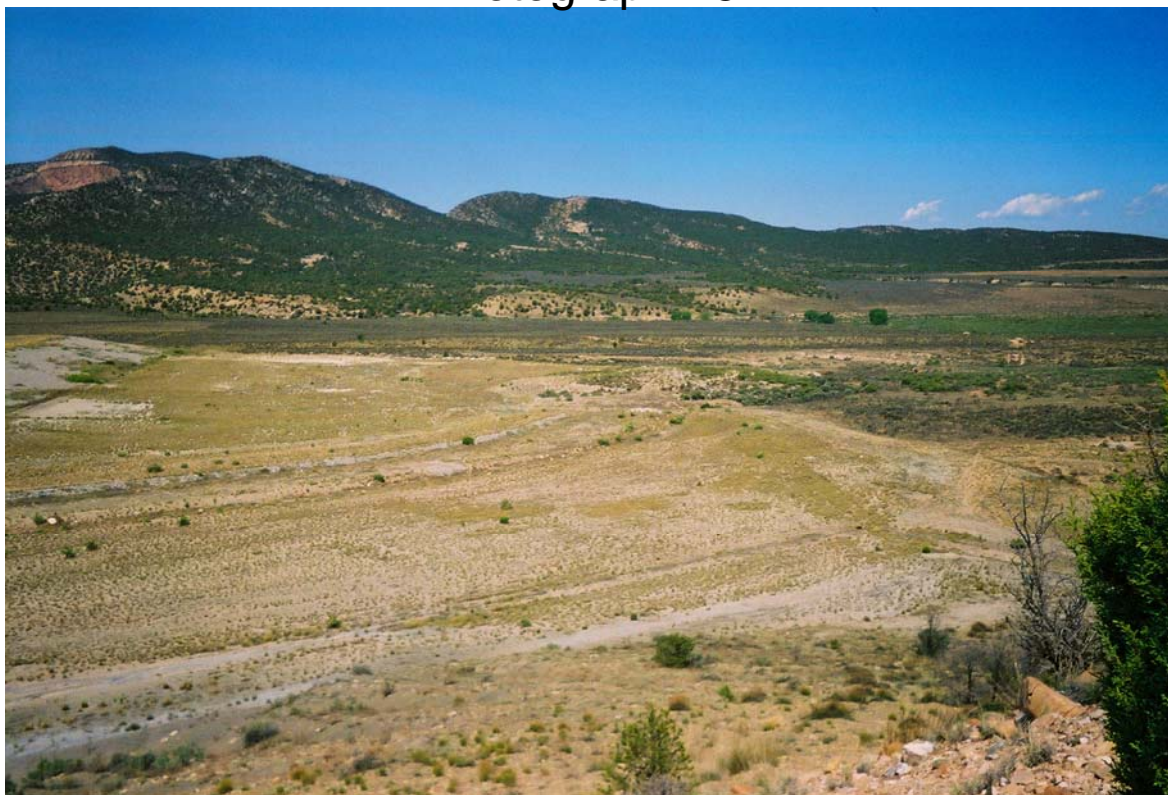
Photograph 24A

24A	View from top of Mancos Hill, facing west. The northern edge of Leach Tank 201 visible in left mid-ground. The former mill area and raffinate pond complex are present in the center of the photo. The central diversion (run-off) channel runs from lower left through the center of the photo.
25A	View from top of Mancos Hill, facing south to southeast. Northern edge of Leach Tank 203 visible in center. Barren area in center of photo likely is former ore processing area, in which tailings from Naturita site (located c. 2.5 miles northeast of Durita site) were agglomerated with H ₂ SO ₄ before placement in leach tanks.
20A	<p>Shallow bench excavated into lower one-third, south side, of Mancos Hill. Pen for scale, pen cap oriented upward. Excavation depth approximately 1.5 feet below grade. Salt-related, friable induration visible at ground surface (note absence of vegetation) in upper portion of photo. Surficial material is heavily weathered, small (<1.0-in) shale fragments; original texture absent.</p> <p>At base of excavation, original structure and texture preserved, but rock friable and easily disaggregated. Vertical and subvertical joints are prominent and frequent. Iron staining and calcite present on bedding planes in joints. White material is crystalline CaCO₃ present in friable veins and lenses, oriented from vertical to horizontal. Calcite crystals exhibited long, slightly curved acicular form; where present as vein filling, exhibited crystal growth from both sides, meeting in center.</p>

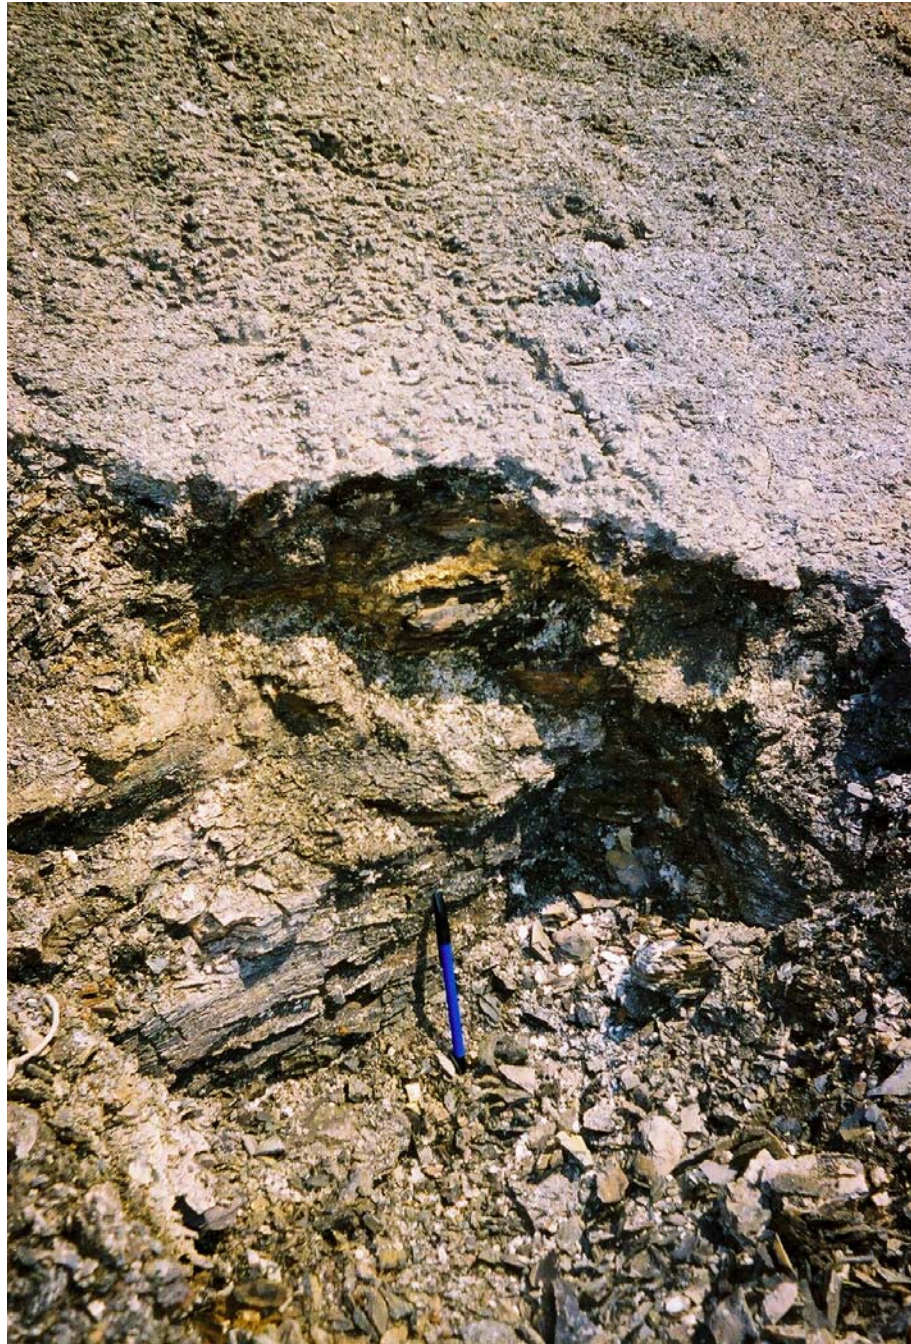
Photograph 20A

Photo	Description
	material same as in Photo 20A – heavily weathered, small shale fragments. Material at 6 inches in center of photo is more competent and hard. Note prominent ¼-inch, northeast-southwest oriented joint, partially filled with unconsolidated sediment ranging in size from silt- to sand-sized particles. Bedding planes nearly horizontal.
18A	Photo taken at base of Mancos Hill, west side, facing north. Absence of vegetation on slope side may be related to reclamation activities, though no processes are reported to have occurred in this immediate area. Note horizontal to subhorizontal, more weathering-resistant layers approximately 3 feet up slope. These layers are laterally extensive and continuous. Note absence of rills or other surface run-off geomorphic features.
17A	Photo of shallow excavation at base of Mancos Hill, west side, facing northeast. Clipboard for scale. Excavation was of more resistant layer visible in Photo 17A. Note rapid change from heavily weathered surficial material to more competent claystone/shale. Note north-south and east-west intersecting joint sets.

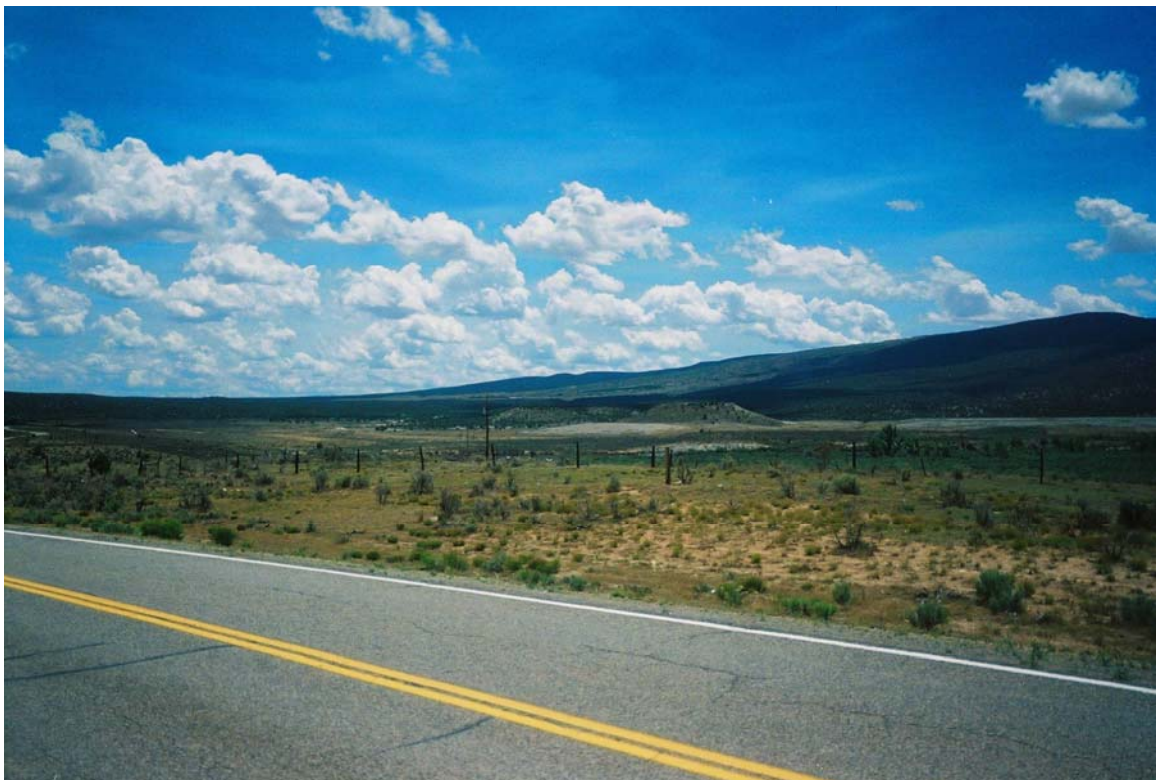
Photograph 00A

0A	View of road cut on west side of access road, facing west-northwest, approximately 2,000 feet north of site. Coke Oven Ranch buildings visible in right-center portion of photo. Upper portion of cut exposes Mancos/Dakota interbeds. Note prominent fractures oriented northwest into plane of photo, some with apertures of several inches. Darker layer near base of section is near-anthracite coal layer, diagnostic of Dakota Formation.
00A	View of site from Highway 90, facing southeast. Mancos Hill visible slightly right of center of photo.
