**DRAFT COMPLETION REVIEW REPORT**

**Hecla Mining Company Durita Facility**

**Montrose County, Colorado**

**March 30, 2015**

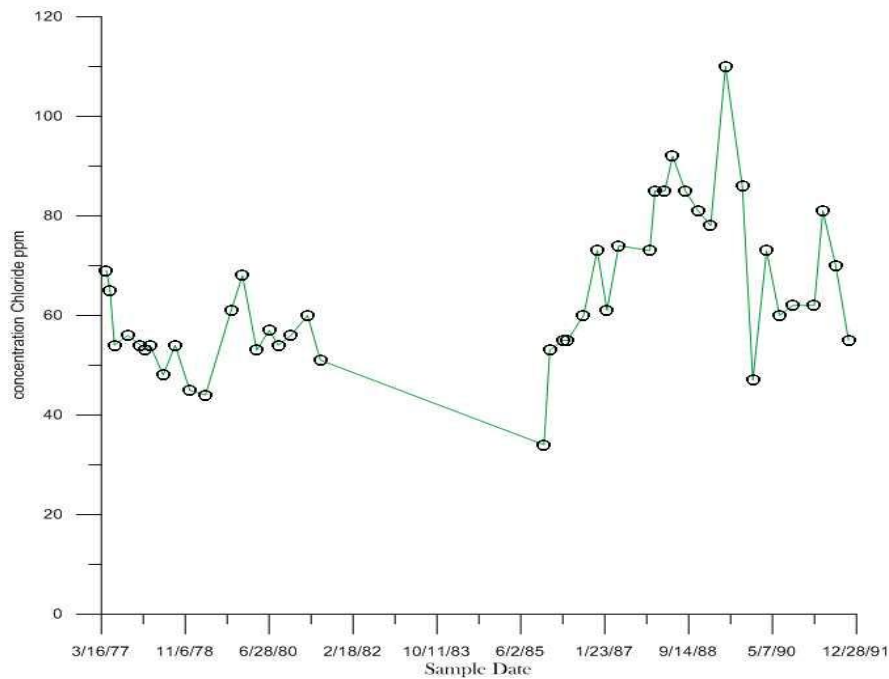
Monitor Well MW-4 chloride content over time

An evaluation of the flow data using a gradient of 0.033 and an apparent water velocity of 120 feet per year using the equation  $velocity = \frac{hydraulic\ conductivity}{porosity} \times \frac{dh}{dl}$  yields an apparent hydraulic conductivity between  $7 \times 10^{-4}$  cm/sec and  $1 \times 10^{-3}$  cm/sec. This is the range of conductivities for a clayey silty sand found as is found in this part of the site (Freeze & Cherry, 1979). The gradient is taken from the general site gradient and from the slope of the shallow aquitard between MW-3 and MW-4 shown on Figure 7.4. Porosity is varied between 0.2 and 0.3. The sandy gravels found beneath the area of LT-202 will have a hydraulic conductivity greater than  $1 \times 10^{-1}$  cm/sec. based on the same source. Using this analysis, the eastern area of LT-202 is within the sampling envelope of MW-4 during the monitoring period.

Plot of chloride content in well MW-4 over time 1977 to 1991.

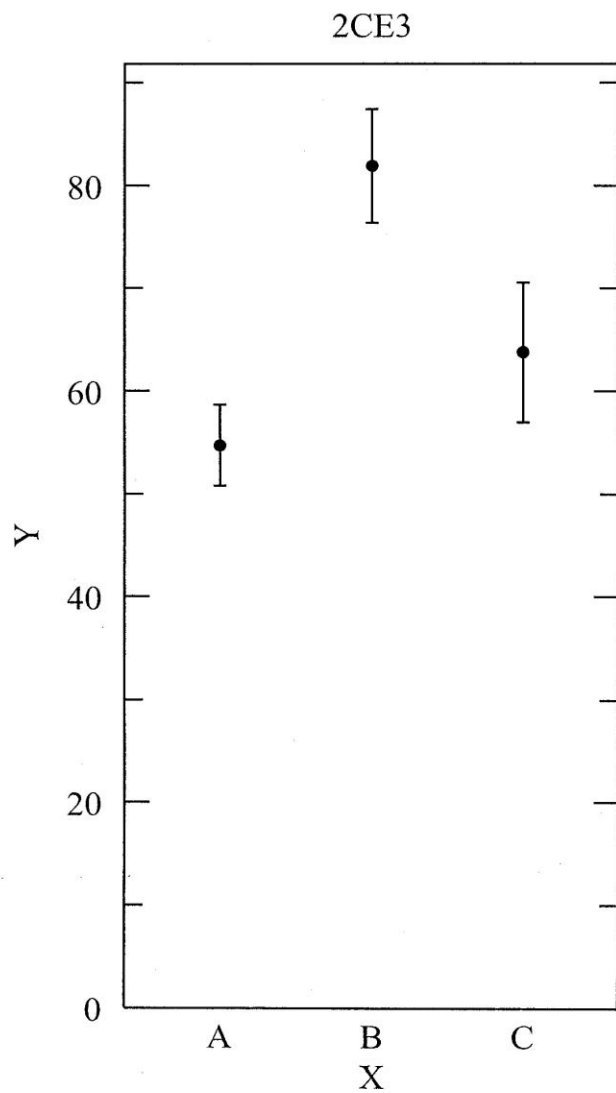
Plot of means with 95% confidence interval of the chloride content populations for monitor well MW-4. Population A is the analyses from April 1977 to August 1986. Population B is the analyses from November 1986 to October 1989. Population C is the chloride analyses from December 1989 to November 1991. Population B shows a distinct statistical character from population A and C.

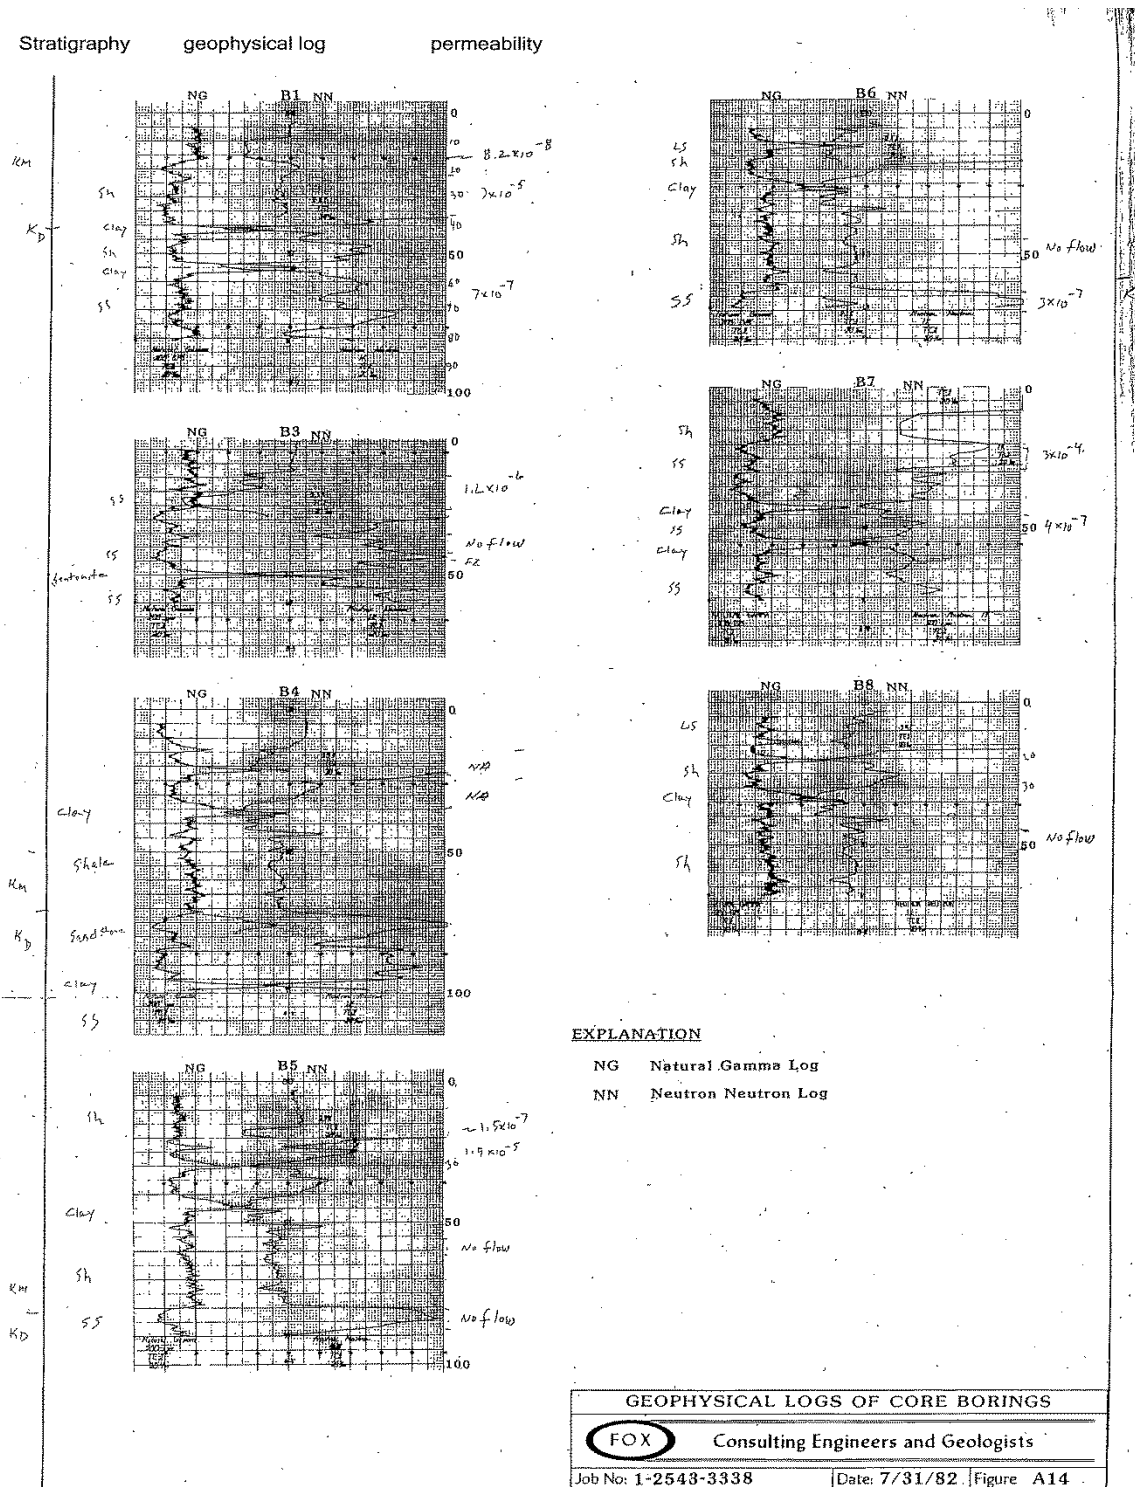
Figure 7.2

The bore hole descriptions, permeability measurements, and geophysical logging reported by F. M. Fox (1982) (Figure 7.2) on and near the Durita site show a consistent pattern of very low hydraulic conductivity in the shale above the Mancos/Dakota contact. Several of the measured conductivities were below measurable flow. This zone acts to physically and chemically isolate water flowing in the upper Dakota and basal Mancos formations from surface waters at the Durita site. There is a clay layer directly above this lower shale consistent in the geophysical measurements that are described as bentonite in the lithologic description for borehole B3.

The drilling logs for monitor well MW-8 through MW-14 show the un-weathered Mancos Shale to be dry between units A and C. The geophysical logs, Figure 7.2, reported by F. M. Fox (1982) show a distinct basal Mancos Shale signature above the Dakota Sandstone. This basal shale feature is topped with a bentonite clay layer about three to four feet thick. Three in-hole conductivity tests were performed in this basal shale. No measurable conductivity was reported for the measurements conducted in boreholes B-5, B-6, and B-8. These are boreholes on or close to the Durita site.

Stratigraphy and measured permeability plotted against the natural gamma and neutron-neutron geophysical measurements. From Fox 1982.

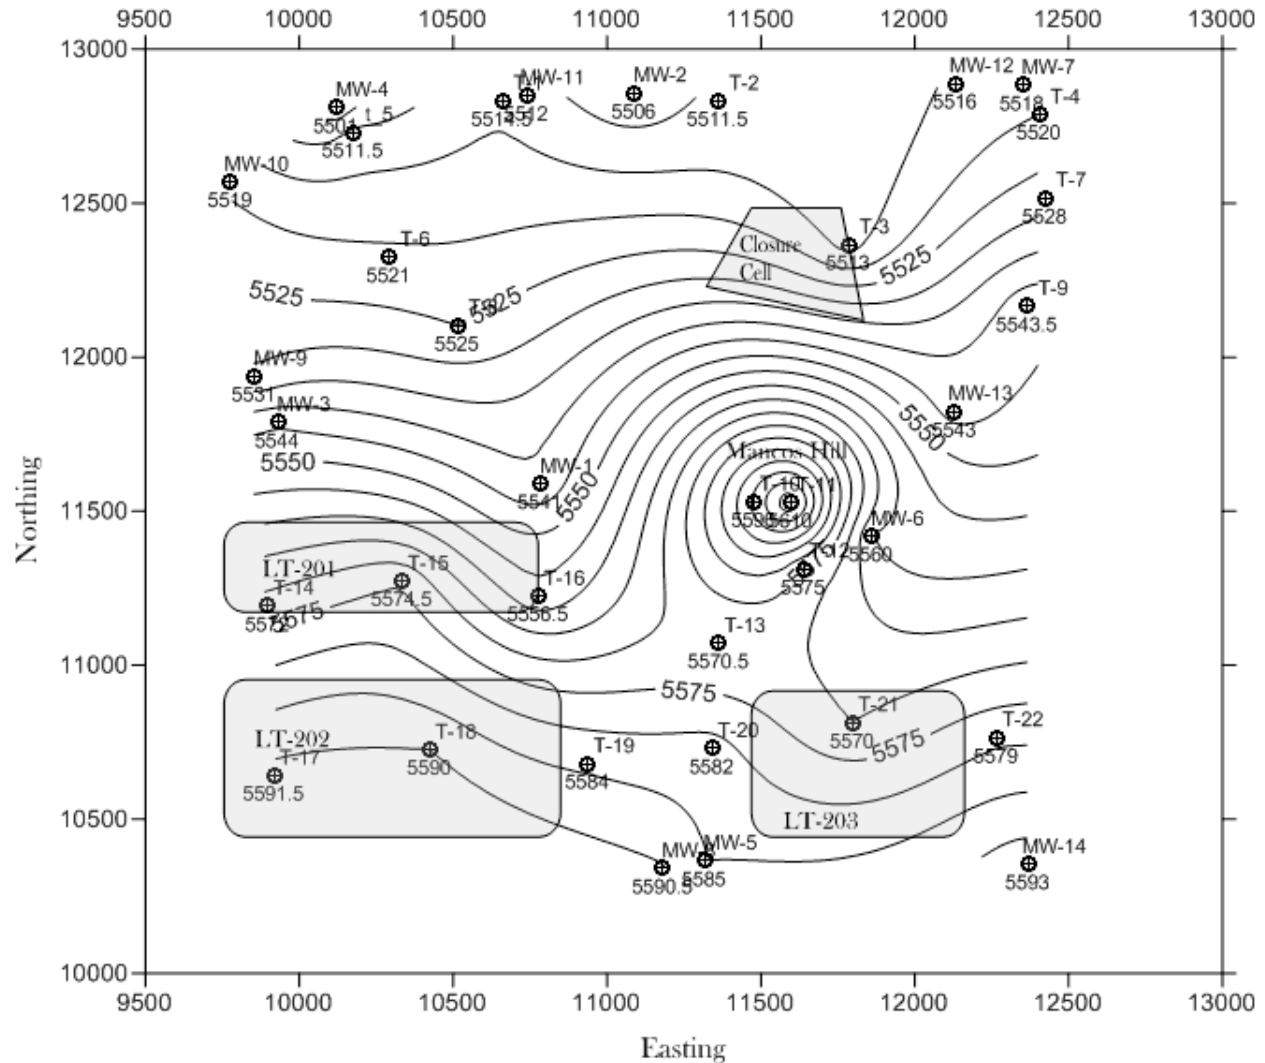
Within the weathered sediments is a continuous interface of higher hydraulic conductivity sitting atop a surface of lower hydraulic conductivity. This surface may represent the Unit A/Unit B contact or conductivity boundary caused by uneven weathering in the upper Mancos Shale. Any waters moving down from the surface and not dissipated by capillary forces or evaporation/transpiration would collect on this aquitard surface and flow according to the slope of this surface. Figure 7.4 shows a plot of this aquitard surface picked from the F. M. Fox (1977) descriptions and the monitoring well drill-log descriptions. While, presently, Figure 7.4 is a computer-generated plot, it does indicate the topography of this surface and that it does mimic the general surface drainage of the site. The test holes and monitoring wells are located on the figure. Monitor wells MW-1 through MW-7 were only surface sealed and any water moving along the aquitard surface could be sampled by these first seven wells.

Durita Site Shallow Aquitard Contours  
based on test holes and monitor wells  
stratigraphic data. Kriging interpolation.

Figure 7.3. The drilling description of MW-1 shows the presence of unconfined ground water at this interface. MW-1 appears to be in the channel of this aquitard surface. This aquitard-surface channel appears to go from the vicinity of MW-8 through MW-1 to the vicinity of MW-4 and MW-10. This channel collects the unconfined flow from the area between T-22 and T-15. Water in the low point of the aquitard surface was seen during the drilling program conducted in Four Corners Environmental Research and reported in 1977. Because of the location of test holes, the prominent positive feature associated with Mancos Hill is displaced to the south.

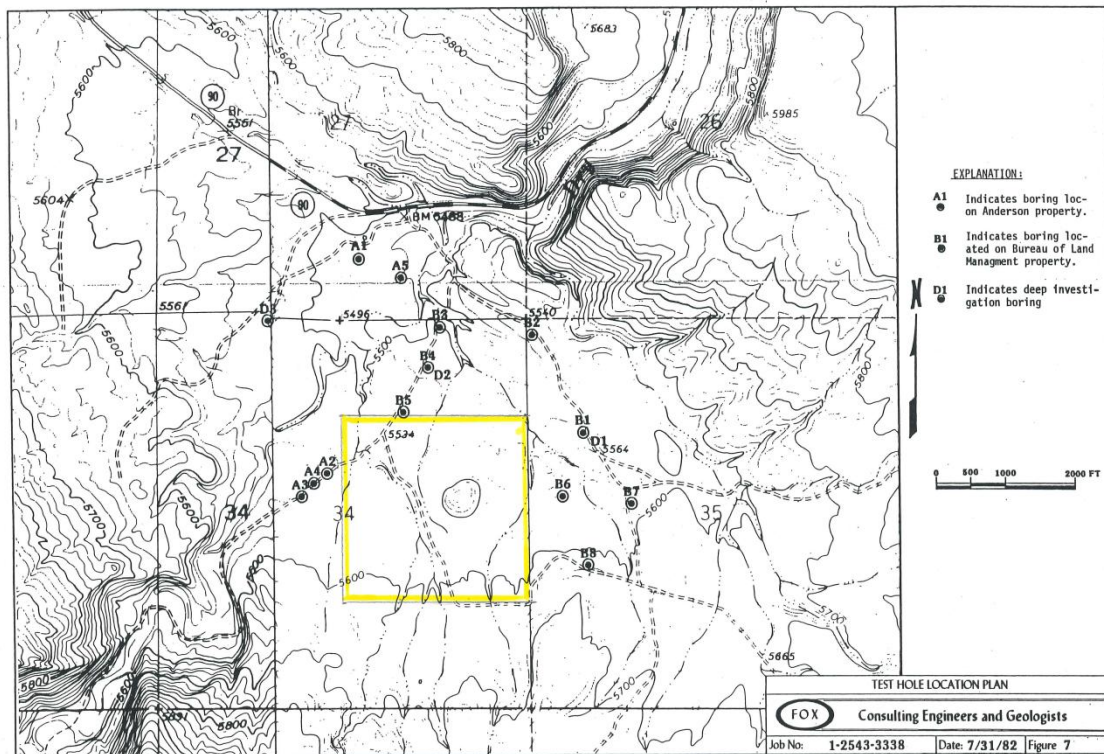
depth than the other measured boreholes. Borehole locations are shown in Figure 7.4.

Figure 7.4 Test hole location map from Fox 1982. The Durita site is outlined in yellow.

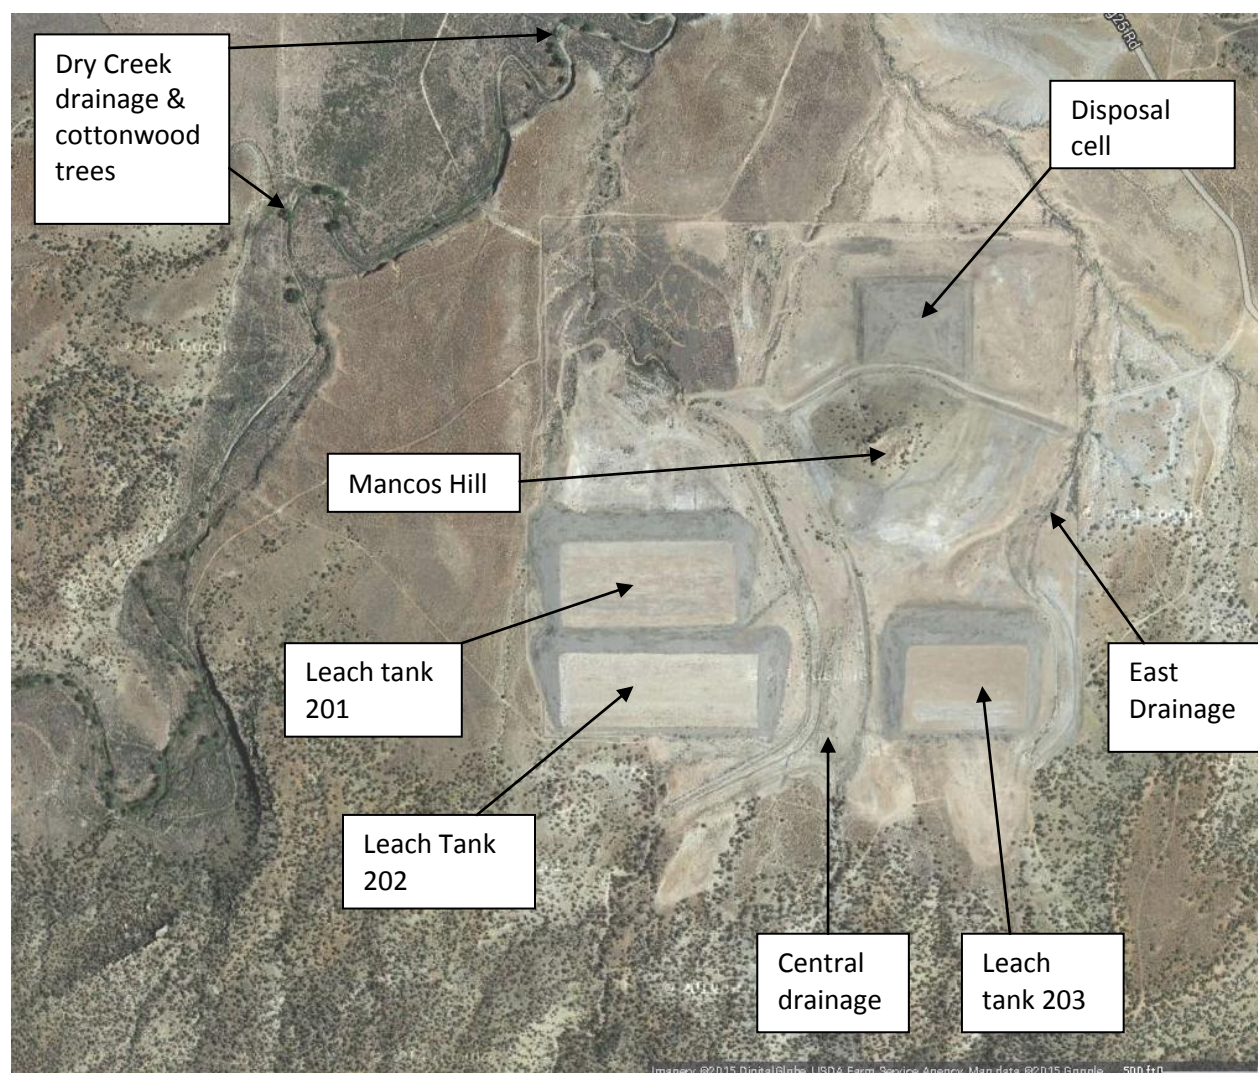
There is no perennial surface water at the site. Ephemeral water flow is associated with precipitation and drains to the north. Natural drainages on the site have been modified to protect the disposal areas. Some areas of Dry Creek west of the Durita site show evidence of continuous near-surface water saturation by the presence of phreatophytes. Figure 7.5 shows the drainage and the location of some cottonwood trees.

Ground water at the site occurs continuously at, or near, the base of the Mancos Shale and into the Dakota Sandstone. The source of the water is infiltration of precipitation and runoff into the surface exposures south of the Durita site and on the slopes of Naturita Ridge. The exposed re-charge area is on the southern limb of the Coke Oven Syncline. Water in the Dakota Sandstone moves north, and down dip, under the site. It is covered by the aquitard/aquiclude of the Unit B Mancos Shale and thus becomes a confined aquifer under the Durita site. Figure 7.1 shows a cross-section across the site. Figure 7.2 shows the geophysical logs and permeability measurements made during this investigation. Figure 7.3 shows the shallow aquitard contours; Figure 7.4 shows the test hole location map where soil borings were installed by F. M. Fox (1982) Figure 7.5 shows a satellite photograph of the Durita site with major features labeled.

Figure 7.5      Satellite image of the Durita site area with major features identified.

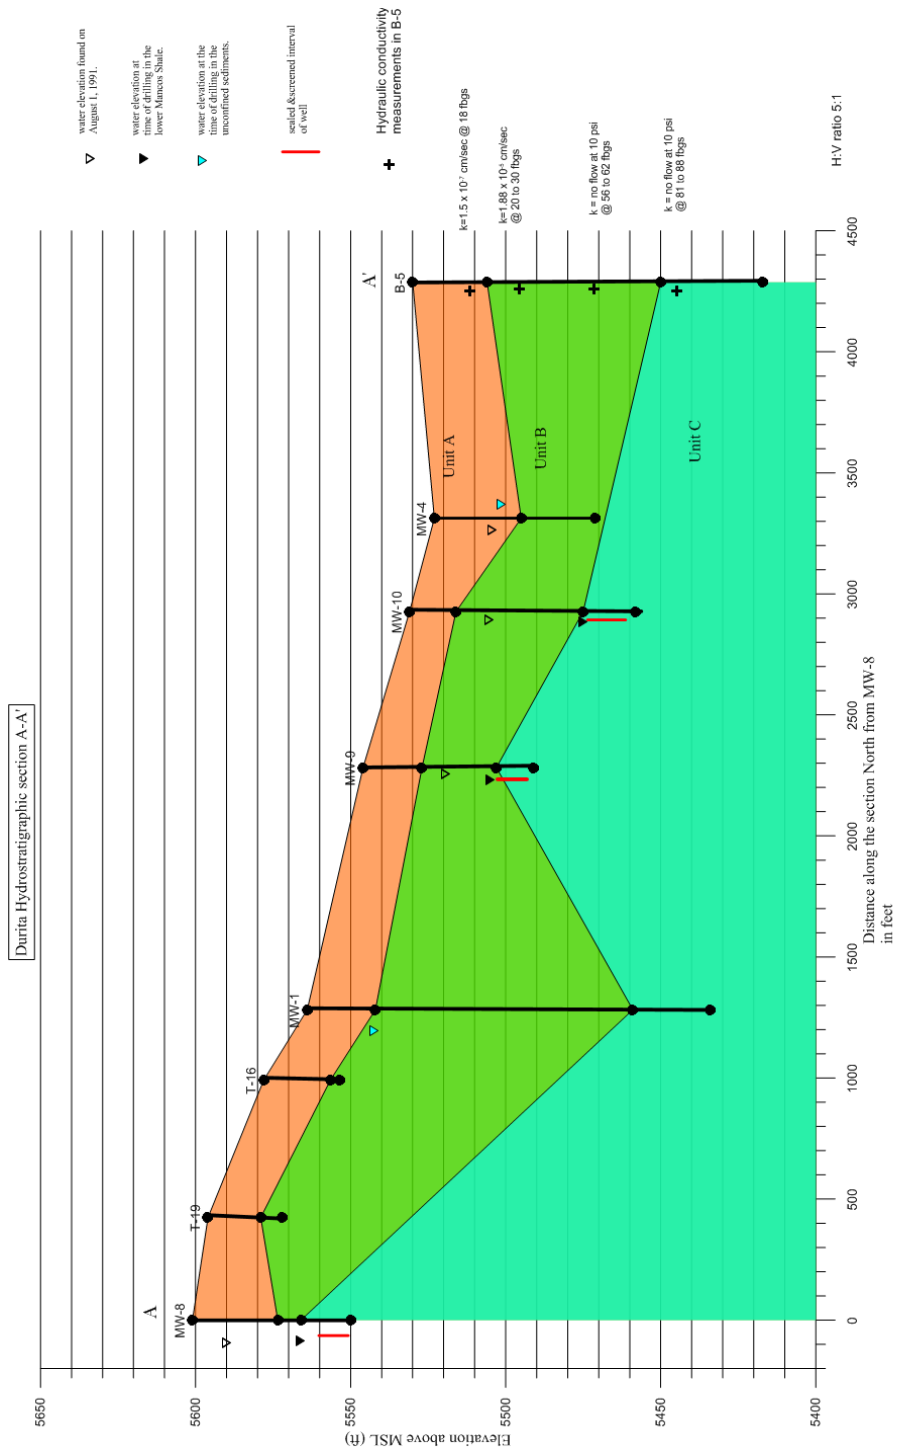
Soil boring descriptions and geophysical logs for boreholes B-1, B-5, and B-6, show a sandstone interval in the upper Dakota Sandstone. There are three measured hydraulic conductivities measured in this section ranging from  $3 \times 10^{-7}$  cm/sec to no measurable conductivity. Figure 7.6 and Figure 7.7 show the hydrostratigraphic section from south to north across the Durita site showing well screen intervals and static water heads. Figure 7.8 shows the locations of the wells and boring shown in Figures 7.6 and 7.7.

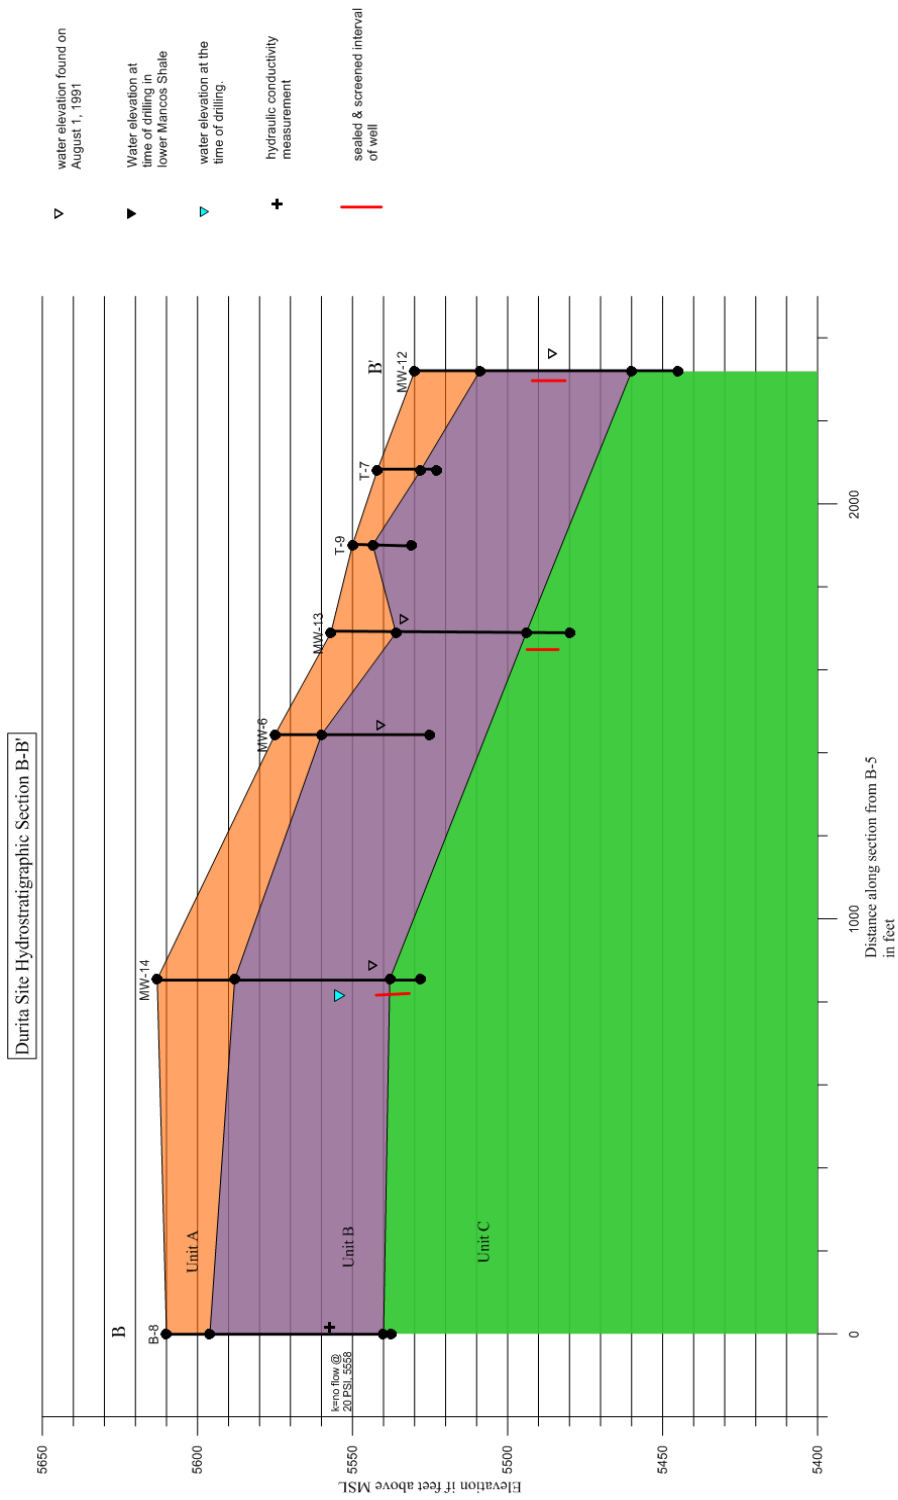
Most wells drilled into the lower saturated interval show a ground water potential higher than the elevation of the saturated section. MW-12 shows that the first saturated interval it penetrates has a free-air potential and is not confined. The first saturated interval in MW-12 is a one-foot thick sand within the Mancos Shale at 20 feet bgs. The drilling log does not indicate that any separate lower saturated interval was encountered. Ground water elevations taken between 1991 and 1998 in MW-12 appear to show a seasonal rise in water elevation in the second quarter of the year. It happened 4 of 6 years when measurements were made. This may indicate evidence from MW-12 of a connection between a saturated sandstone interval and the surface. This connection, if it exists appears related to the un-named drainage along the east side of the site. However, the chemical analyses of water from MW-12 shows high levels of total dissolved solids (TDS) and dissolved sulfate consistent with the monitor wells known to be confined. It is also consistent within the range of natural sulfate and TDS found in the Mancos Shale as per DOE, (2011). The concentrations are among the highest on the site. This is inconsistent with recharge of fresh water from the surface. Please refer to Figure 7.7 for a hydrostratigraphic section along the east side of the Durita site.
