FINAL COMPLETION REVIEW REPORT

**For the Hecla Mining Company Durita Facility
Montrose County, Colorado**

Colorado Radioactive Materials License No. 317-02

March 2, 2016

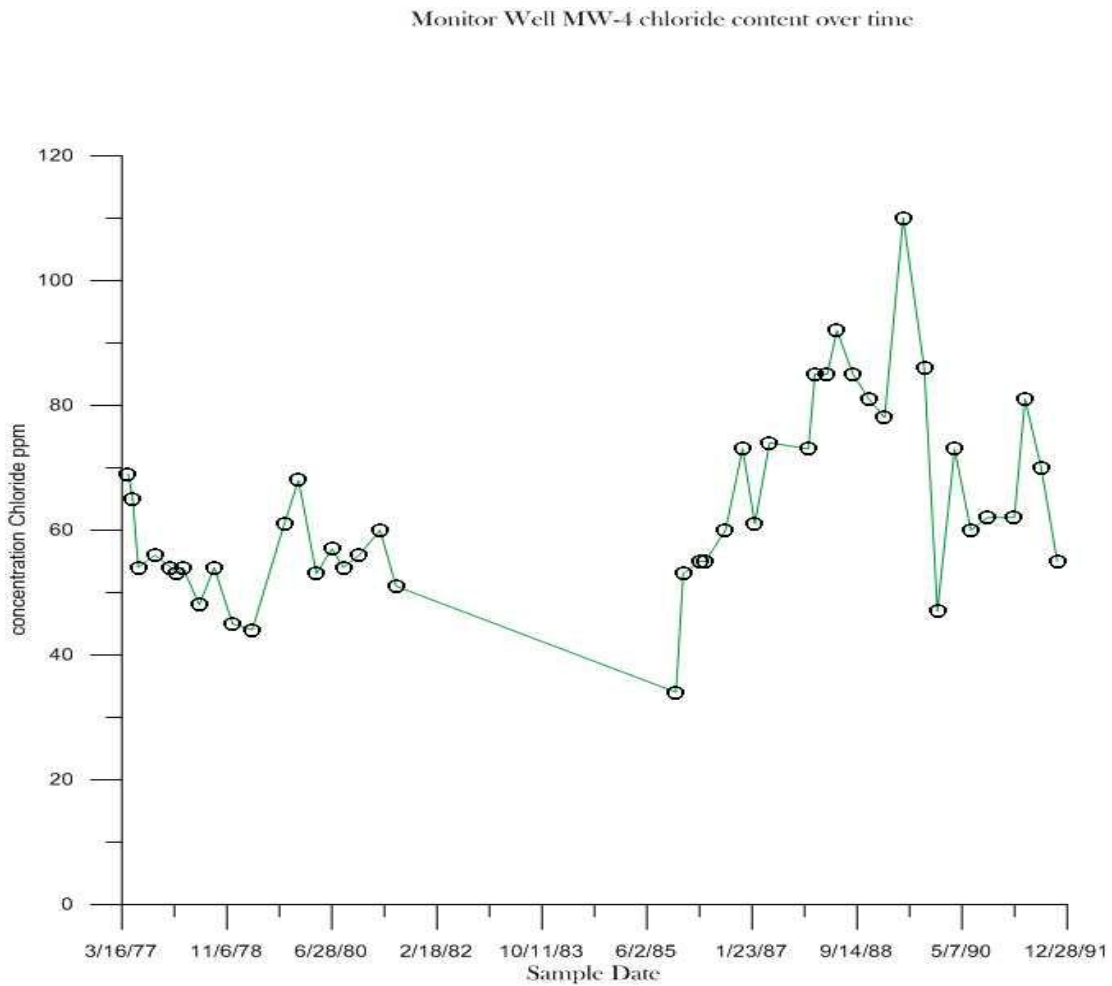
Attachment 7.1

ANOVA analysis of groundwater chloride content over time in monitoring well MW-4
Plot of chloride content in well MW-4 over time 1977 to 1991.

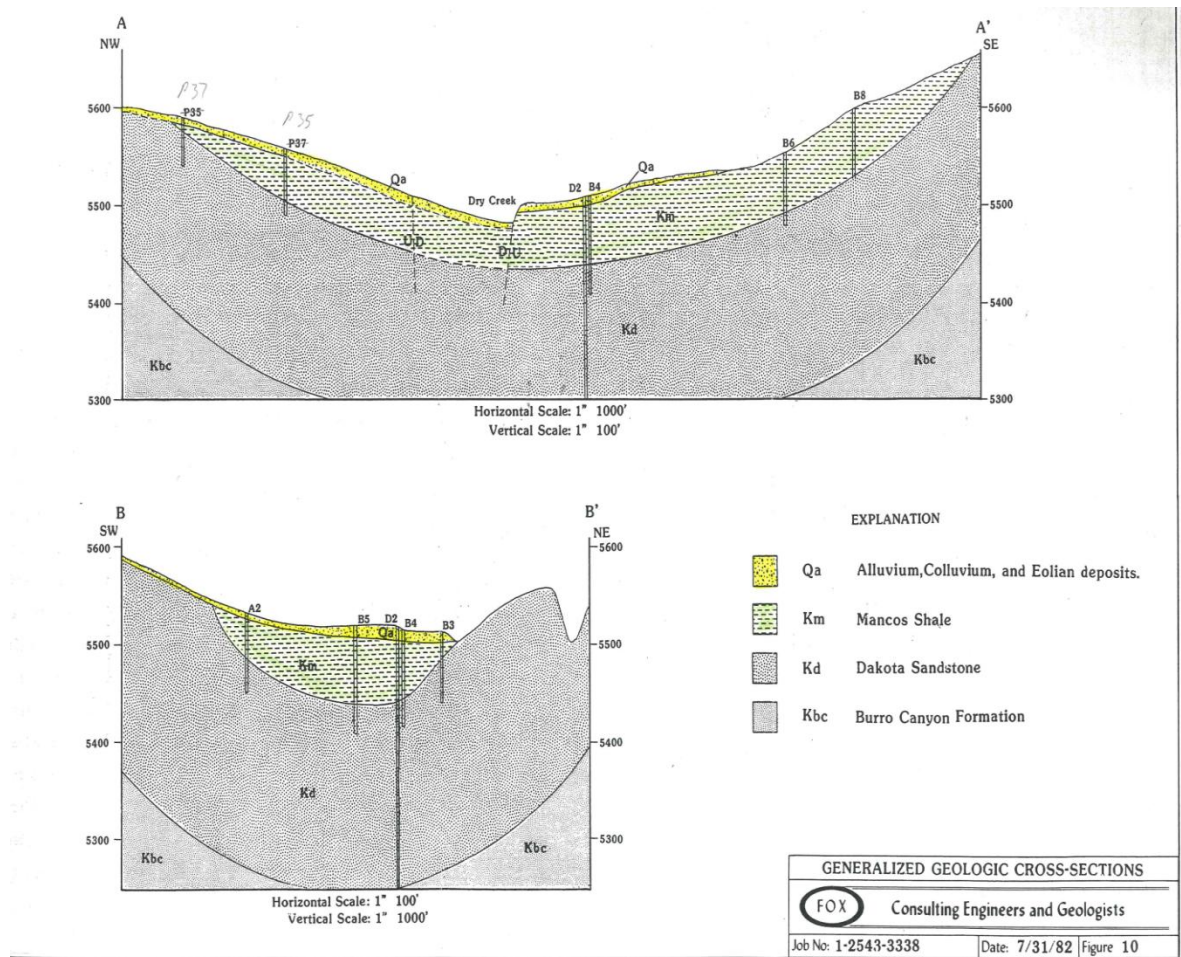
Figure 7.1
Generalized cross section across the Coke Oven Syncline. From Fox 1982

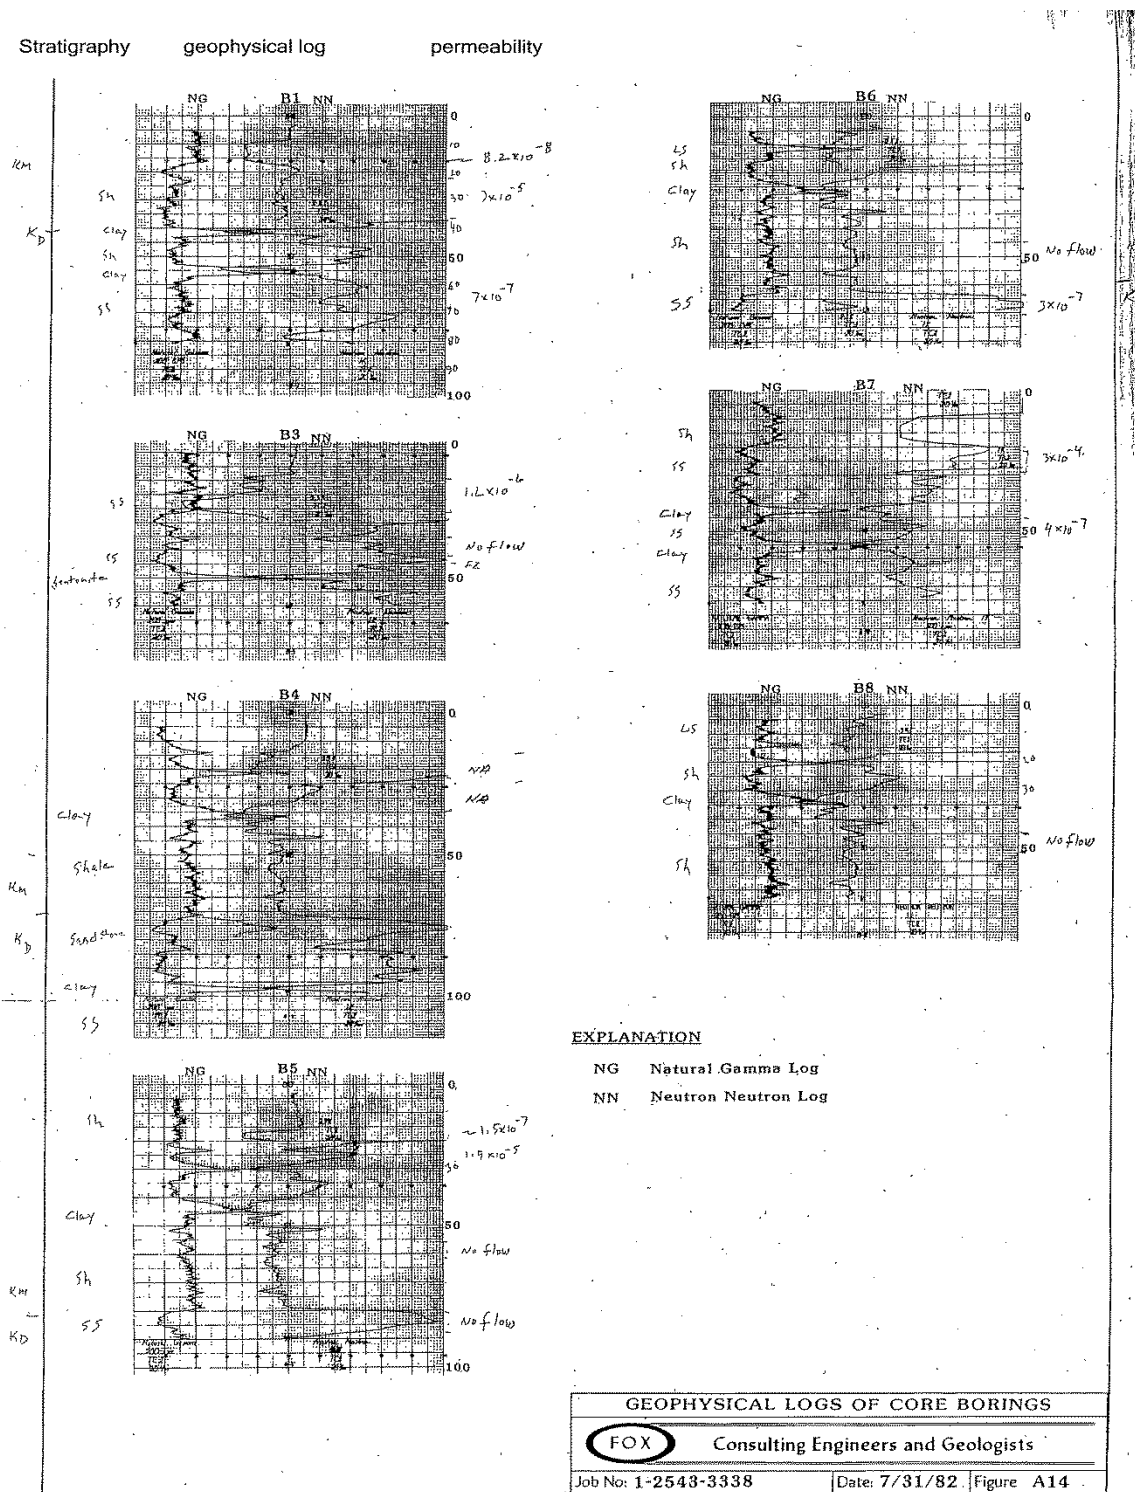
Figure 7.2

The drilling logs for monitor well MW-8 through MW-14 show the un-weathered Mancos Shale to be dry between units A and C. The geophysical logs, Figure 7.2, reported by F. M. Fox (1982) show a distinct basal Mancos Shale signature above the Dakota Sandstone. This basal shale feature is topped with a bentonite clay layer about 3 feet to 4 feet thick. Three in-hole conductivity tests were performed in this basal shale. No measurable conductivity was reported for the measurements conducted in boreholes B-5, B-6, and B-8. These are boreholes on or close to the Durita site.

Stratigraphy and measured permeability plotted against the natural gamma and neutron-neutron geophysical measurements. From Fox 1982.

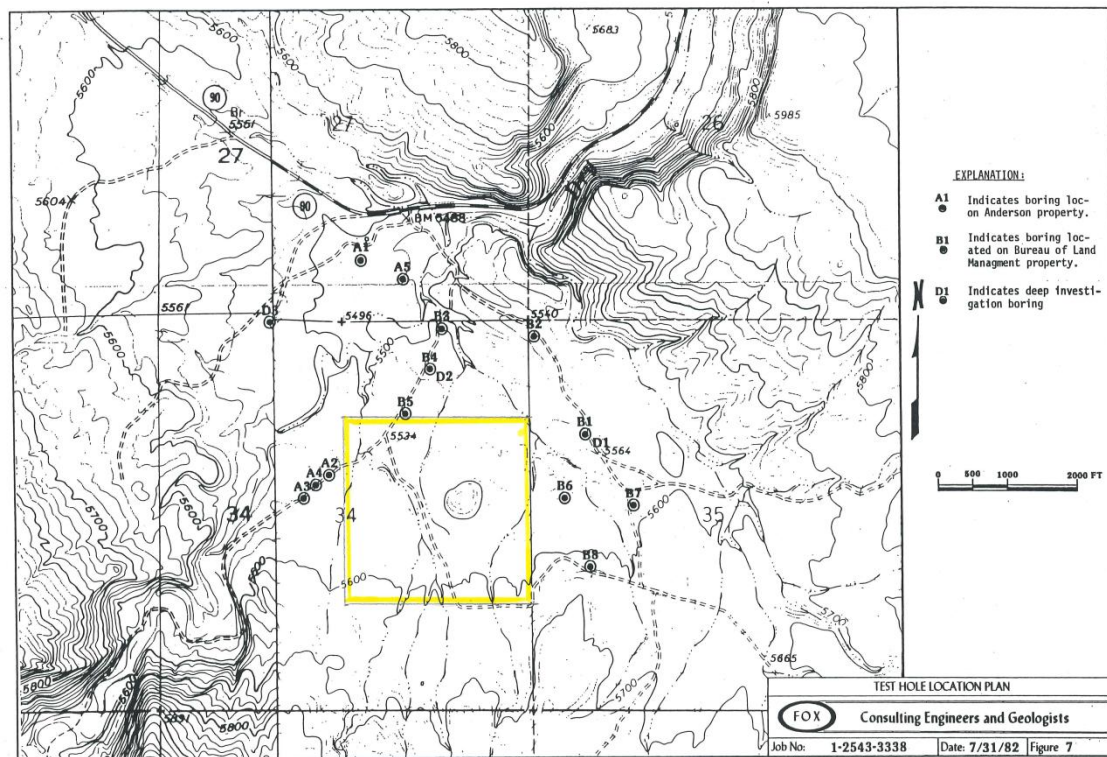
Two hydraulic conductivity measurements were performed in the basal shale in borehole B-1 with values of 8.2×10^{-8} cm/sec and 3×10^{-5} cm/sec. The drilling log of B-1 indicates that the conductivities were done in an oxidized zone. The basal Mancos Shale is at a shallower depth than the other measured boreholes. Borehole locations are shown in Figure 7.4.

Figure 7.4 Test hole location map from Fox 1982. The Durita site is outlined in yellow.

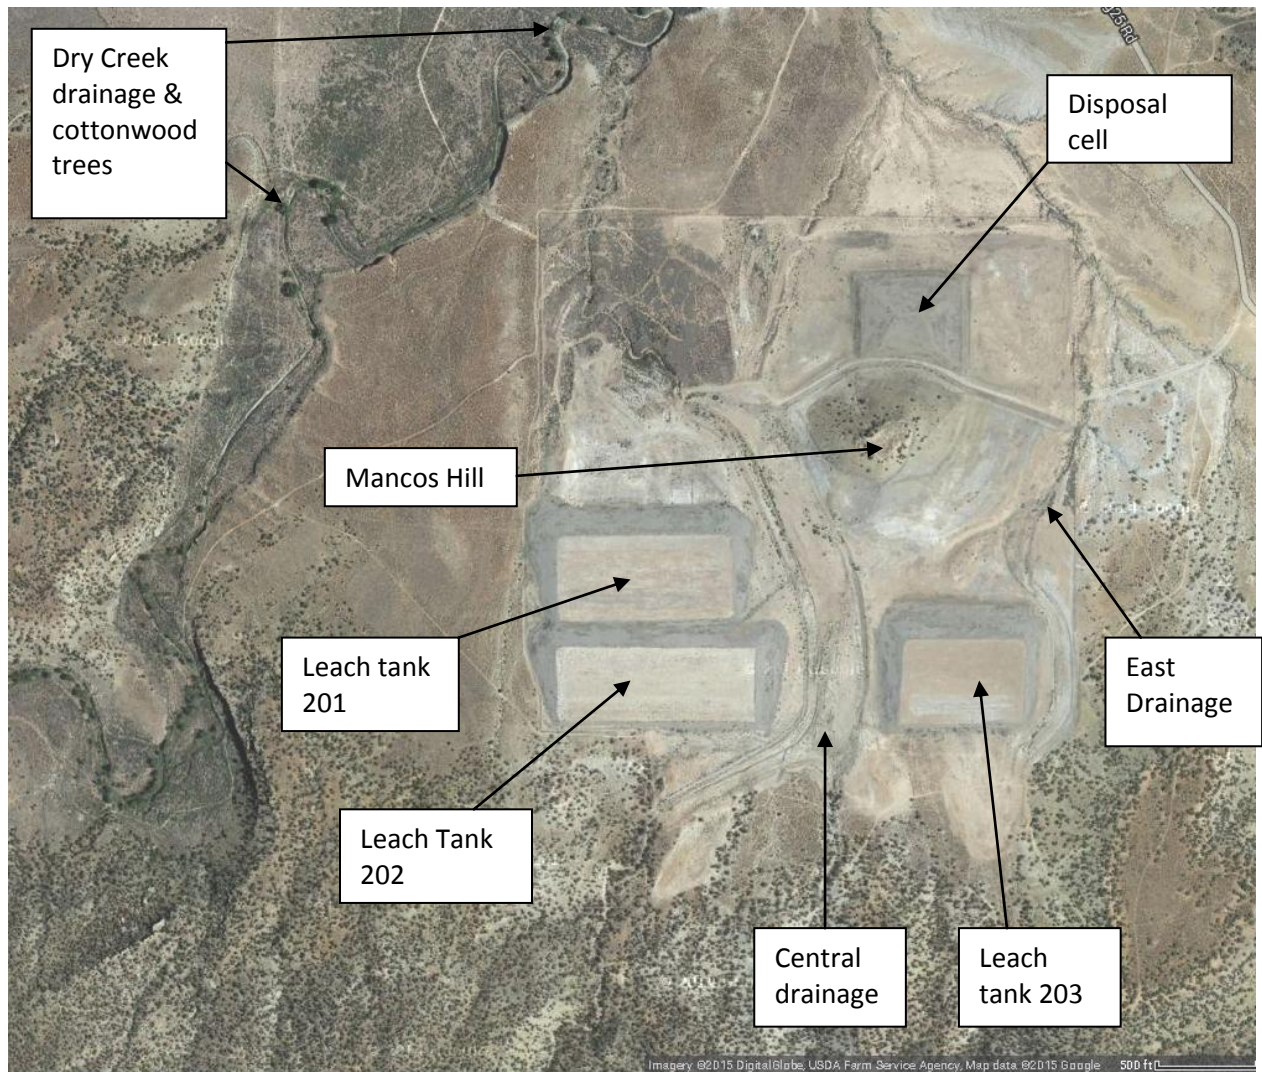
Groundwater at the site occurs continuously at, or near, the base of the Mancos Shale and into the Dakota Sandstone. The source of the water is infiltration of precipitation and runoff into the surface exposures south of the Durita site and on the slopes of Naturita Ridge. The exposed re-charge area is on the southern limb of the Coke Oven Syncline. Water in the Dakota Sandstone moves north, and down dip, under the site. It is covered by the aquitard/aquiclude of the Unit B Mancos Shale and thus becomes a confined aquifer under the Durita site. Figure 7.1 shows a cross-section across the site. Figure 7.2 shows the geophysical logs and permeability measurements made during this investigation. Figure 7.3 shows the shallow aquitard contours; Figure 7.4 shows the test hole location map where soil borings were installed by F. M. Fox (1982) Figure 7.5 shows a satellite photograph of the Durita site with major features labeled.

Figure 7.5 Satellite image of the Durita site area with major features identified.

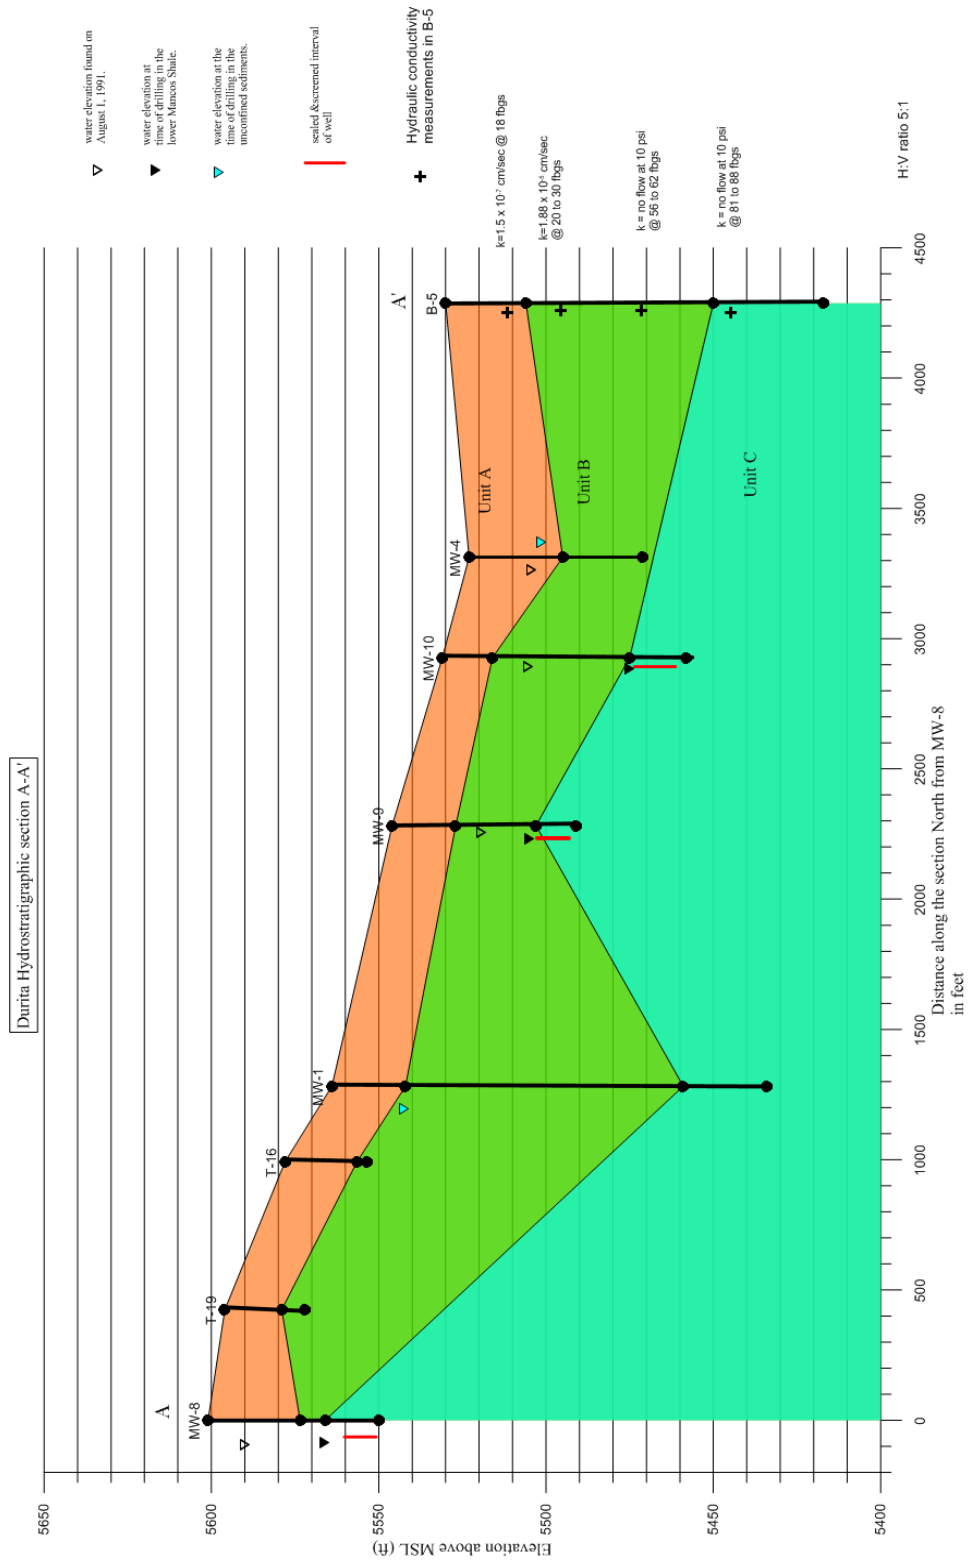
Soil boring descriptions and geophysical logs for boreholes B-1, B-5, and B-6, show a sandstone interval in the upper Dakota Sandstone. There are three measured hydraulic conductivities measured in this section ranging from 3×10^{-7} cm/sec to no measurable conductivity. Figure 7.6 and Figure 7.7 show the hydrostratigraphic section from south to north across the Durita site showing well screen intervals and

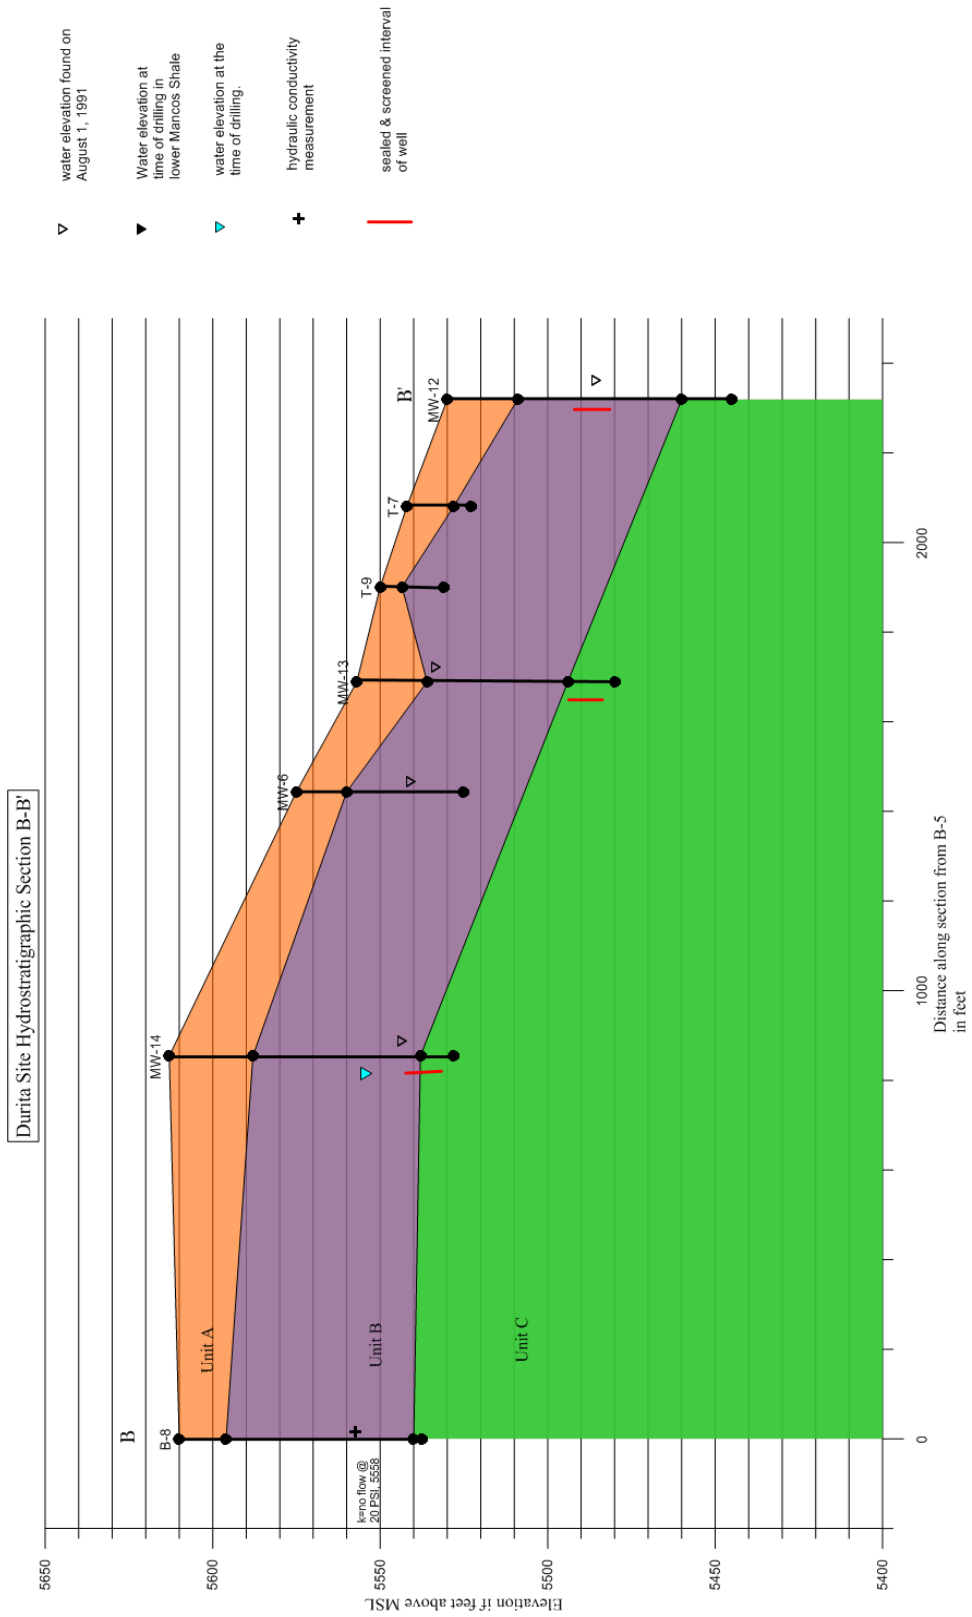
Most wells drilled into the lower saturated interval show a groundwater potential higher than the elevation of the saturated section. MW-12 shows that the first saturated interval it penetrates has a free-air potential and is not confined. The first saturated interval in MW-12 is a 1-foot thick sand within the Mancos Shale at 20 feet below ground surface (bgs). The drilling log does not indicate that any separate lower saturated interval was encountered. Groundwater elevations taken between 1991 and 1998 in MW-12 appear to show a seasonal rise in water elevation in the second quarter of the year. It happened in four of six years when measurements were made. This seasonal rise may indicate evidence from MW-12 of a connection between a saturated sandstone interval and the surface. This connection, if it exists, appears related to the unnamed drainage along the east side of the site. However, the chemical analyses of water from MW-12 shows high levels of total dissolved solids (TDS) and dissolved sulfate consistent with the monitor wells known to be confined. It is also consistent within the range of natural sulfate and TDS found in the Mancos Shale as per DOE, (2011). The concentrations are among the highest on the site. This is inconsistent with recharge of fresh water from the surface. Please refer to Figure 7.7 for a hydrostratigraphic section along the east side of the Durita site.

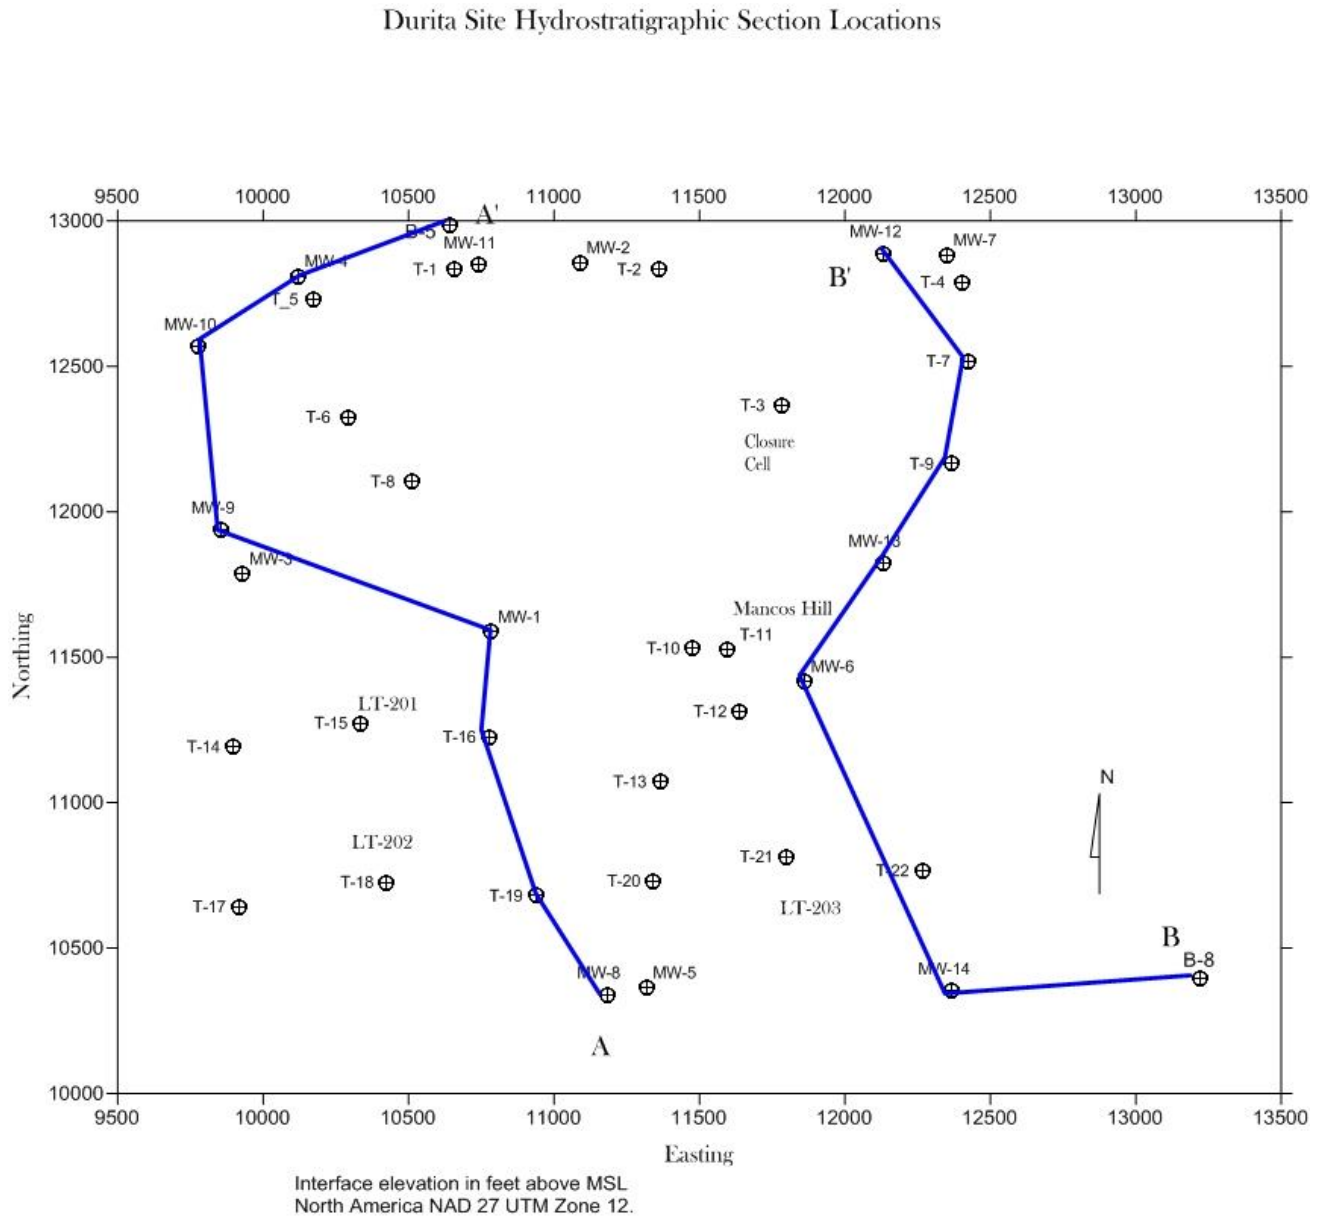
static water heads. Figure 7.8 shows the locations of the wells and boring shown in Figures 7.6 and 7.7.
