GINNA STATION
B-STEAM GENERATOR
NRC MEETING
MARCH 23, 1982

INSPECTION UPDATE
NO. 4 WEDGE AREA

R. E. GINNA S/G B - POSTULATED TUBE RUPTURE MECHANISM.

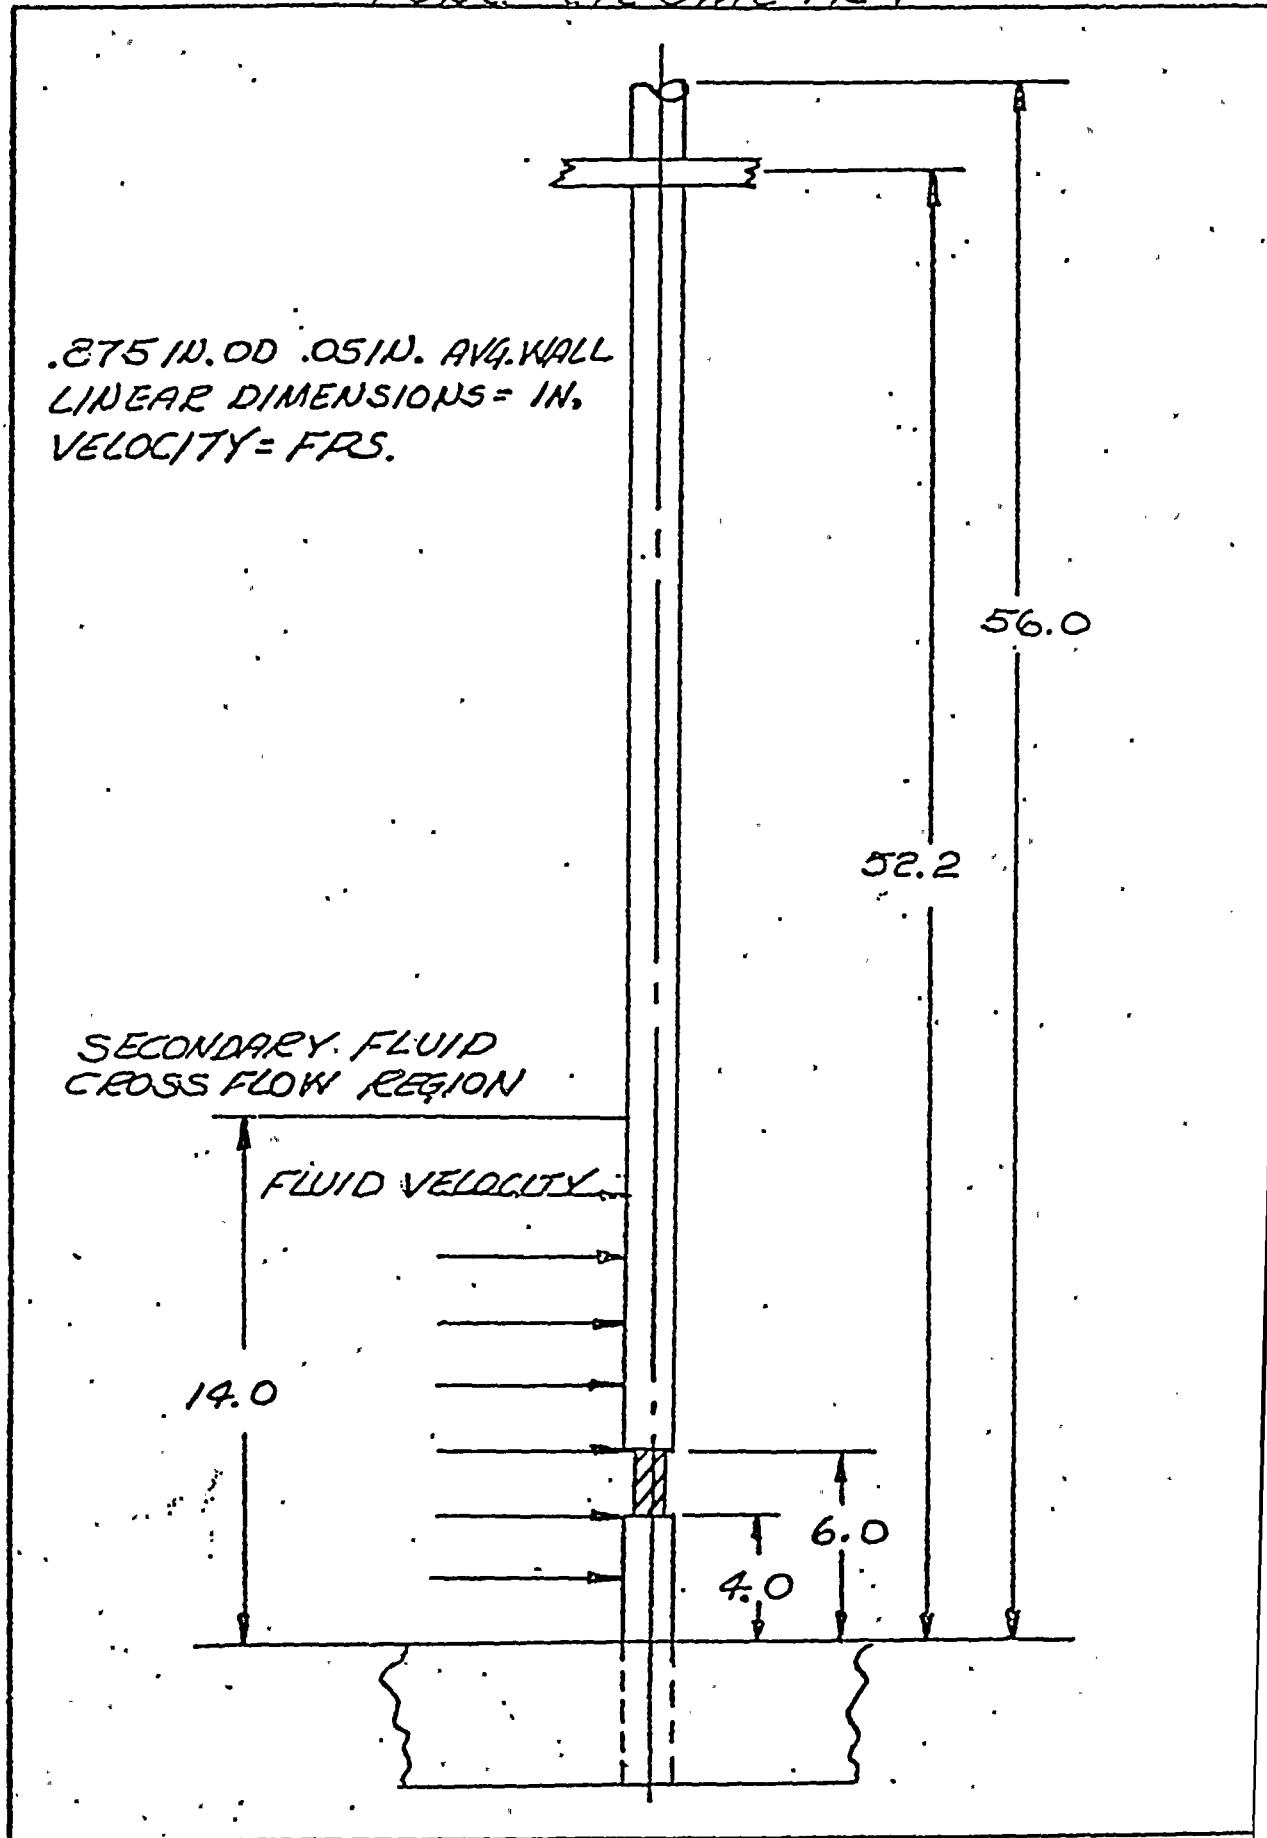
FIXED-FIXED BOUNDARY CONDITIONS
DAMPING RATIO = 0.01

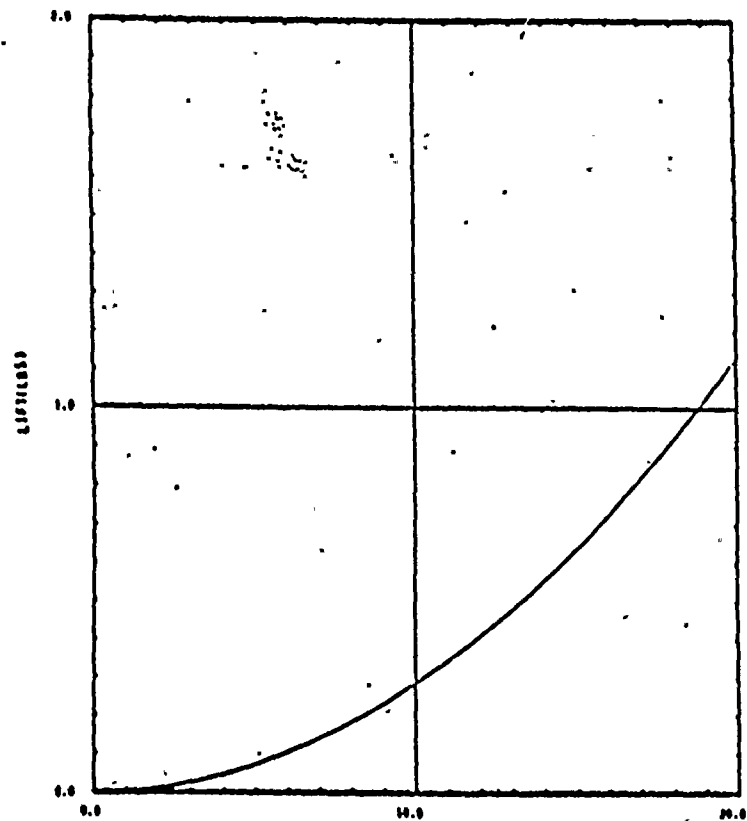
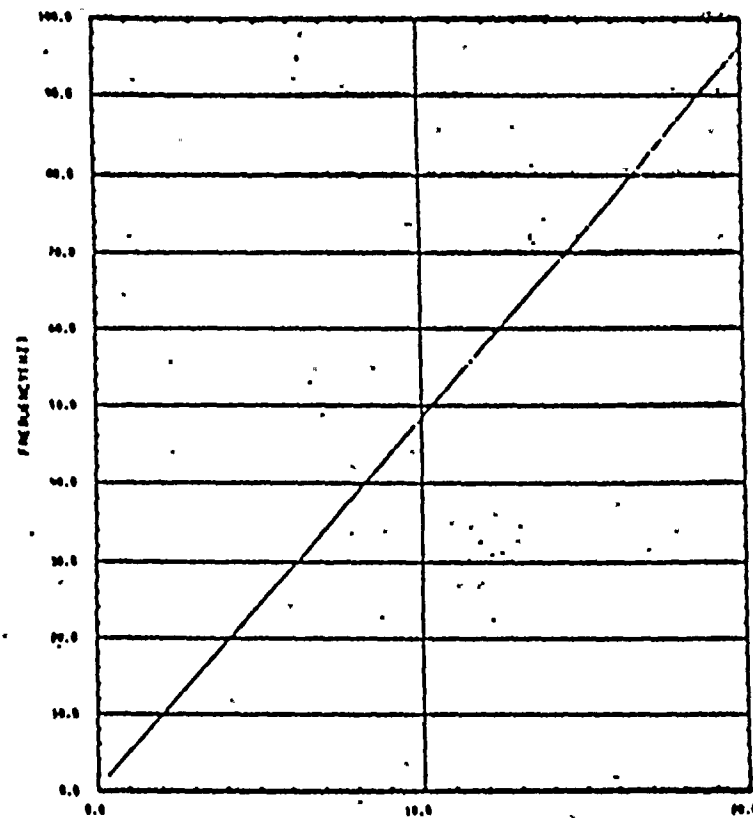
OSCILLATING LIFT AND VORTEX - SHEDDING FREQUENCY FOR $D = 0.5$ INCH, $H = 2.0$ INCH

VELOCITY (FPS)
LIFT VS. VELOCITY

VELOCITY (FPS)
FREQUENCY VS. VELOCITY
