REVIEW OF THE OPERATING EXPERIENCE HISTORY
OF THE GINNA NUCLEAR POWER PLANT FOR THE
NUCLEAR REGULATORY COMMISSION'S
SYSTEMATIC EVALUATION PROGRAM

Performed by the Staff of the
Nuclear Safety Information Center (NSIC)
Oak Ridge National Laboratory (ORNL)

October 1981

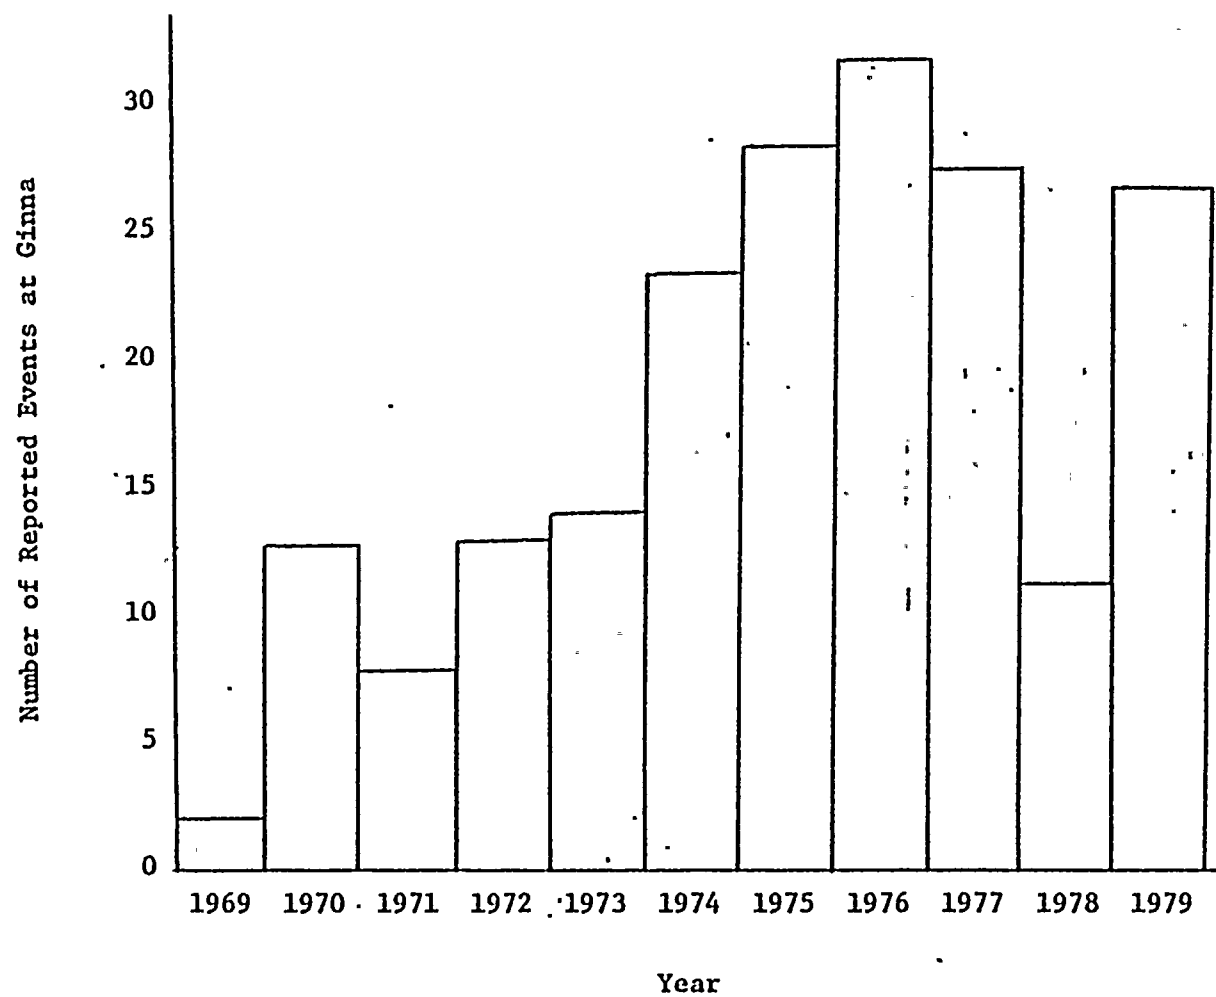
Figure 4.1 Number of Reported Events at Ginna

The reporting pattern over the life of Ginna is shown in Figure 4.1, with the trend toward more reported events. The years 1970 through 1973 averaged 10 reported events per year whereas the years 1974 through 1979 averaged over 23 per year. The recurring failures discussed in Sect. 4.5.2.2.1 contribute to this trend. But even if these recurring failures are subtracted from the total number of reported events, the upward trend is still marked. (The year 1978 set capacity factor records and, thus, is below this trend.)

Whereas trends in shutdowns and power reductions generally followed trends in reactor availability, reportable events had two distinct phases (Fig. 4.1). Through 1973, reportable events were generated consistently at a rate of about ten per year; then, in 1974, these rates doubled and averaged about 25 per year through 1979. The exceptional year, 1978, with only nine reportable events, set the record for capacity factor at 78.2%. This is the only reason found for the low number of reportable events in 1978.
