SACRIFICIAL SHIELD WALL

- ANALYSIS, DESIGN, CONSTRUCTION OF SSW

- o BWR MARK II
- o 1100 MW PLANT

Docket # 50-397
Control # 8007310013
Date 7-11-80 of Document:
REGULATORY DOCKET FILE

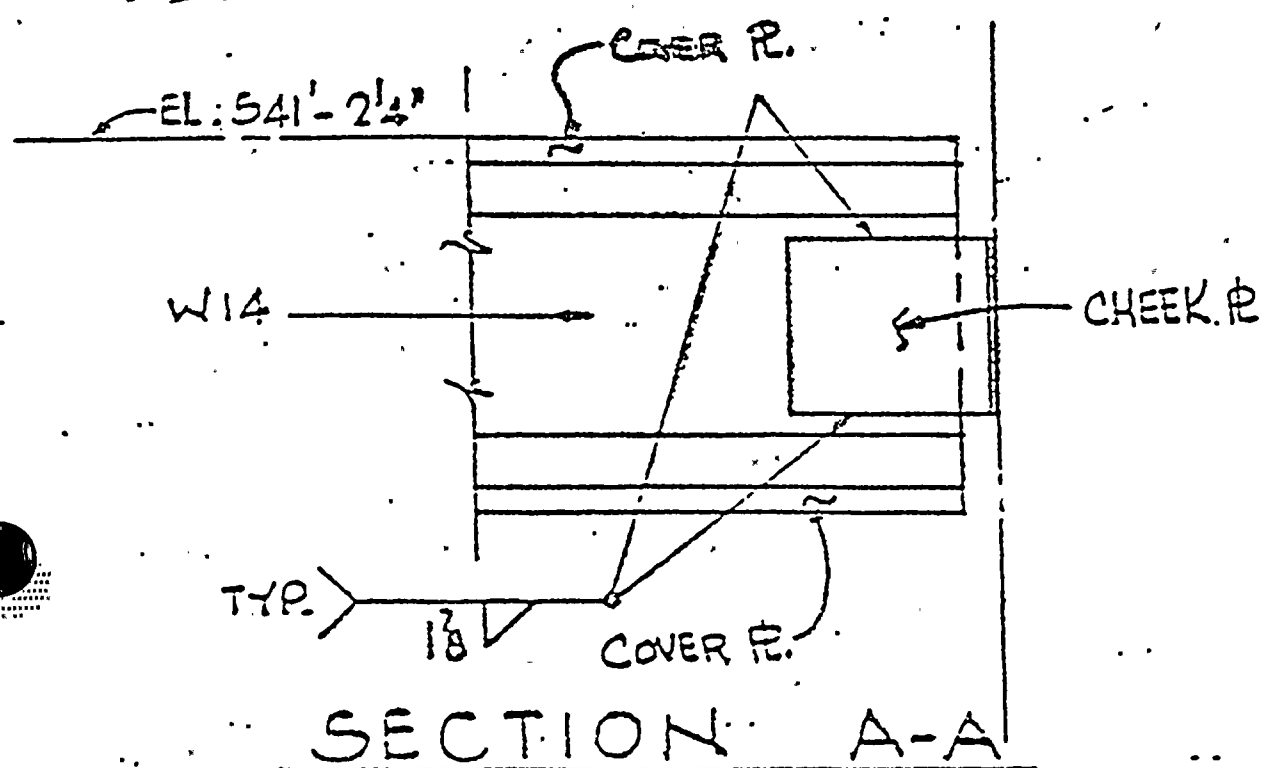
PROBLEM 20

(SSW) B&R Dwg. S-802 note 3 refers to the spec. for PWHT requirements of the stabilizer assemblies on the SSW. The spec. does not appear to specifically address PWHT of stabilizers. It is, therefore, not clear whether designers intended to have PWET. Material involved is A514, A588, and SA537, 1 3/4" & 2" thick, full penetration welds. The SSW @ stabilizer level is also A588 Grade A Steel 2 1/2" & 2 1/2" thick with full penetration welds (U channel 1 B&R dwg. S783.).

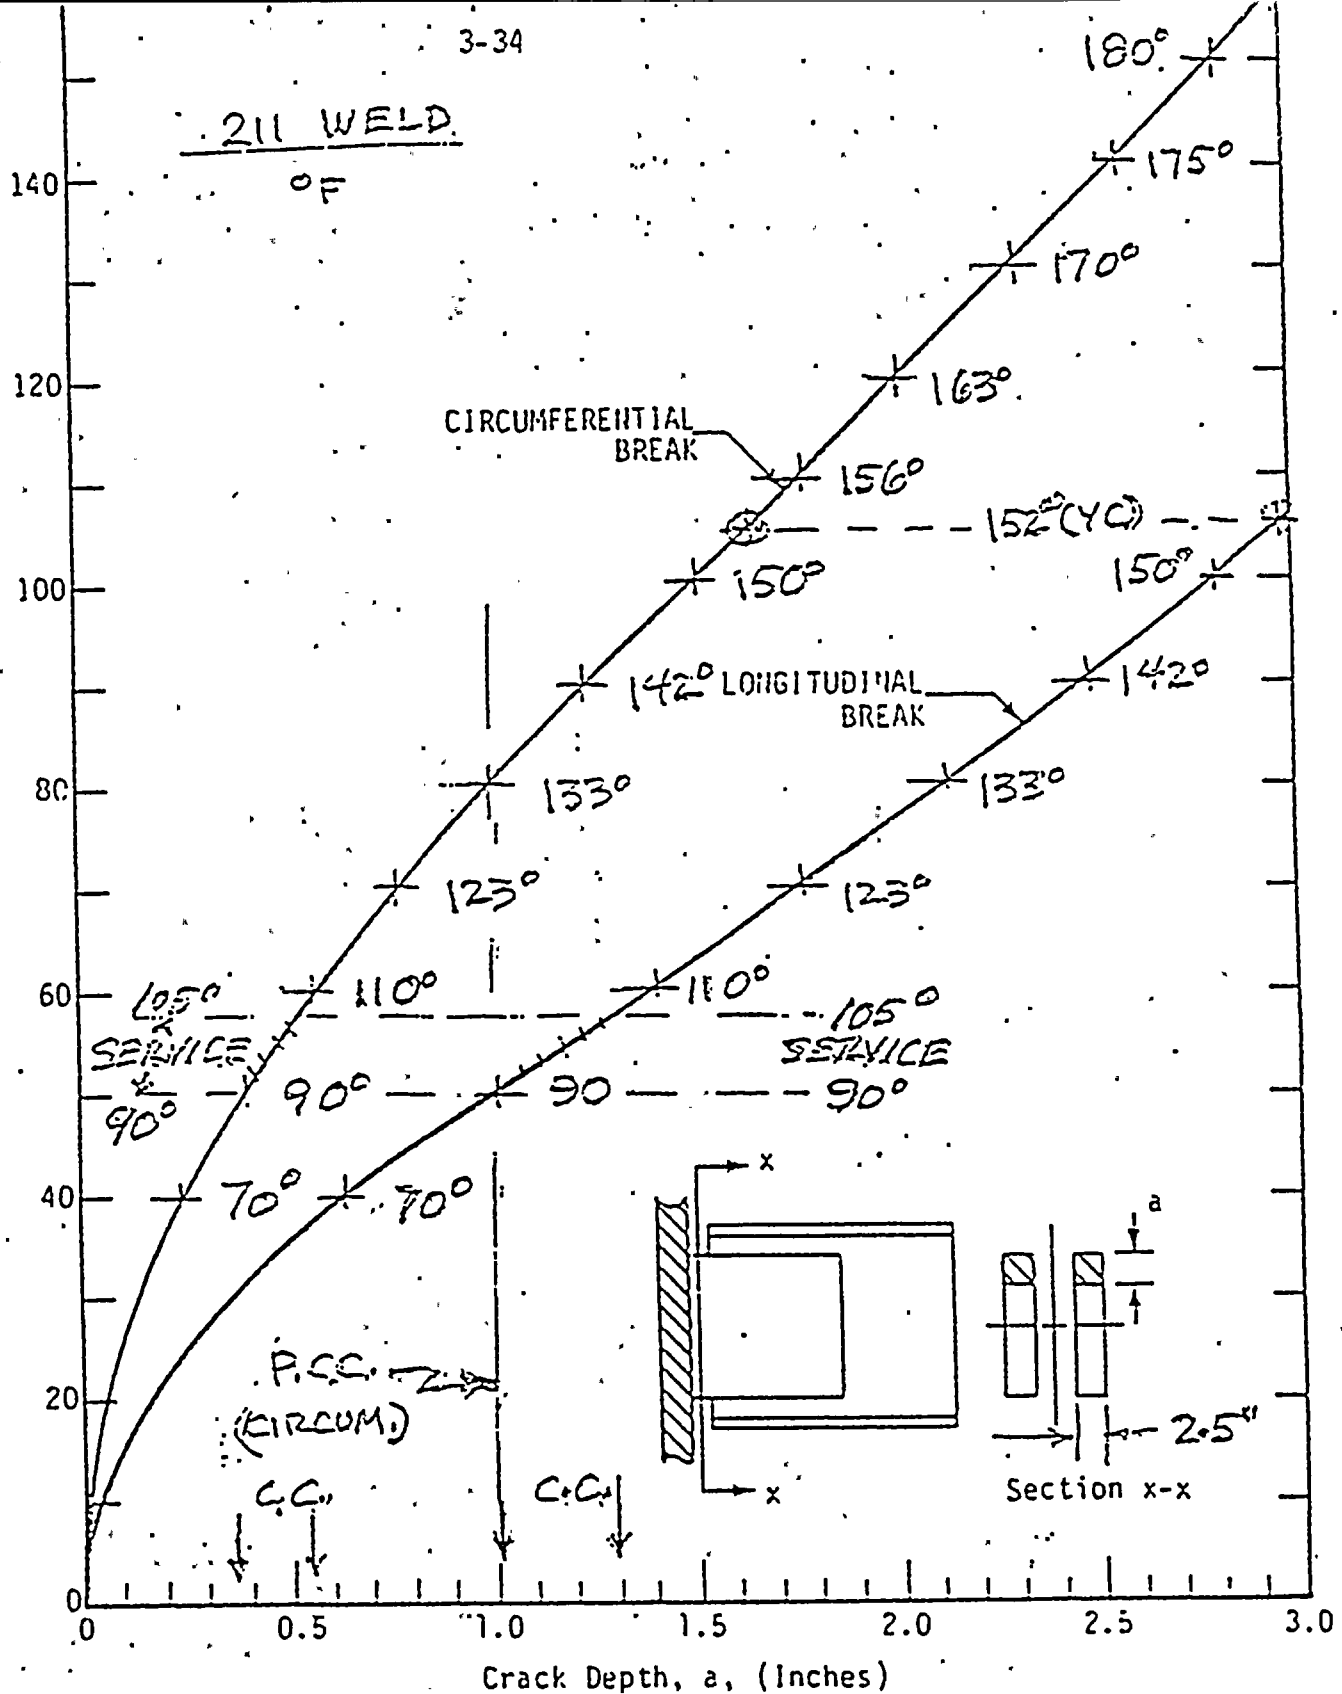
Figure 3.14 - Total Stress Intensity Factor for an Edge Crack in the Cheek Plate-to-Wall Connection Weld (With Residuals).

Figure 3.14 - Total Stress Intensity Factor For an Edge Crack in the Cheek Plate-to-Wall Connection Weld (With Residuals).
