RESPONSE TO
NRC HUMAN FACTORS ENGINEERING
PRELIMINARY DESIGN ASSESSMENT AUDIT
REPORT OF AUGUST 26, 1983

WASHINGTON PUBLIC POWER SUPPLY SYSTEM
NUCLEAR PROJECT NO. 2 (WNP-2)

October 7, 1983

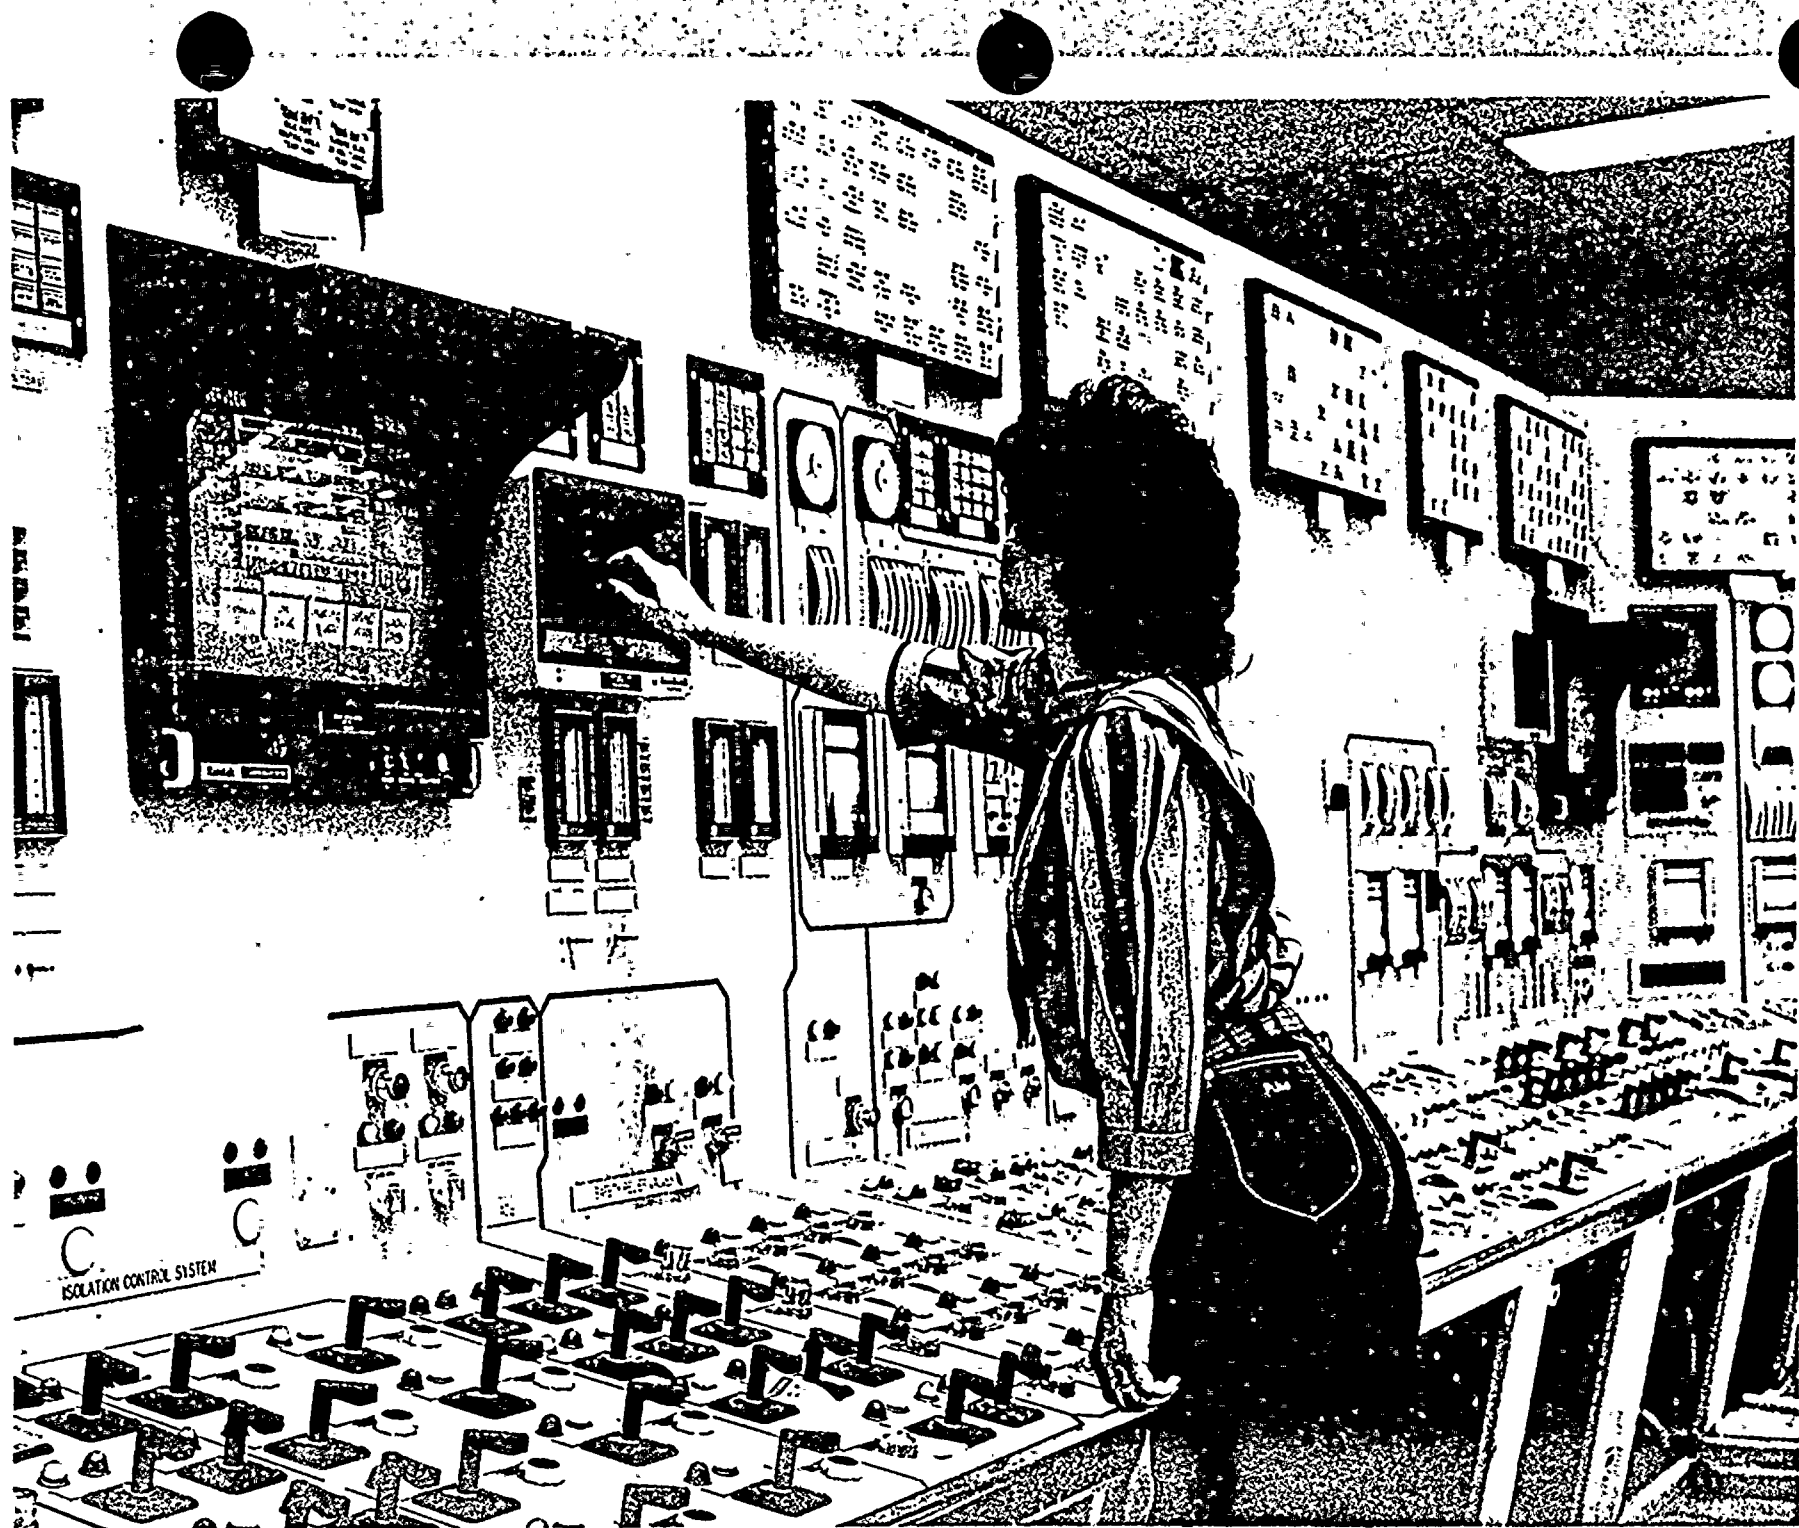
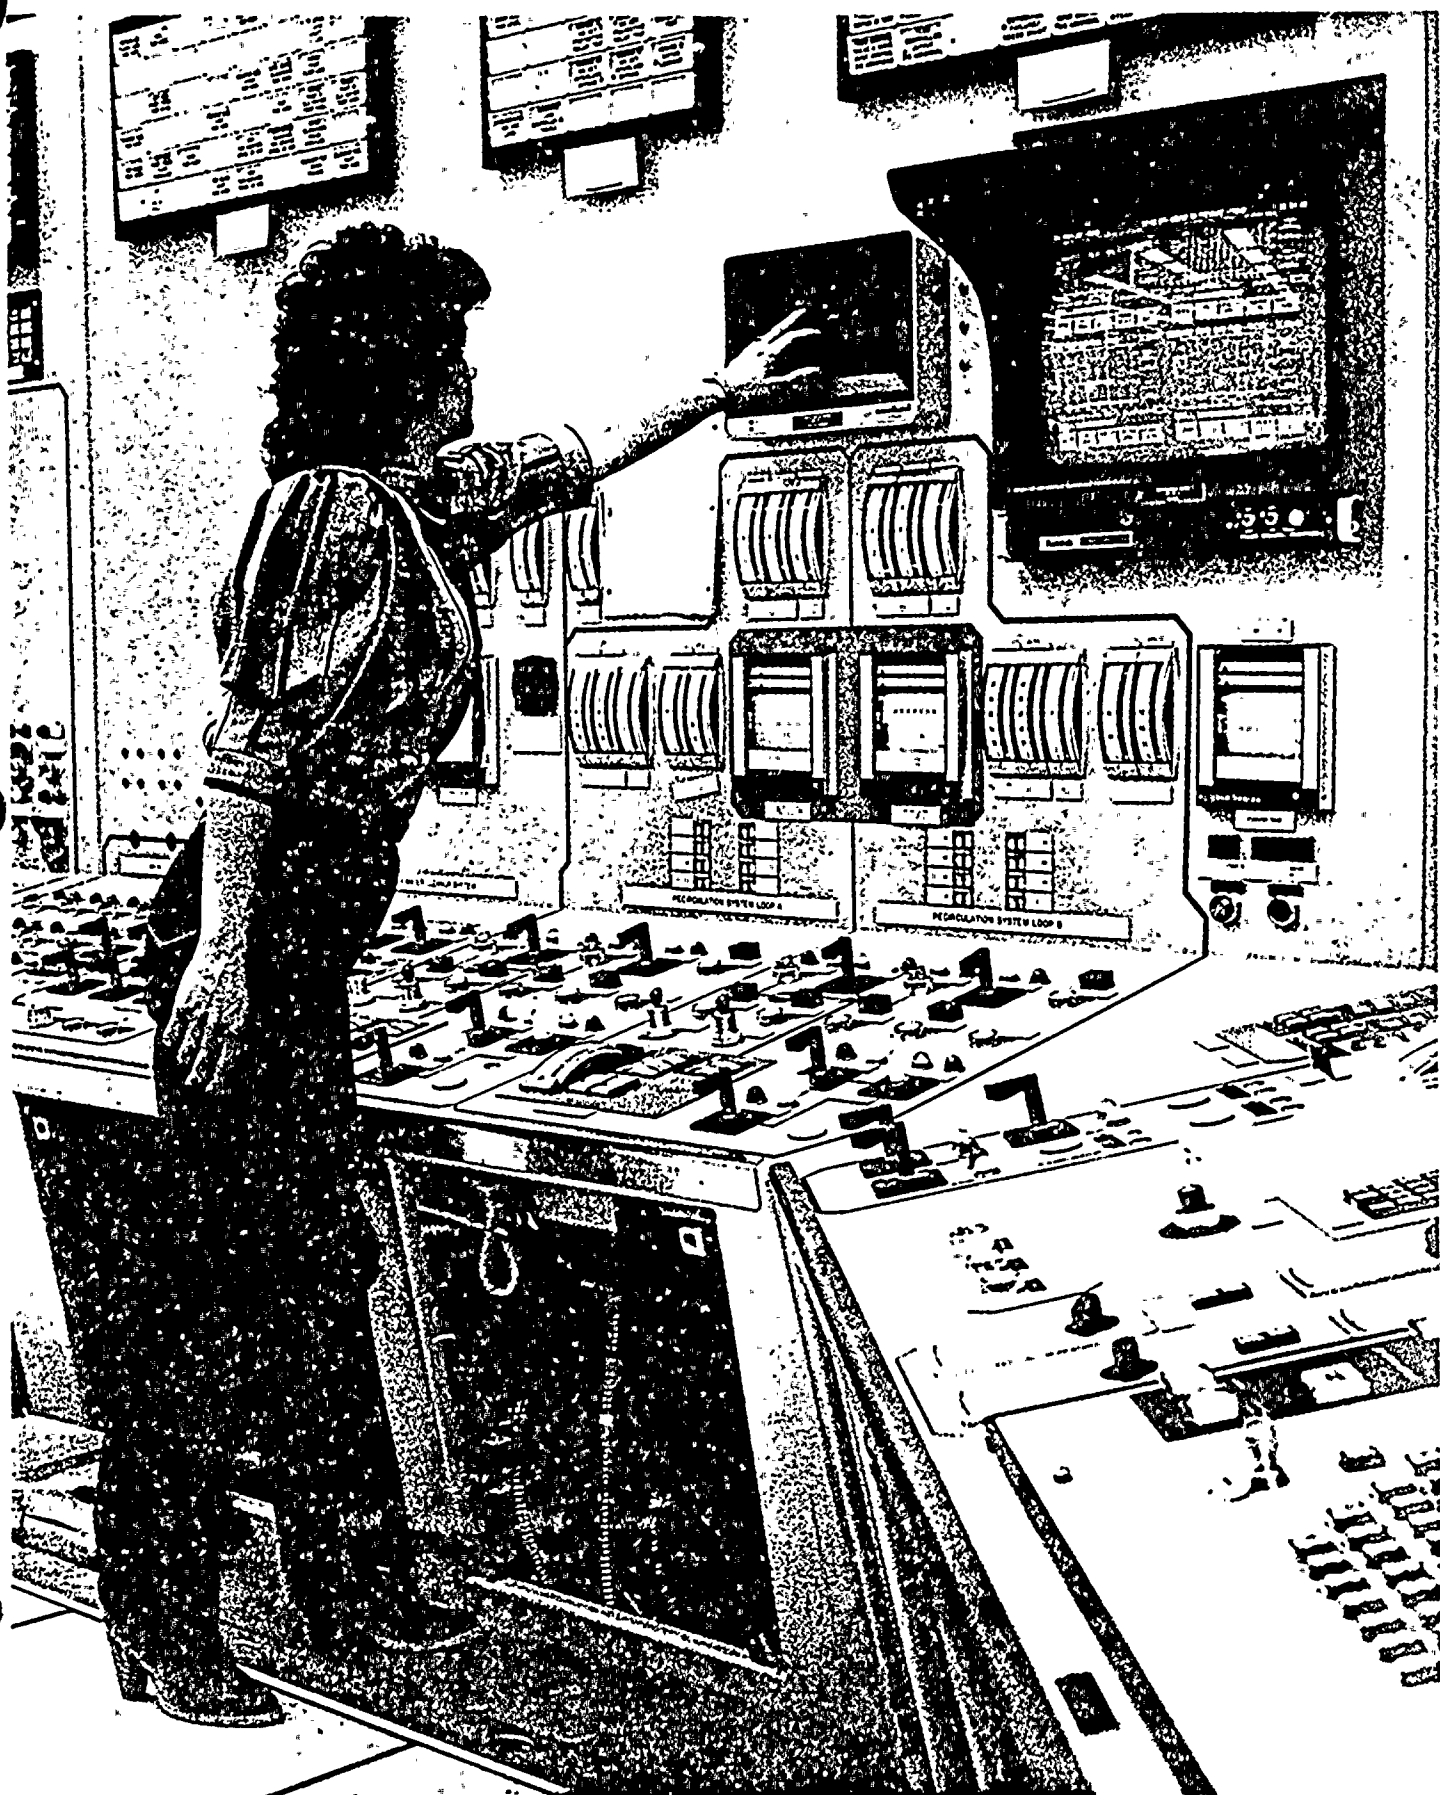
P-820 - This panel needs demarcation. (B214)

RESPONSE: NRC Audit Finding D-8.34 specifies the same panel needs demarcation. However, installation of all demarcation lines have now been completed in the control room and remote shutdown room. No further action is required.
