PALO VERDE NUCLEAR GENERATING STATION
PROJECT EVALUATION -
DEFICIENCY EVALUATION REPORT
JOB NO. 10407

REPORT NO. 82-53

FAILURE ANALYSIS

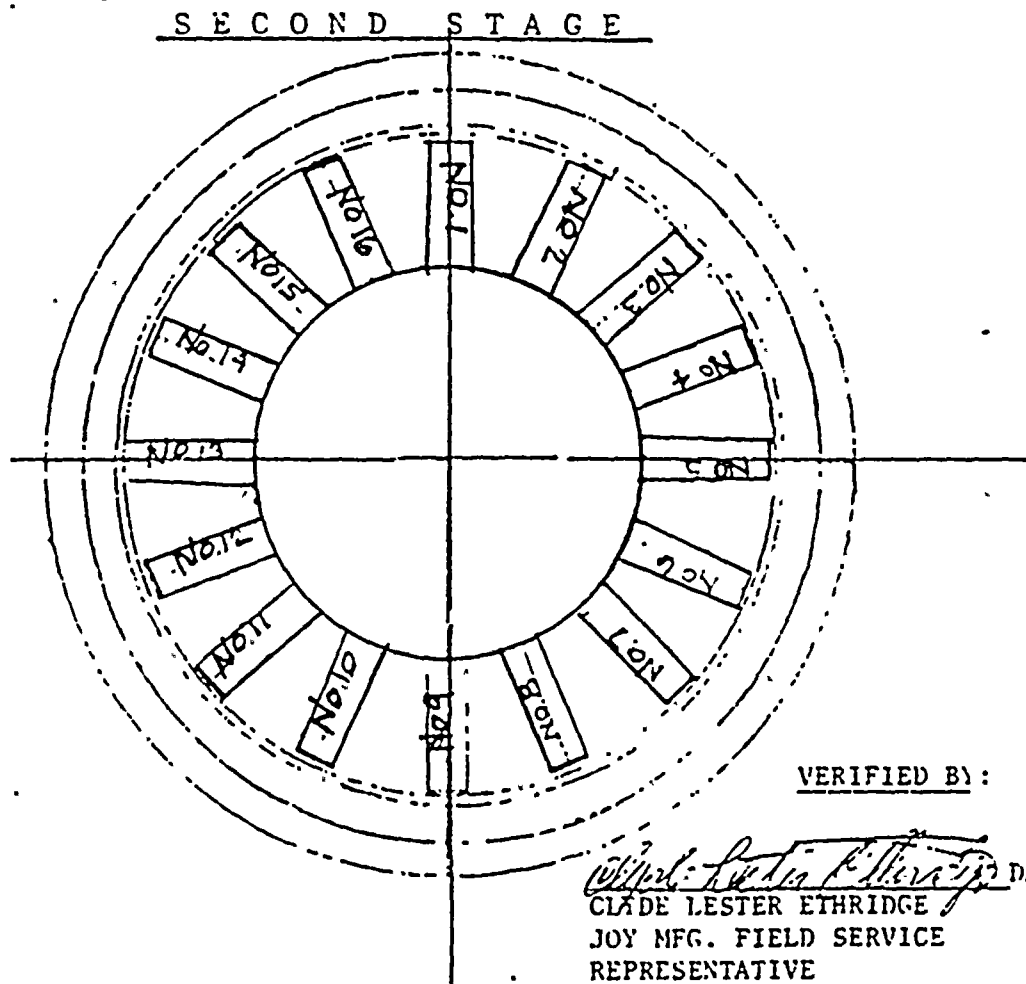
JOY VANEAXIAL FAN - QUALITY CLASS "R"
UNIT TAG NO. 1-M-HCN-F01A SERIAL NO. GF-21598
34" DIA. 26" S.S. HUB SERIES 2000 - 2 STAGE

BLADE NO. 1 - 400 Ft./Lbs.
2 - 400 Ft./Lbs.
3 - 400 Ft./Lbs.
4 - 400 Ft./Lbs.
5 - 400 Ft./Lbs.
6 - 400 Ft./Lbs.
7 - 400 Ft./Lbs.
8 - 400 Ft./Lbs. 2° Off

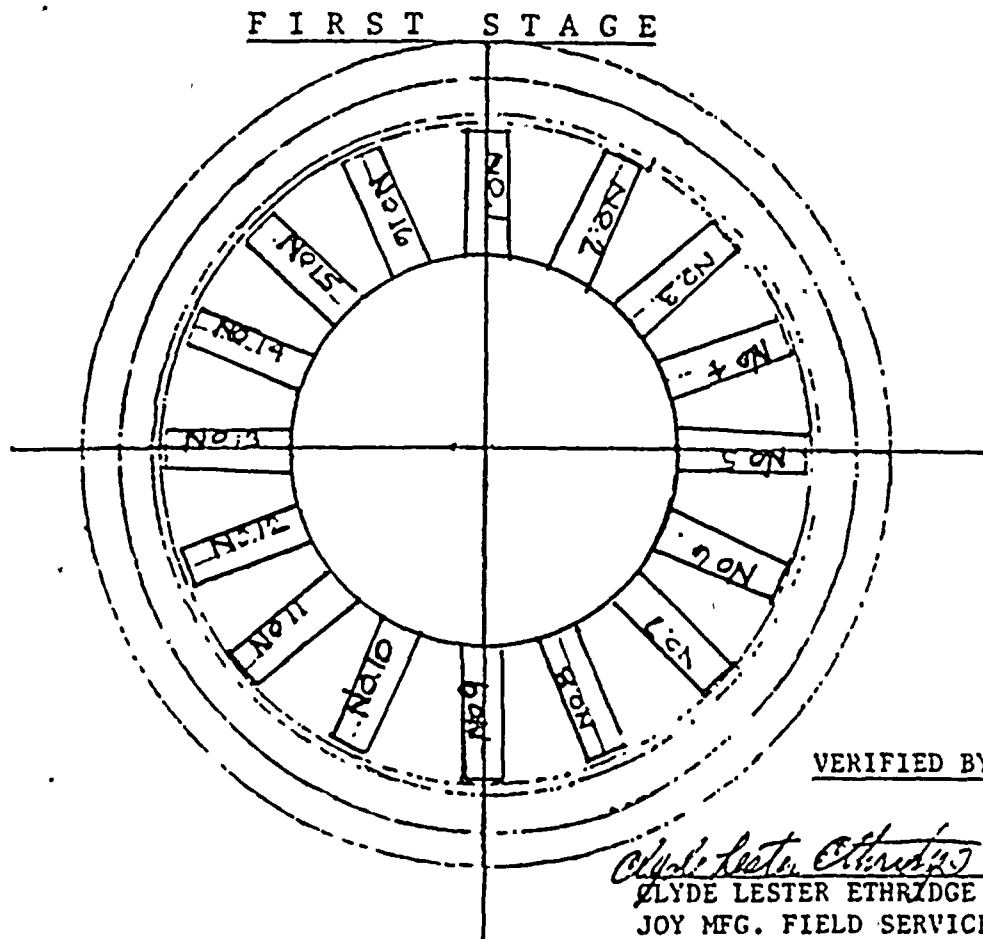
JOY VANEAXIAL FAN - QUALITY CLASS "R"
UNIT TAG NO. 1-M-HCN-FO1B SERIAL NO. GF-21599
34" DIA. 26" S.S. HUB SERIES 2000 - 2 STAGE

Blade No. *1 - 360-380 Ft./Lbs.
2 - 400 Ft./Lbs.
3 - 400 Ft./Lbs.
*4 - 400 Ft./Lbs.
5 - 400 Ft./Lbs.
6 - 400 Ft./Lbs.
7 - 400 Ft./Lbs.
*8 - 400 Ft./Lbs.

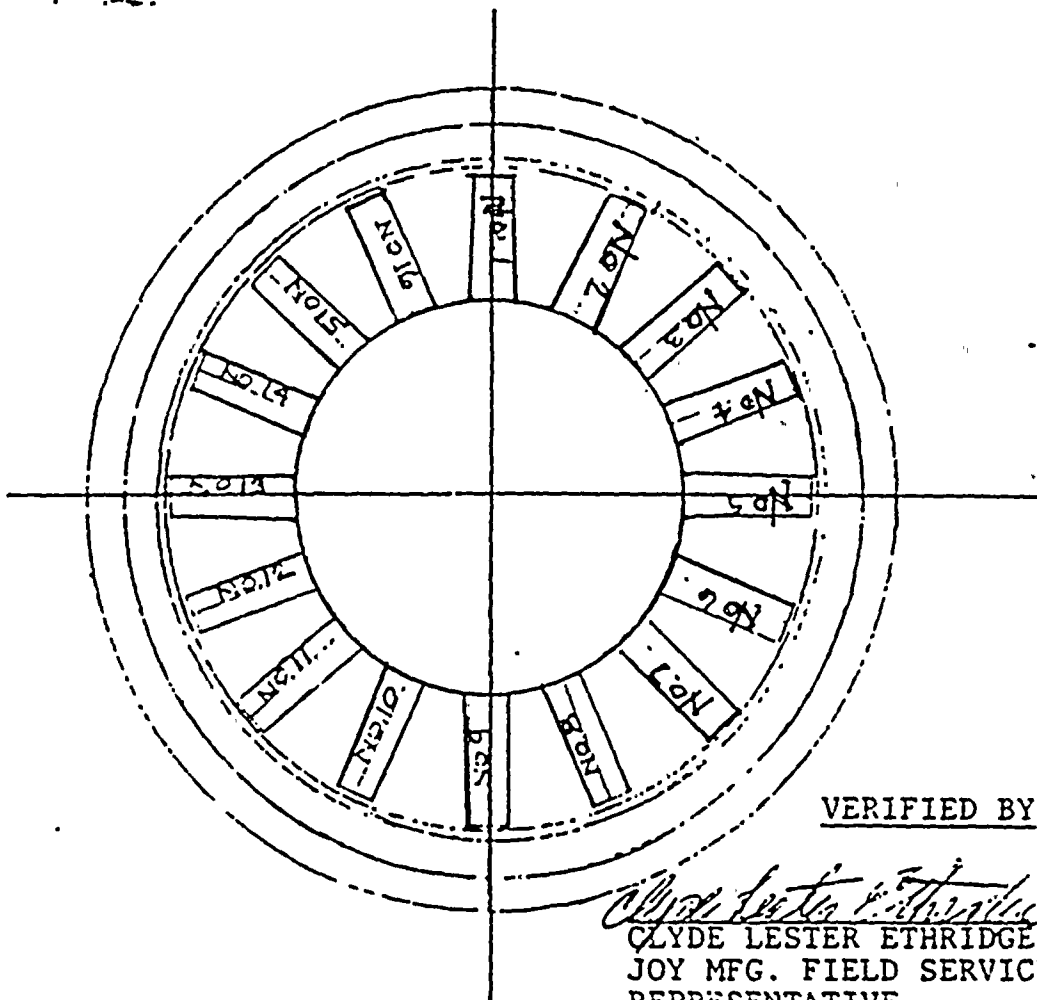
Joy Vaneaxial Fan - Quality Class "R"
Unit Tag No. 1-M-HCN-A03B Serial No. GF-21617
36" Dia. 26" S.S. Hub Series 2000 - Single Stage

VERIFICATION OF TORQUE & TIP ANGLES WAS UNABLE TO BE PERFORMED ON SUBJECT FAN: DUE TO CRAFT INADVERTENTLY STARTING TORQUEING PROCESSES WHILE LES ETHRIDGE AND MYSELF WERE INVOLVED IN VERIFICATION AT ANOTHER LOCATION. TIP ANGLES WERE CORRECTED AND EACH LOCKNUT TORQUED TO THE SPECIFIED VALUE.

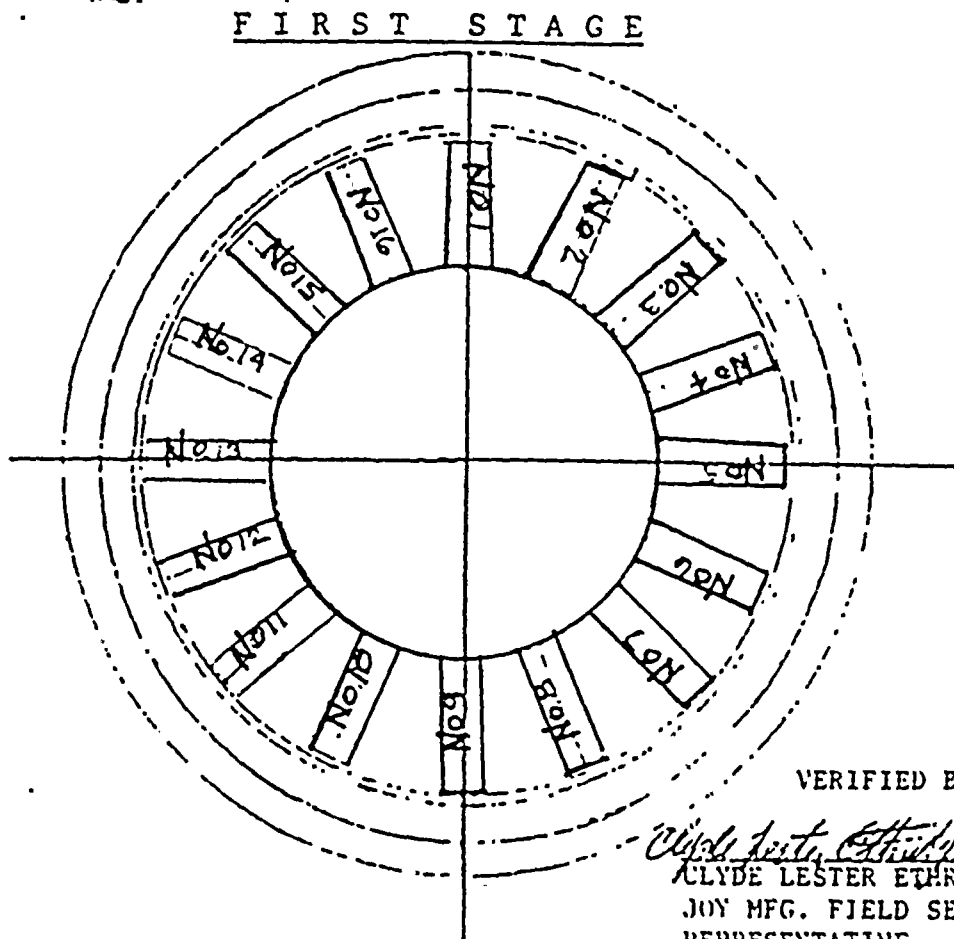
JOY VANEAXIAL FAN - QUALITY CLASS "R"
UNIT TAG NO. 1-M-HCN-A02D SERIAL NO. GF-21611
45" DIA. 26" S.S. HUB SERIES 2000 - 2 STAGE

Blade No. *1 - See Attached Ver. Report
2 - 400 Ft./Lbs.
3 - 400 Ft./Lbs.
*4 - 340-360 Ft./Lbs.
5 - 400 Ft./Lbs.
6 - 400 Ft./Lbs.
7 - 400 Ft./Lbs.
8 - 400 Ft./Lbs.

DUE TO THE ABOVE SITUATION, LOCKNUT WAS TIGHTENED WITH A (24") CRESCENT WRENCH, AND WE WERE ABLE TO OBTAIN A (1/2) TURN OF THE LOCKNUT. PREVIOUSLY NOTED, I INSTRUCTED CRAFT TO TRY AND TIGHTEN A LOCKNUT THAT HAD BEEN VERIFIED @ 400 FT./LBS. WITH THE SAME (24") CRESCENT WRENCH. CRAFT WAS UNABLE TO TURN THE LOCKNUT WITH SUBJECT WRENCH.

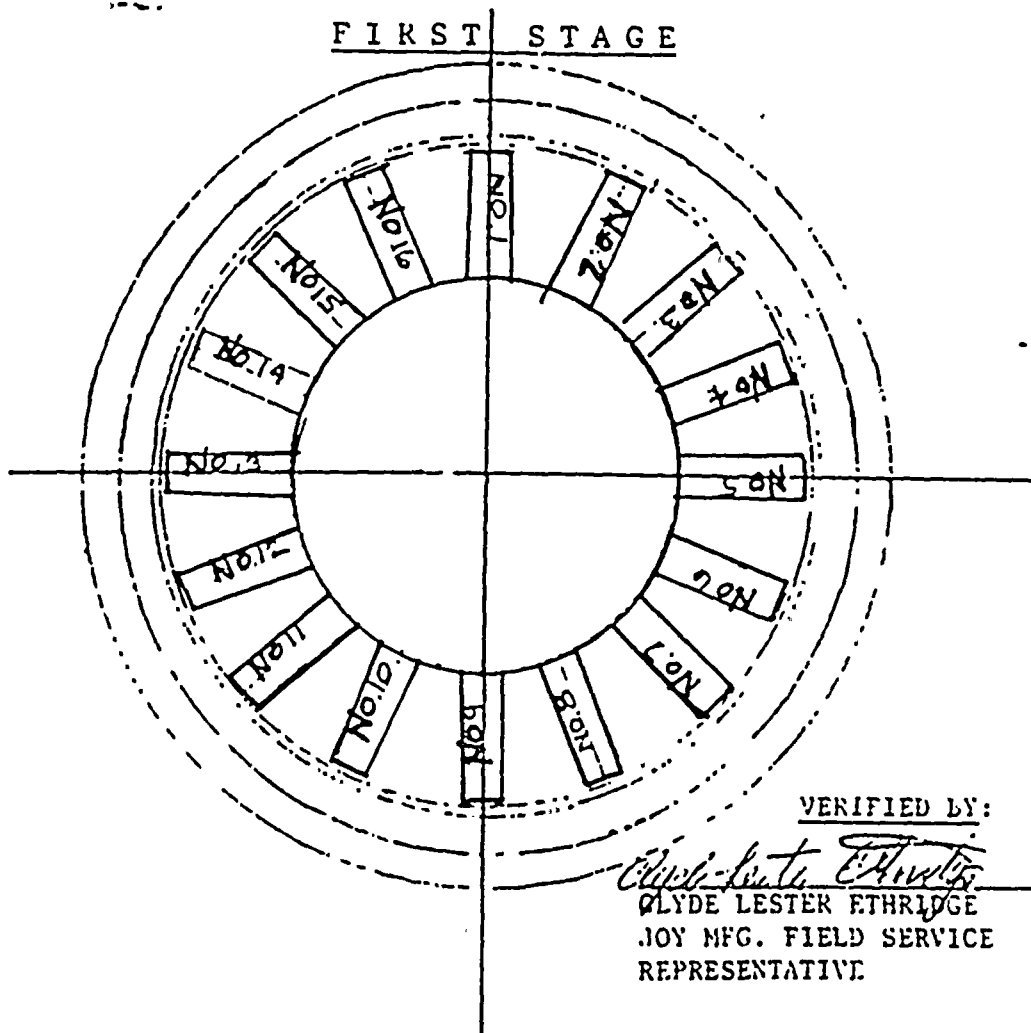
JOY VANEAXIAL FAN - QUALITY CLASS "R"
UNIT TAG NO. 1-M-HCN-A02C SERIAL NO. CF-21610
45" DIA. 26" S.S. HUB SERIES 2000 - 2 STAGE

BLADE NO. *1 - See Attached Ver. Report
2 - 400 Ft./Lbs.
3 - 400 Ft./Lbs.
4 - 400 Ft./Lbs.
5 - 400 Ft./Lbs.
6 - 360 - 380 Ft./Lbs.
7 - 400 Ft./Lbs.
8 - 400 Ft./Lbs.
