REPORT ON THE STEAM GENERATOR

TUBE LEAK AT PVNGS UNIT 1

Revision 0  
February 1987

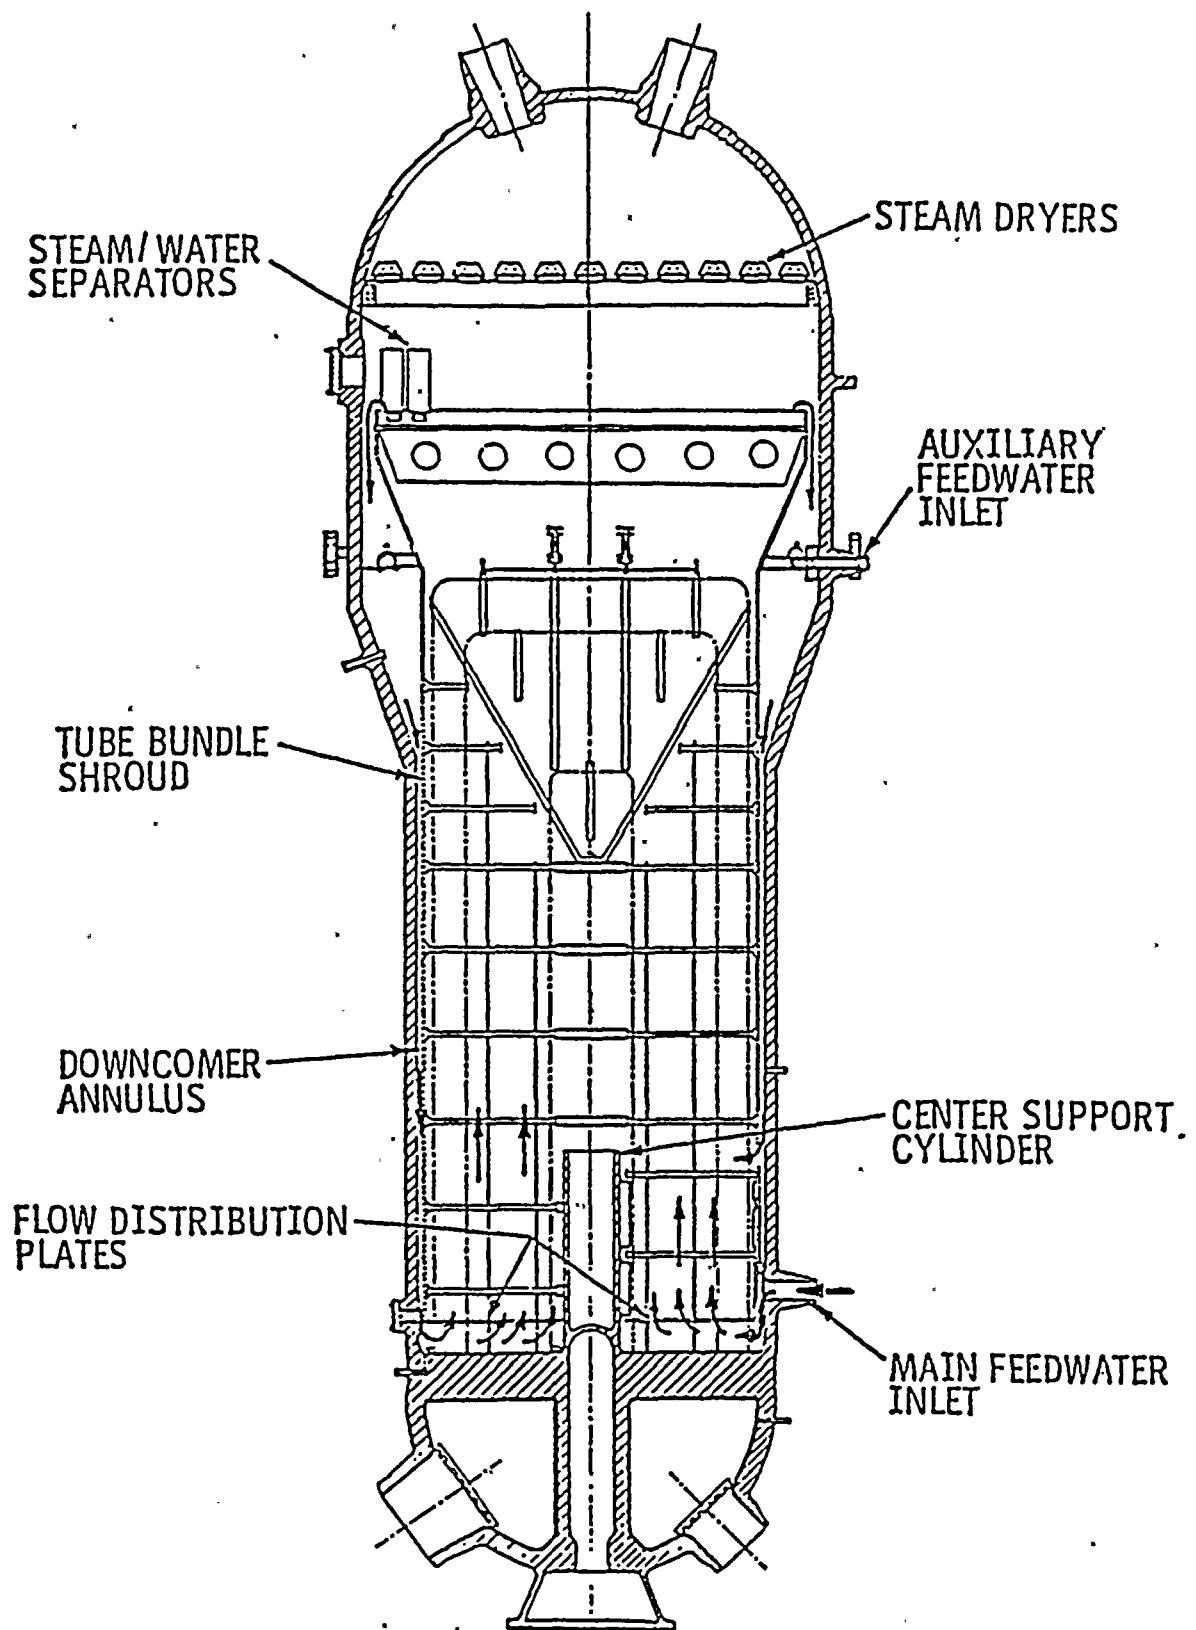
Figure 1

In the CE System 80 steam generators (Figure 1), the downcomer recirculating flow enters the cold leg side tube bundle above the integral economizer between the second and third tube supports (Figure 2). At the intersection of the recirculating water entrance window and the tube lane, a unique condition exists wherein the downcomer recirculating water can preferentially seek the low flow resistance open tube lane (Figure 17). This results in high local radial cross flow velocities. These velocities are believed to be of sufficient magnitude to cause tubes along the tube lane near the recirculating water entrance window to vibrate within the eggcrate supports, resulting in the observed tube wear.

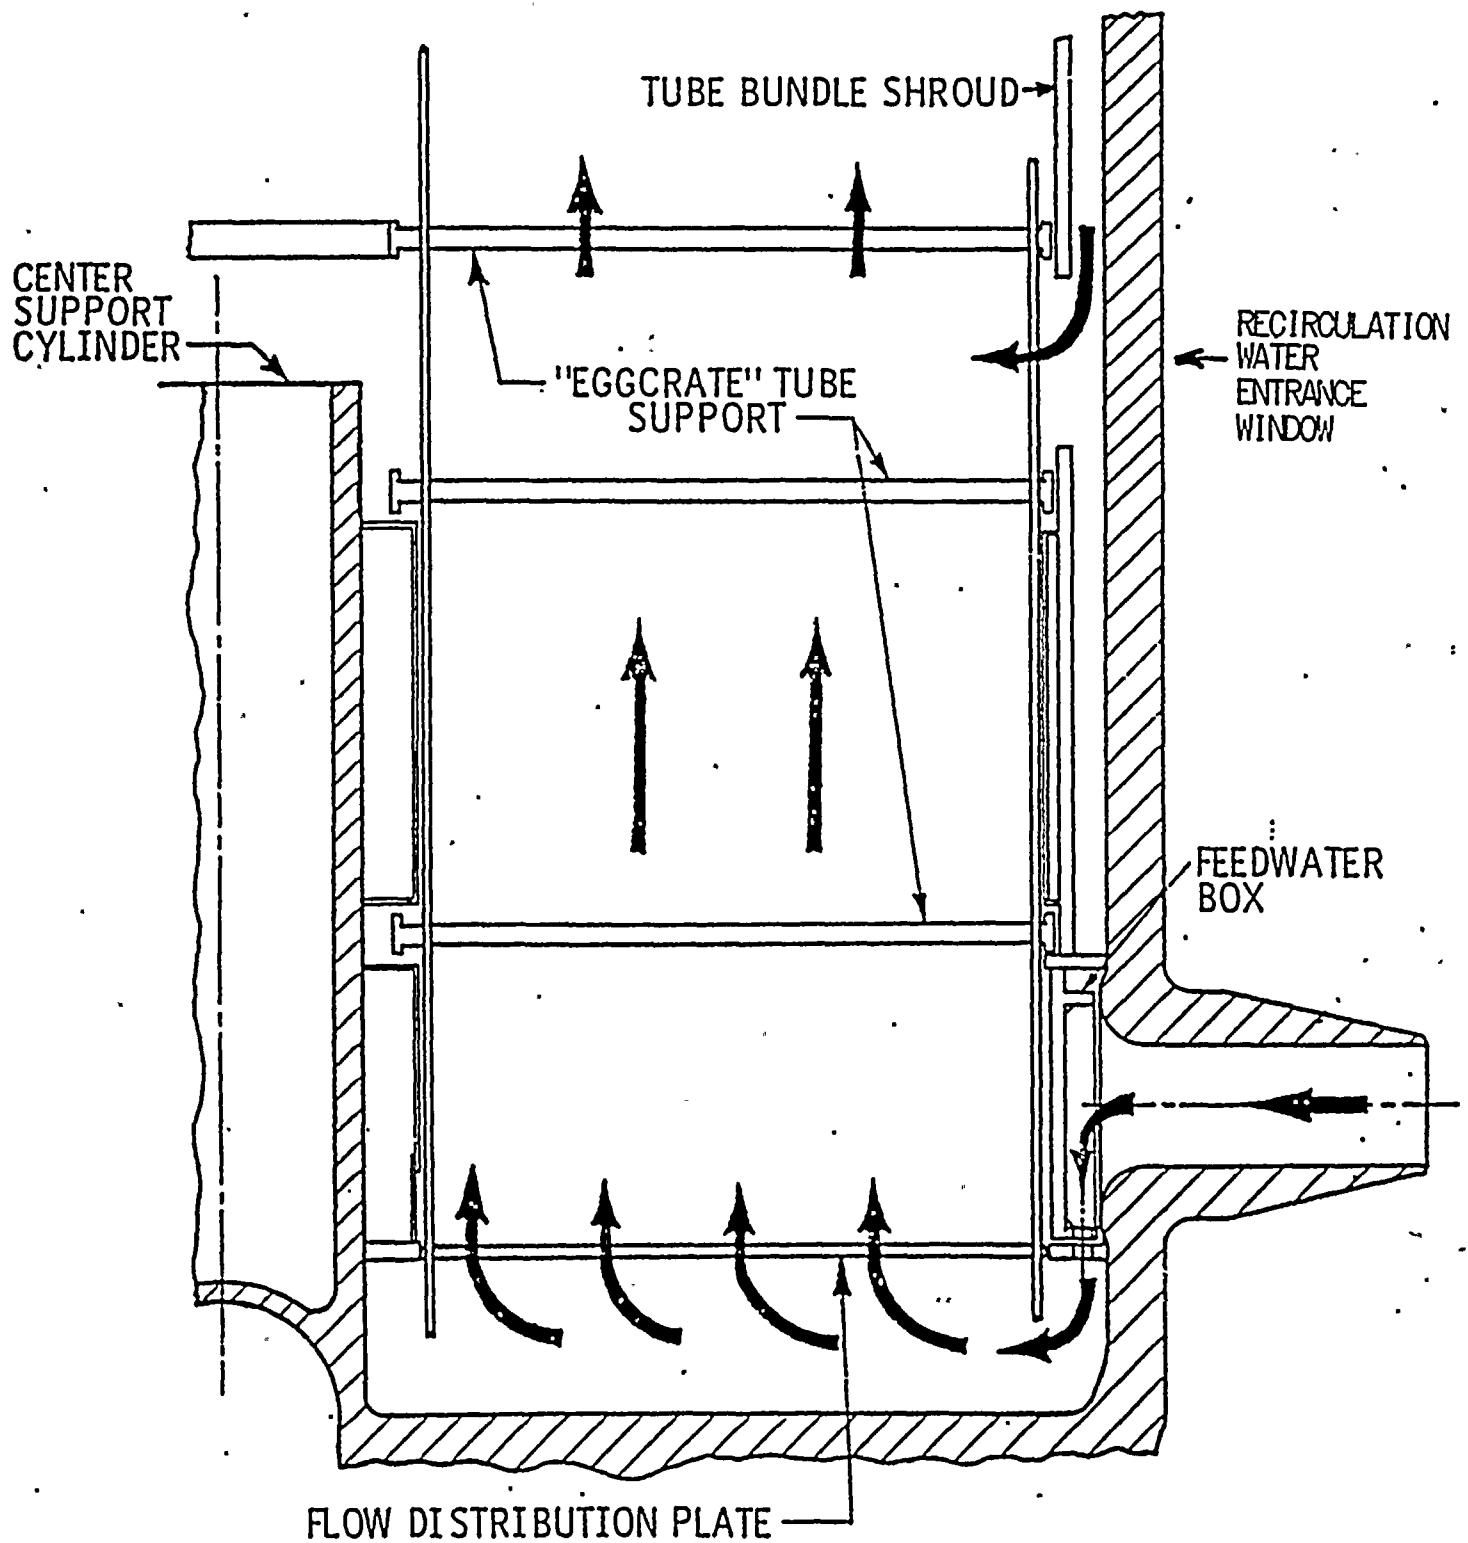
Figure 2

At the top of the economizer section (economizer section extends to the top of the divider plate as shown in Figure 4), the saturated feedwater from the economizer section mixes with recirculating water introduced through a 16-inch entrance window extending 180° around the cold leg side half-circumference (Figure 2).

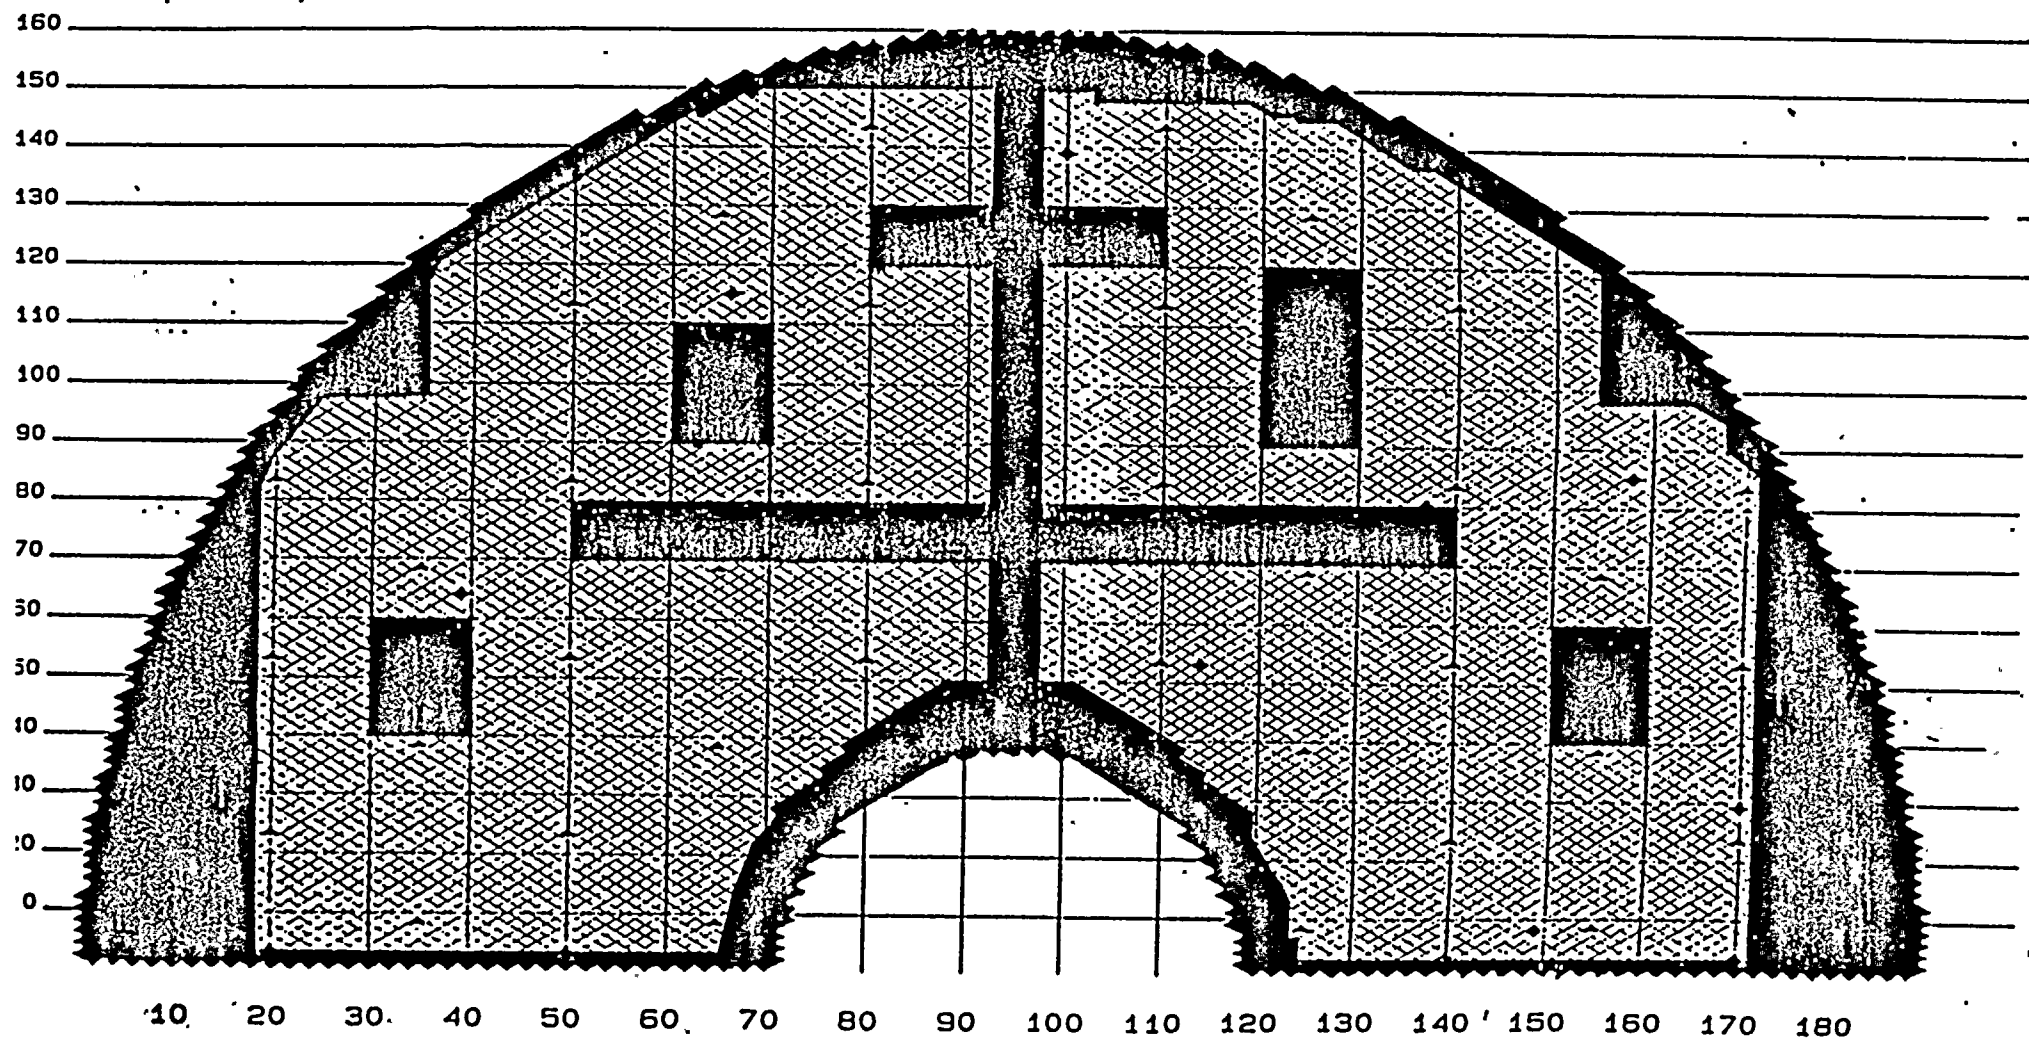
Figure 5

to increase the inspection scope to include additional tubes in the cold leg corner regions. The final Unit 1 inspection pattern is indicated by the shaded regions of Figure 5.

Steam Generator Inspection Pattern  
For Unit 1 (Shaded Regions)

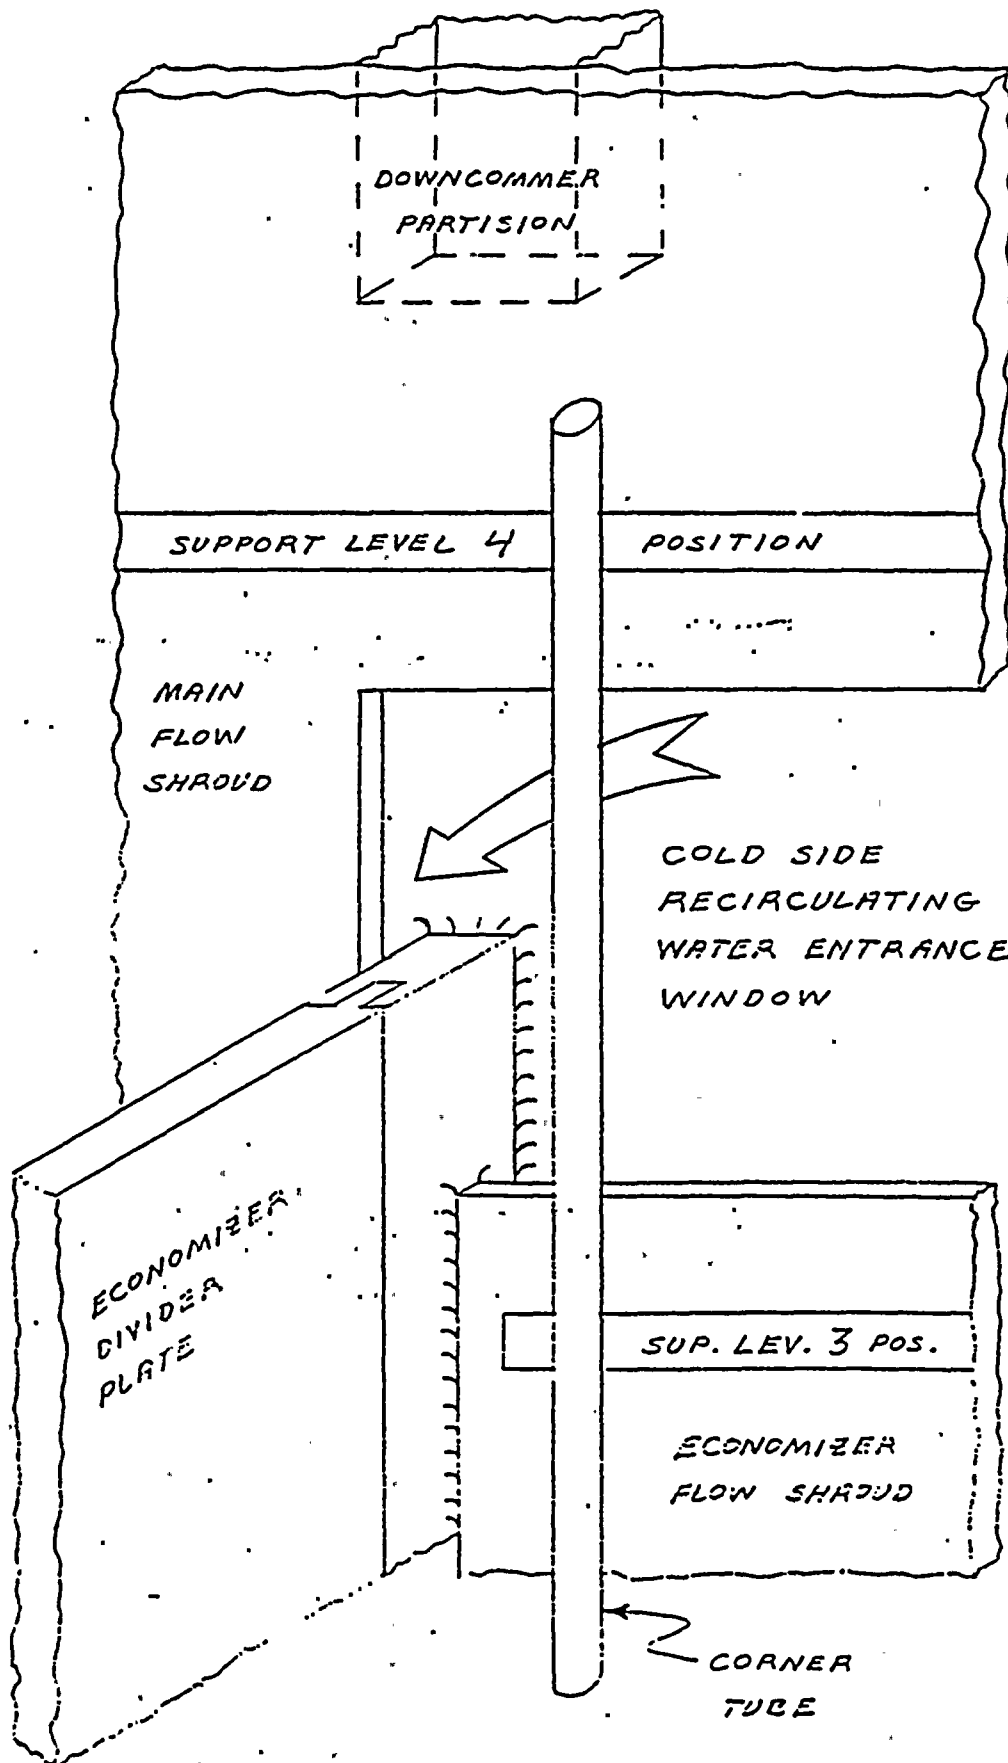
Figure 17

COLD SIDE TUBE BUNDLE ENTRANCE REGION
