PALO VERDE NUCLEAR GENERATING STATION  
UNITS 1, 2, AND 3

JUSTIFICATION FOR CONTINUED OPERATION  
CEA DROP EVENTS

REV. 1

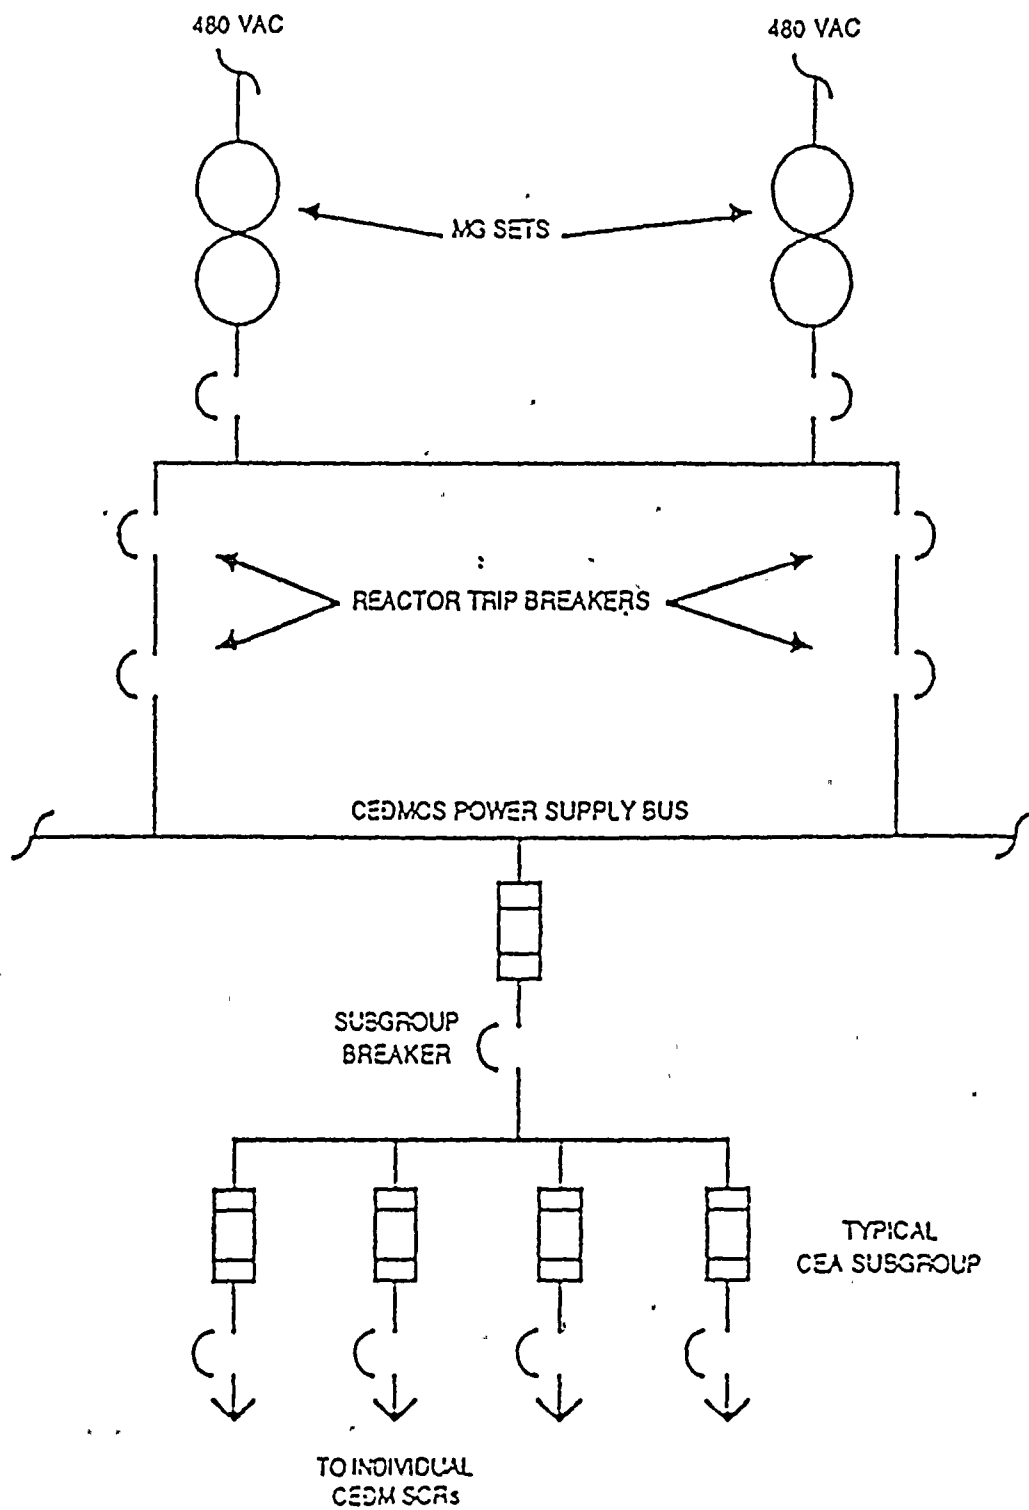
FIGURE 1 - CEDMCS POWER SUPPLY

The purpose of the CEDMCS is to provide the drive signals to the coils of the magnetic-jack Control Element Drive Mechanisms (CEDMs) which position and hold the individual Control Element Assemblies (CEAs). The CEDMCS controls the direction, rate, and duration of CEA motion in response to automatic or manual demands. The CEDMCS is a non-safety related control system. The safety function of the CEAs is to drop into the core when power is removed from the CEDMs. Power is removed from the CEDMs when the reactor trip breakers open in response to valid reactor protection signals. Refer to Appendix A, Figure 1 for a schematic of the power supply arrangement to the PVNGS CEDMCS.
