Subject: R. E. Ginna Nuclear Power Plant
Docket No. 50-244
SEP Topics III-3.A, II-3.A, II-3.B, II-3.B.1
& II-3.C

Response to NRC Correspondence on SEP Topics
III-3.A (3/24/81) and II-3.A, II-3.B, II-3.B.1 & II-3.C (4/10/81)

SUBJECT: Trip Report Concerning Stone Revetment at R.E. GINNA Nuclear Generating Plant

R.E. GINNA NUCLEAR GENERATING PLANT
GEOTECHNICAL APPENDIX

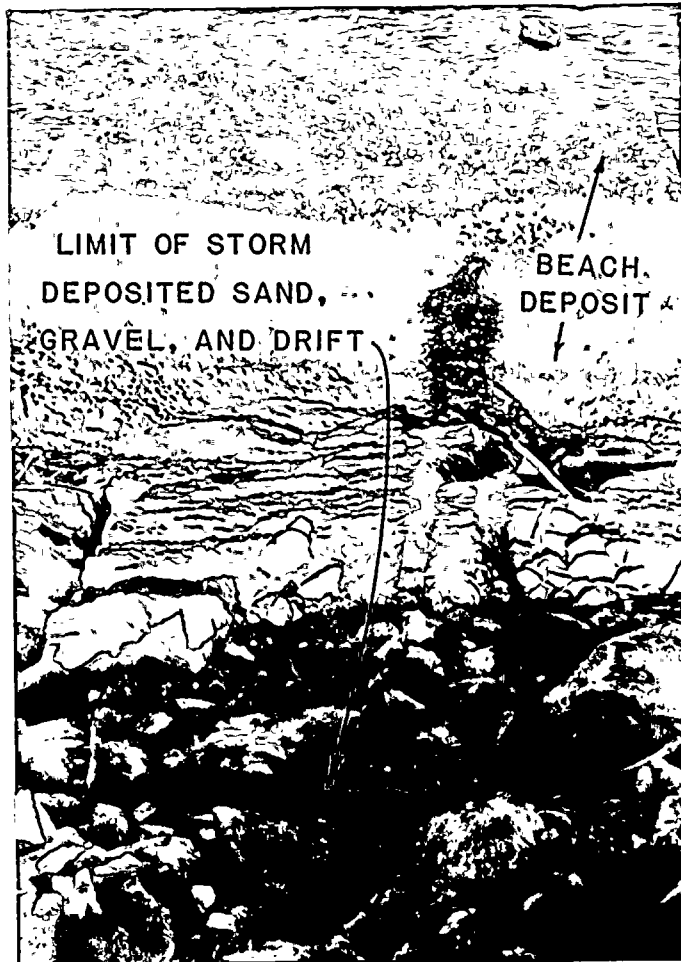
(a) Erosion/Deposition Processes. Slight to moderate erosion of the medium high bluffs updrift (to the west) and downdrift (to the east) of the project revetments is occurring (Photographs 1, 2, and 4). However, the narrow beach deposit that is accumulating at the West Revetment indicates a depositional environment for this reach except during storm periods (Photographs 1, 2, and 3). The coarse sands and gravels that have been deposited on the lower one-half of the armor stone indicate the significant limits of deposition from wave run-up during storm periods (Photographs 2 and 3).

Photograph 3 - Looking at toe of West Revetment from the crest.

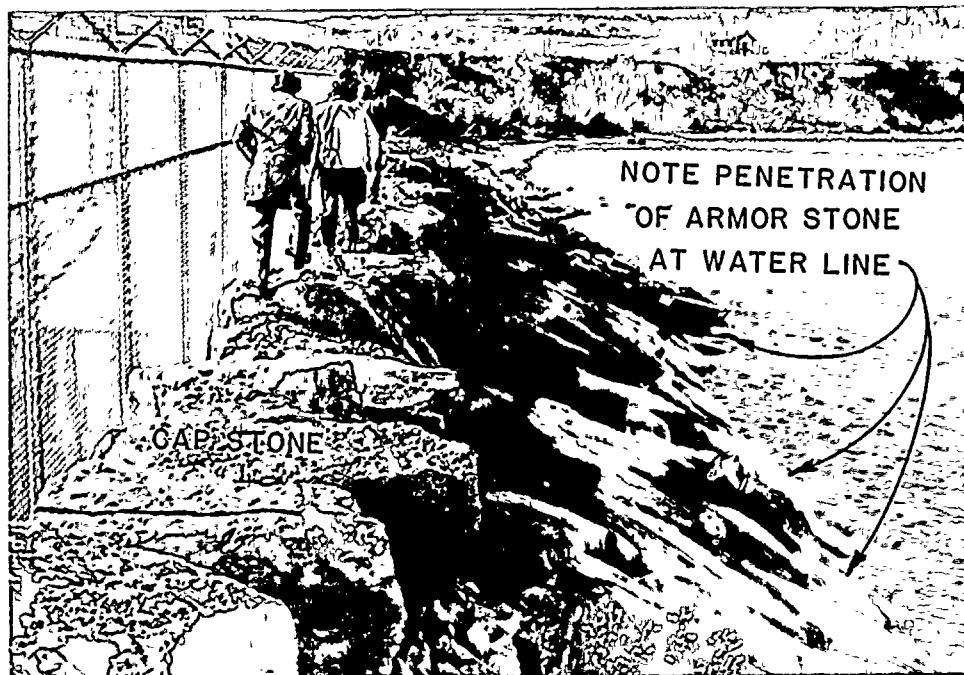
(a) Armor Stone Layers. Over most of the West and East Revetments the armor stone has good rock to rock contact with only a minimum amount of voids (Photographs 5, 6, and 7). The armor face is relatively uniform; the slope has good to excellent penetration at the water line (Photographs 5 and 7). The second layer of armor stone can be seen at numerous inspection points (voids - see Photograph 8). The outer layer of armor stone contains a fairly high amount of cracked stones. Although no counts were made, about one-third or more of the stones contained fractures that penetrate the interior of the stones (Photographs 15 and 16).

Three localized anomalous conditions were present in the armor layer. The first is a layer of fines (4 to 9-inch size) that veneer portions of the upper one-half of the revetments (Photographs 2 and 7). Test pits revealed the presence of a second layer of armor (Photographs 9 and 10). There was no evidence of removal of fines from the interior select fill of the revetment. The upper limit of coarse sand/gravel and drift deposition is below the lower limit of the 4 to 9-inch fines deposition which supports the lack of wave action/run-up that might cause removal of fines from the zone in question (Photograph 2, 3, and 10). Also, the lack of any distress in the cap stone layer tends to rule out removal of fines from wave action (Photographs 5 and 6).

(b) Cap Stone Layer. A row of cap stones were placed at the original revetment crest for added protection. The stones appear fairly uniform in alignment and show no signs of distress that would be indicative of settlement or migration of armor stone down the slope (Photographs 2, 5, 6, and 7). The cap stone layer contains a very high percentage of cracked stones. Although no counts were taken, the vast majority of the stones contained fractures that penetrate the interior of the stones (Photographs 17 and 18).

Photograph 5 - Looking west at crest of West Revetment, near west end.

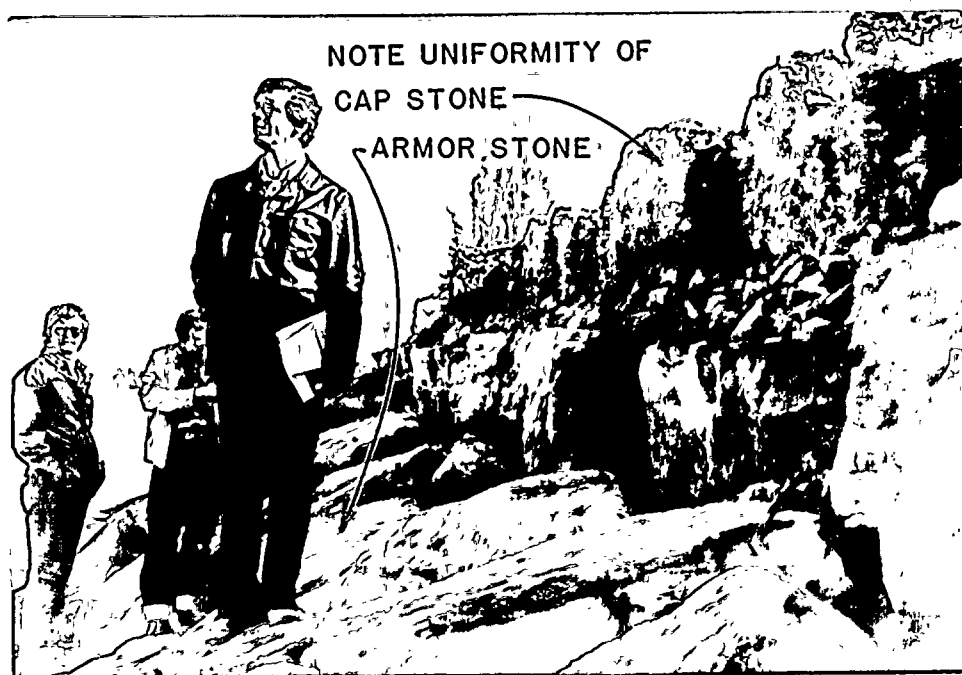
The original revetment construction was completed about 1965, to Elevation 257.0 msl. In 1973, a row of cap stones was placed to increase the elevation to offset the effects of relatively high lake levels (Photograph 6). The armor stone was placed in a "laid-up" configuration, with a side slope of 1 V on 1-1/2 H (Photograph 7).

Photograph 6 - West Revetment, looking at top of armor stone slope and cap stones.
