Palo Verde Nuclear Generating Station

Status of PVNGS Steam Generator Activities

August 1994

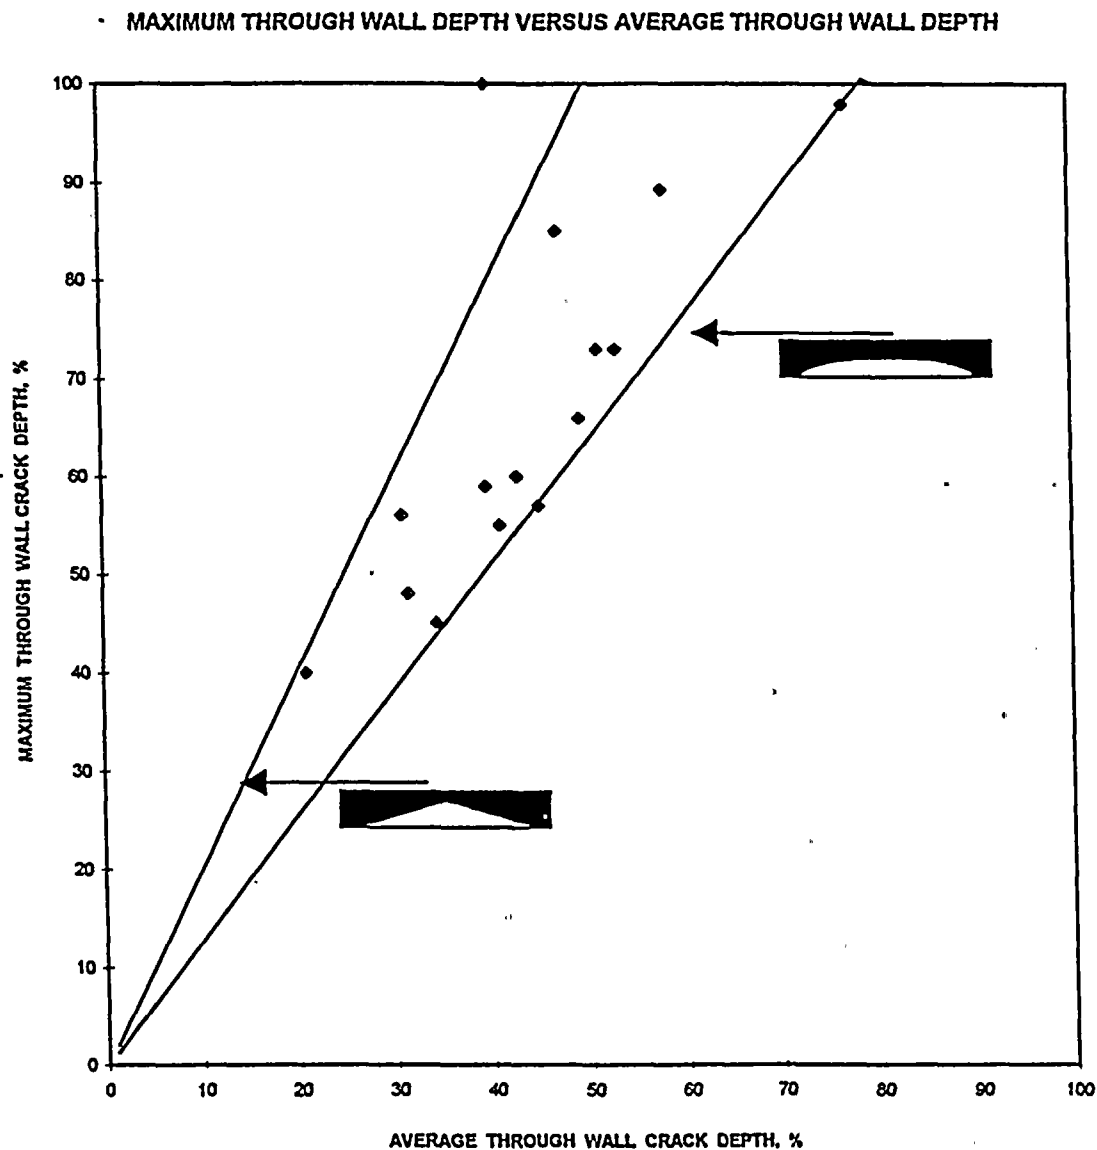
Figure 3.4 Maximum Through Wall Depth Versus Average Through Wall Depth, Palo Verde Unit 2 Pulled Tubes.

Two geometric shapes essentially bound the data of Figure 3.4. A likely candidate to bound the lower ratio of average crack depth to maximum crack depth is a triangle. A ratio of average to maximum depth greater than 0.5 would require a figure with concave sides, which is mechanistically improbable. An average to maximum depth ratio of 1 requires a rectangle. Since a square cornered profile is again mechanistically improbable, a more likely bounding figure is a semi-ellipse. In this case, the average to maximum depth ratio is $\pi/4$. This figure is an excellent bound to actual observations. Using a conservative ratio of average to maximum crack depth of $\pi/4$, the maximum depth POD curve of figure 3.2 can be converted to an average depth POD curve. Both average and maximum depth POD curves based on industry wide data are shown in Figure 3.5. A preliminary average depth POD curve is shown in Figure 3.6 using only measured depths from Palo Verde pulled tubes. Data from both Unit 2 tube exams is included. The Palo Verde and industry database POD curves based on average depth compare very well. If more data had been available at larger crack depths for the Palo Verde tubes, the two POD curves would be expected to be virtually coincident.

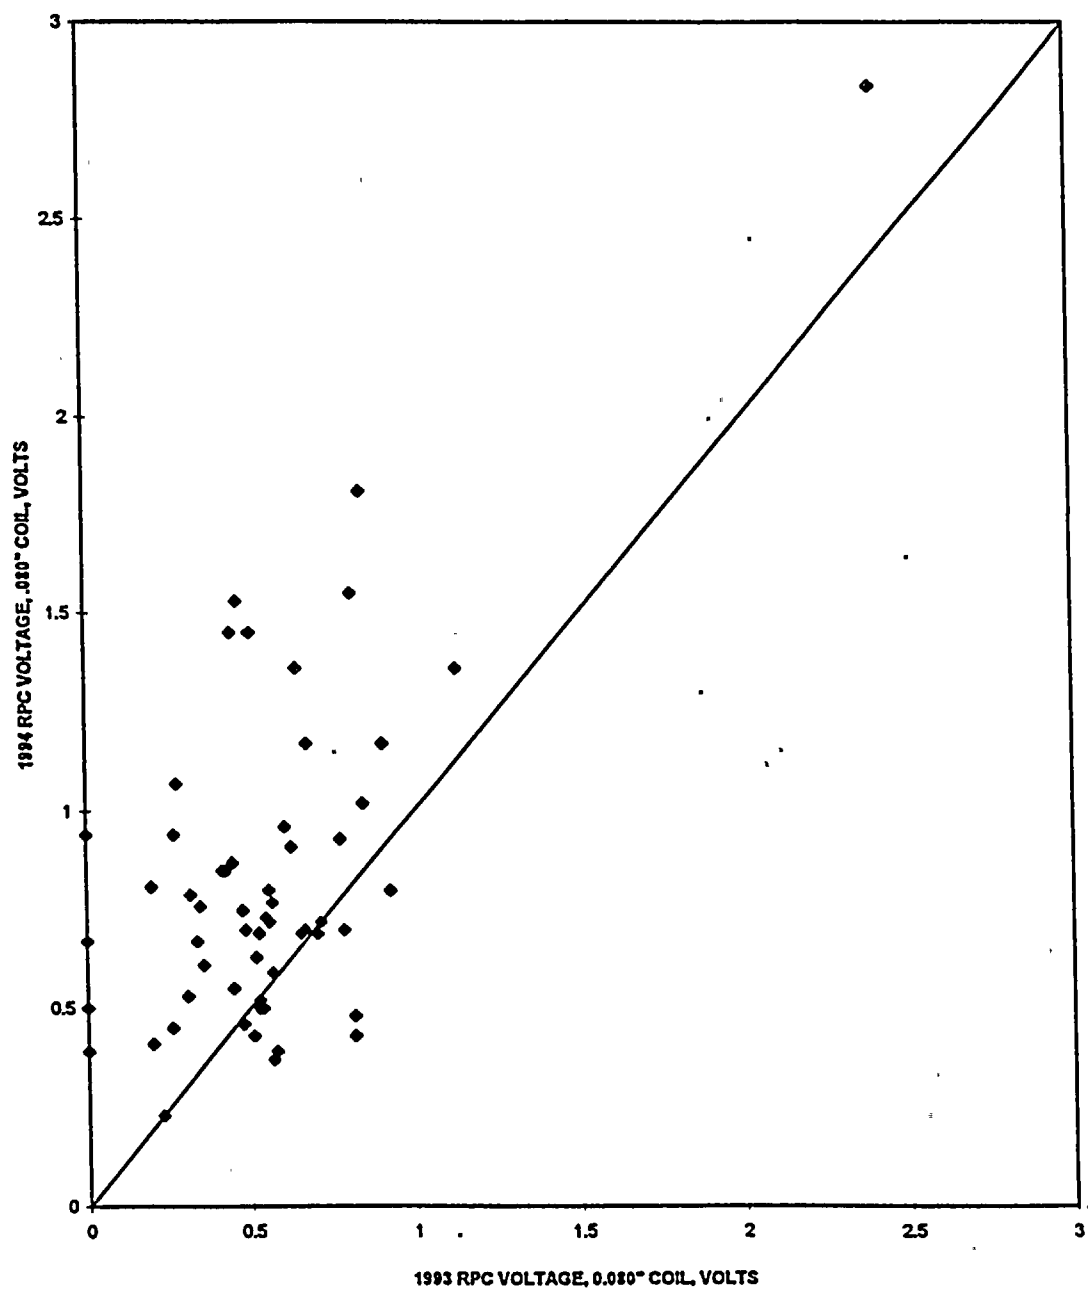
Figure 4.3 MRPC Voltage of Indications at U2M5 Versus
MRPC Voltage of Same Indications at U2R4,
0.080" Diameter Coil.

Figures 4.3 and 4.4 illustrate a comparison of MRPC voltages at the beginning of cycle 5 for Unit 2 and again after 4.5 months of operation. There is a consistent increase in voltage levels from one inspection to the next. This is true for both sizes of MRPC coils. Some voltage changes are negative, but, in general, the scatter in voltage measurements does not obscure the fact of increased voltage levels after operation for 4.5 months. Additional analysis shows that the increase in voltage is not correlated with the beginning of cycle voltage.

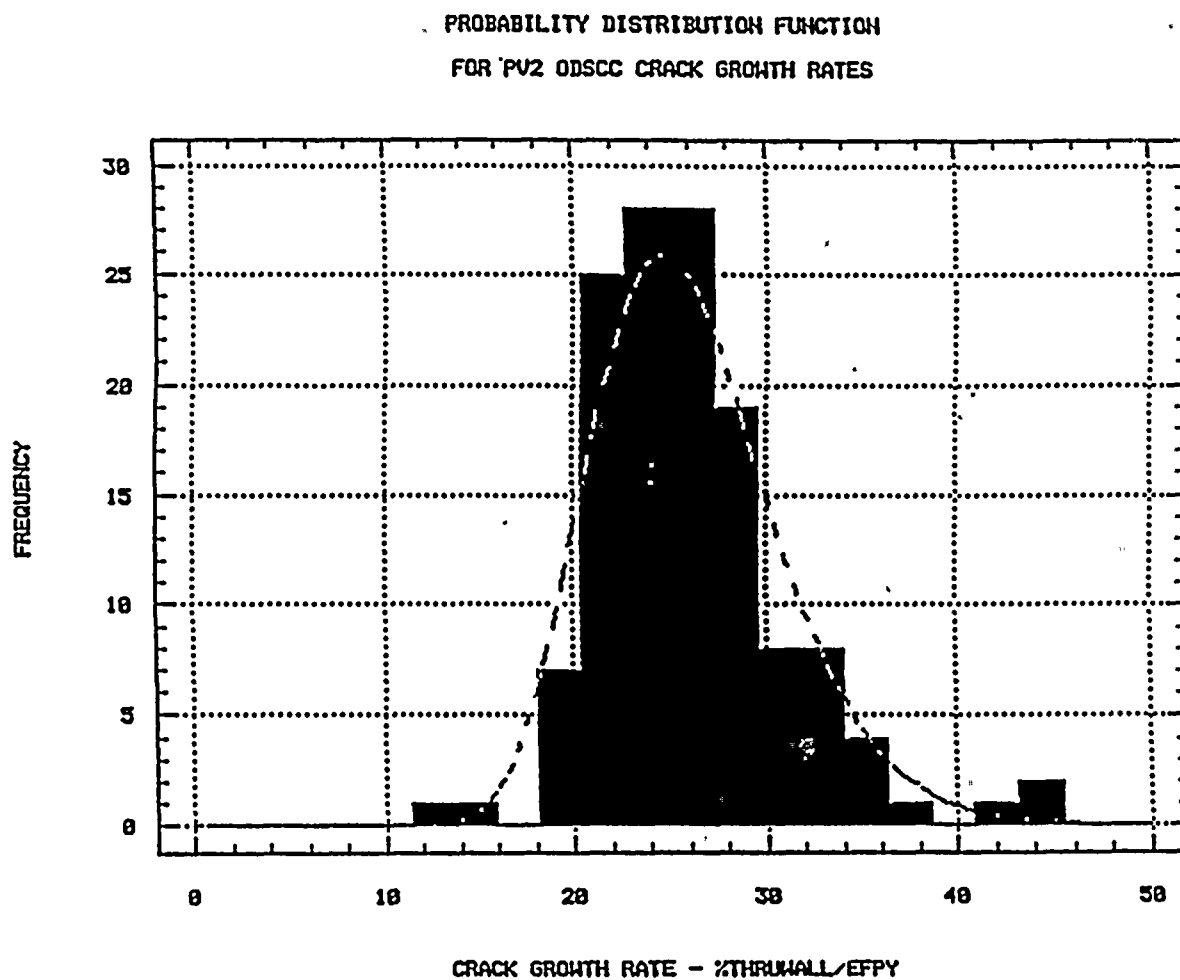
Figure 4.5 Distribution of Crack Growth Rates
Calculated From MRPC Voltages.

A lognormal probability distribution function fitted to these crack growth rates is shown in Figure 4.5. The most likely crack growth rate is about 28% through wall per effective full power year. This is about 1mil per month. The bar graph representation shows the upper range of estimated crack growth rates to be about 45% through wall per effective full power year, or about 1.6 mils/month. These crack growth rates are somewhat slower than those estimated from bobbin coil eddy current data collected during the U2R4 outage. Several other approaches to estimating crack growth rates from MRPC data are under development. Crack growth rates will be updated as alternative approaches are completed.

The crack growth model discussed in Section 4 was incorporated into the simulation in log-normal form (Figure 4.5). Since the data was obtained from the most recent Unit 2 inspection results, adjustments were made to the growth rate to compensate for temperature differences (611°F vs. 605°F). It should be noted that the average through wall crack propagation rate based on Unit 2 data was significantly less adverse in the extremes than those observed in circumferential cracking at the tube sheet.

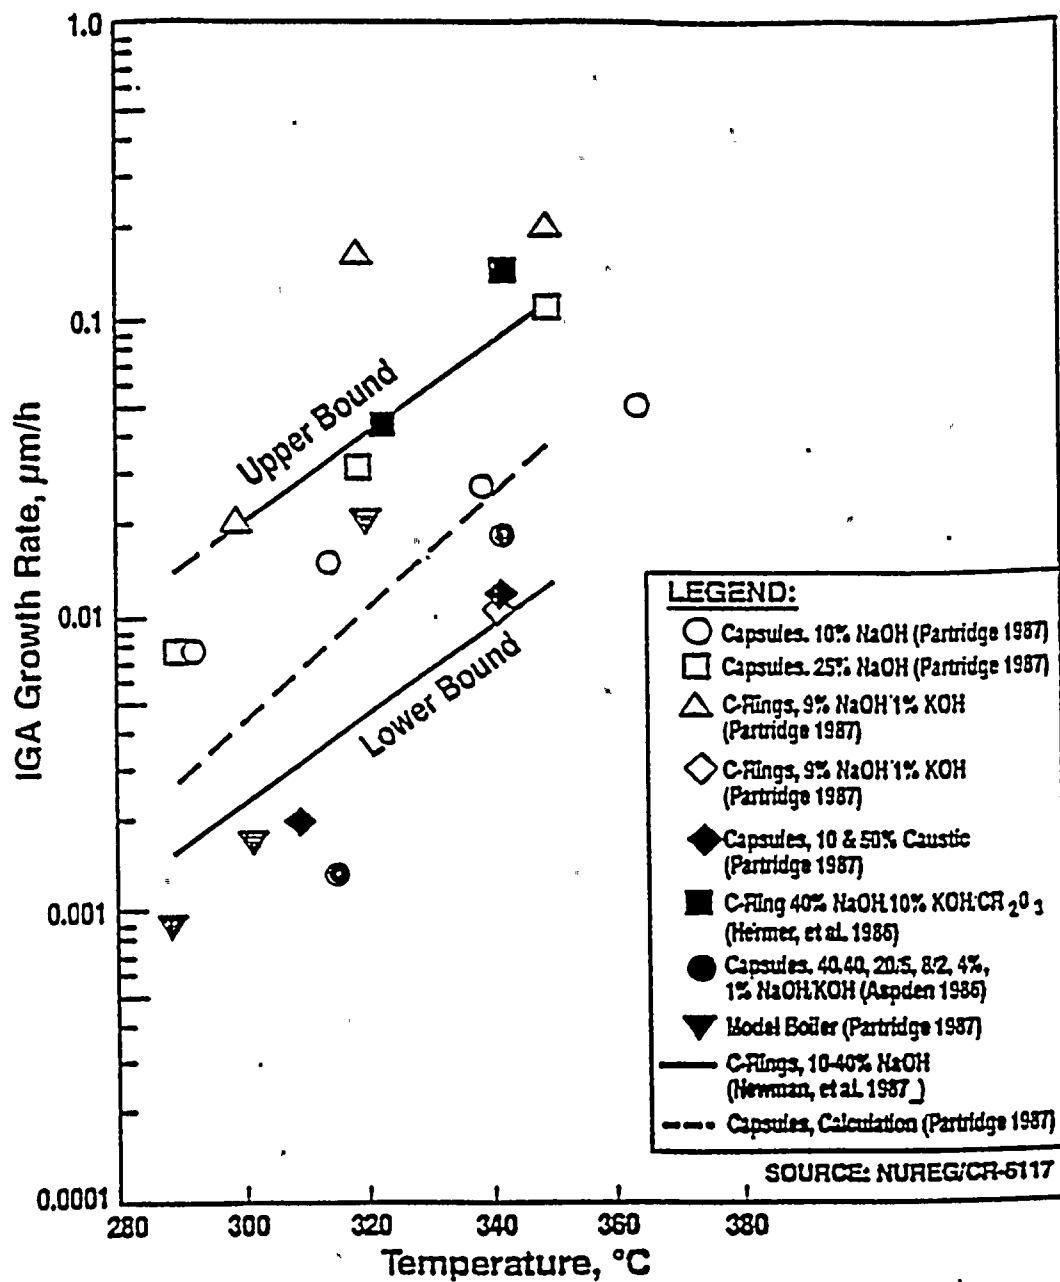
Figure 4.6 Growth Rates of Intergranular Stress Corrosion Cracks in Alloy 600 Versus Temperature Concentrated Caustic Solutions.

As discussed in previous reports,^{2,3} estimated crack growth rates are a reasonable fit to data in the literature.⁴⁻¹⁴ Data for IGSCC and IGA degradation rates in caustic environments are shown in Figures 4.6 through 4.8. A significant IGA component was noted in the examination of the first tubes pulled from Unit 2. Fractographic and metallographic examination of tubes pulled during the Unit 2 mid cycle outage indicate a somewhat enhanced IGA nature with a morphology that has been termed cellular corrosion or cellular IGA. Since propagation rates for IGA are approximately an order of magnitude slower than IGSCC rates in caustic environments, tube examination results support the use of crack growth rates at least on the low side of the IGSCC scatterband, if not lower.

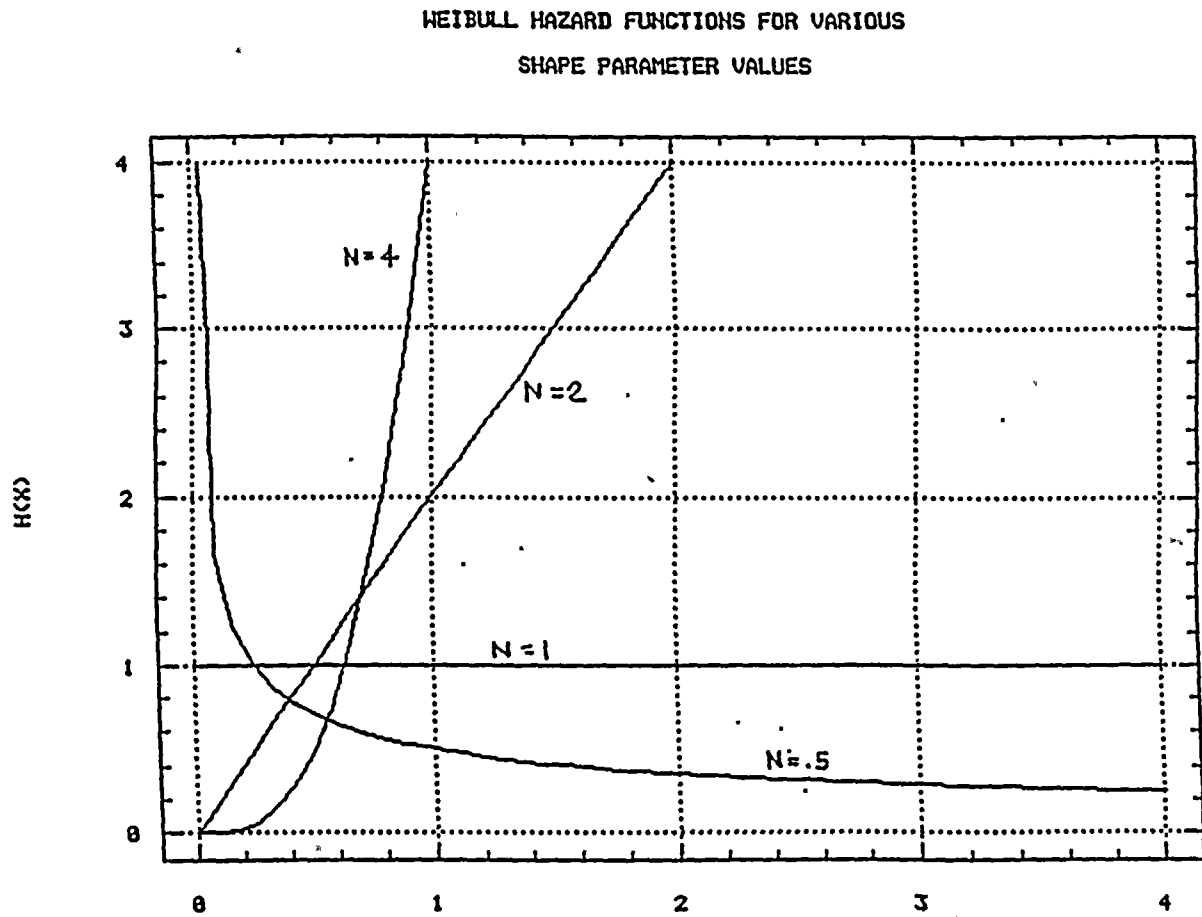
Figure 5.1 Weibull Hazard Functions for Various Shape Parameter Values.

The parameters for the Weibull distribution have physical significance. The scale parameter (B) is the exposure time at which approximately 63% of the population at risk is expected to have failed. The shape parameter (N) has significance in terms of hazard rate as shown in Figure 5.1. For $N < 1$, the hazard rate is decreasing such as is typical of electronic components during the "burn-in" period. For $N = 1$, the hazard rate is constant and the Weibull model becomes equivalent to an Exponential model. For $N > 1$, the hazard rate increases with exposure time, a situation typical of most corrosion phenomena. The range of interest for steam generator tube modeling appears to be:

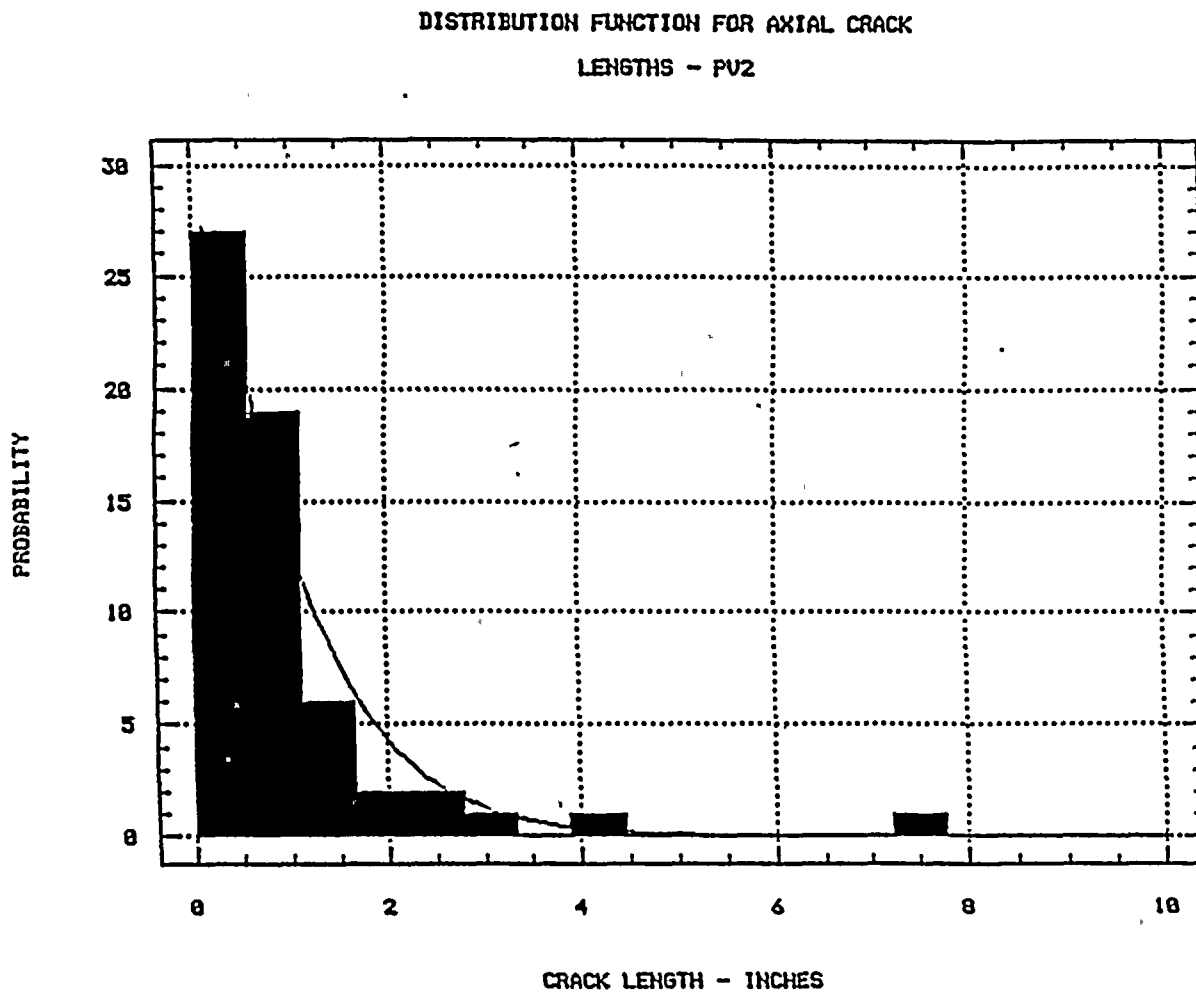
**Figure 5.2 Distribution Function for Axial Cracks
Based on Unit 2 MRPC Data.**

For Palo Verde Unit 1 which has experienced no upper bundle axial cracking as of the most recent inspection, Weibull parameters were developed from Unit 2 behavior. The shape parameter used in the analysis has a relatively conservative value of 5.5 typical of IGA/IGSCC phenomena in HTMA tubing. The scale parameter was developed on the basis of null inspection results for the R4 inspection outage. The value of the scale parameter ultimately chosen is in fact the lowest (most conservative) value for which the Weibull model would predict a zero incidence of axial cracks at reasonable probability (5%).

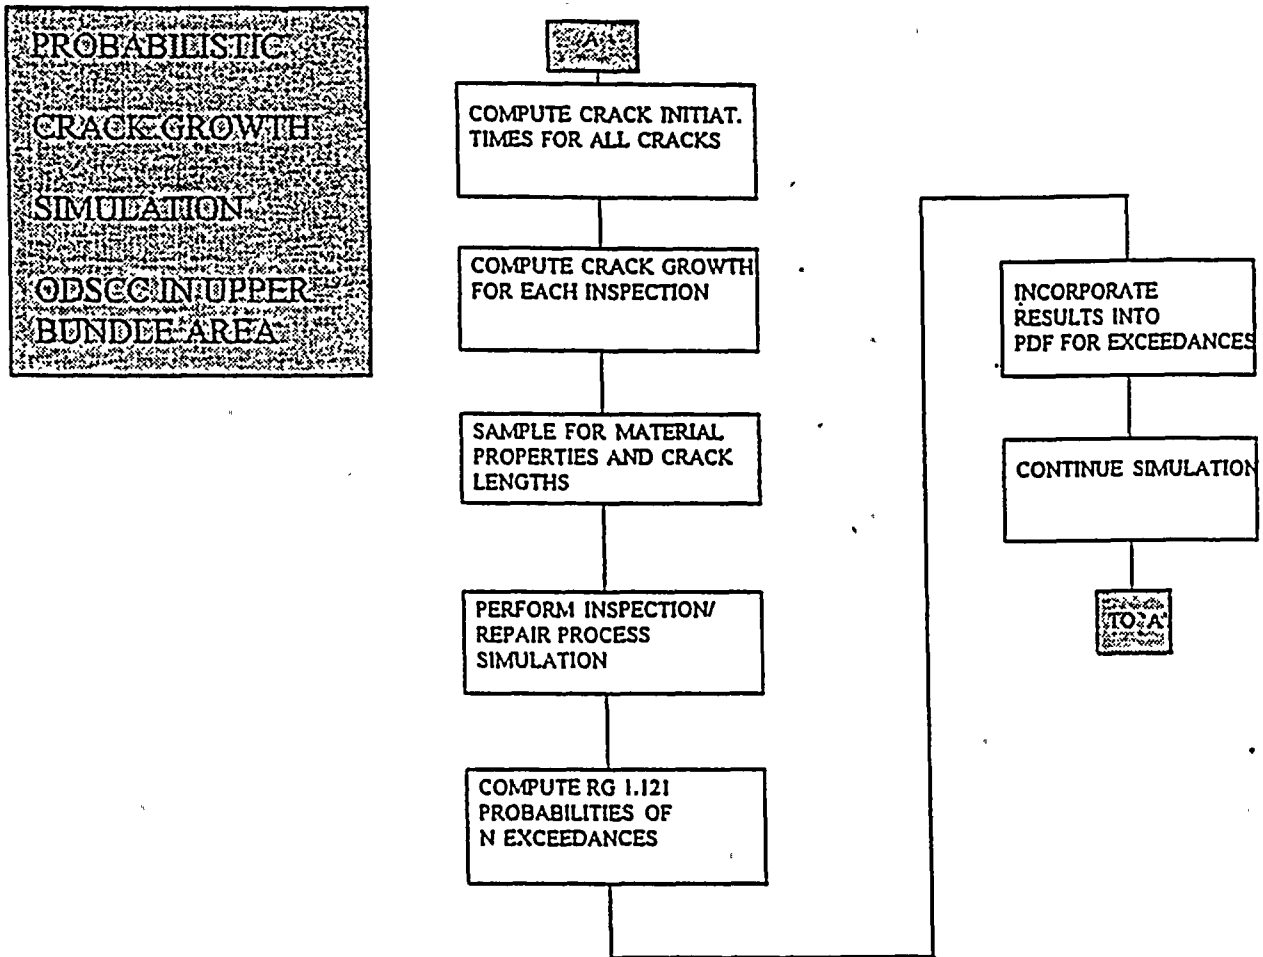
Figure 5.3 Flowchart for Computer Simulation of Crack Initiation, Growth, Detection, Removal/Repair and Structural Limit Check.

The computer simulation of the overall process is shown conceptually in Figure 5.3 and consists of steps reflecting the four basic processes discussed in Section 4.1. The initial sequence involves the computation of crack population size, crack initiation times, and crack growth rates for given Monte-Carlo trial. The population size (NMAX) is determined from the Weibull initiation model and the final inspection time for a given case. The crack initiation times (TI_i) for a given sample are determined from a randomized selection using the Weibull initiation model.
