Palo Verde Nuclear
Generating Station

**Subject: Palo Verde Nuclear Generating Station (PVNGS)
Units 1, 2, and 3
Docket Nos. STN 50-528/529/530
Response to Generic Letter 97-06: "Degradation of Steam Generator
Internals"**

**Response to Generic Letter 97-06:
"Degradation of Steam Generator Internals"**

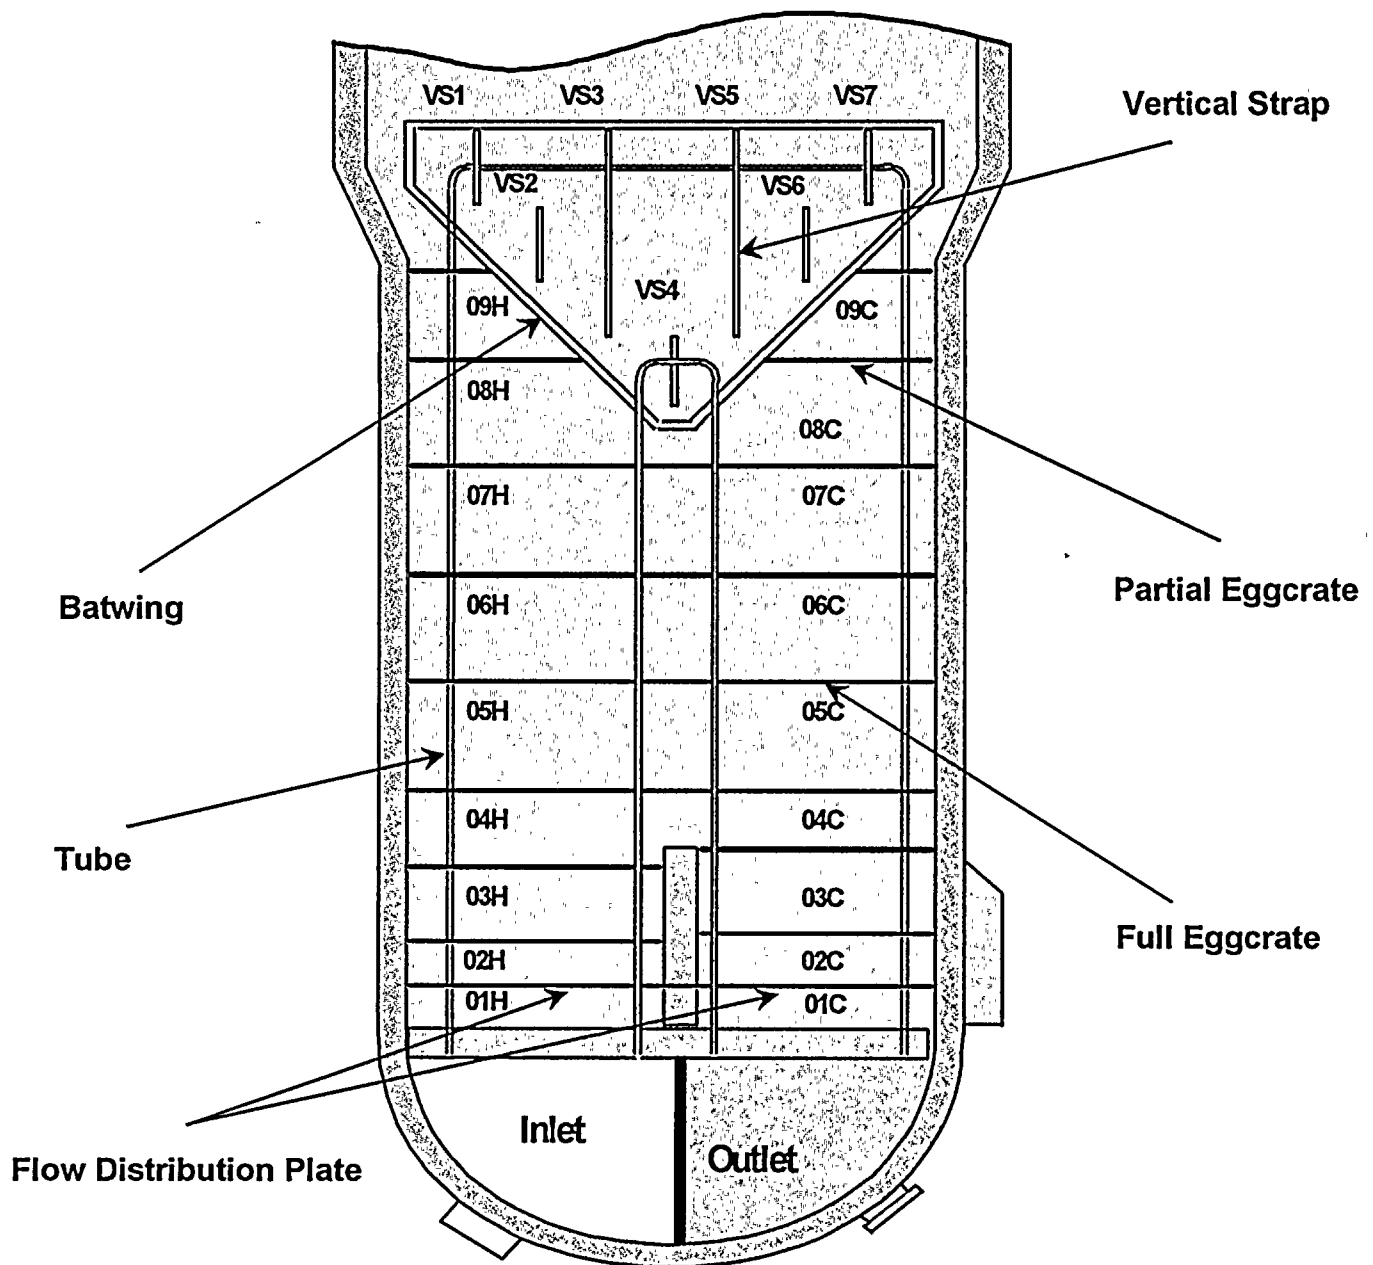
Figure 1

With respect to applicability to PVNGS, the analyses and evaluations conducted by ABB-CE for the CEOG conclude that units with stainless steel eggcrate supports have a very low susceptibility to FAC of tube supports. The tube support design for the PVNGS Units are shown in Figure 1. The horizontal tube supports located along the vertical section of the tubes are all of the eggcrate design. The bend and horizontal regions of the tubes are supported by batwing and vertical lattice supports, respectively. All of the tube supports are manufactured from 409 ferritic stainless steel. To minimize sludge accumulation on the tubesheet, the PVNGS steam generators also include flow distribution plates (FDP) designated as 01H and 01C in Figure 1. The FDPs are 405 ferritic stainless steel plates with holes sized to provide a sweeping action across the tubesheet and reduce the particle dropout leading to sludge formation. Testing conducted by ABB-CE and EPRI (Reference 16) demonstrates that denting and associated plate damage is not credible for type 400 series stainless steel.

PVNGS Steam Generator Tube Supports

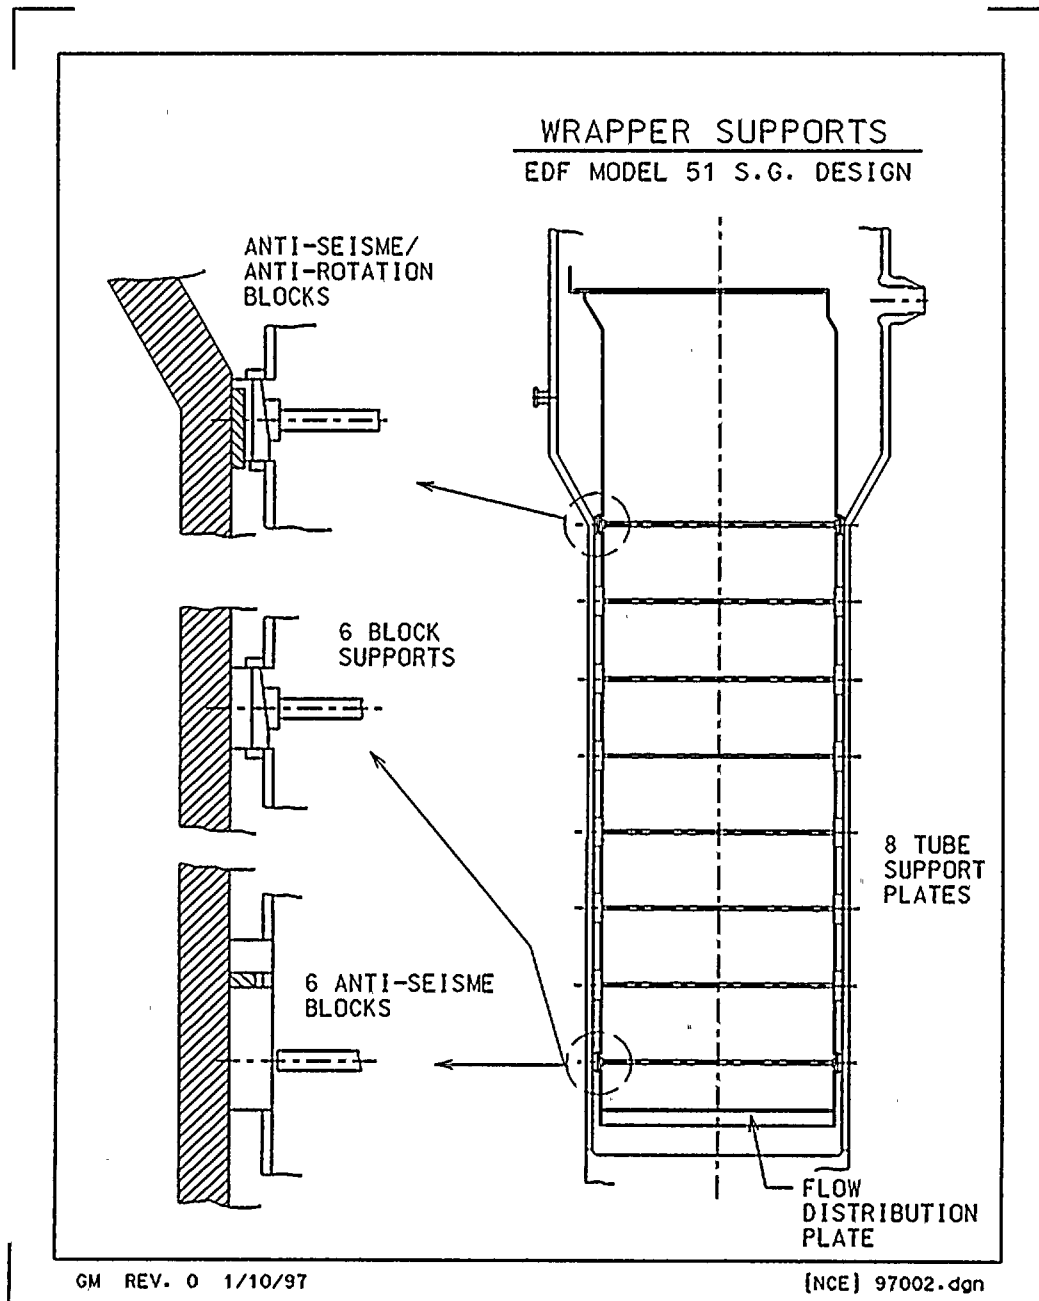
Figure 3

EdF discovered wrapper support failure at Blayais Unit 3 in 1994. The failure was discovered as a result of an interference experienced during sludge lancing as the wrapper actually dropped 20mm. The failure was attributed to the inability of the EdF shroud design (Figure 3) to accommodate thermal expansion loads during expedited plant cooldown. The condition was aggravated by the presence of poor quality welds and potential fatigue induced crack propagation.

EdF Wrapper Support Design

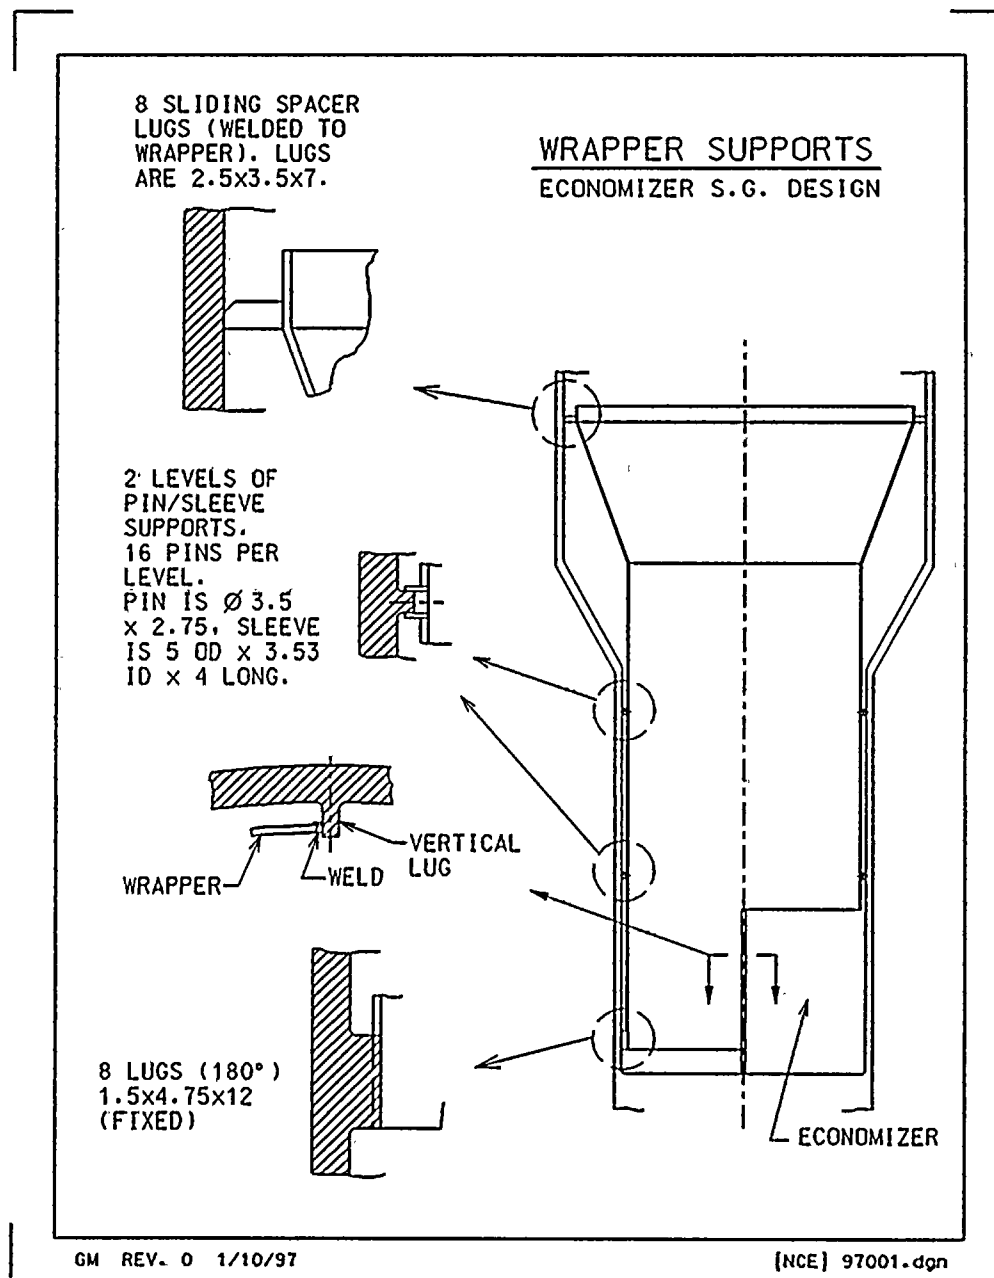
Figure 4

The PVNGS steam generators are of economizer design. For this design, the baffle is segmented and separate for the economizer region. The baffle (Figure 4) is attached to the lower shell just above the tubesheet by eight lugs and is also attached to the two substantial lugs which support the secondary divider plate. The baffle is welded along the vertical length of the economizer. These ten lugs provide a point of fixation to the shell from which the baffle expands. The baffle is further supported at two higher elevations, each with sixteen lugs. These 32 lugs are cylindrical lugs with an external sliding collar. These lugs permit radial thermal expansion and limited differential thermal expansion, but restrain vertical and lateral movements due to seismic loading

PVNGS Wrapper Support Design

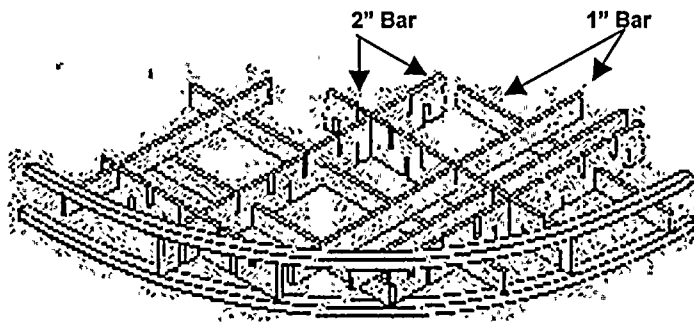
Eggcrate Assembly
