SUBJECT: Forwards executive summary of investigation, results of
 investigation & conclusions re integrity of containment
 operating deck hatches.

Donald C. Cook Nuclear Plant Units 1 and 2
Docket Nos. 50-315 and 50-316
License Nos. DPR-58 and DPR-74
INVESTIGATION OF INTEGRITY OF CONTAINMENT OPERATING DECK
HATCHES EXECUTIVE SUMMARY

D. C. COOK NUCLEAR PLANT - UNIT #1
CONTAINMENT INVESTIGATION - REACTOR COOLANT PUMP & CRDM HATCHES
EXECUTIVE SUMMARY

D. C. COOK NUCLEAR PLANT - UNIT #2
CONTAINMENT INVESTIGATION REACTOR COOLANT PUMP HATCHES
EXECUTIVE SUMMARY

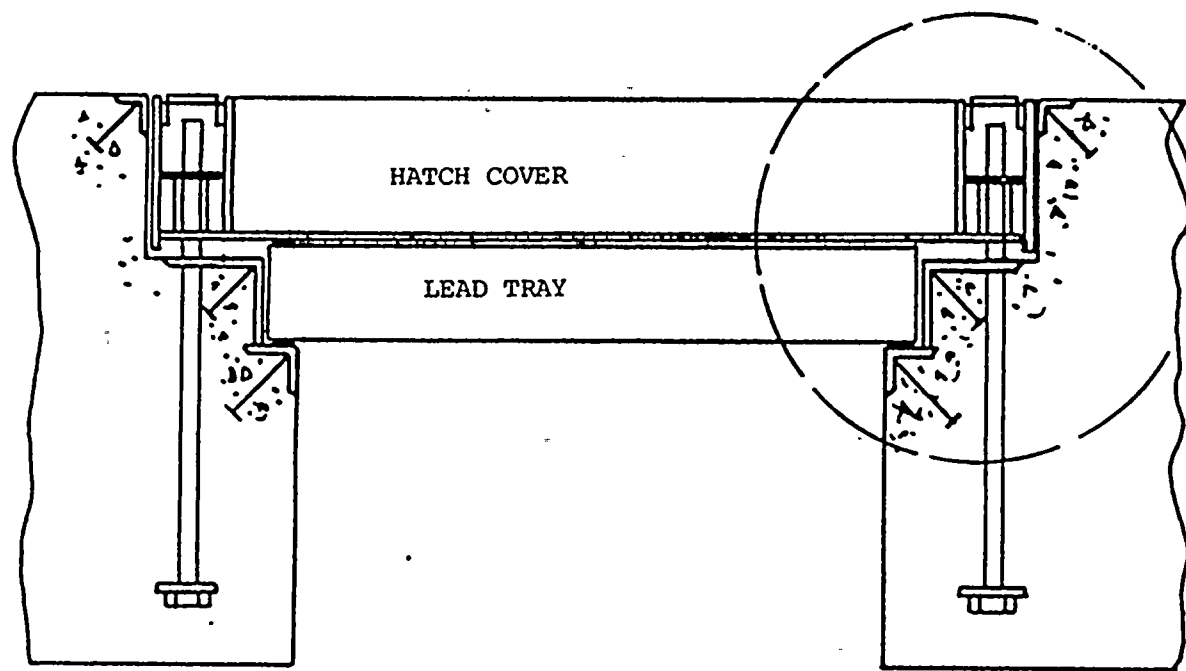
FIGURE NO. 4

Each of the four (4) RCP hatches and the CRDM hatch has a steel tray which holds lead bricks. This steel tray is situated below but is independent of the hatch cover which is a welded plate frame filled with concrete. The lead tray and the hatch cover rest on ledges formed in the concrete deck by an angle frame embedment. (Figure No. 4)

Each of the four (4) RCP hatches has a steel tray which holds lead bricks. This steel tray is situated below but is independent of the hatch cover which is a welded plate frame filled with concrete. The lead tray and the hatch cover rest on ledges formed in the concrete deck by an angle frame embedment. (Figure No. 4)

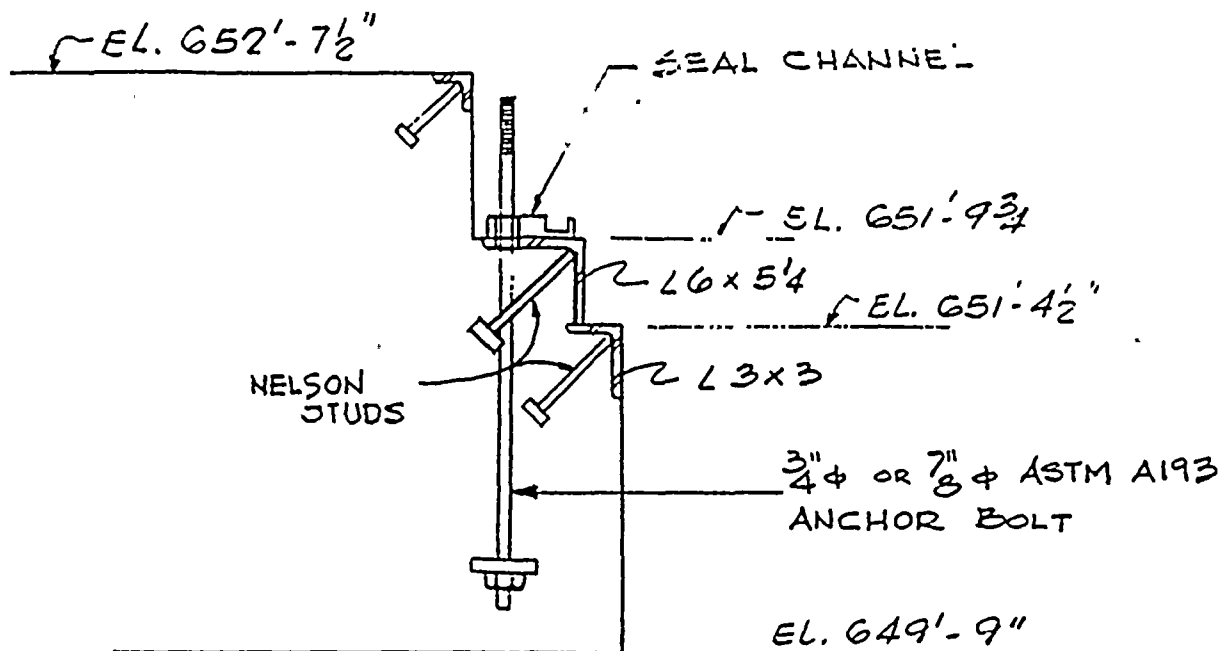
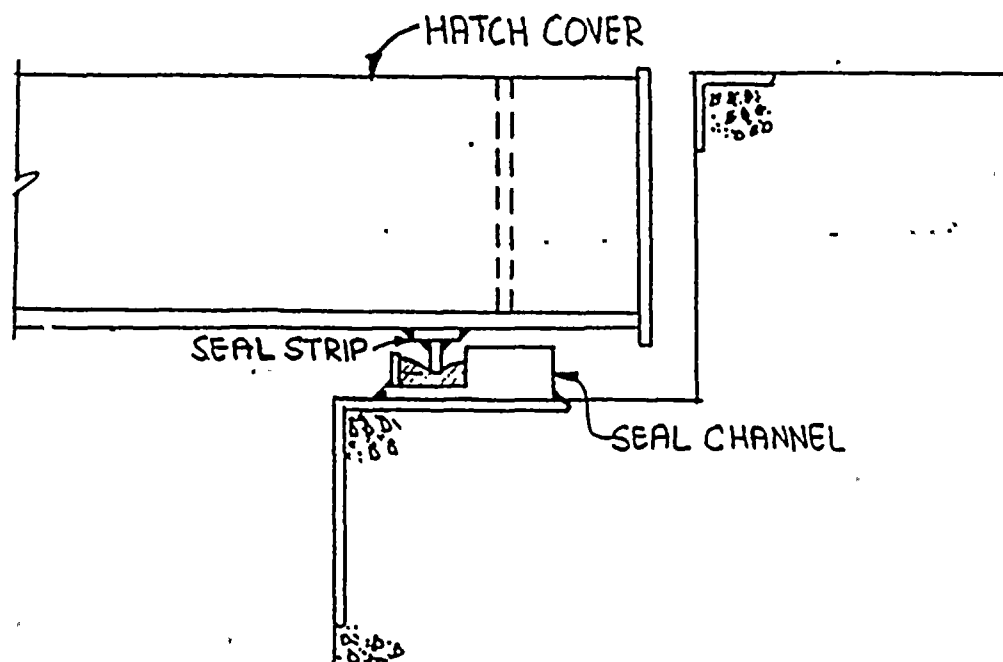
FIGURE NO. 5

Each RCP hatch cover is anchored to the operating deck by either 18 or 19 - 3/4" or 7/8" diameter ASTM A193, grade B7 high strength anchor bolts which fit into pockets in the cover. (Figures No. 5 & 6)

A seal bar welded to the bottom of the hatch cover fits into a seal channel welded atop the angle that forms the upper ledge which supports the hatch cover. The seal channel which runs around the periphery of the hatch has a continuous notch cut into it, into which an elastomeric seal material is fitted. The seal bar on the bottom of the hatch cover seats into the elastomeric material in the notch in the seal channel to seal the hatch. (Figure No. 5)

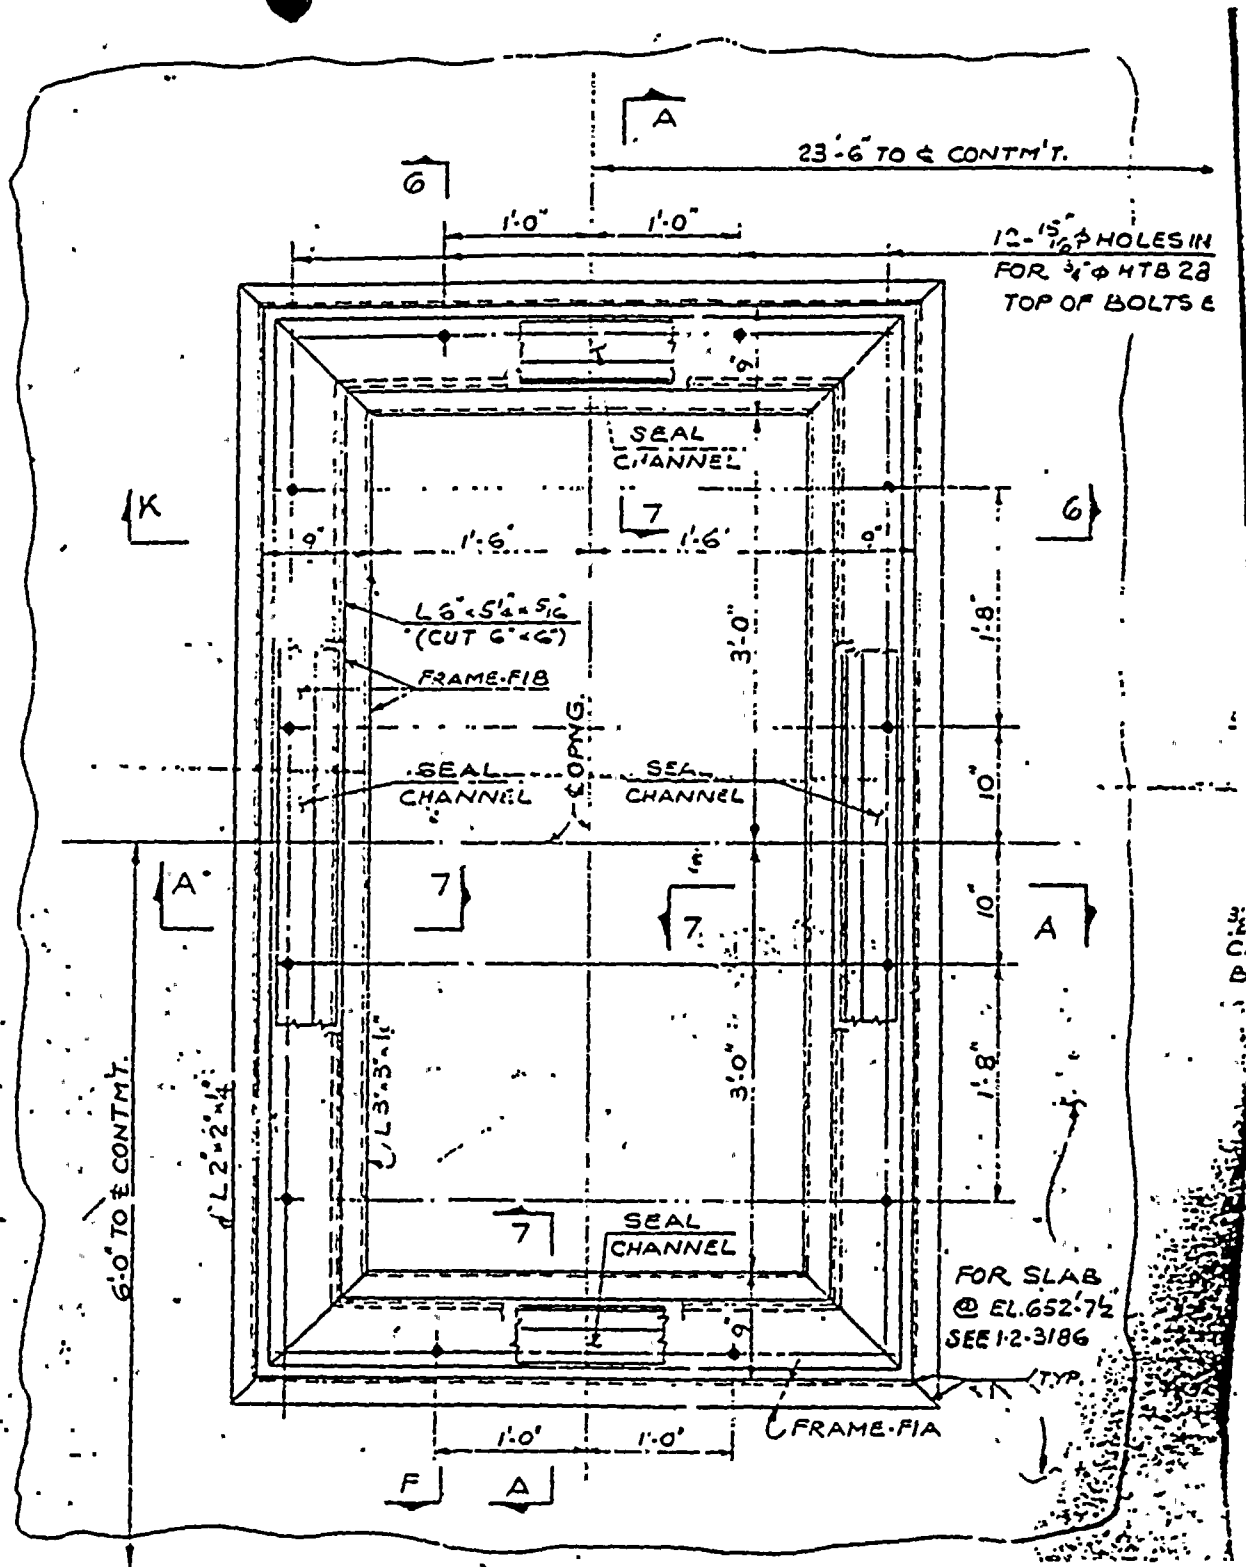
Figure No. 23

The RCP hatches are approximately rectangular in shape and measure 7 feet 6 inches by about 11 feet. (Figures No. 2 & 3) The CRDM hatch is rectangular in shape and measures 3 feet by 6 feet. (Figure No. 23)

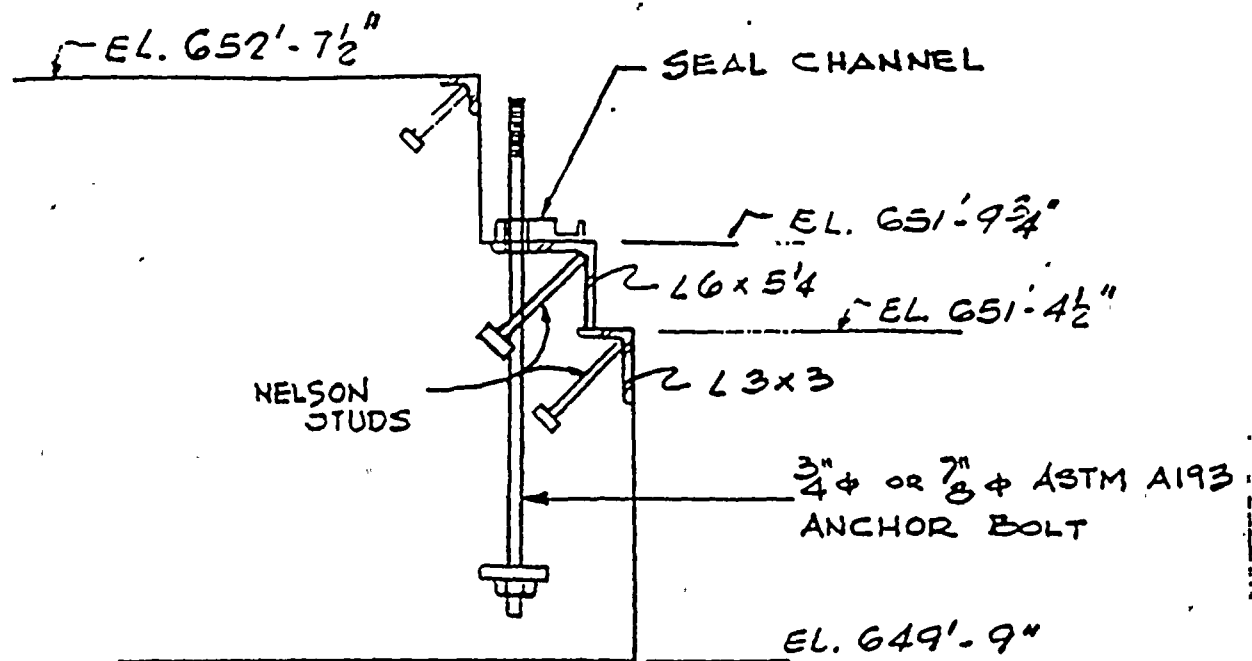
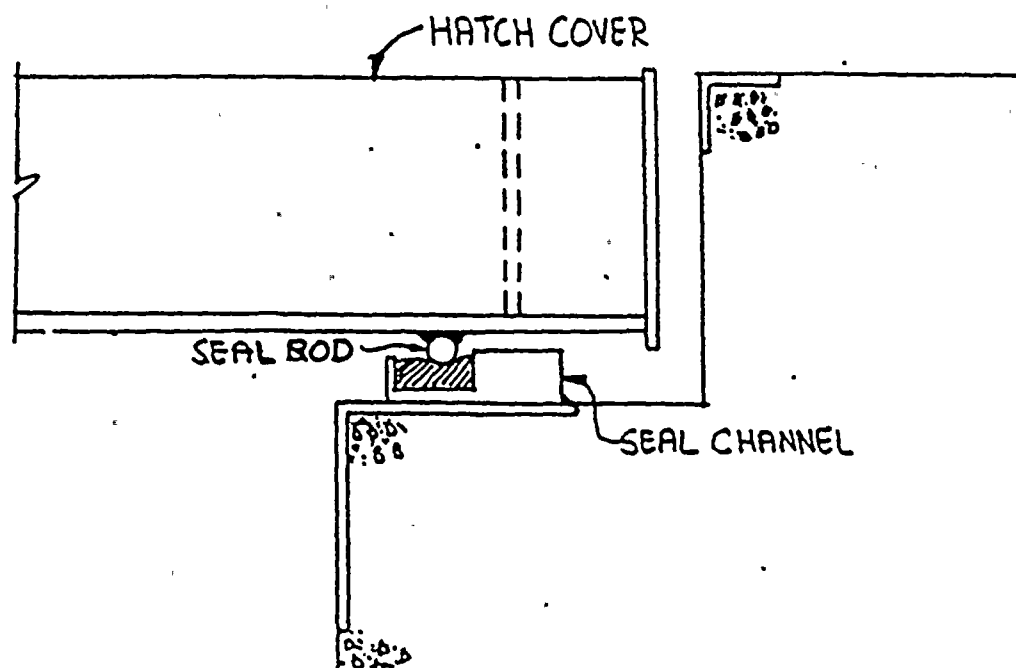
FIGURE NO. 24

A seal rod welded to the bottom of the hatch cover fits into a seal channel welded atop the angle that forms the upper ledge which supports the hatch cover. The seal channel which runs around the periphery of the hatch has a continuous notch cut into it, into which an elastomeric seal material is fitted. The seal rod on the bottom of the hatch cover seats into the elastomeric material in the notch in the seal channel to seal the hatch. (Figure No. 24)
