METALLURGICAL INVESTIGATION OF WALL THINNING
AND LEAKAGE OF THE BMI THIMBLE TUBING AT
D.C. COOK UNIT 2

Gutti V. Rao

January 1991

WESTINGHOUSE ELECTRIC CORPORATION
Nuclear and Advanced Technology Division
P. O. Box 2728
Pittsburgh, Pennsylvania 15230-2728

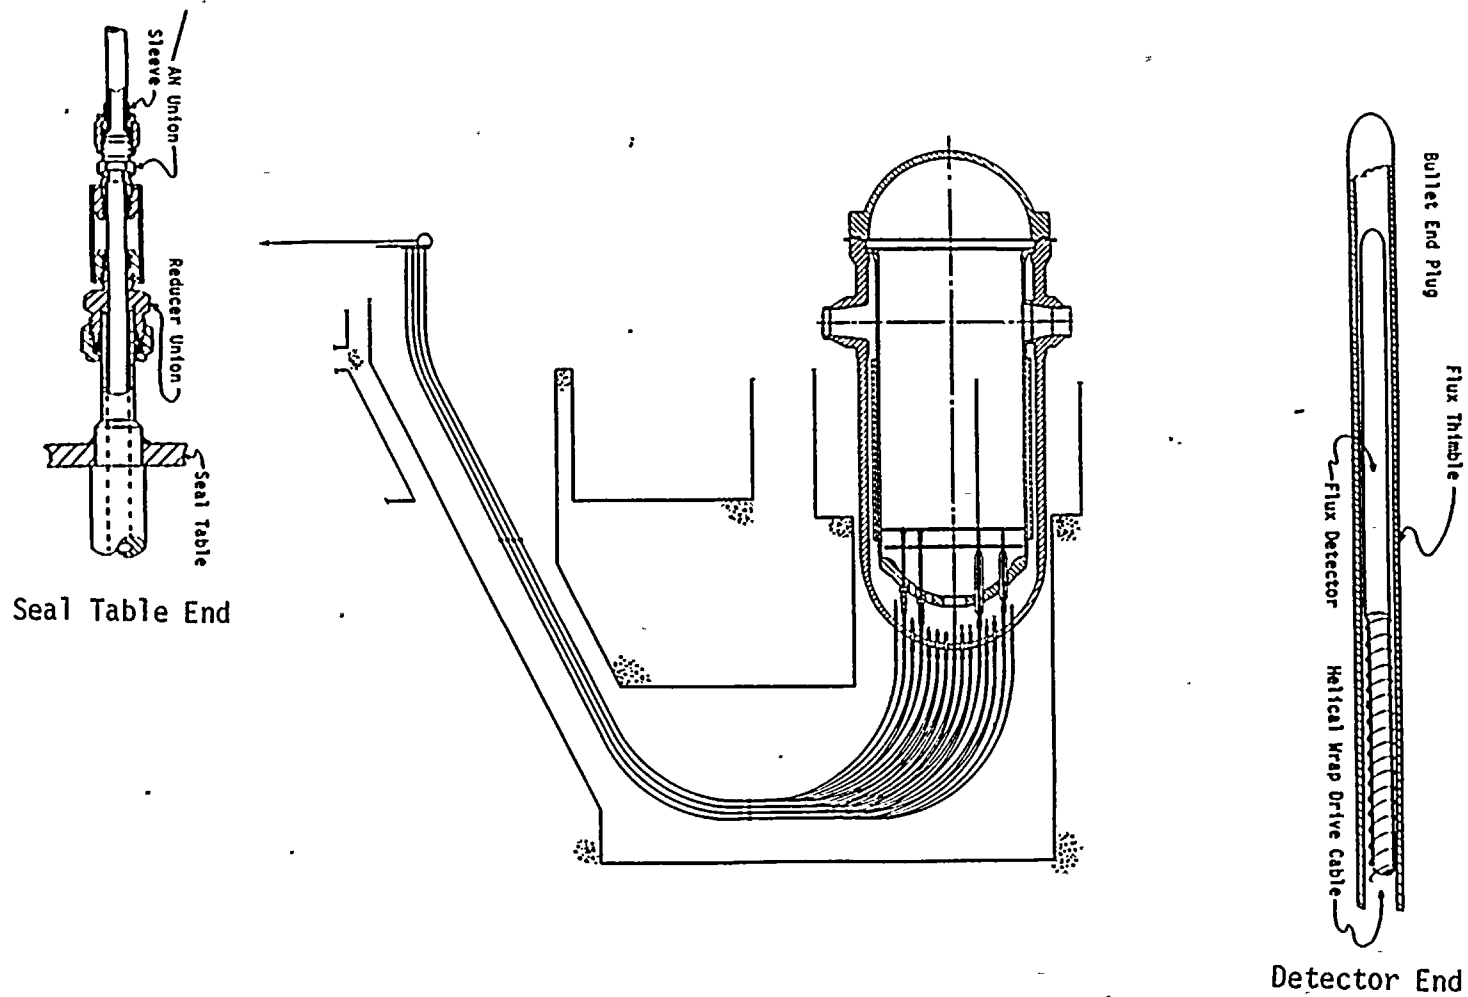
This report summarizes the findings of the metallurgical investigation of the wear and leakage of the reactor vessel bottom mounted instrumentation (BMI) thimble tubes at D. C. Cook Unit 2. The reactor vessel instrumentation thimble is a small tubing with an outside diameter ranging from 0.300 in. to 0.385 in. and a wall thickness ranging from 0.05 in. to 0.06 in. respectively, depending on the plant. The thimble tubing is made of cold worked 316 stainless steel material although most recently cold worked 316L grade has been applied to limit the cobalt content. A schematic representation of the reactor vessel BMI thimble system is illustrated in Figure 1.1.

Figure 1.1 Schematic Representation of the Reactor Vessel Bottom Mounted Instrumentation Thimble Tube System
