WCAP-14447

Repair Boundary for Parent Tube Indications
Within the Upper Joint Zone of
Hybrid Expansion Joint (HEJ) Sleeved Tubes

September 1995

WESTINGHOUSE ELECTRIC CORPORATION
NUCLEAR SERVICES DIVISION
P.O. BOX 158
MADISON, PENNSYLVANIA 15663-0158

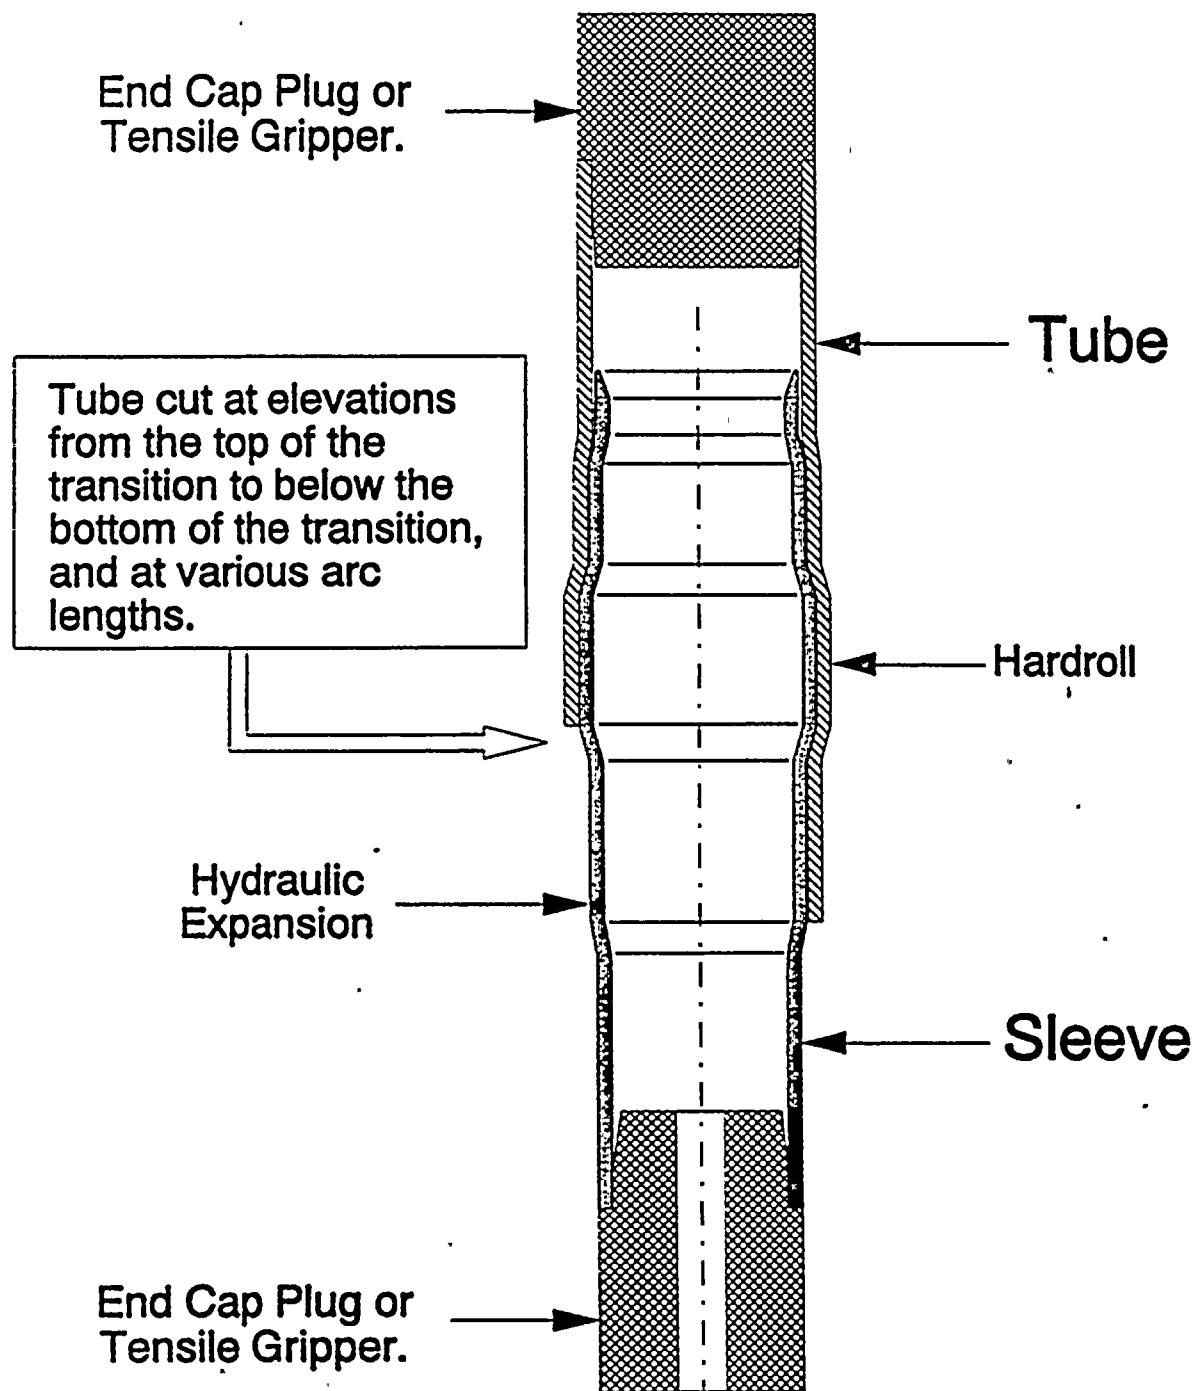
Figure 6-1: HEJ specimen used for tensile testing.

Two types of structural tests were performed, tensile strength tests and hydraulic proof tests (References 8 and 9). Prototypic HEJ test specimens, see Figure 6-1, were fabricated using Alloy 600 tubing and both Alloy 600 and Alloy 690 sleeve material.¹ The initial tensile strength tests were performed on prototypic HEJ sleeved tube specimens with the lower portion of the tube completely machined away at various postulated crack elevations. For specimens where the tubes were completely removed by machining at the elevation corresponding to the bottom of the HRLT, i.e., ~1.25 inches below the bottom of the HRUT, the structural capability of the joints were approximately twice the most limiting RG 3ΔP end cap loading. For specimens where the tubes were completely removed by machining at the elevation corresponding to the approximate midspan of the hydraulically expanded region, i.e., ~2.25" the bottom of the HRUT, the structural capability of the joints were ~3.5 to 4 times the most limiting RG 1.121 3ΔP end cap load.

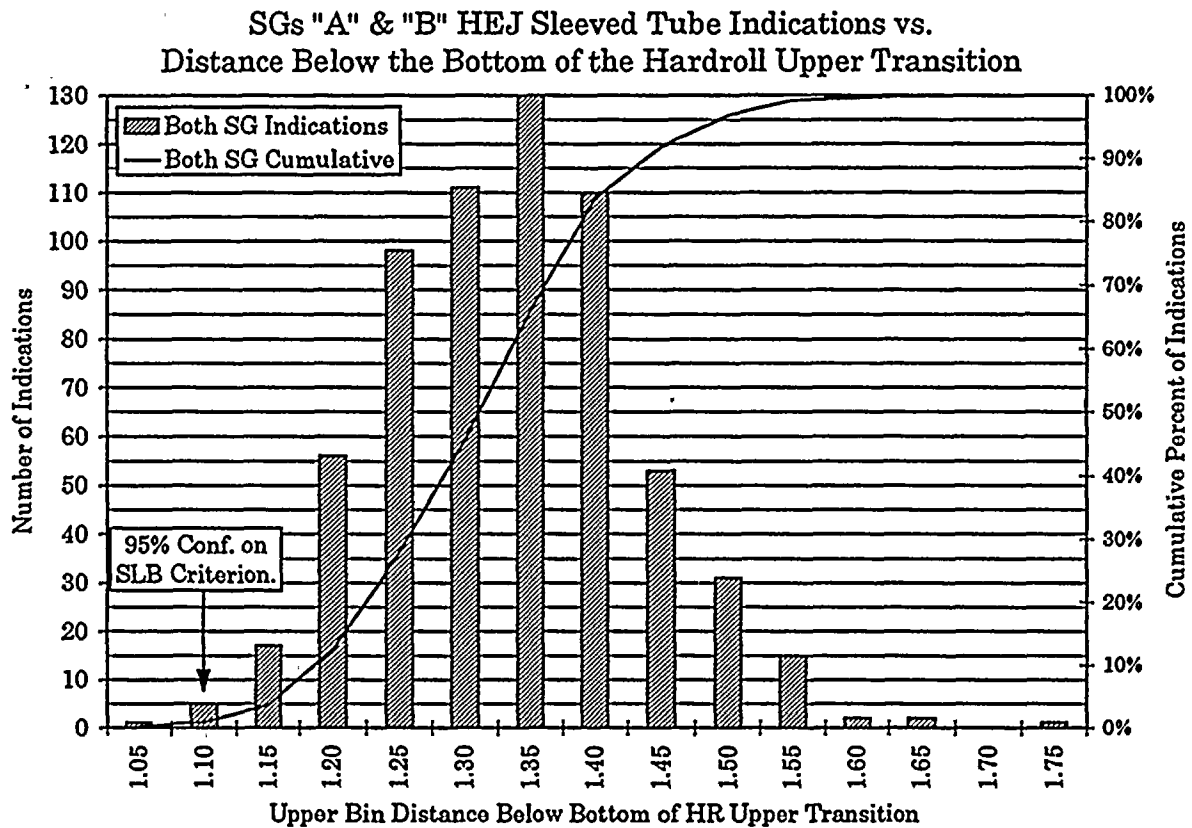
Figure 7-5

The distance from the bottom of the hardroll upper transition to the elevation of the indications in the Kewaunee SG tubes was measured for each indication near the elevation of the hardroll. A summary of the measured distances for each SG and for the combined SGs is provided in Table 7-3. Histogram and cumulative frequency plots of the distribution of indications in SGs "A" and "B" are provided on Figure 7-3 and Figure 7-4 respectively. The combined distribution and cumulative frequency information for both SGs is provided on Figure 7-5.
