REPORT
ON
SYSTEM DISTURBANCE
JUNE 28, 1974

FLORIDA POWER & LIGHT COMPANY

JULY 19, 1974

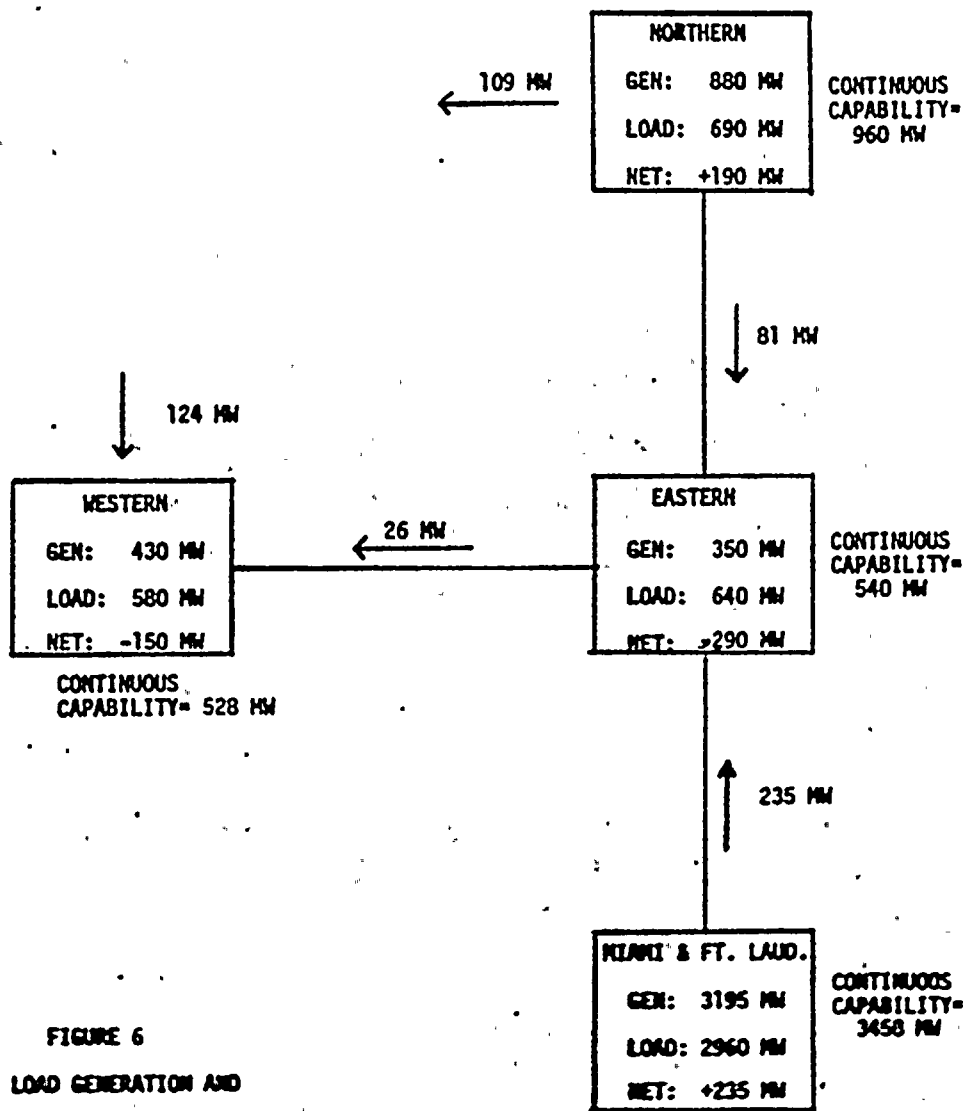
FIGURE 6
LOAD GENERATION AND
INTER-AREA FLOWS PRIOR TO
SYSTEM DISTURBANCE JUNE 28, 1974

Prior to the disturbance, the system load was 4870 MW, including 3210 MW in the affected area. System generating capability on line was 5486 MW. The capability in the affected area was 3458 MW. The system spinning reserve was 616 MW. Inter-area flows were well within limits. Area load and generation data and inter-area flows prior to the disturbance are given in Figure 6.
