FLORIDA POWER & LIGHT COMPANY

SYSTEM DISTURBANCE

LOSS OF GENERATION AT TURKEY POINT

WEDNESDAY, APRIL 4, 1979

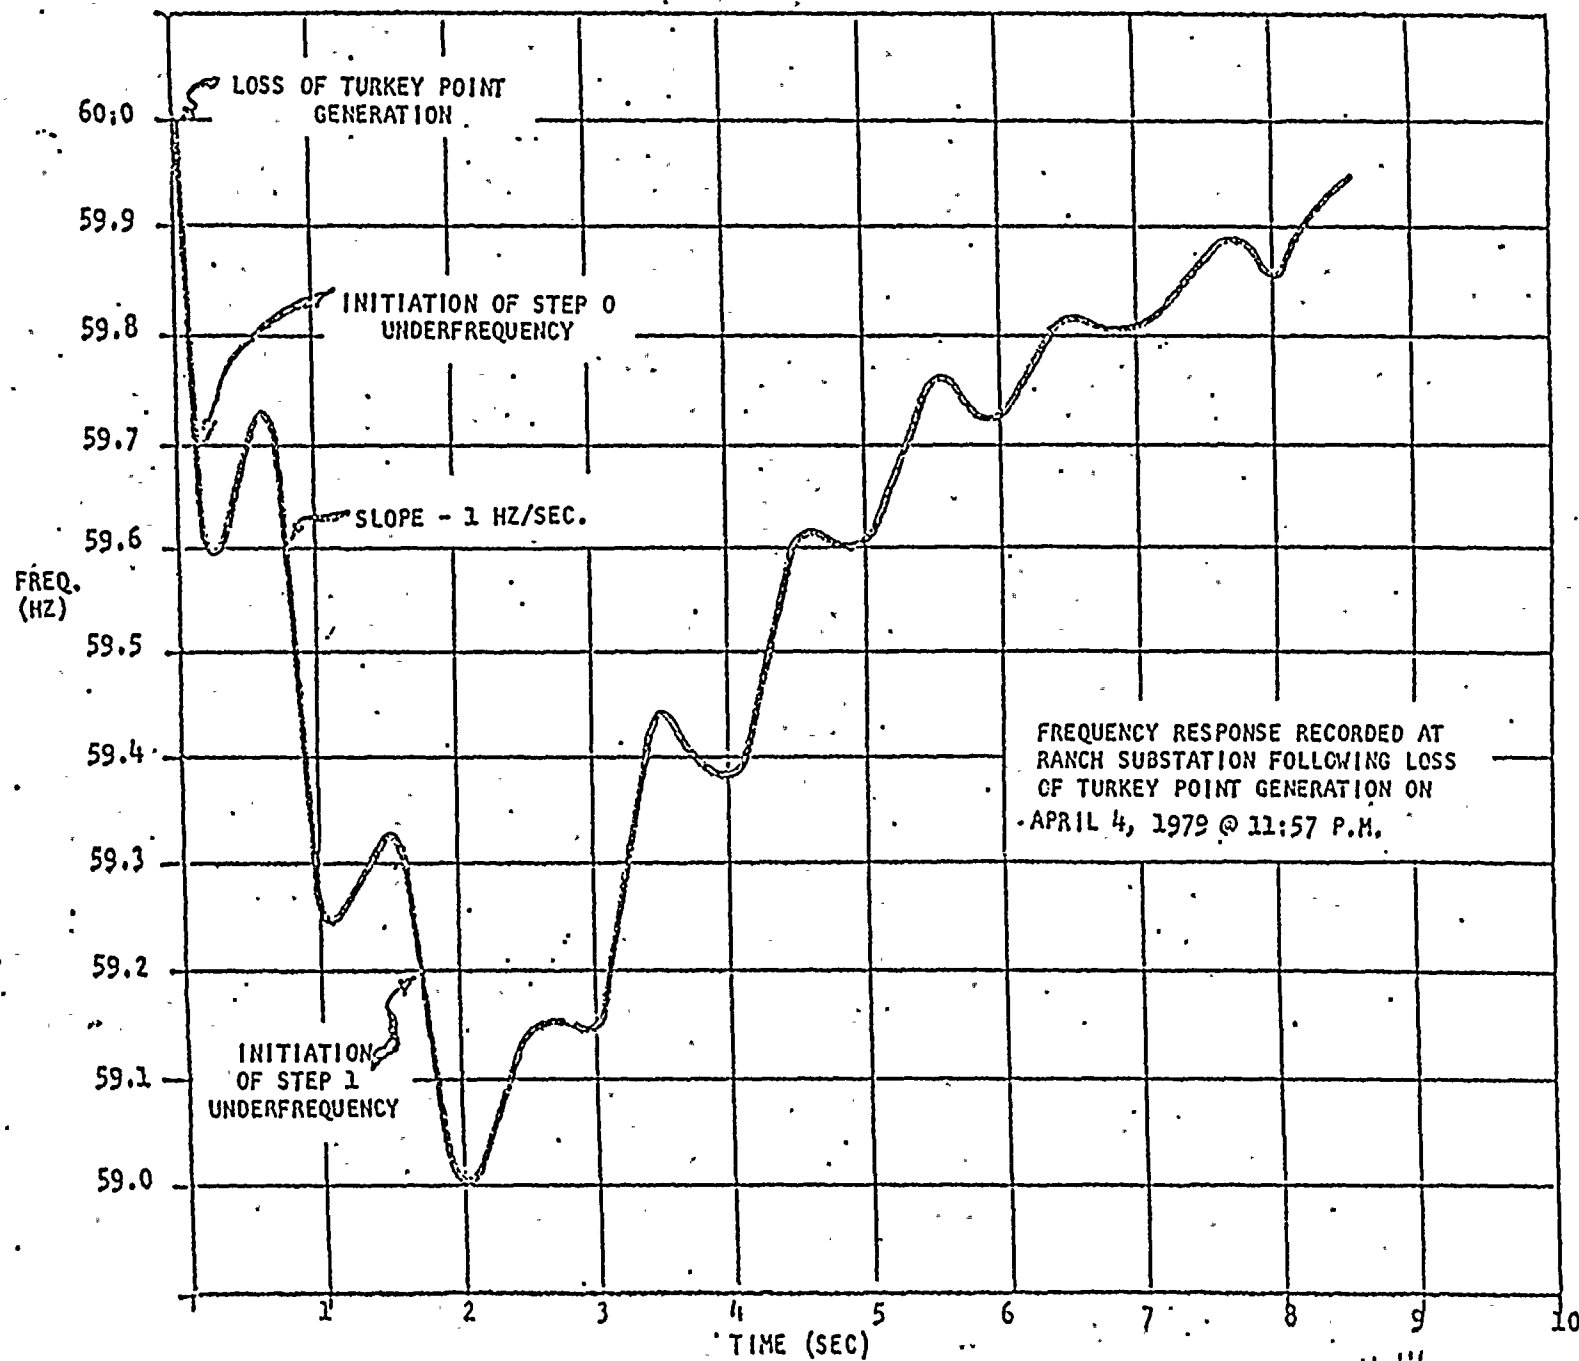
SYSTEM FREQUENCY
AT PORT EVERGLADES 138KV BUSS
APRIL 4, 1979

The resulting mismatch of load and generation caused the frequency to decline. Within FPL the system frequency declined to a low of 59.01 Hz, and initiated underfrequency relays which shed approximately 470 Mw of load in the areas shown below. Governor response and load shedding within Peninsular Florida stabilized the frequency at 59.85 Hertz within 10 seconds.
