REPORT
ON
SYSTEM DISTURBANCE

MAY 16, 1977

FLORIDA POWER & LIGHT COMPANY
JUNE 29, 1977

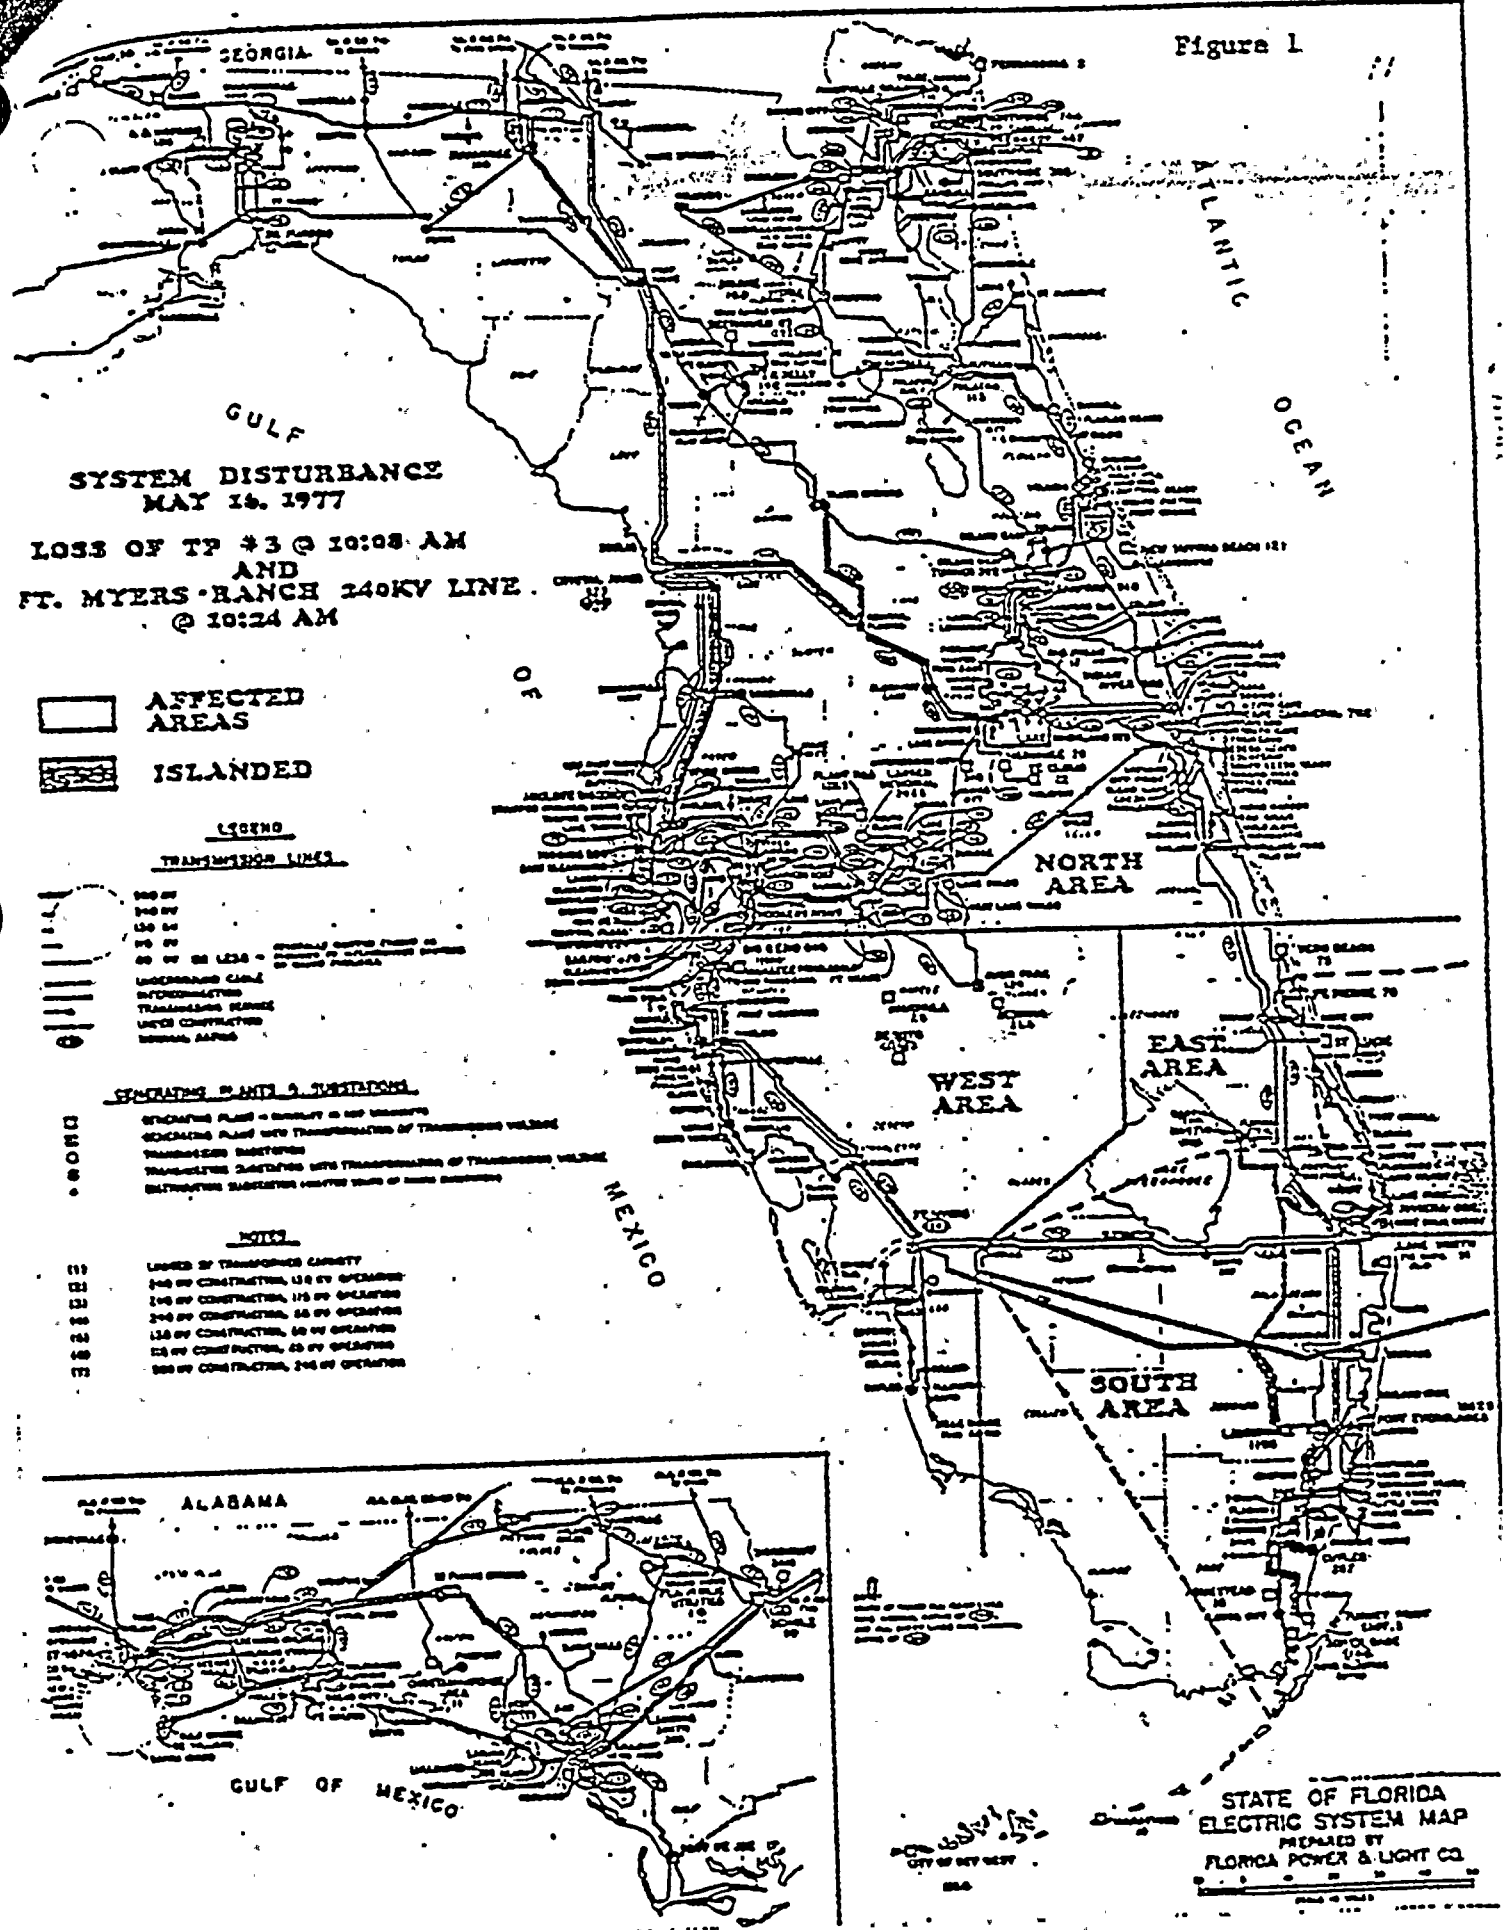
Figure 1

2004W At 10:24 a.m. the Ft. Myers-Ranch 240 kV Line, carrying approximately 420 MW, tripped due to a phase-to-ground fault. The east and south areas of the FPL system (See Figure 1) became separated from the north and west areas when three 240 kV and seven 138 kV lines relayed sequentially due to instability. This split of the transmission system resulted in the St. Lucie Plant of the east area being tied only to the north and the Riviera Plant being islanded along with a portion of the east area load.

At 10:24 a.m. the Ft. Myers-Ranch 240 kV line relayed due to a phase-to-ground fault. Just prior to this relay action the line was carrying approximately 420 MW. The loss of the Ft. Myers-Ranch 240 kV line resulted in a further increase in flow south from Malabar. This power swing resulted in the separation of the east and south areas from the remainder of the system at 10:24 a.m. (See Figure 1) The sequence of relay and breaker operations is given in Figure 6.
