TURKEY POINT 4 STEAM GENERATOR  
INSPECTION PROGRAM

An extensive inspection program for the Turkey Point Unit 4 steam generators was conducted in May, 1980. The following items were accomplished:

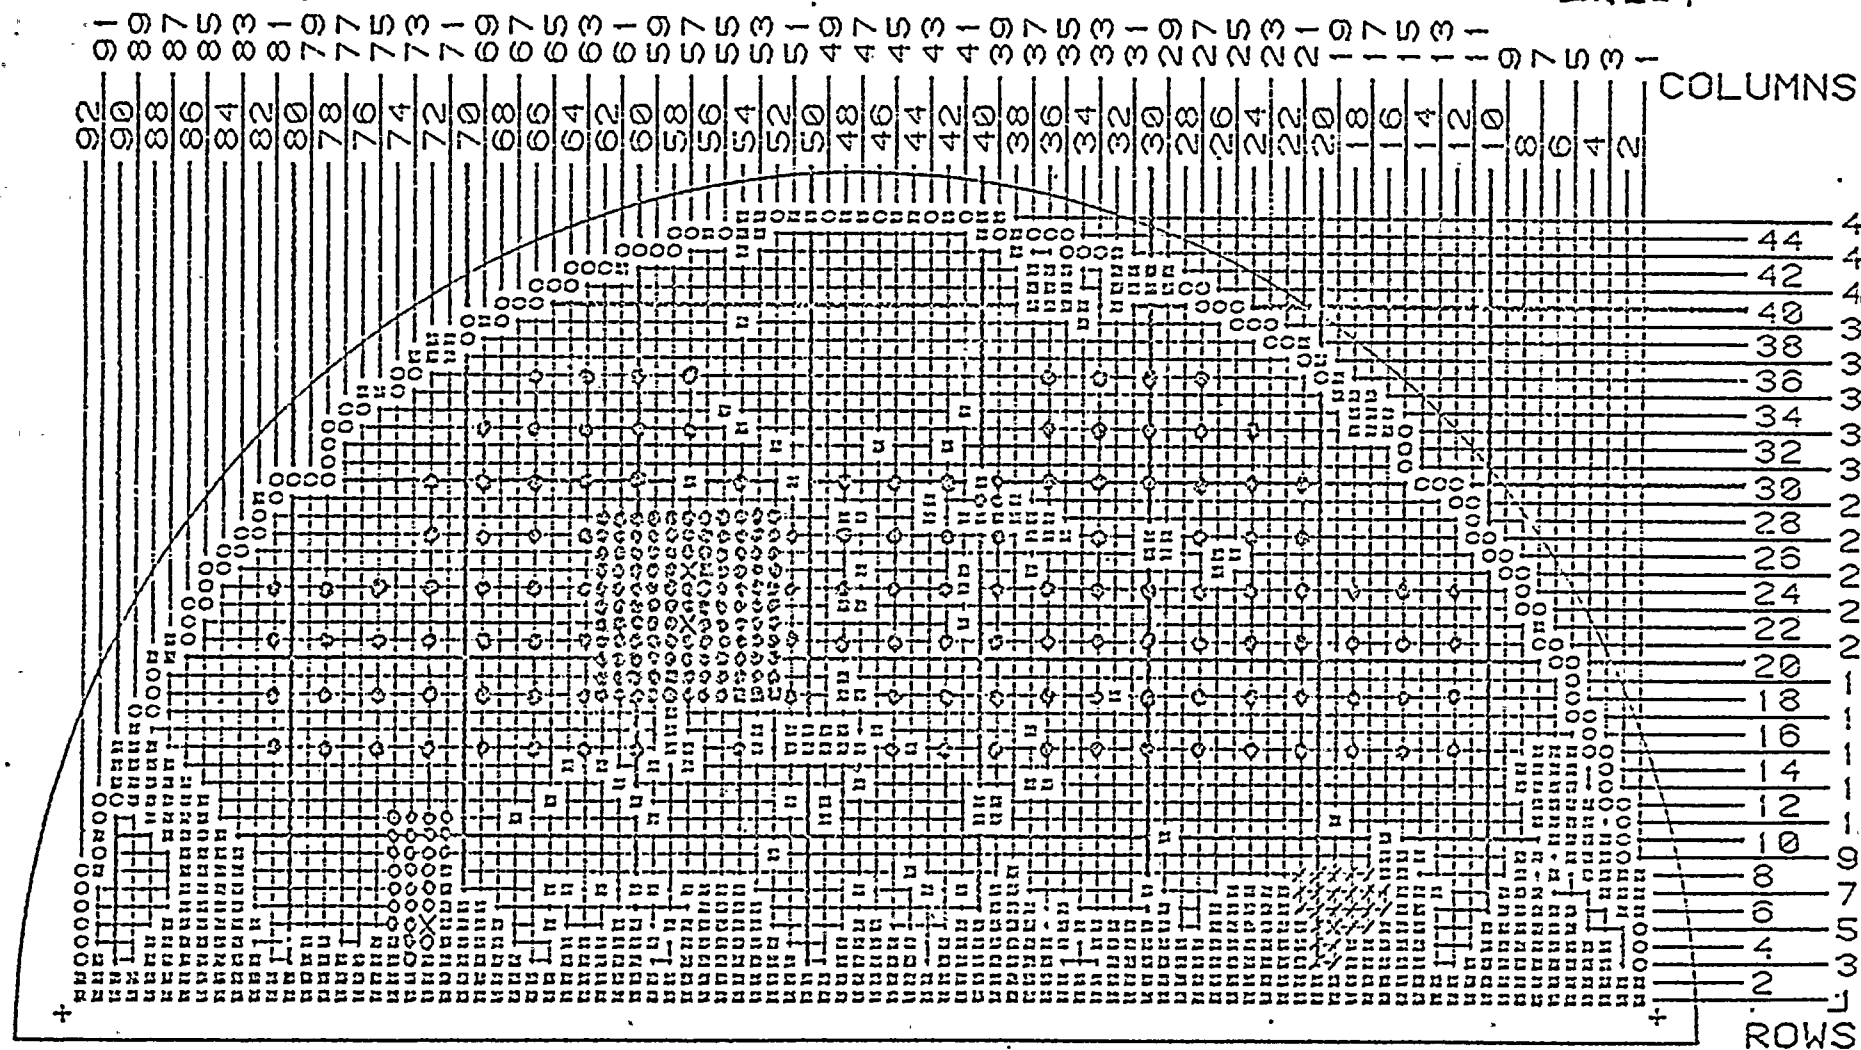
FIGURE 3

FLA-A  
INLET

TOTAL 301 TUBES INSPECTED

←--- MANWAY Reg Guide Program - 400 KHZ THROUGH U-BEND (TECH SUP #1)

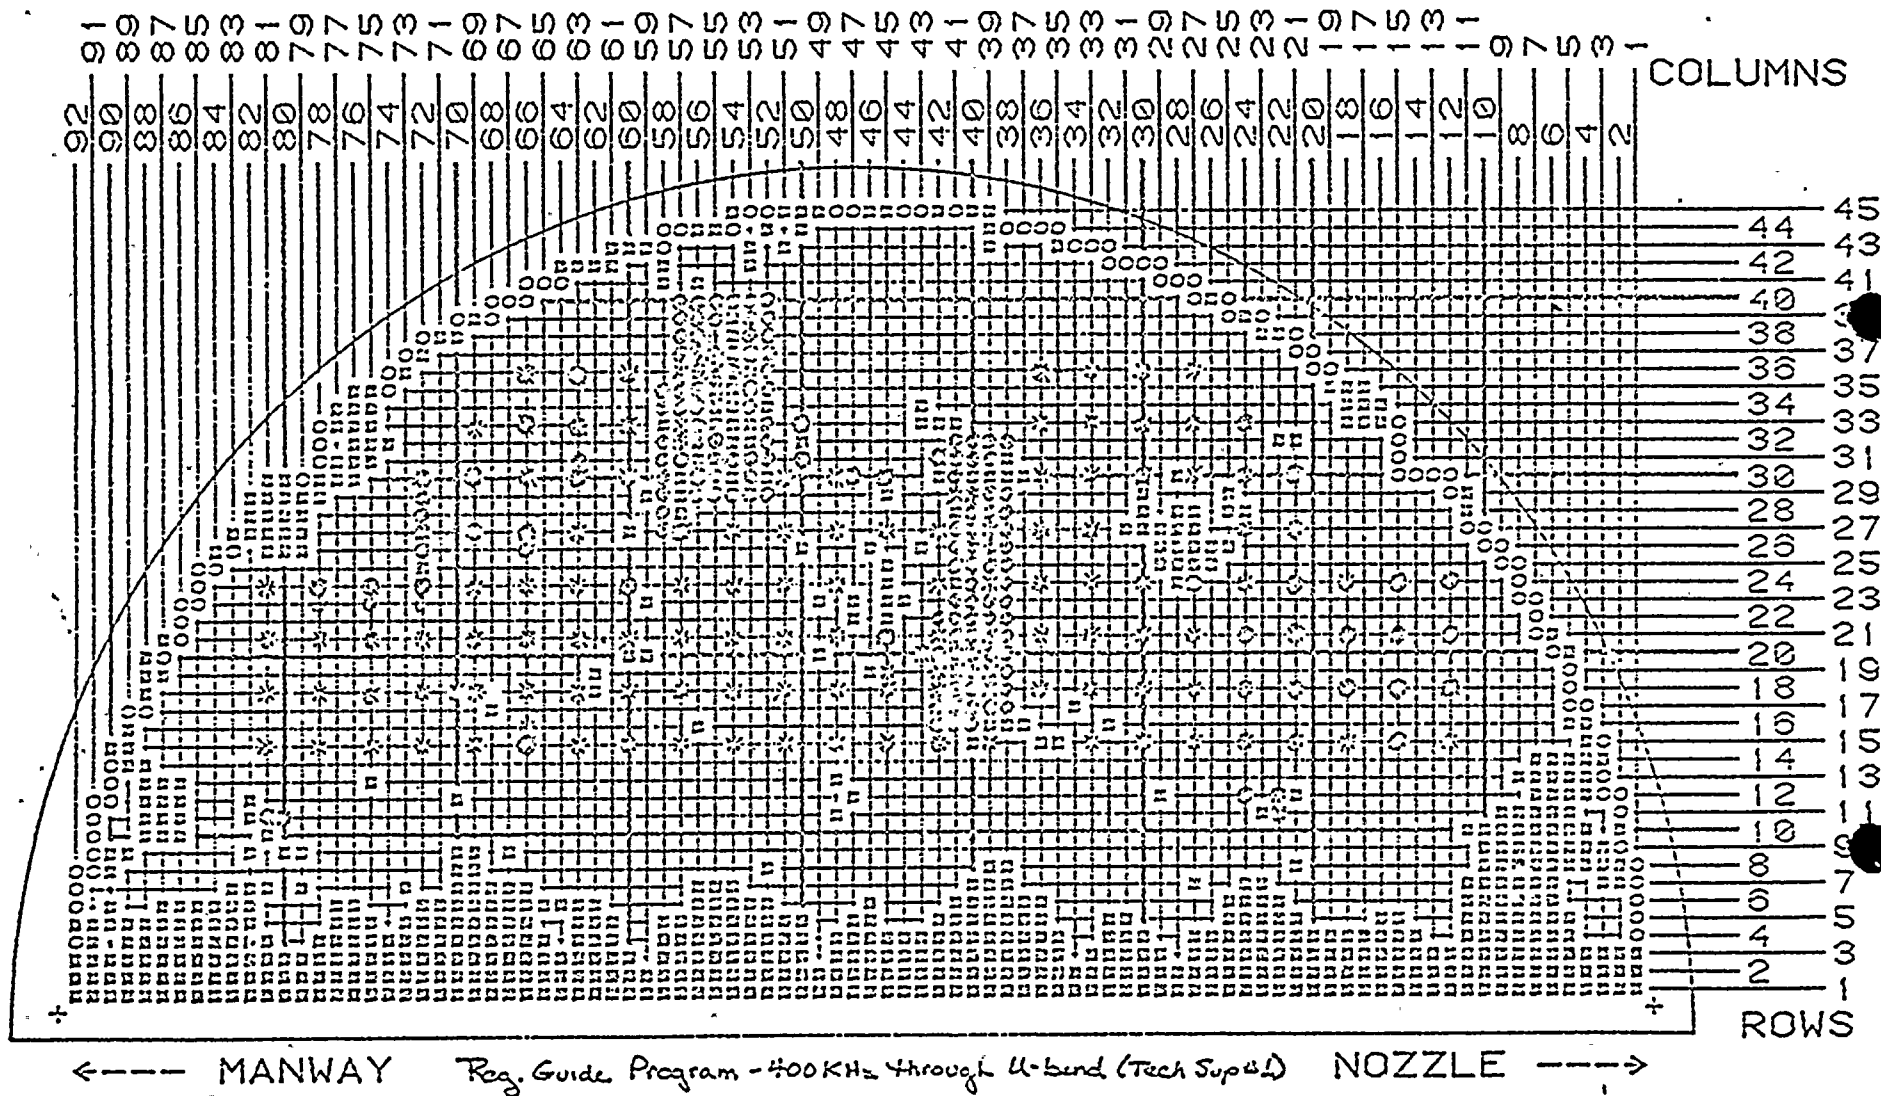
FLA-B  
INLET

TOTAL 283 TUBES INSPECTED

162 Tubes (ORIGINAL PROGRAM)

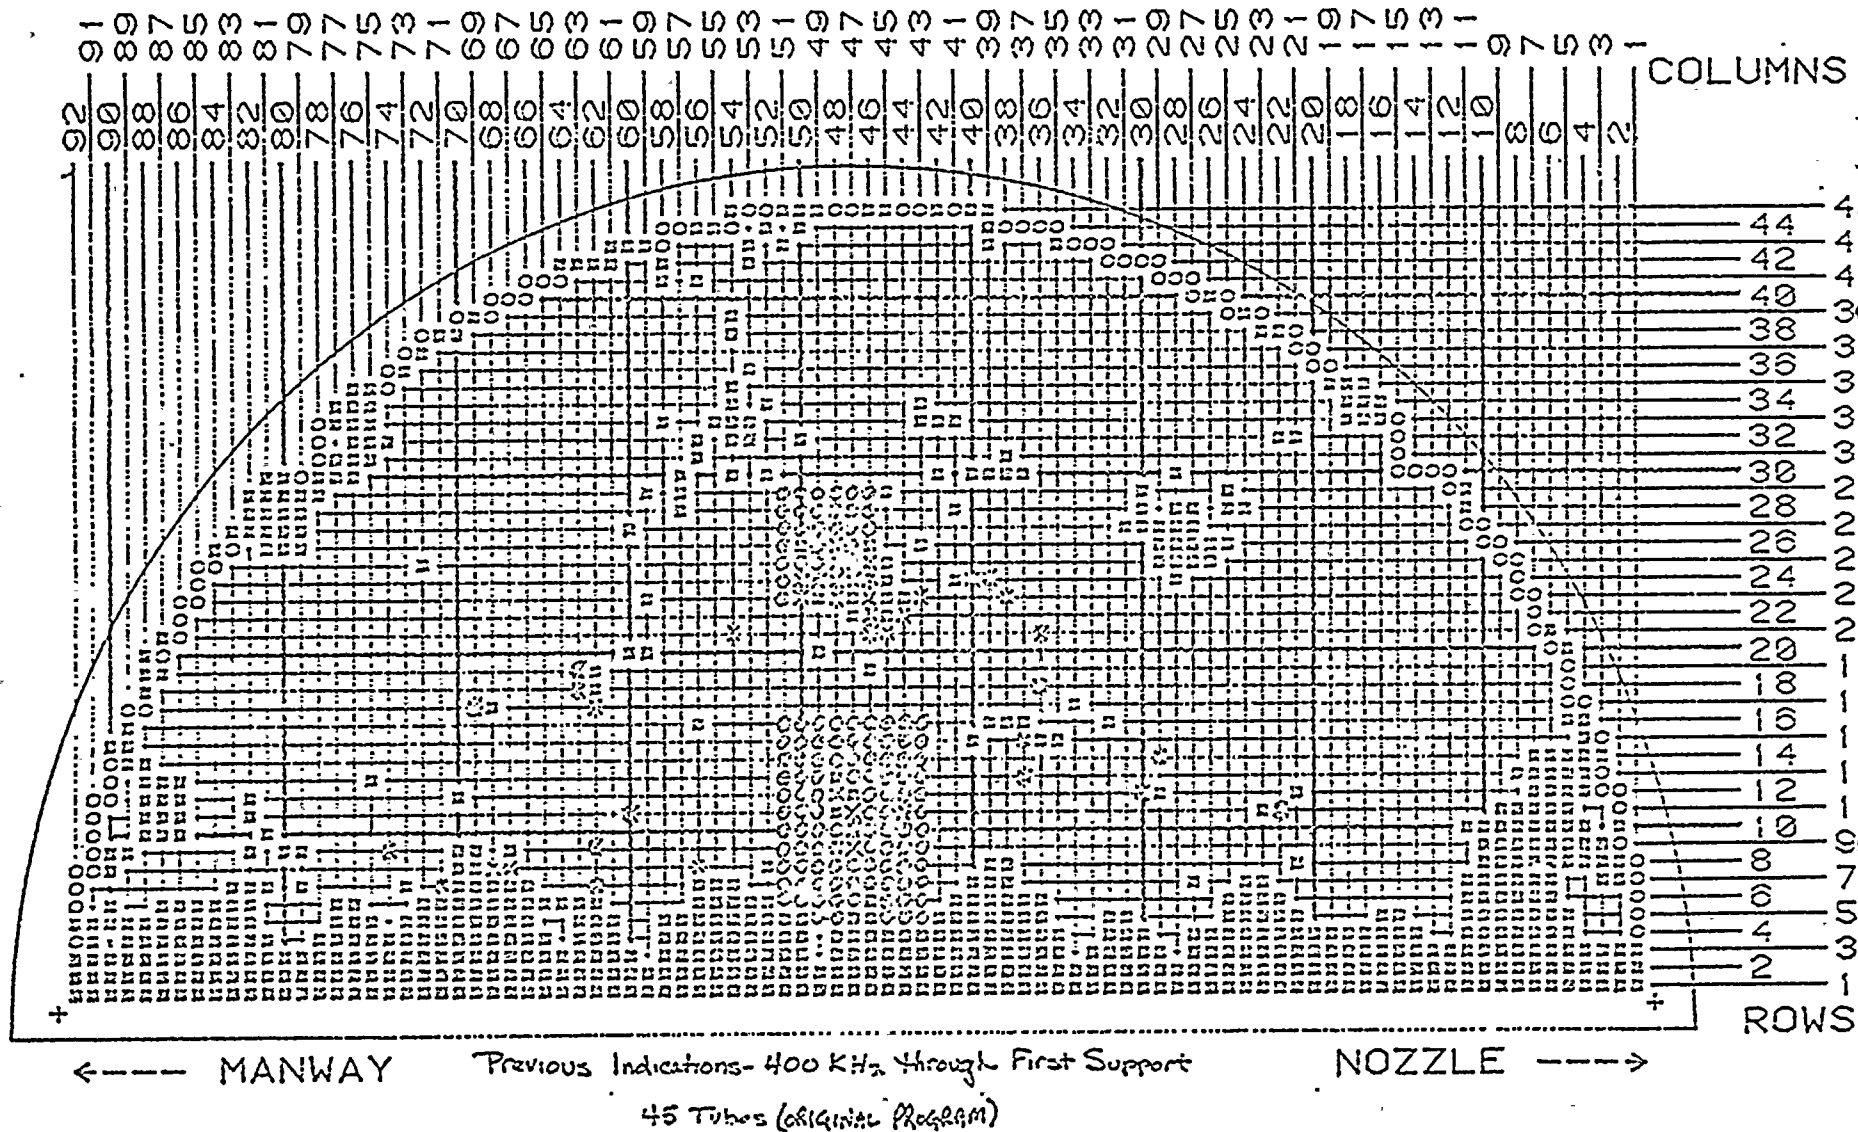
FIGURE 6

FLA-B  
 OUTLET

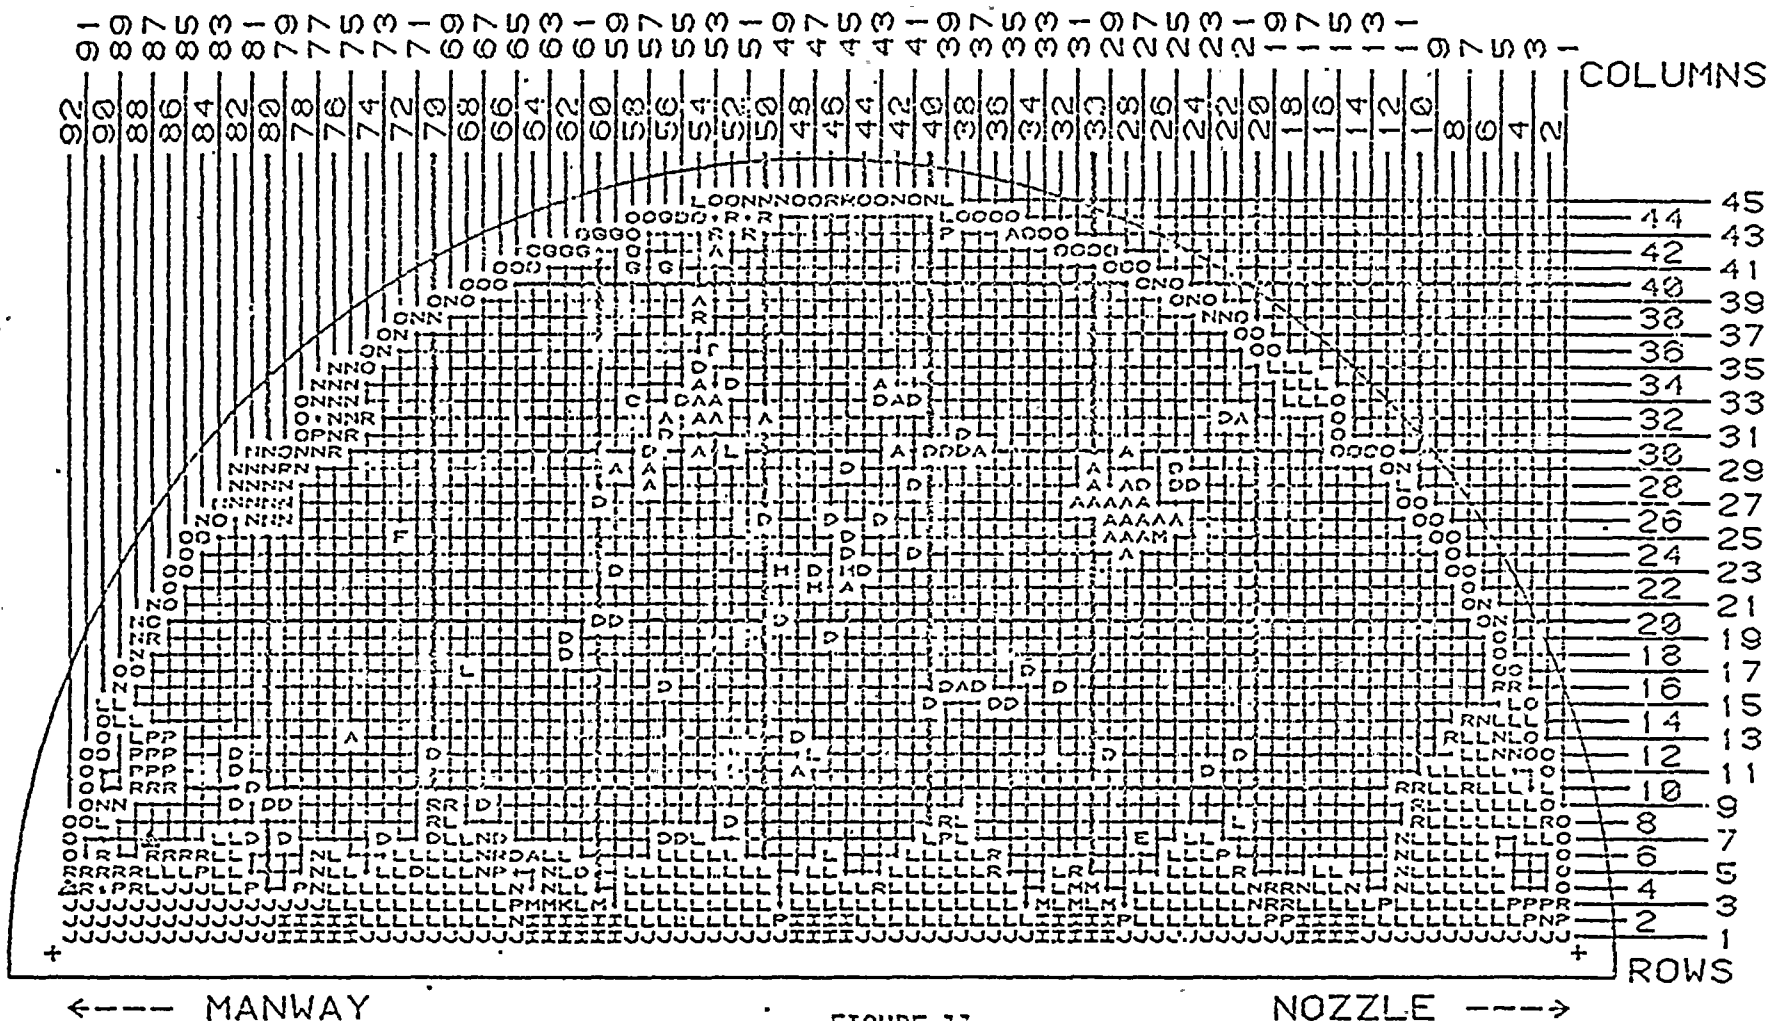
TURKEY POINT UNIT #4  
 STEAM GENERATOR B COLD LEG  
 GAUGING RESULTS, MAY, 1980

RESTRICTIONS	NO OF TUBES
$\phi = .650$	0
$\Delta = .610$	2
$\times = .540$	0
