TURKEY POINT 3 STEAM GENERATOR
INSPECTION PROGRAM

I. Introduction

An extensive inspection program for the Turkey Point Unit 3 steam generators was conducted in October, 1980. The following items were accomplished:

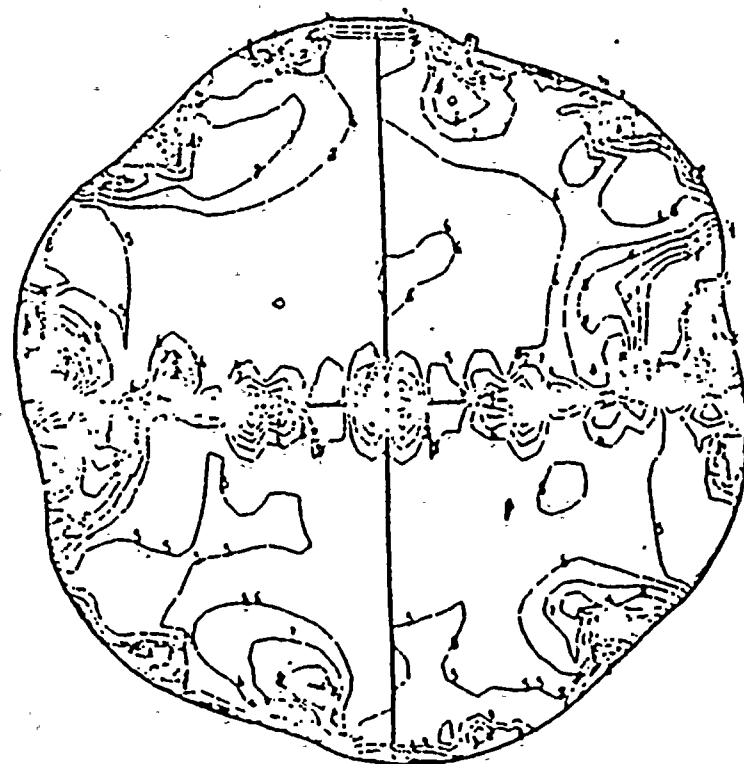
FIGURE 1 - TUBE HOOP STRAIN AT
24 EFPM's BEYOND FULL CLOSURE

expectations as to the position of a strain boundary which might be linked to location of the most severely restricted tubes. The 17.5% strain contour utilized in the 12/79 inspection would encompass most of the hot leg tube bundle at 24 effective full power months beyond closure of the support plate flow slots, which is regarded as having occurred as of the 12/77 inspection. (The tube hoop strain at 24 effective full power months beyond full closure is given for reference purposes in Figure 1). Therefore, the gauging program, based on the program used in 12/79, has been adjusted to reflect prior experience at the Surry and Turkey Point plants. Additional inspection programs were defined for the periphery, wedge, and patch plate regions. These programs were based on previous tube leakage histories at the Turkey Point and Surry plant sites, as well as previous gauging results at the Surry and Turkey Point sites, as deemed appropriate. Due to the current awareness of the potential for tube deformation on the cold leg side, inspections of all three steam generator cold legs were performed.

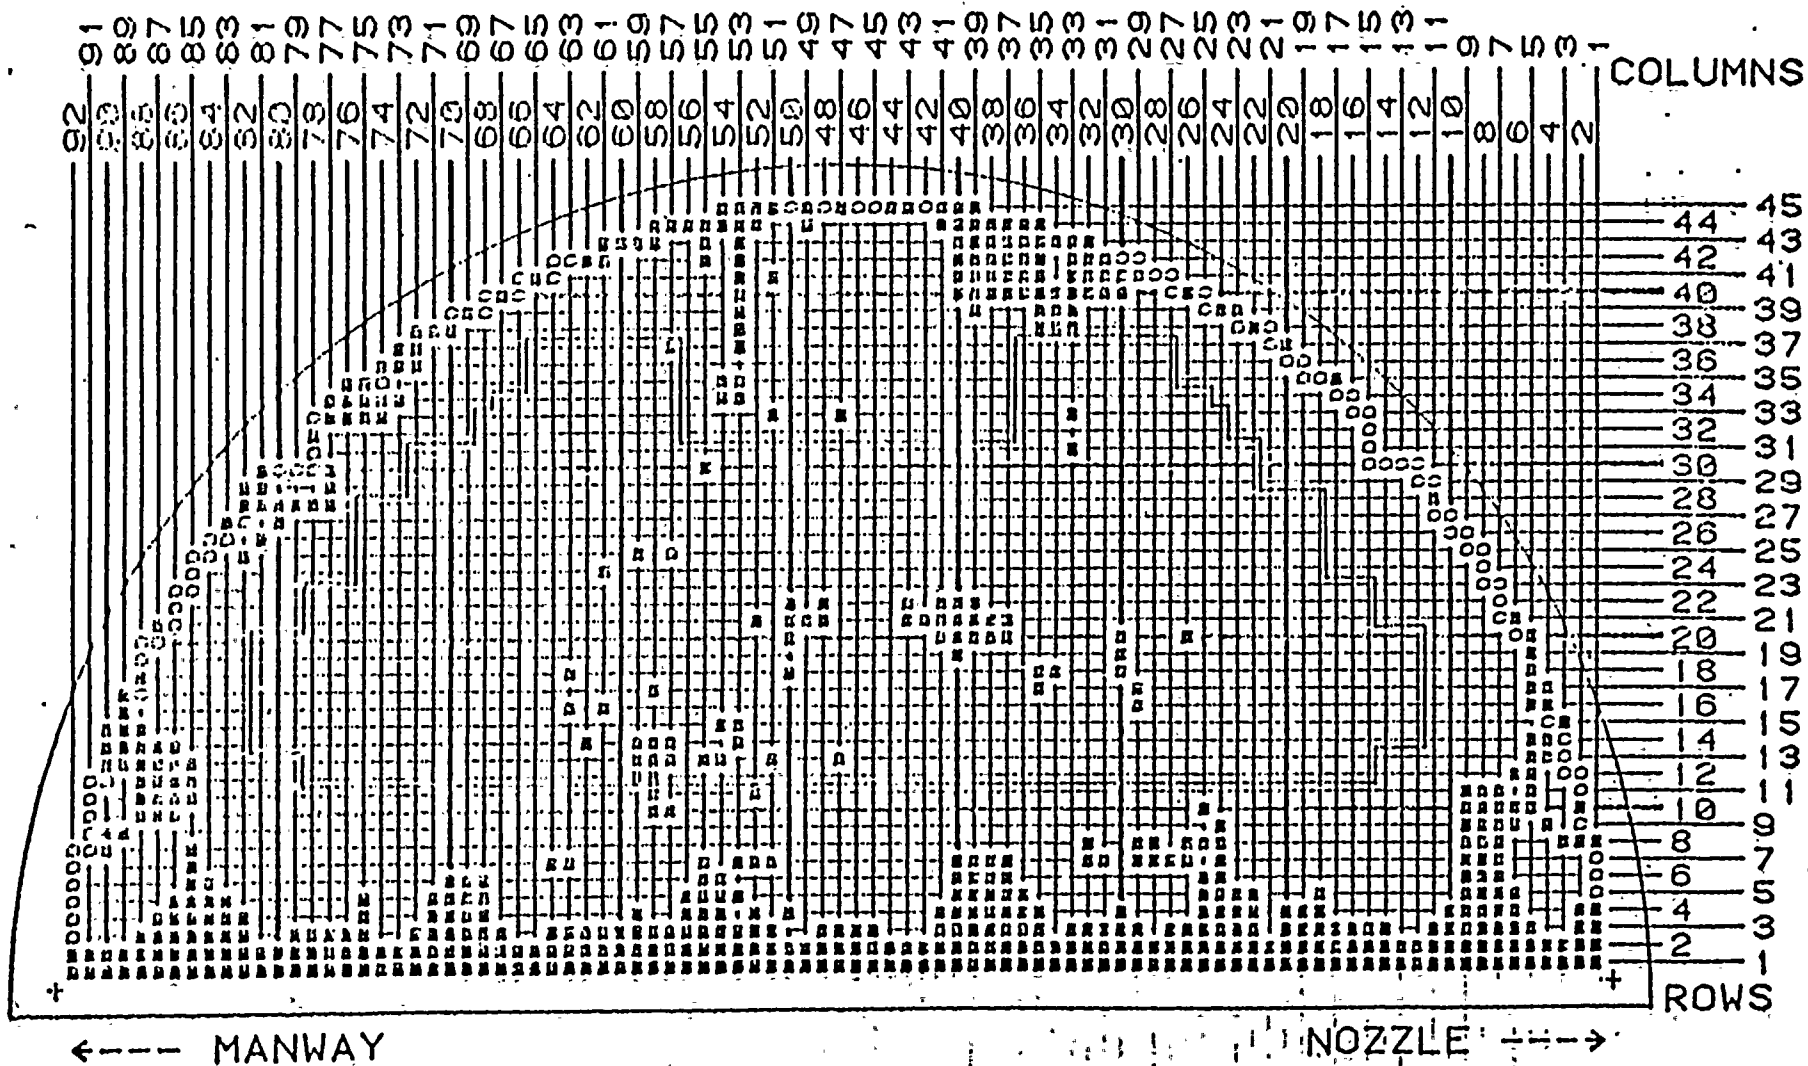
FIGURE 4

The inspection boundary for the December 1979 inspection (Figure 2) is included for reference. The gauging inspection boundaries for the October 1980 inspection are indicated in Figure 3 (typical hot leg) and Figure 4 (typical cold leg).

GAUGING PROGRAM (TYPICAL) OUTLET
GAUGE ALL TUBES WITHIN BOUNDED AREA
OCTOBER, 1980

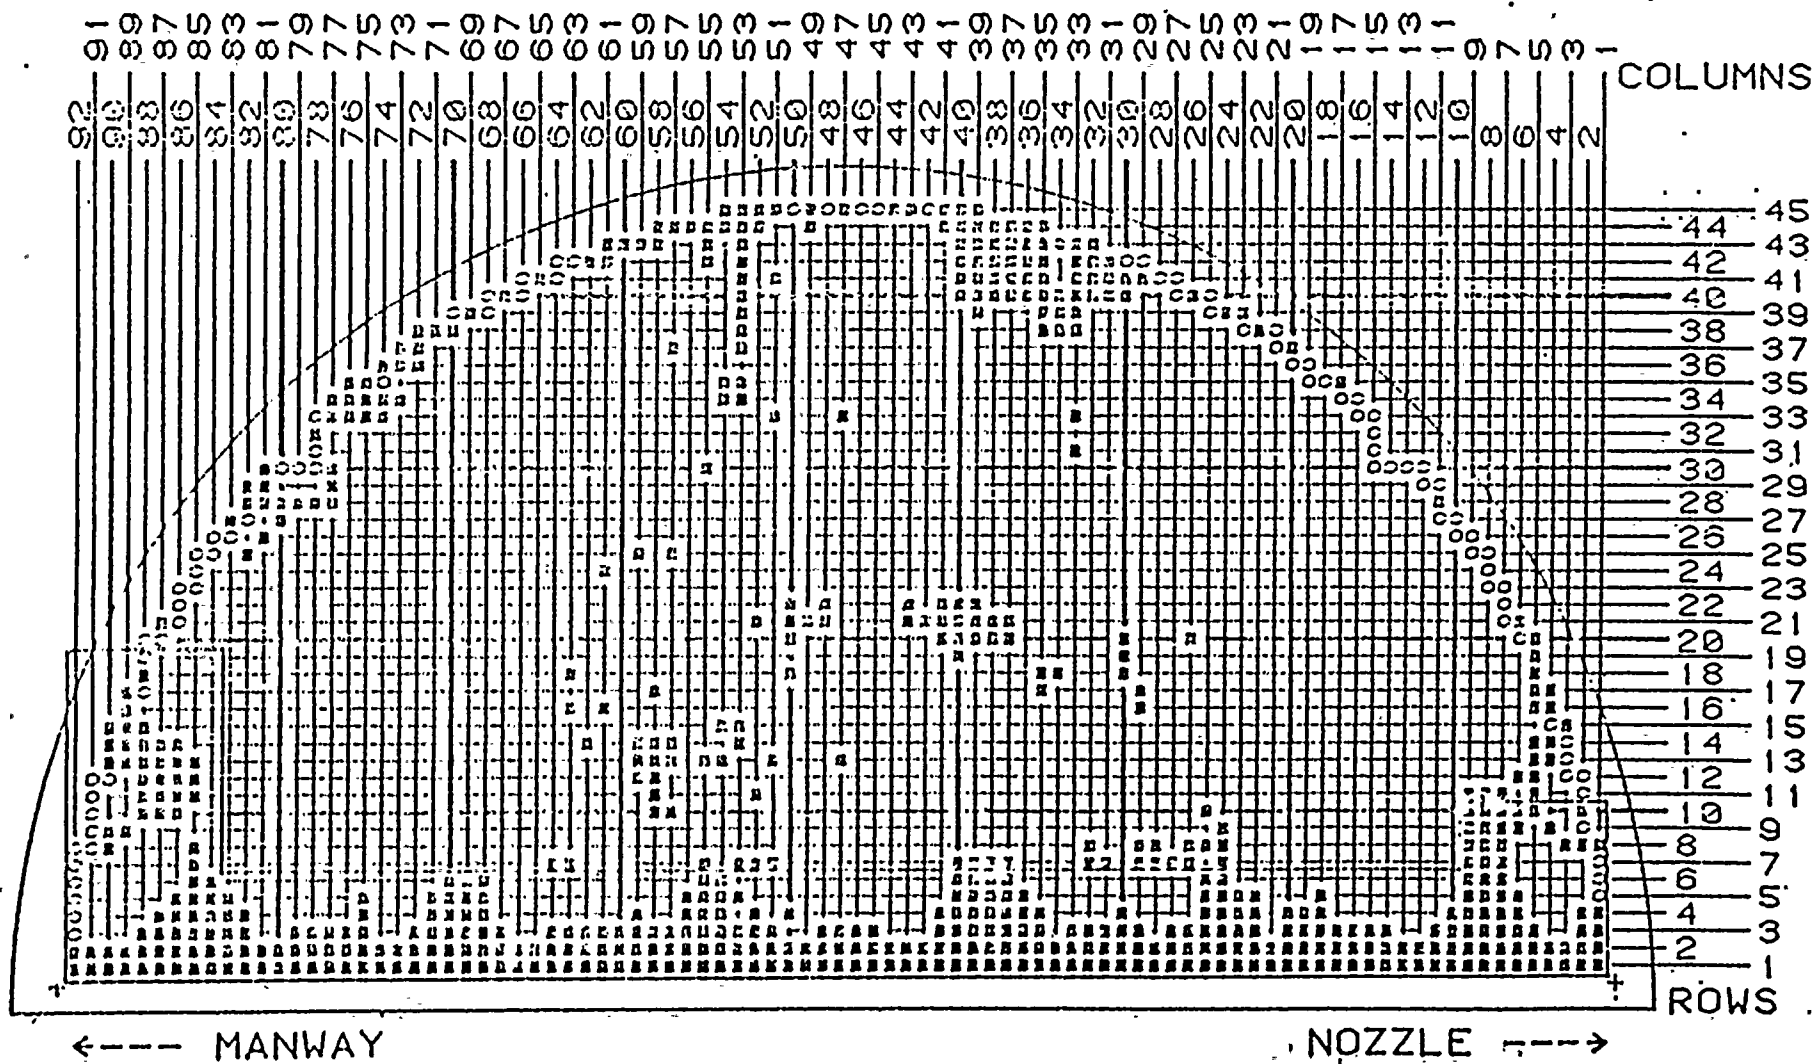
FIGURE 5

The types and extent of inspections required in this area are specified in R.G. 1.83. Typical inspection plans are included (Figures 5 and 6). During the inspections, expansions of the program in steam generators A and C were accomplished as required by R.G. 1.83. Results of the inspection are discussed later in this report.

Regulatory Guide 1.83 Inspection
Program (Typical) - Inlet Leg

- FOR THOSE REG. GUIDE TUBES (X) RESTRICTED TO 720 or 700F, Gauge W/ 650 ϕ - IF RESTRICTED TO 650, Gauge (Thru Top Support) WITH 610 & 540 ϕ AS REQD. WHEN THE X TUBE IS IDENTIFIED AS BEING RESTRICTED TO 650 ϕ , box that tube in by doing the adjacent B tubes Thru 6" Support with 650 ϕ probe. Any found restricted must have adjacent tubes gauged w/ 650 (w/ 610 in) as well as that tube being gauged thru.

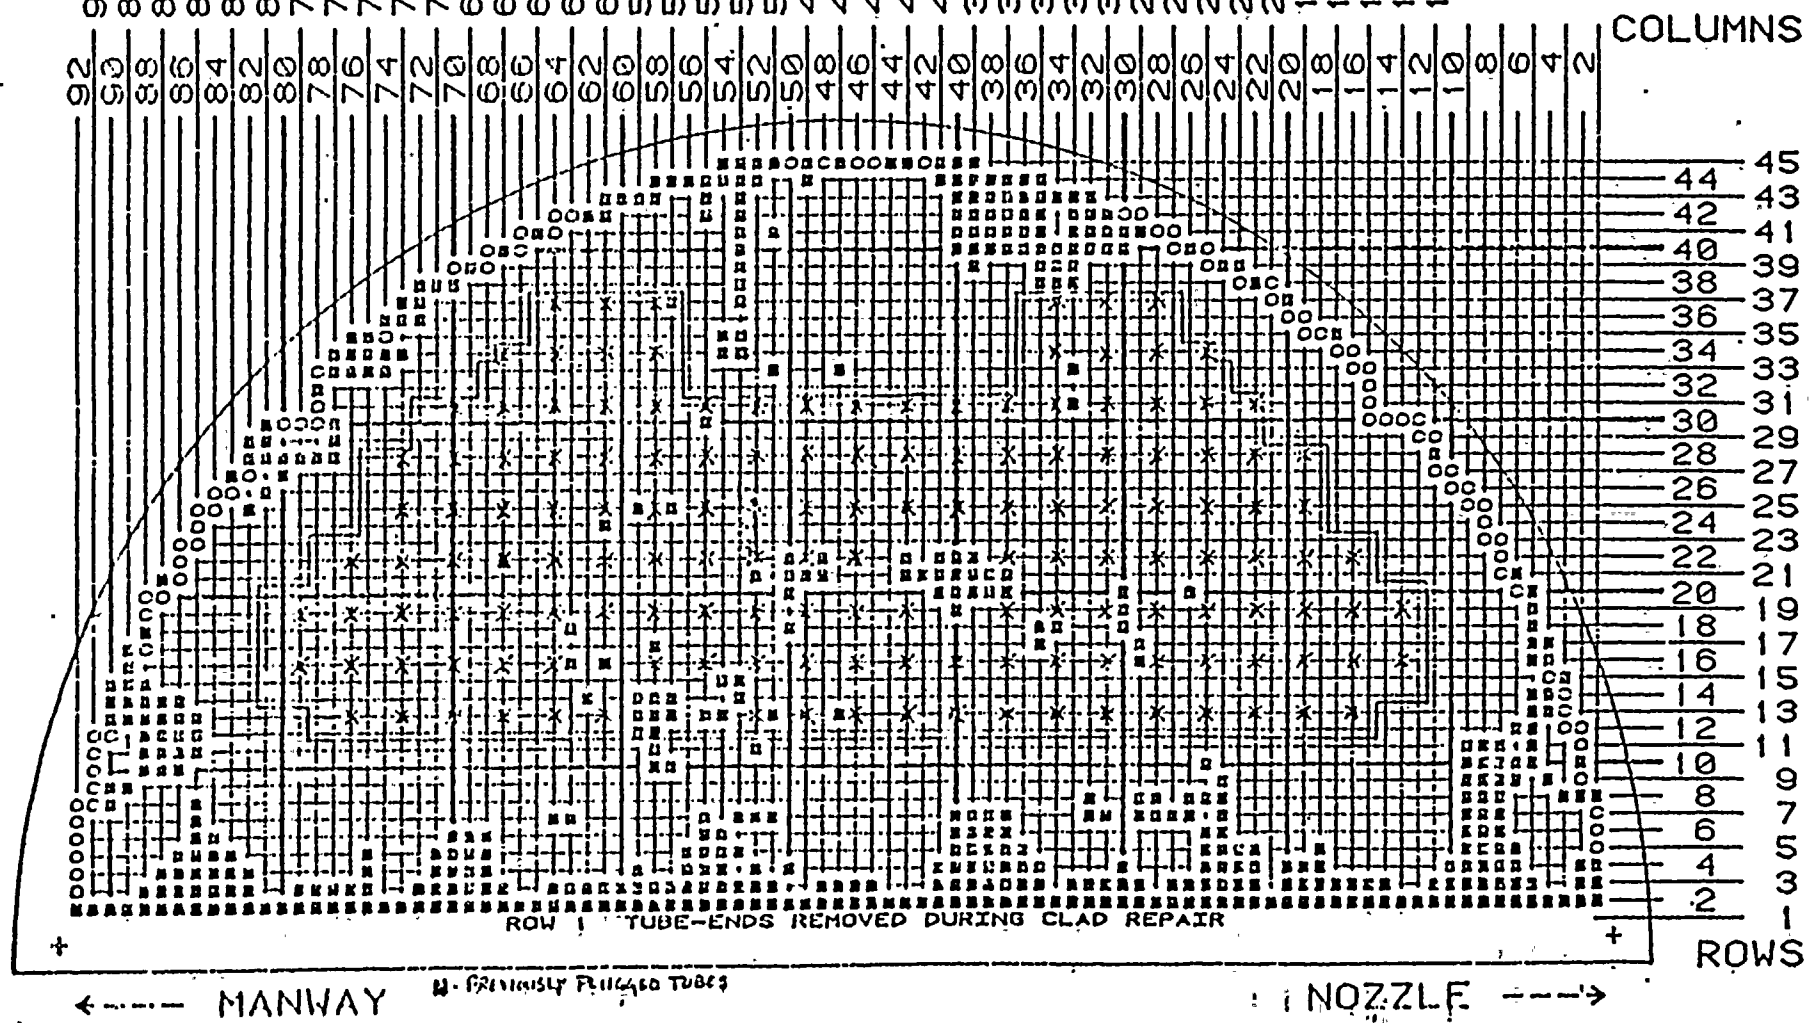
FIGURE 6

Regulatory Guide 1.83 Inspection
Program (Typical) - Outlet Leg

- REG. GUIDE - 1 - INSPECT 59 TUBES THRU 1ST SUPPORT W/ 726SF (726FAU) - IF ANY TUBES ARE FOUND TO BE restricted, Gauge w/ 610 ϕ probe to 6th support, Gauge adjacent tubes w/ 610, & any \geq 610 ϕ restrictions WITH 540 ϕ . CONTINUE ADJACENT TUBE 'BOX IN' UNTIL ALL ADJACENT TUBES PASS 610 ϕ RESTRICTIONS WITH 540 ϕ . CONTINUE LISTING SHEET EXTENT COLUMN BY 'RA' AND EXTENT
