SUBJECT: Forwards results of steam generator insps conducted during
 Nov 1981 outage. Insp revealed no new phenomena & verified
 general pattern of denting is within predictable limits.
 Return to power presents no unresolved safety question.

Re: Turkey Point Unit 4
Docket No. 50-251
Steam Generator Inspections

TURKEY POINT 4 STEAM GENERATOR
INSPECTION PROGRAM

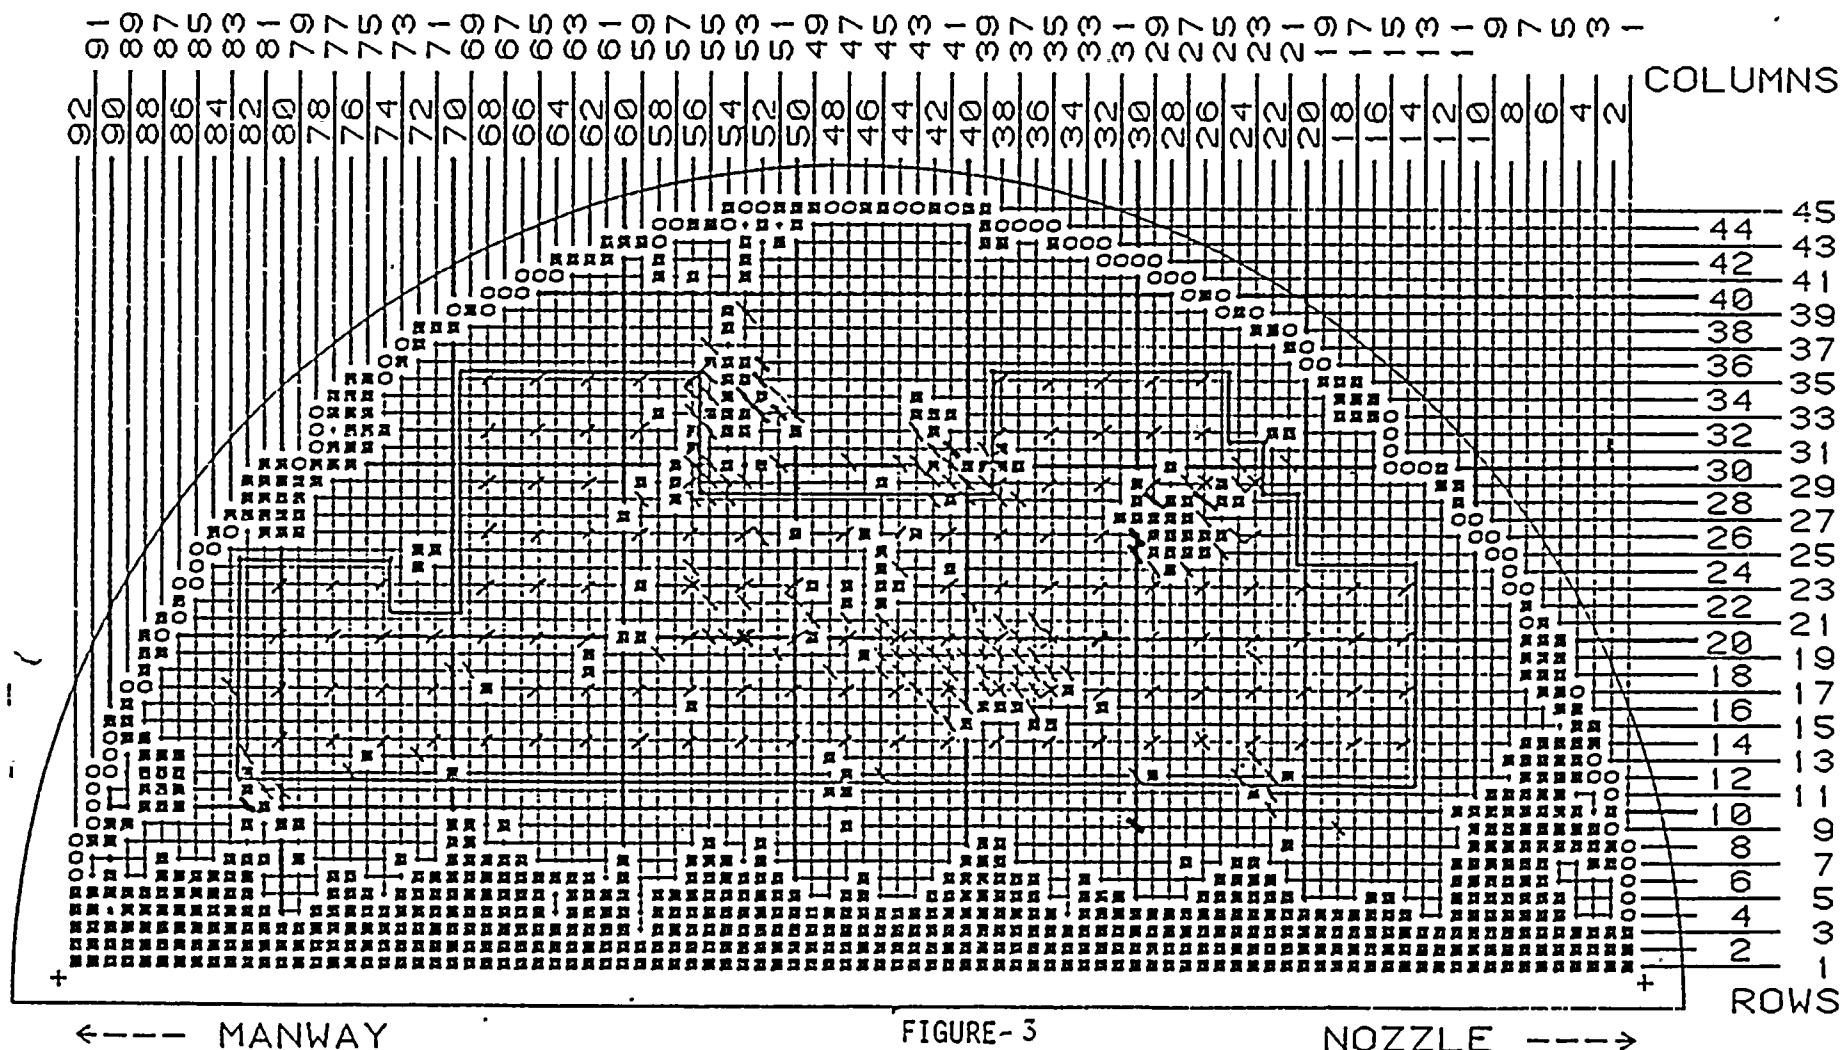
FIGURE- 3
INSPECTION PROGRAM-NOV., 1980
TURKEY POINT UNIT #4
STEAM GENERATOR B
INLET

CAUSING TO BE PERFORMED 1159 TUBES ON TENSION BOUNDARY AREA TO TOP SUPPORT
-.650, .610, .540 PROBS -

- REG. GUIDE INSPECT 219 TUBES THRU 1/2 INCH W 720 1/2 (700F) GAUGE ANY RESTRICTED TUBES WITH .610E PASSAGE DURING GAUGING PROGRAM

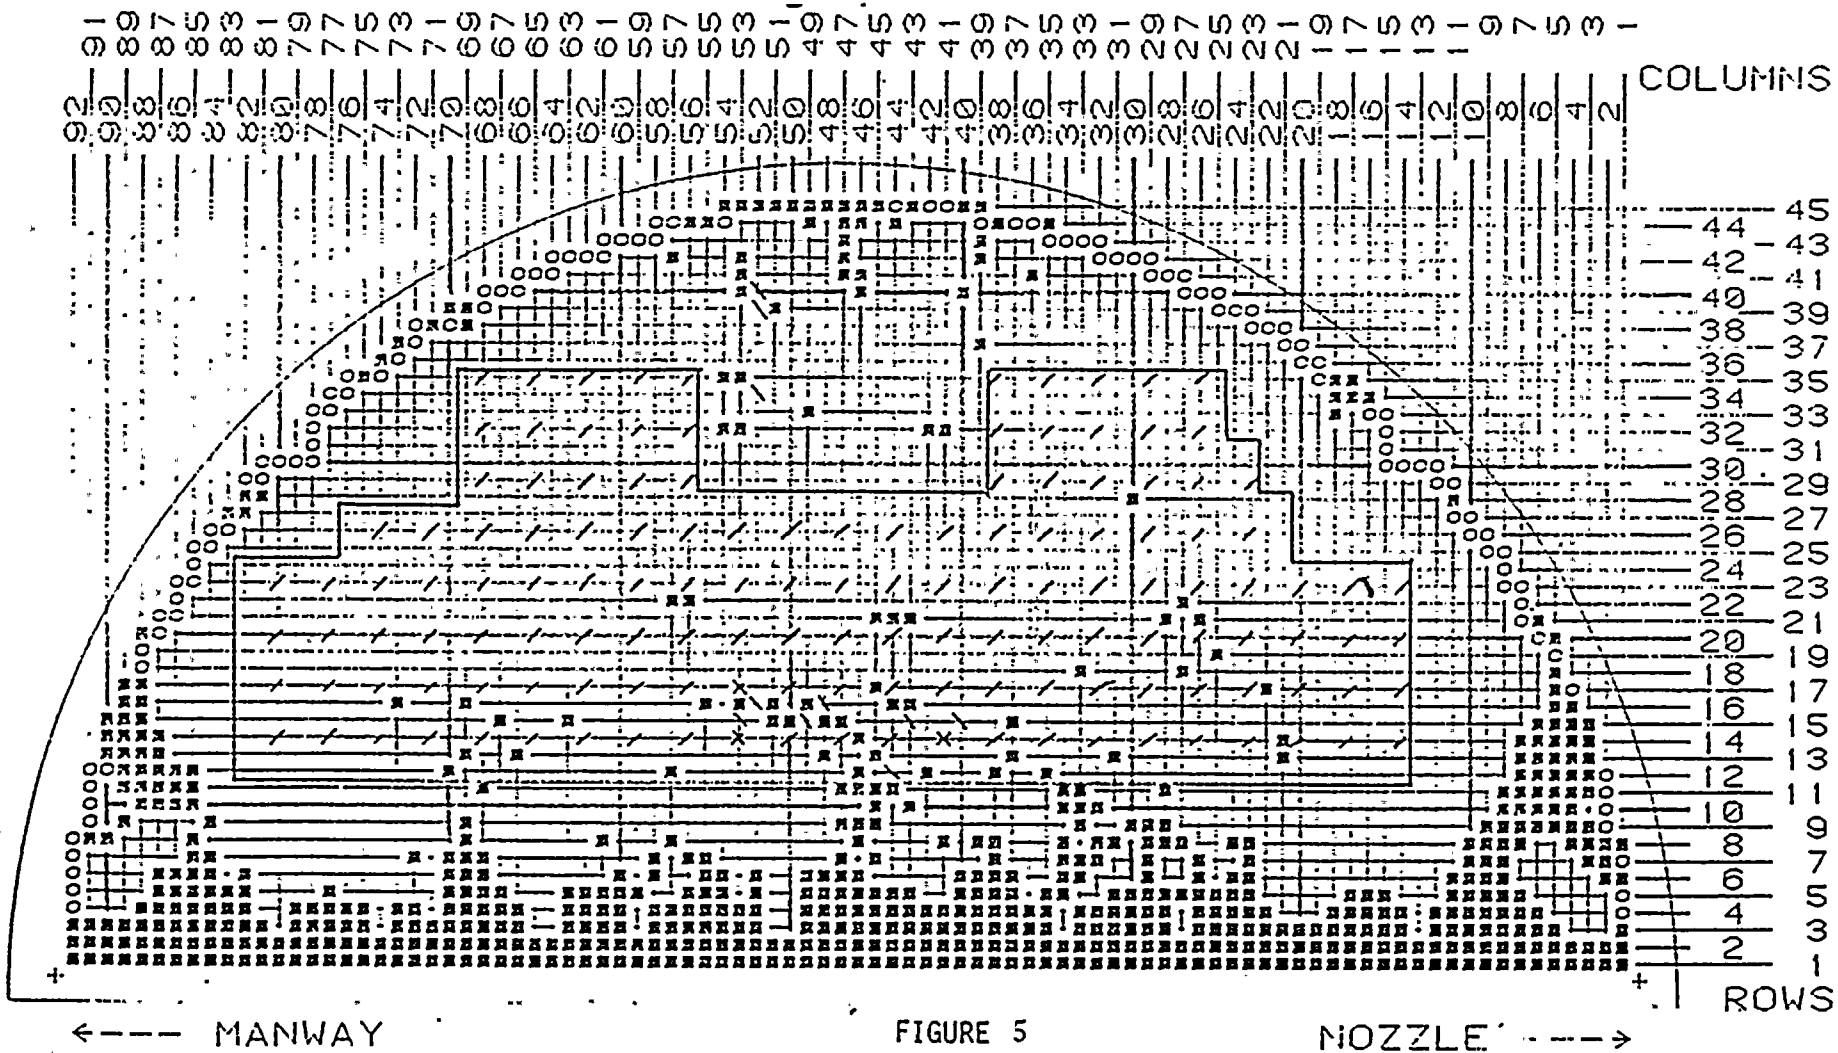
FIGURE 5
 INSPECTION PROGRAM-NOV., 1980
 TURKEY POINT UNIT #4
 STEAM GENERATOR C
 INLET

REG. CODE INSPECT 3rd TUBES THRU 1st SUPPORT W/ LOSS (ALT 2015) GAUGE ANY RESTRICTED
TUBE WITH .610 & PAUSE DURING GAUGING PROGRAM

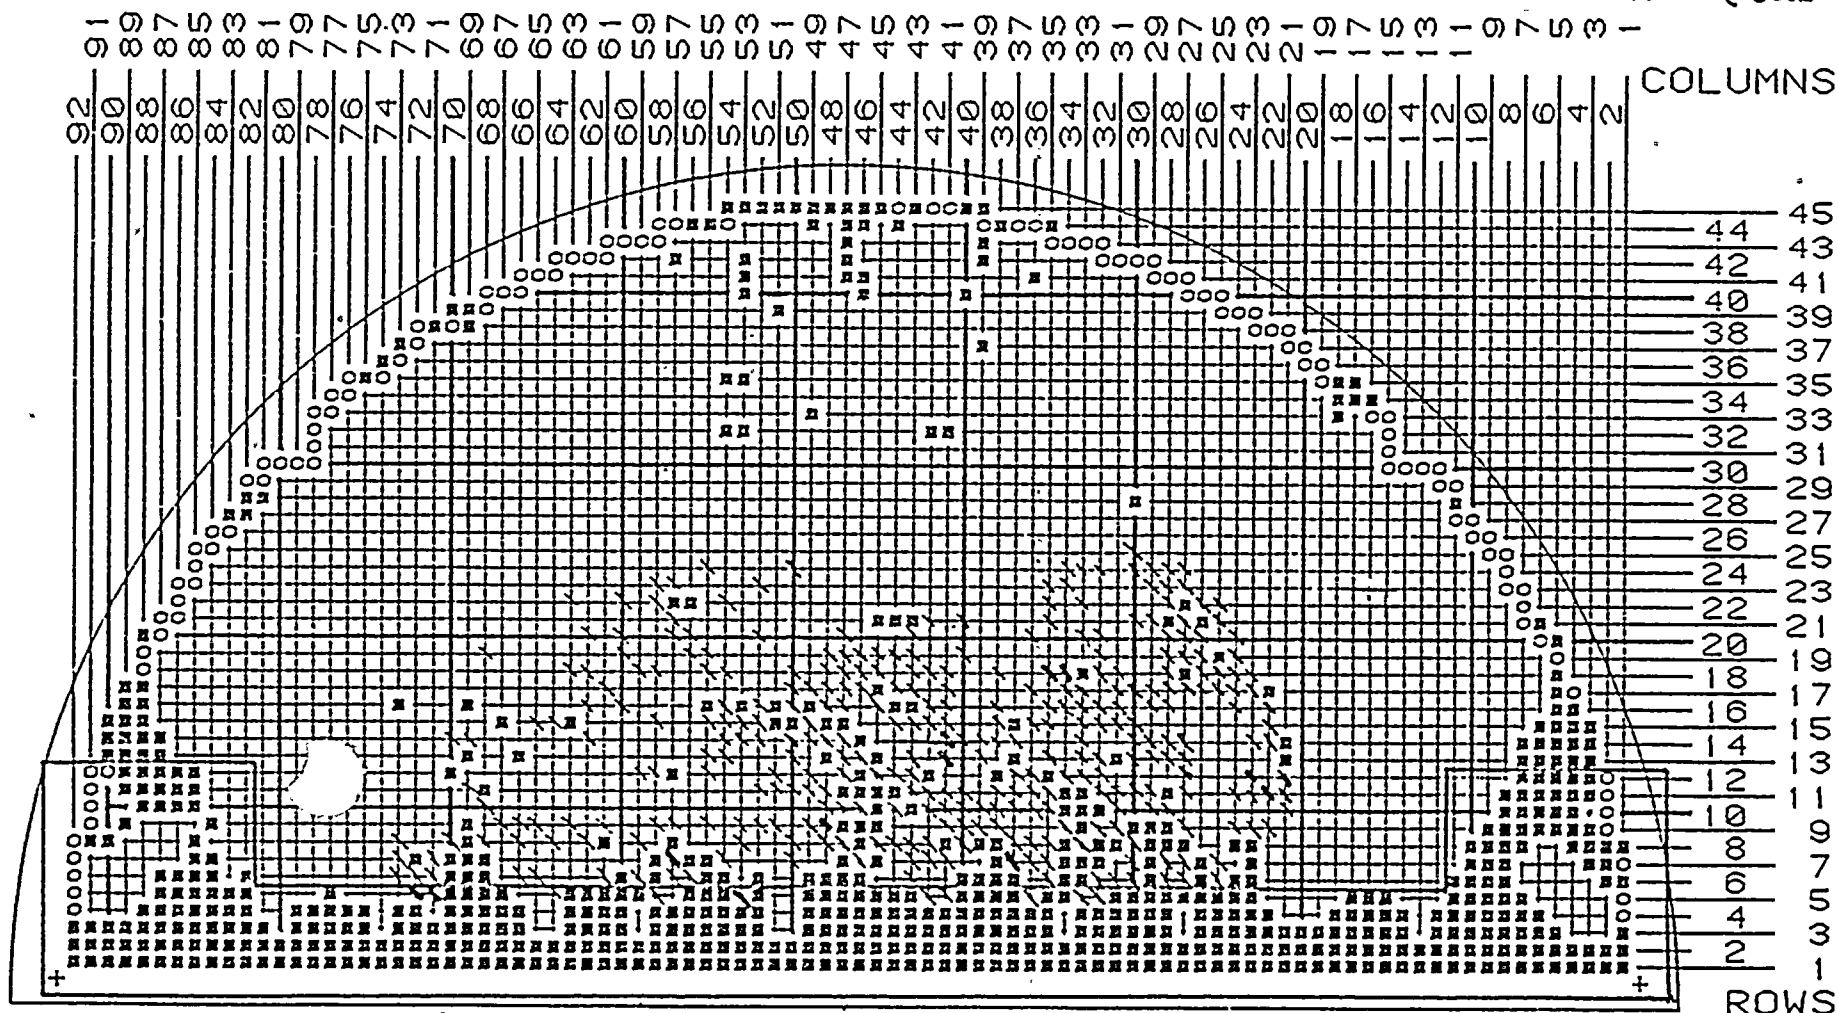
FIGURE 6

LI-BEND TESTING ALL TUBES ROWS 1-5 / COLUMNS 1-12 .610 BF

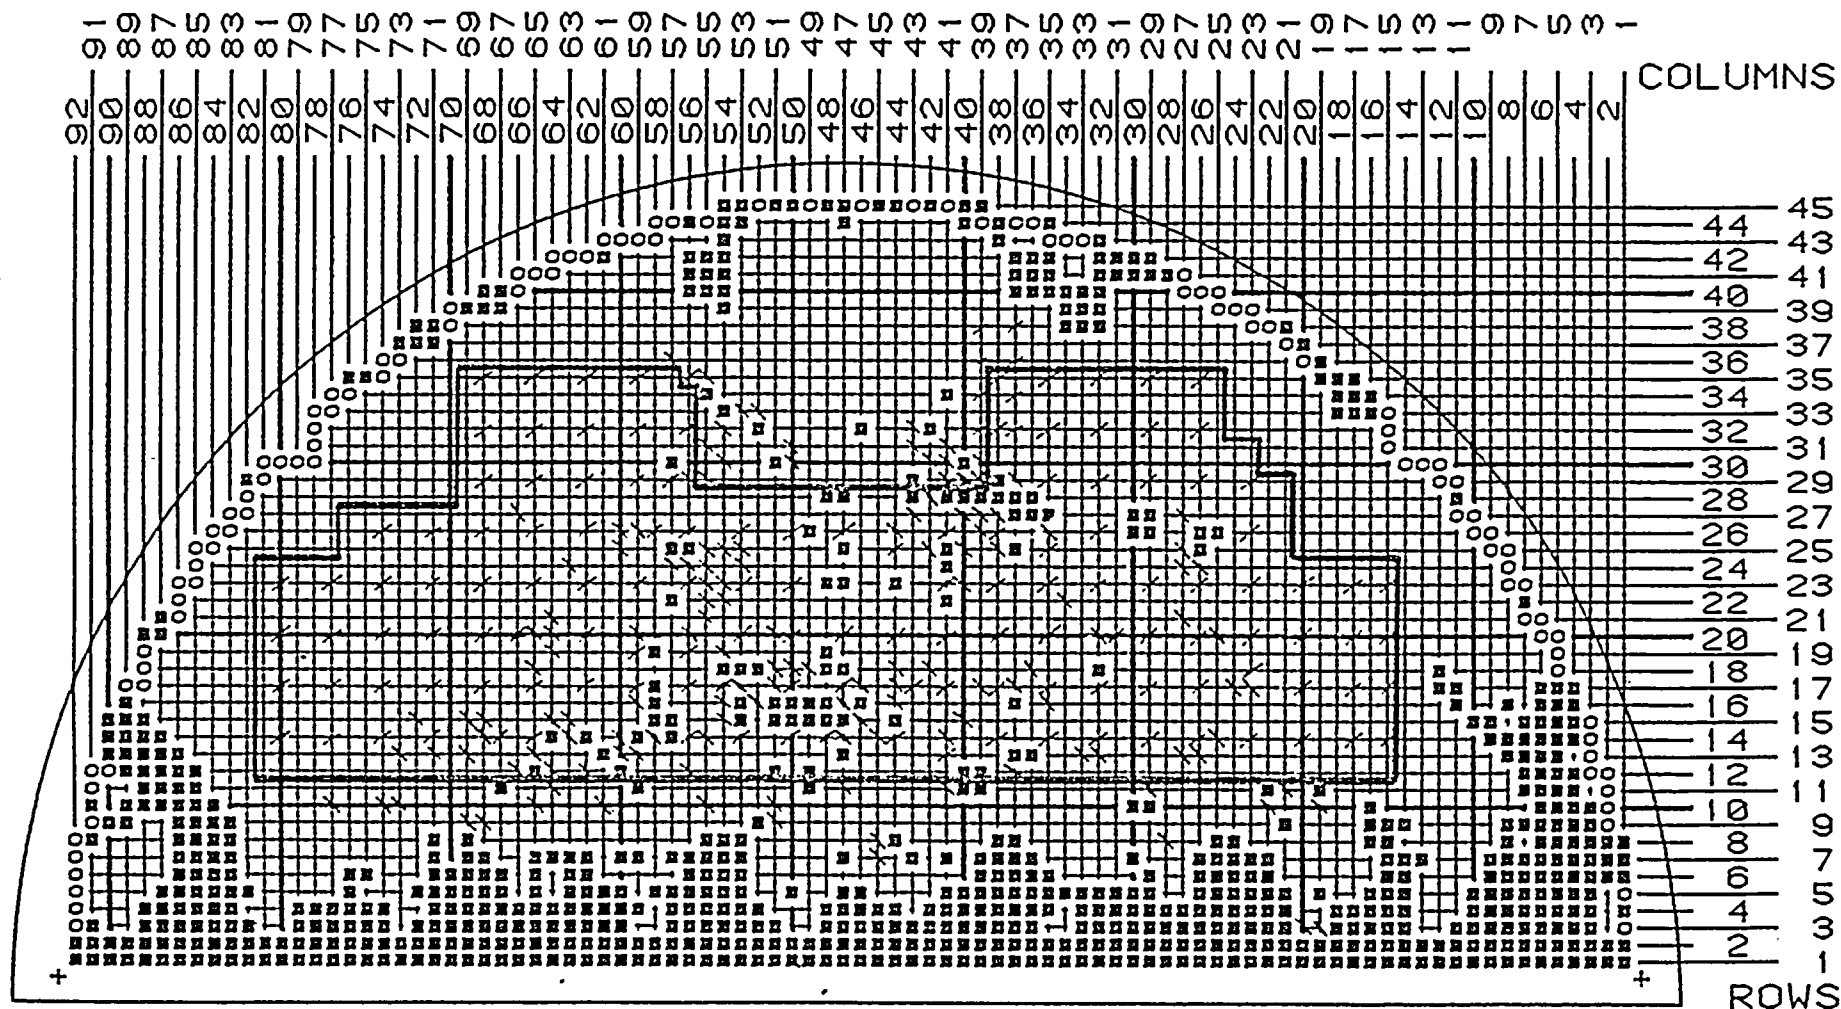
TURKEY POINT UNIT #4
STEAM GENERATOR A - INLET
OCTOBER, NOVEMBER, 1981
INSPECTION PROGRAM

4. In steam generator A inlet, 2 tube restrictions appeared away from the pattern of prior inspection results. Both were restricted to passage of the 0.650" probe and passed the next smallest (.610" probe). One of these 0.650" restrictions was located in tube R23-C15 which is located between the 2 o'clock and 3 o'clock wedge regions and may be related to an interactive effect between these regions. The other 0.650" restriction reported away from the previously observed results is in tube R23-C41, located near the center of the tube bundle.

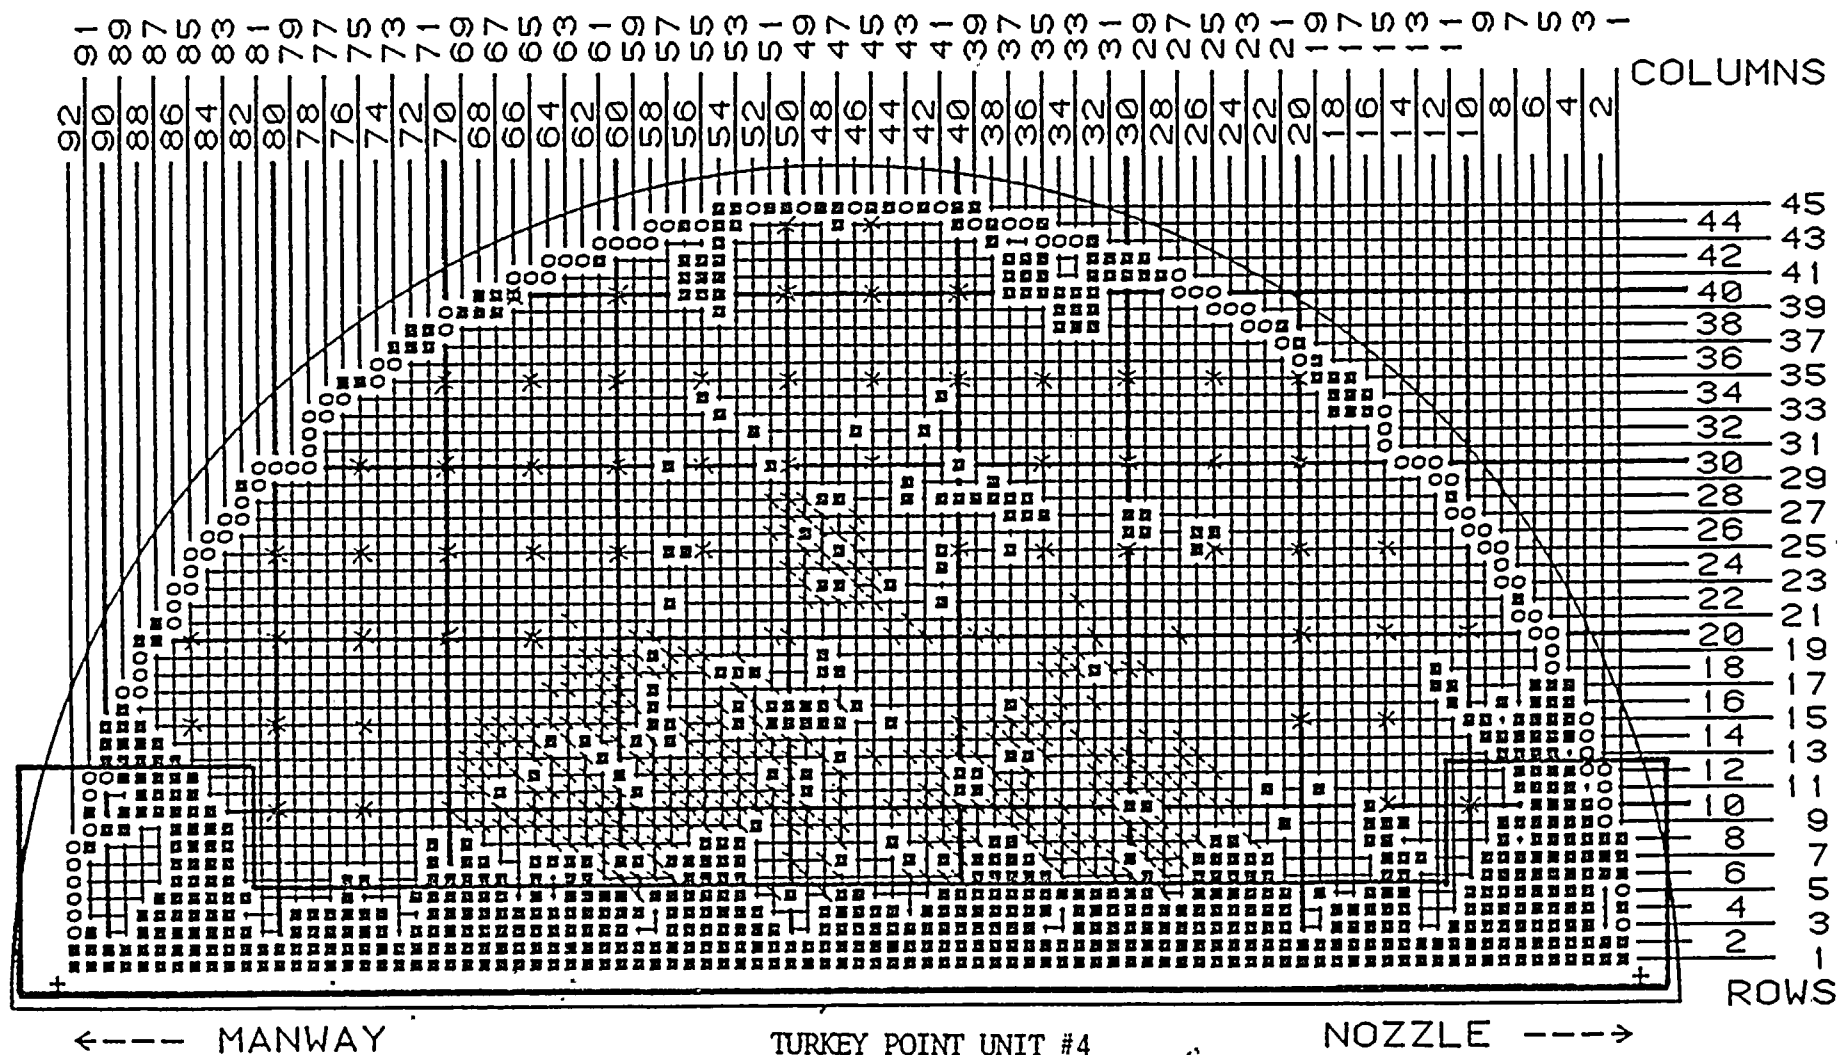
FIGURE 10

The U-bends of unplugged tubes in rows 3 thru 5 in steam generator A outlet were examined at 100 kHz. No indications were noted in these small radius U-bends.
