REPORT OF STEAM GENERATOR INSPECTION AND TUBE REPAIR

TURKEY POINT UNIT 4

JULY 1982 OUTAGE

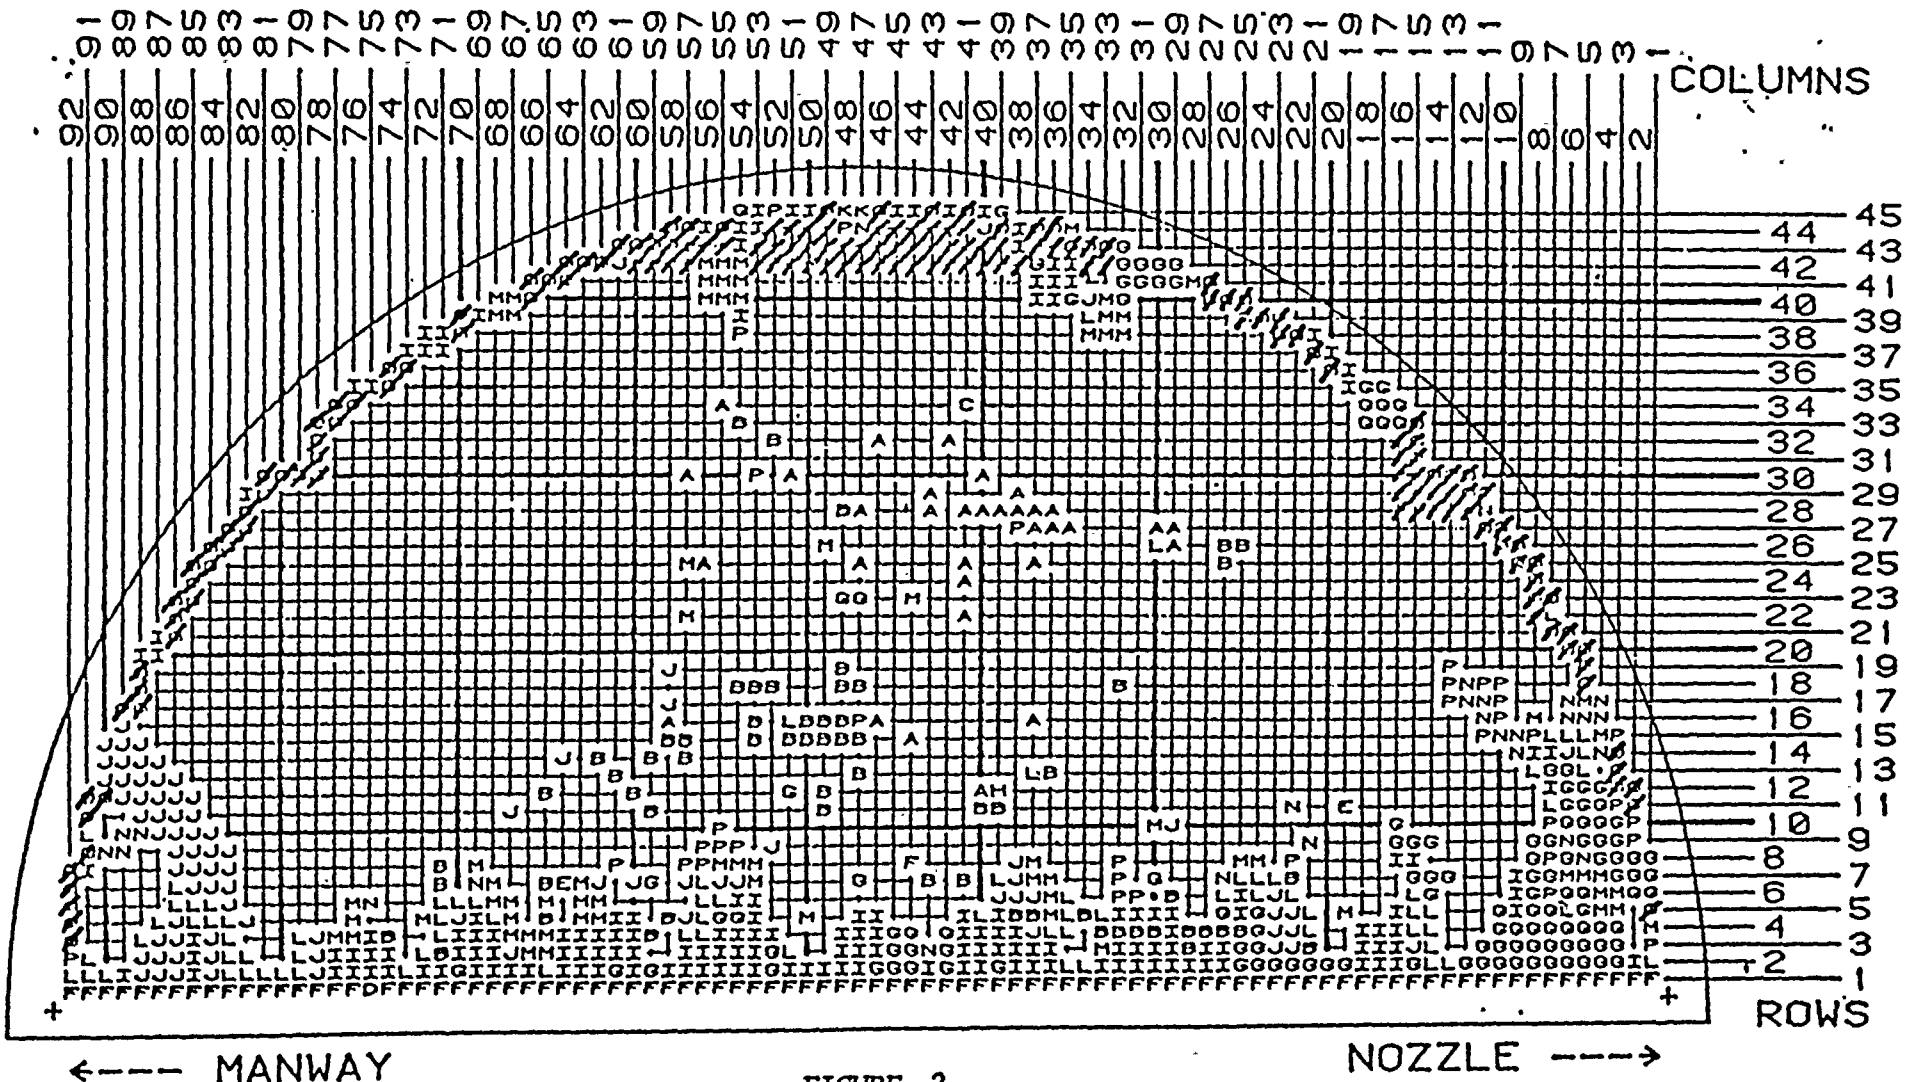
FLA-A

33 9/74, TUBES PLUGGED
03 6/75, TUBES PLUGGED
1 DATE NOT KNOWN, TUBES PLUGGED
1 SHOP WELD
2 5/76, TUBES PLUGGED
02 11/78, TUBES PLUGGED
131 7/77, TUBES PLUGGED
1 7/77, WELD REPAIR HL, E/P CL
