# 2017 Annual Site Inspection and Monitoring Report for Uranium Mill Tailings Radiation Control Act Title II Disposal Sites

December 2017

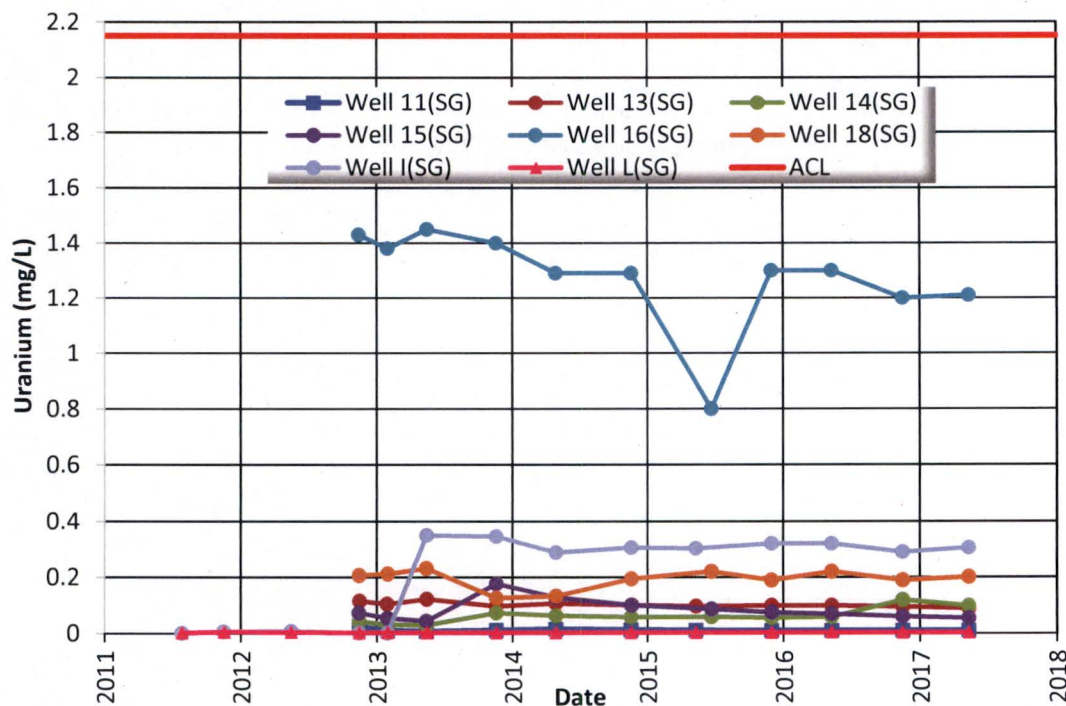
Figure 1-5. Uranium Concentrations in the San Andres/Glorieta Aquifer  
at the Bluewater, New Mexico, Disposal Site

Uranium concentrations in the San Andres/Glorieta aquifer are shown in Figure 1-5. Uranium concentrations in well I(SG) before 2013 are not shown because they were erroneously low due to an incorrect sampling depth in the well. Uranium concentrations at POC wells OBS-3 and S(SG) are not shown in Figure 1-5 because the well screens are encrusted with iron scale that has resulted in erroneously low uranium concentrations since DOE began sampling the wells.

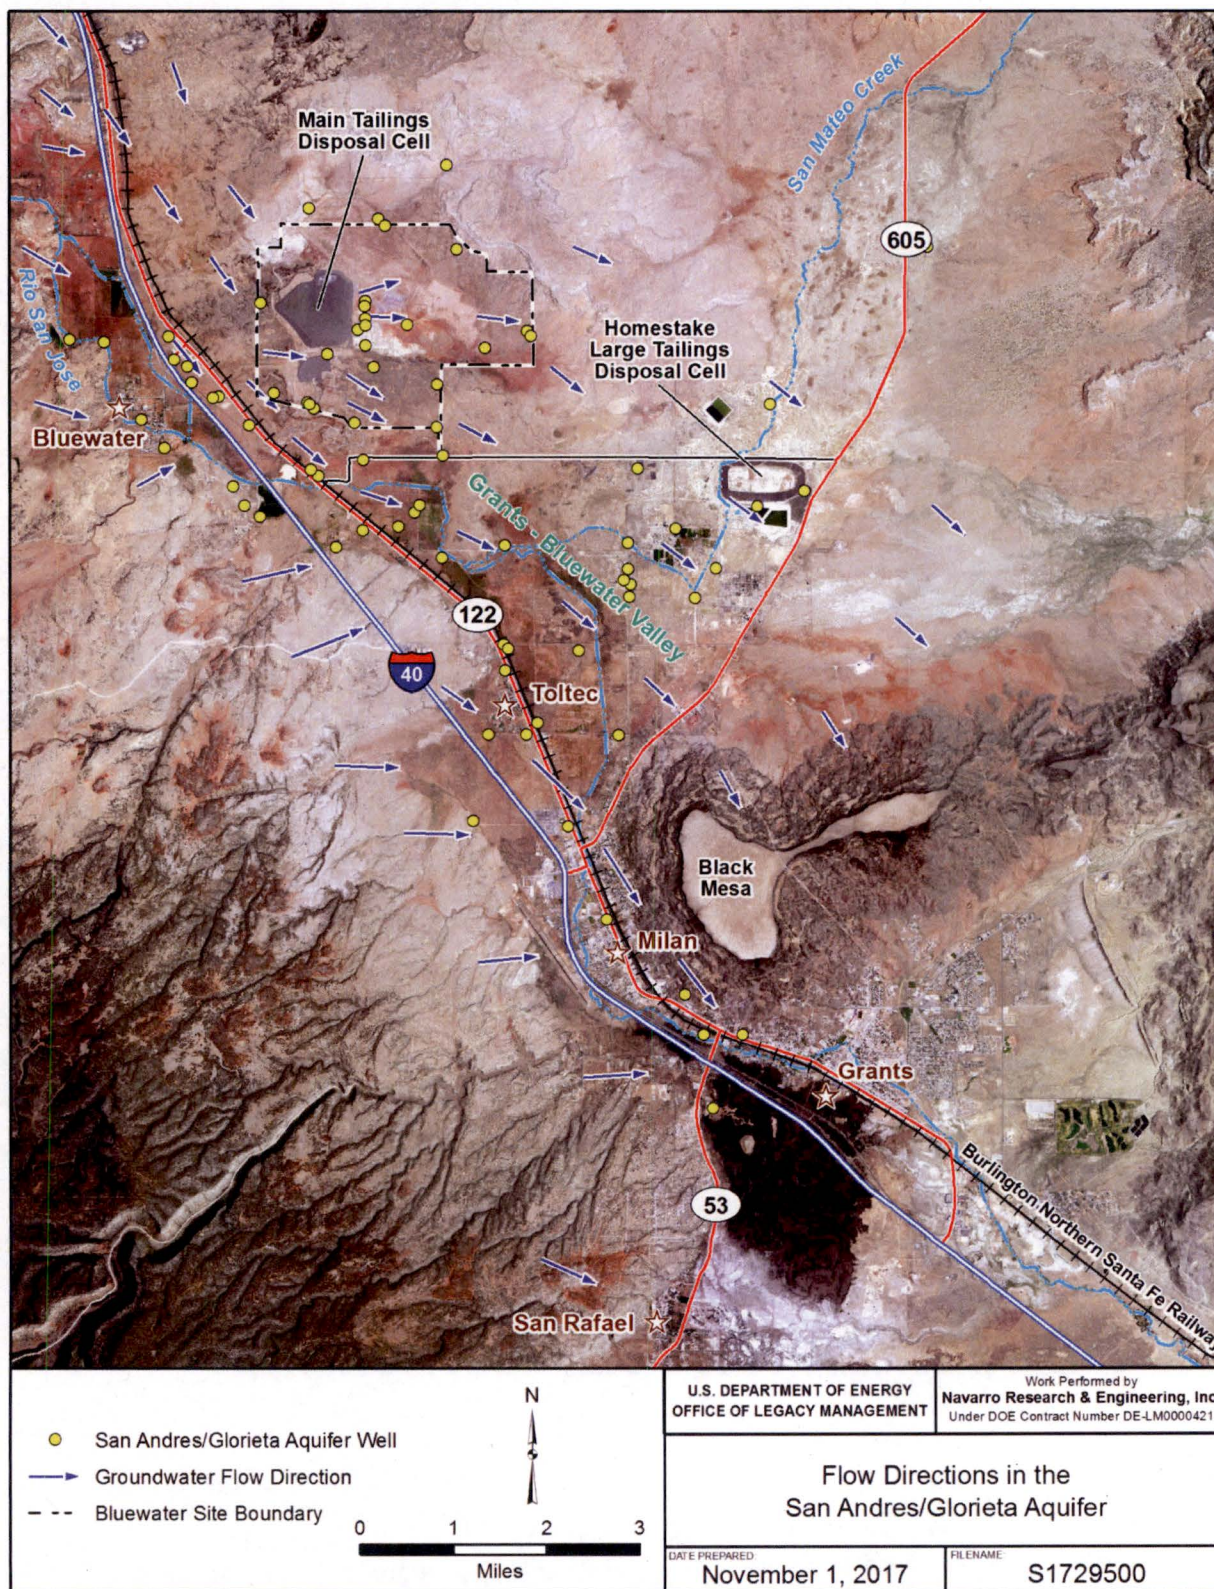
Figure 1-6. Groundwater Flow Directions in the San Andres/Glorieta Aquifer at the Bluewater, New Mexico, Disposal Site

The extent of uranium contamination in the San Andres/Glorieta aquifer and the potential risk to downgradient groundwater users was evaluated in DOE's groundwater conceptual model (DOE 2014). Evaluation of previous groundwater studies in the region and available groundwater data indicated that the flow path of the groundwater in the aquifer from the site is to the east-southeast. The groundwater from the site passes under the Homestake mill site and turns south toward Grants due to the influence of a major fault that passes under Grants (San Rafael Fault). The flow path from the site is substantially north of the Milan municipal wells (Figure 1-6).

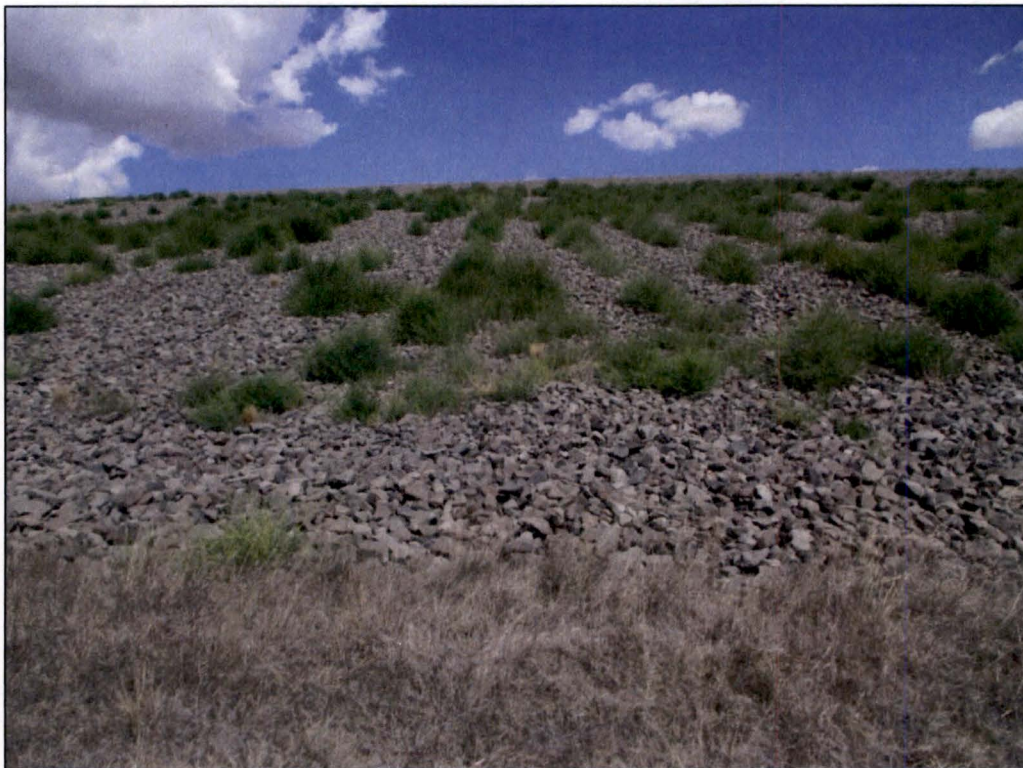
Plant encroachment (annual weeds, perennial grasses and forbs, and scattered perennial shrubs) continues on the main tailings disposal cell top and side slopes (PL-5). Siberian elm saplings on the top slope are managed to prevent the establishment of trees that could damage the main tailings disposal cell cover materials; none were observed during the inspection.

*PL-5. Vegetation on South Side Slope of Main Tailings Disposal Cell*

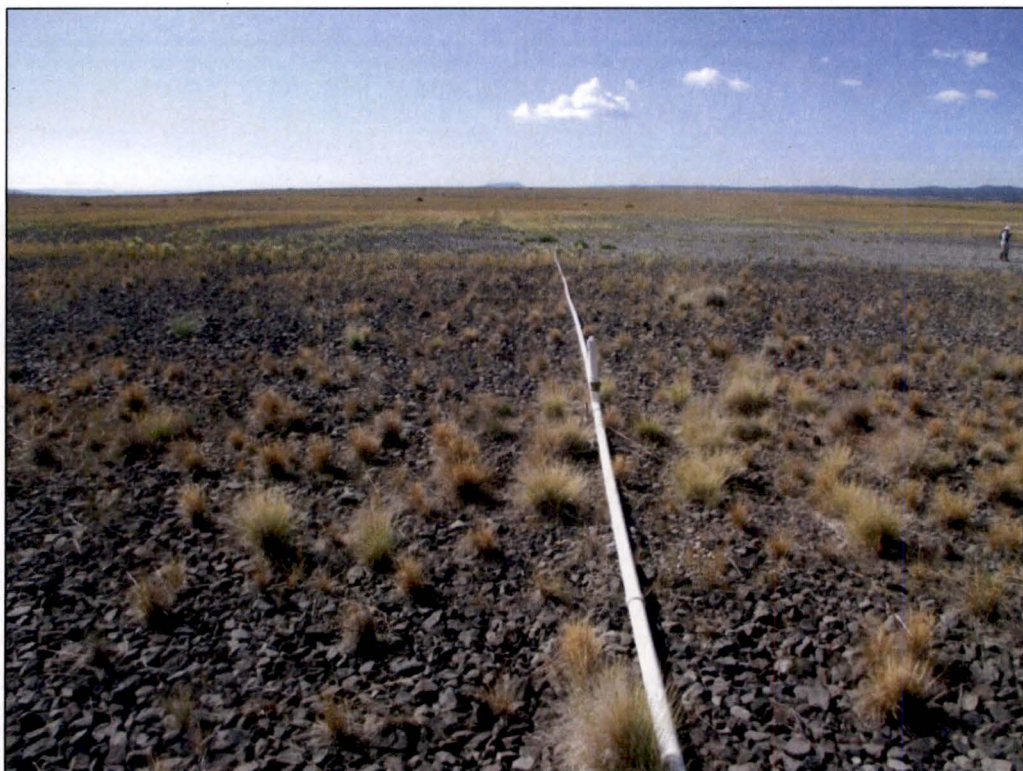
*PL-6. Siphon on Main Tailings Disposal Cell Top Slope*

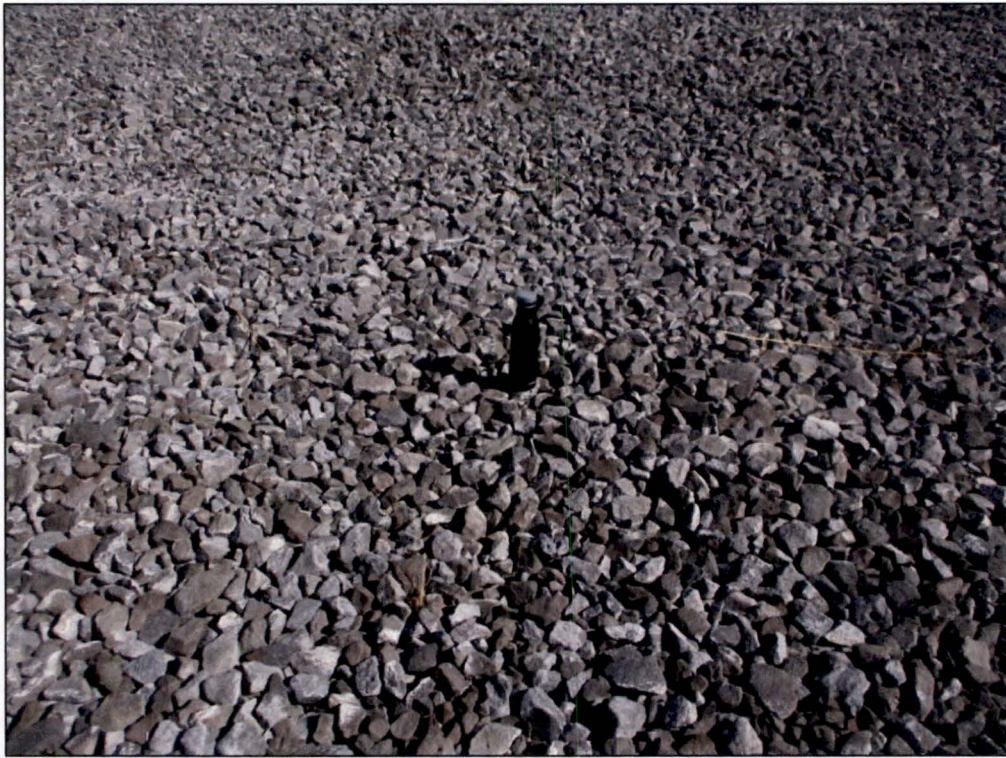
*PL-7. Reclaimed Test Pit 1A on Main Tailings Disposal Cell Top Slope (Water Bottle Provided for Scale)*

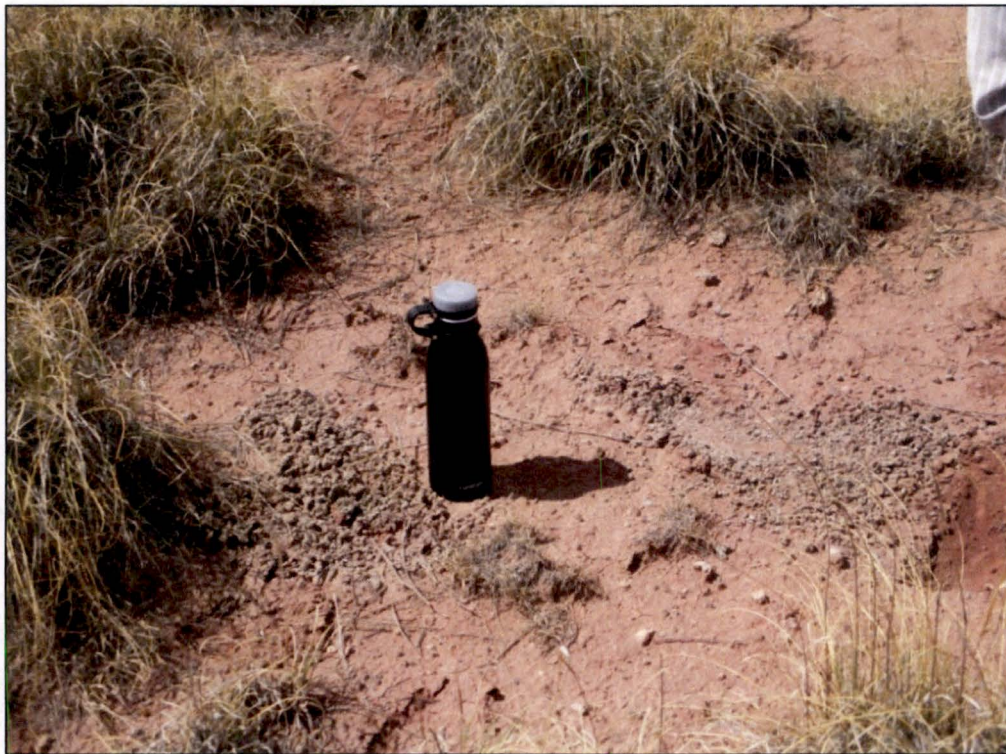
*PL-8. Reclaimed Test Pit 9A on Acid Tailings Disposal Area of Main Tailings Disposal Cell (Water Bottle Provided for Scale)*

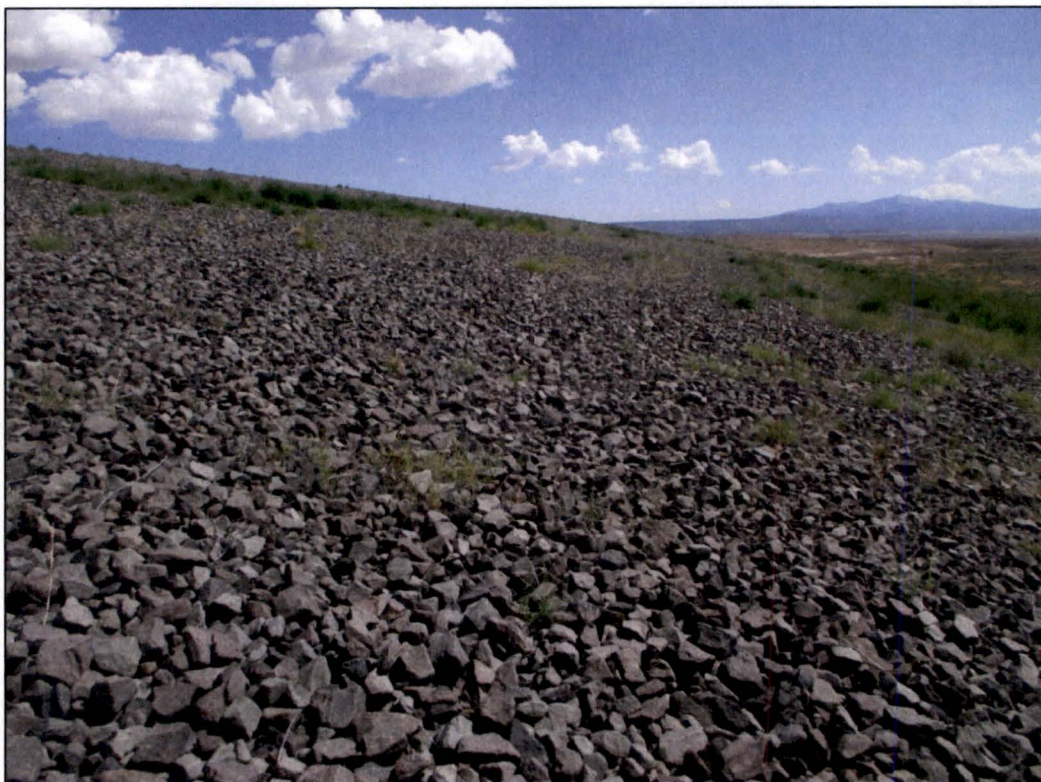
The side slopes and toe of the main tailings disposal cell were inspected for signs of erosion or sediment deposition. No abnormal irregularities were observed on the side slopes (PL-9), and no sediment deposits were present along the toe. No maintenance needs for the side slopes or acid tailings and south bench disposal areas were identified.

*PL-9. South Side Slope of Main Tailings Disposal Cell*

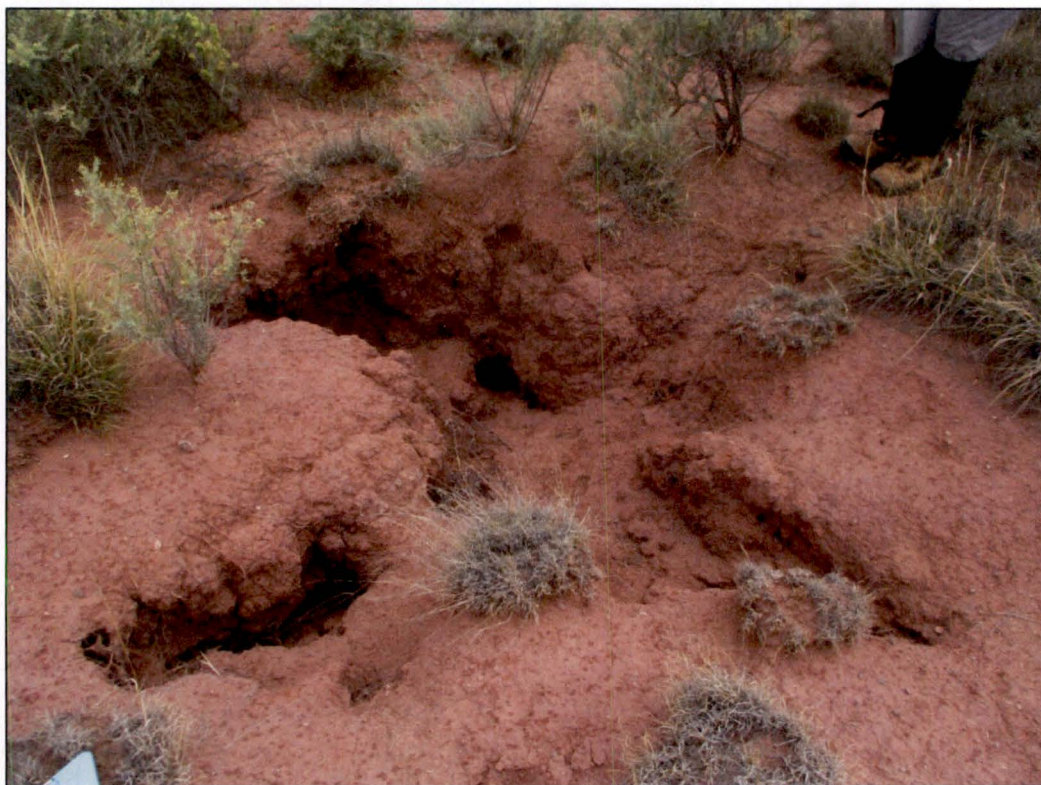
*PL-16. Settlement on Soil Cover of Disposal Area 1*

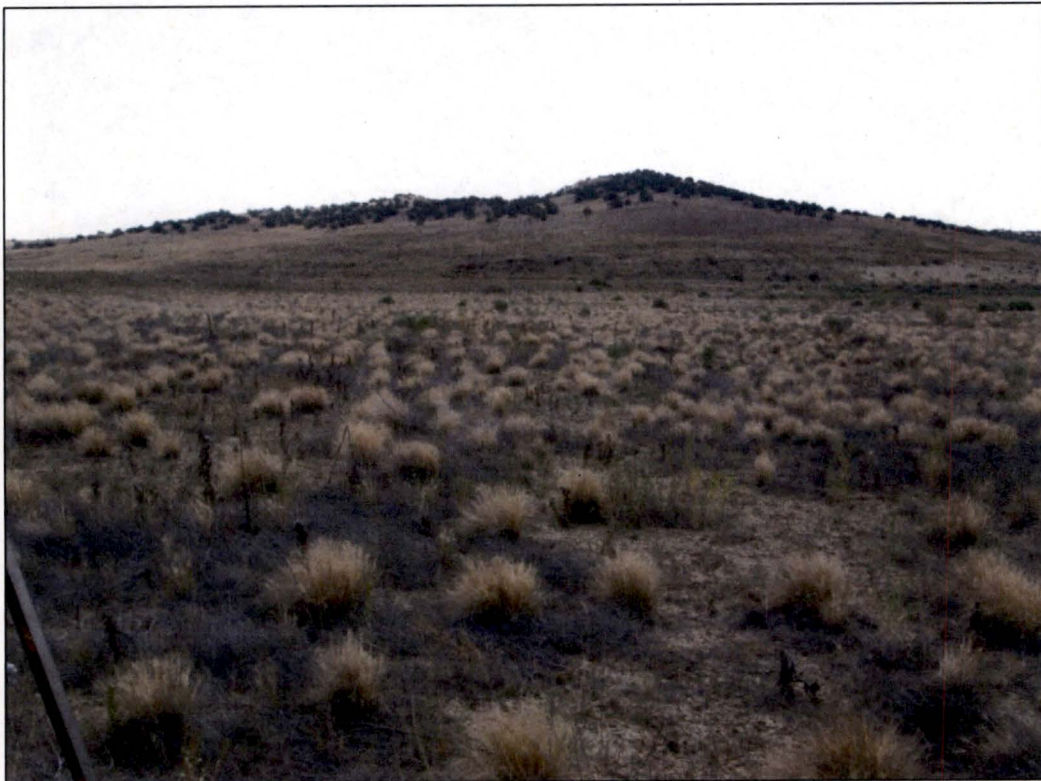
*PL-7. Southeast Portion of Disposal Cell Top Slope Seeded in 2009*

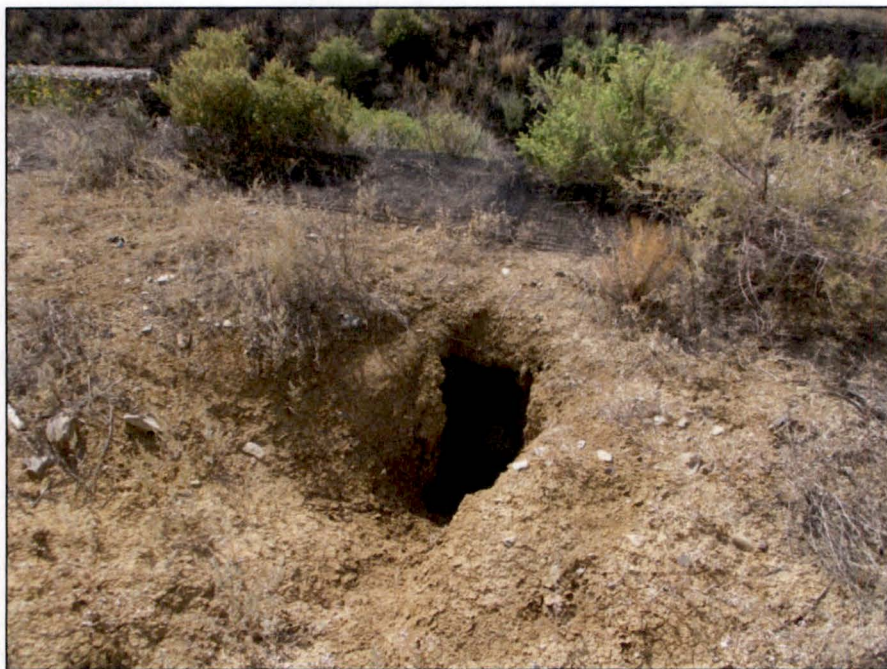
*PL-11. Soil Piping Along Runoff Control Structure A Channel*

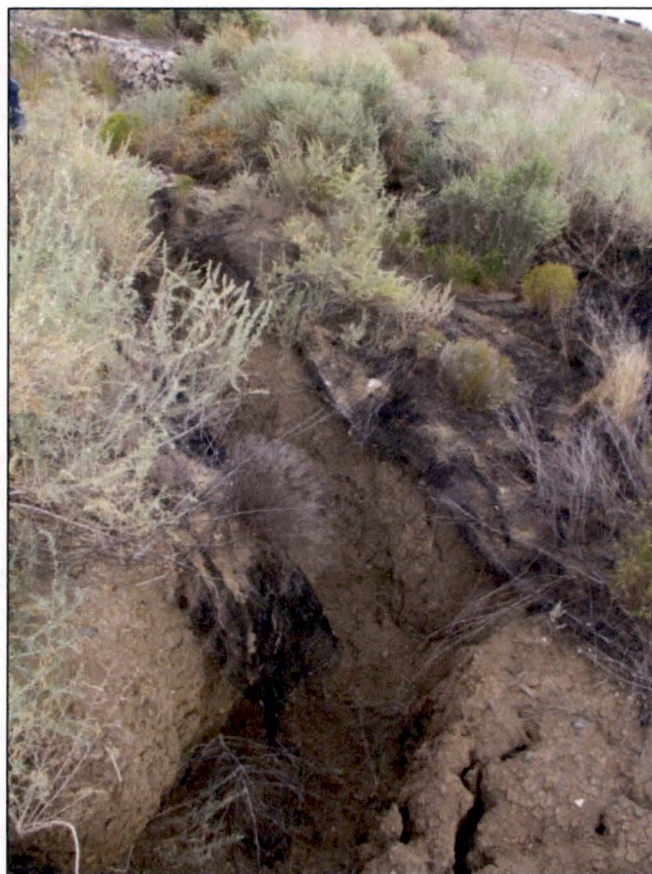
*PL-12. Gully Below Runoff Control Structure D*

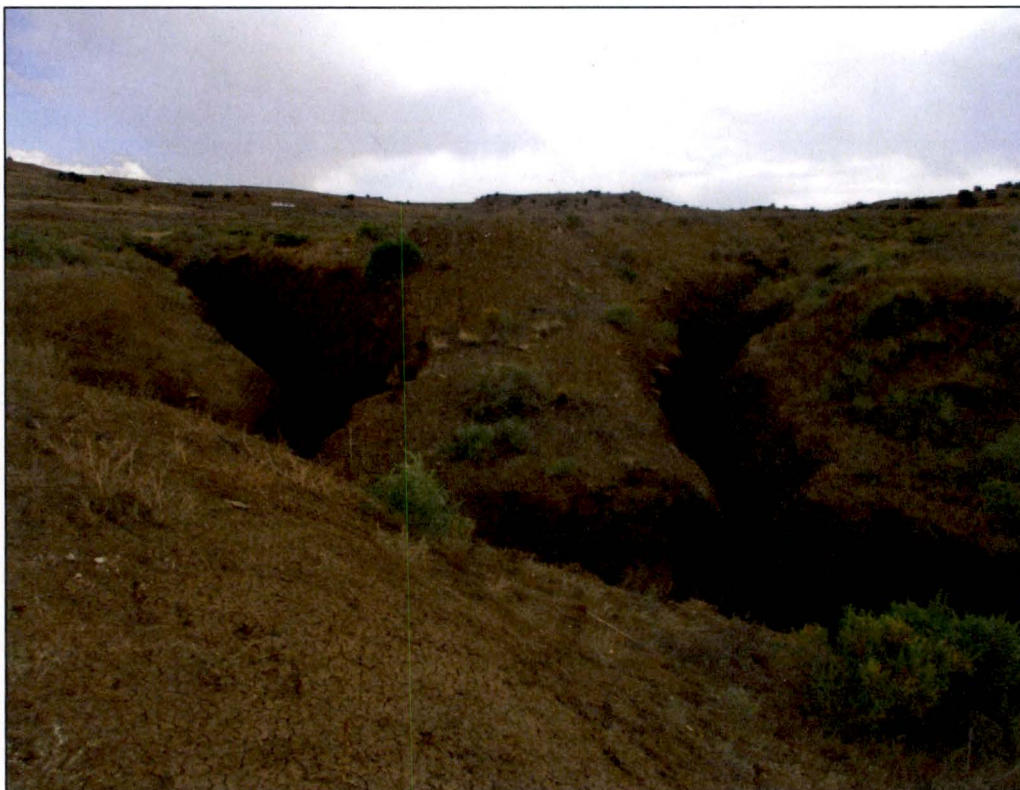
*PL-13. Gullies Upgradient of Sediment Trap*

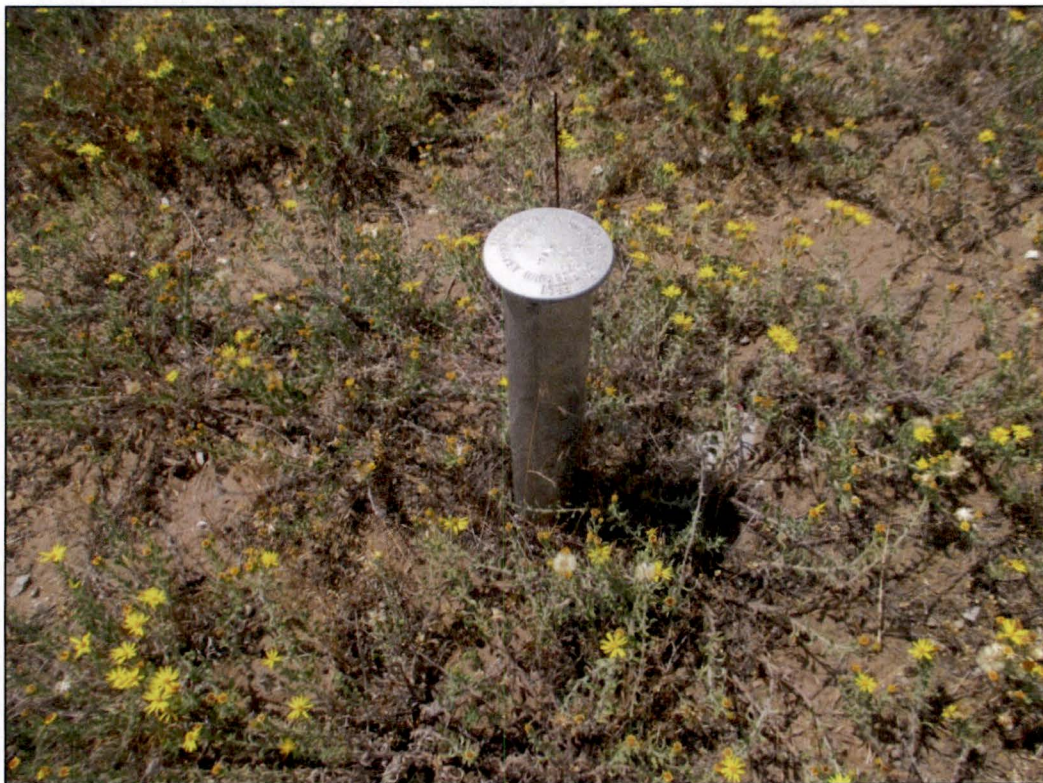
*PL-6. Boundary Monument BM-2*

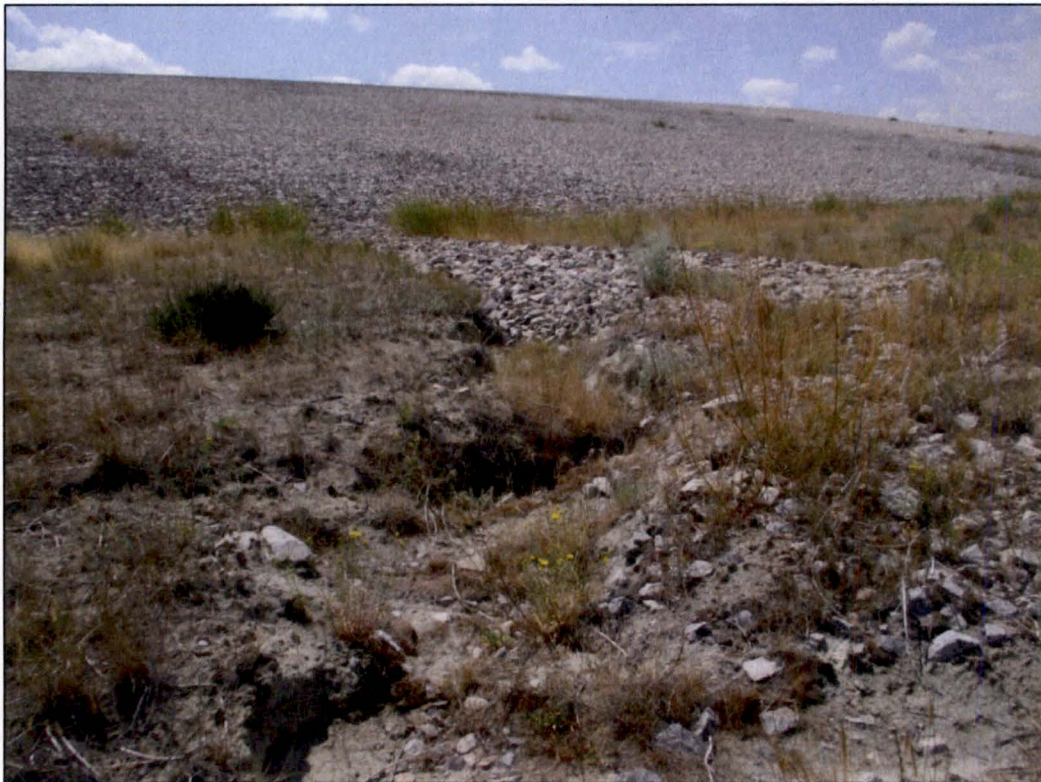
*PL-11. Erosion Downslope of Disposal Cell Toe Drain*

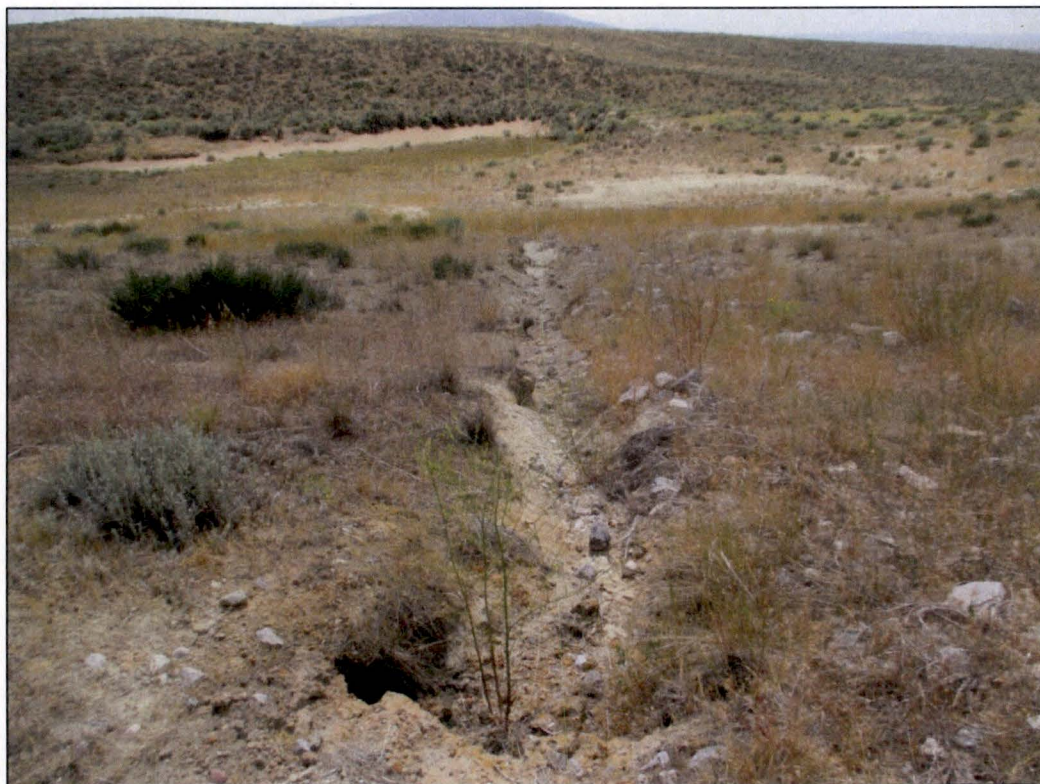
*PL-18. Erosion Downslope of Disposal Cell*

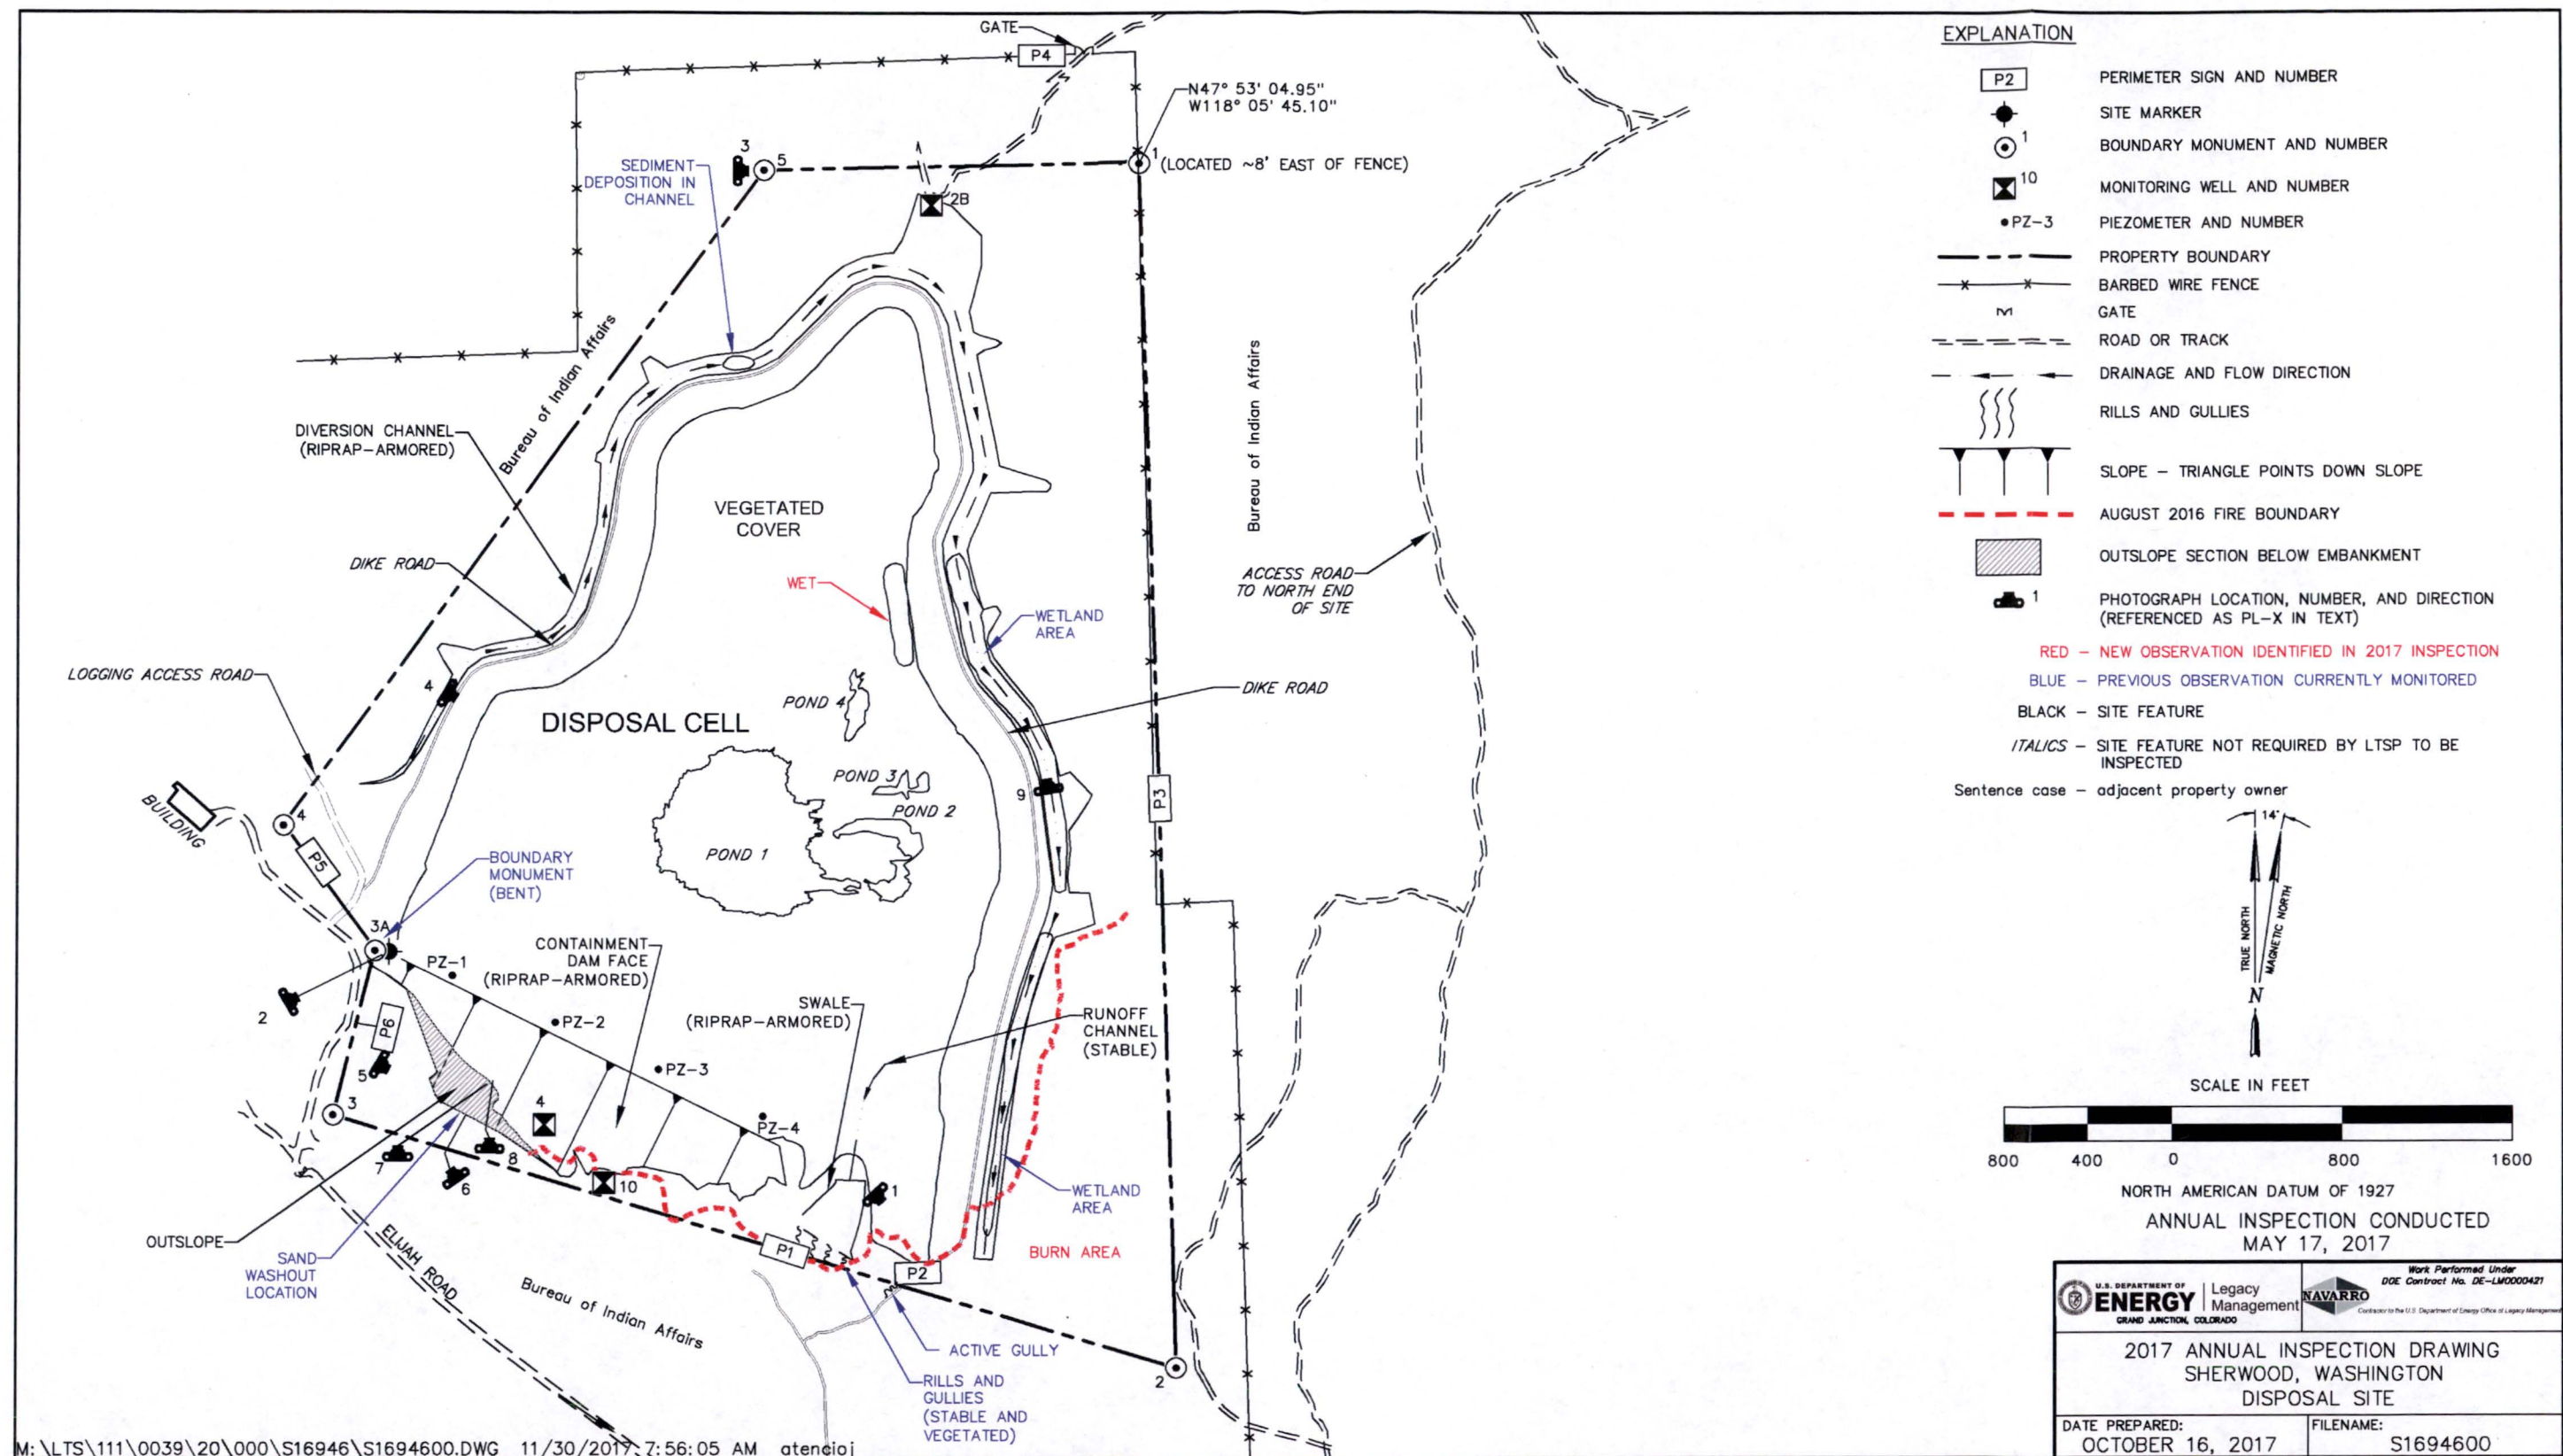
Figure 5-1. 2017 Annual Inspection Drawing for the Sherwood, Washington, Disposal Site

Figure 5-1 shows the locations of site features in black, including site surveillance features and inspection areas. Site features that are present but not required by the LTSP to be inspected are shown in italic font. Observations from previous inspections that are currently monitored are shown in blue text, and new observations identified in the 2017 inspection are shown in red. Inspection results and recommended maintenance activities associated with site surveillance features are included in the following subsections. Photographs to support specific observations are identified in the text and in Figure 5-1 by photograph location (PL) numbers. The photographs and photograph log are presented in Section 5.9.

In late August 2016, the 18,000-acre Cayuse Mountain Fire occurred near the site. A follow-up inspection (detailed in the 2016 Title II Annual Compliance Report) confirmed that the fire had burned a corner of the site south and east of the disposal cell (Figure 5-1) and posed no risk to the disposal cell. No maintenance needs were identified.

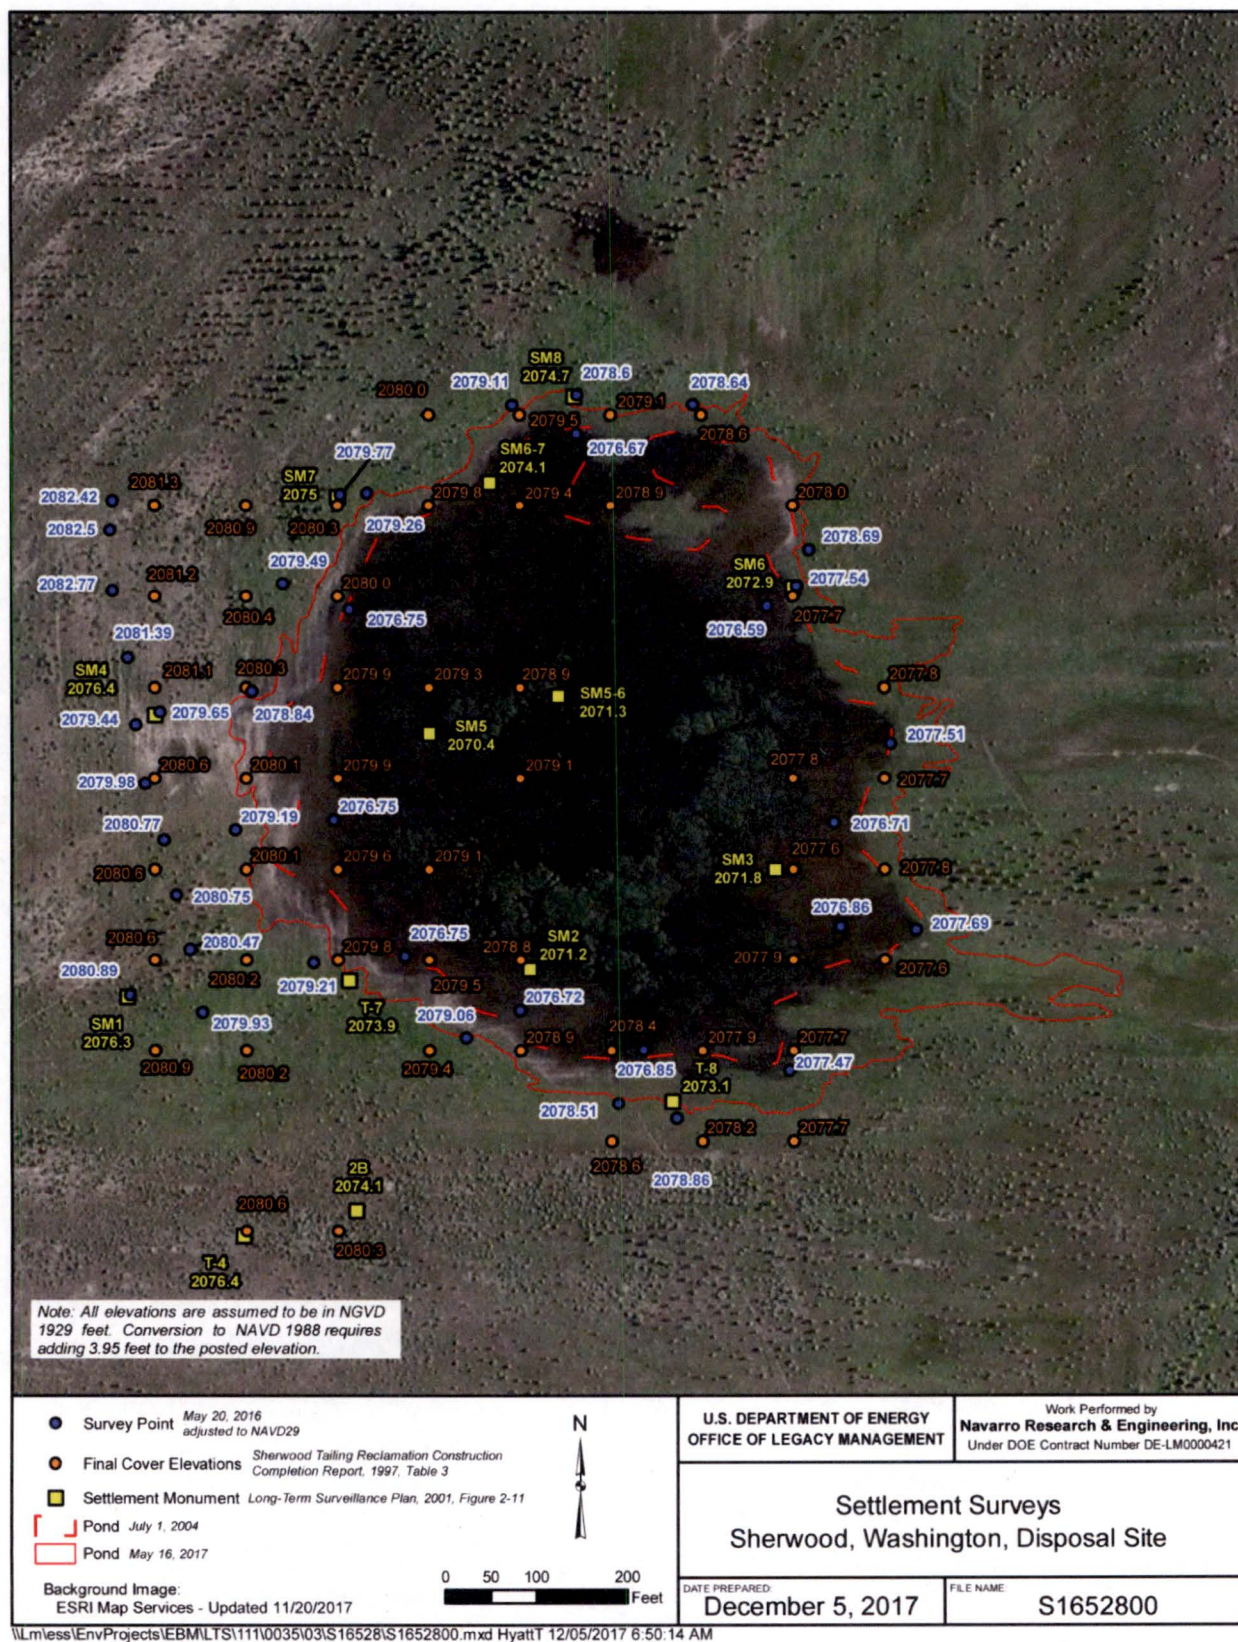
Figure 5-2. Settlement Surveys Sherwood, Washington, Disposal Site

During the 2015 annual site inspection, a ground-level elevation survey was requested to determine actual settlement values (opposed to estimated values) to verify that settlement is within the allowance of the disposal cell design. A survey team collected GPS elevation data for locations on the surface of the disposal cell at the time of the 2016 annual inspection. Evaluation of the data indicates some settlement has occurred on the disposal cell; the settlement is estimated at 2 to 3 feet near the ponds, which is less than the 10 feet of settlement allowed for in the LTSP (Figure 5-2). Comparisons between the as-built survey and the 2016 survey were not exact since the 2016 data were not collected in the same locations. During the data-evaluation process, it was noted that the surface elevations presented in the 2001 LTSP were incorrect (LTSP Figure 2-11). The incorrect LTSP values, the correct as-built values, and the 2016 recent survey values for the cover elevations are shown in Figure 5-2.

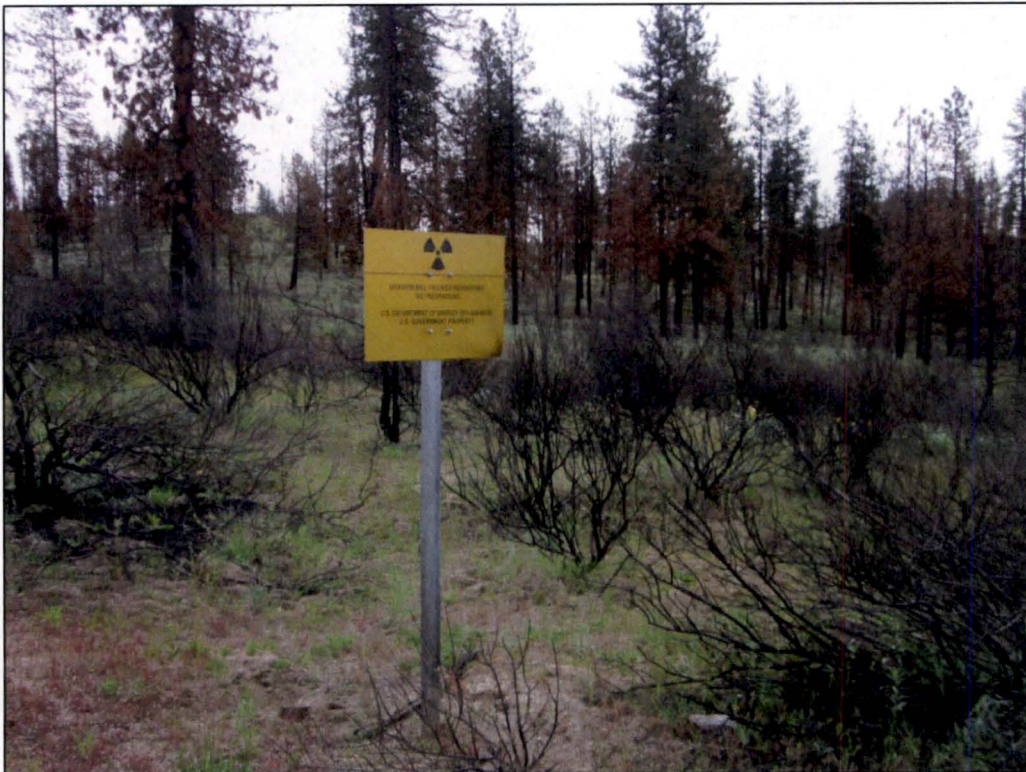
There are six warning or perimeter signs, attached to steel posts set in concrete, positioned along the site boundary at likely access points around the site. Signs have been vandalized in the past (including bullet damage) and text on signs may become illegible due to fading or bullet damage. Sign P2 was scorched by an August 2016 forest fire but remains legible (PL-1). No maintenance needs were identified.

*PL-1. Perimeter Sign P2, Scorched by August 2016 Fire*

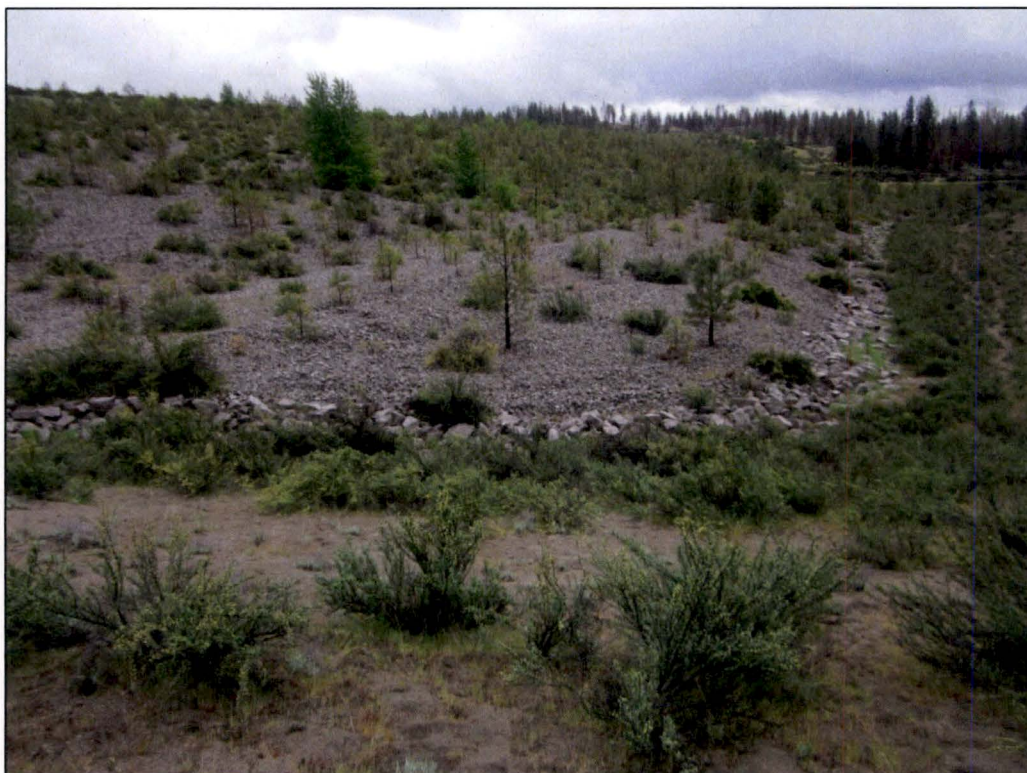
The containment dam face has a rock cover consisting primarily of highly durable quartz monzonite. The face was designed to allow a vegetated cover, including mature trees, to establish and stabilize the surface and mitigate erosion. Consequently, the presence of this vegetation does not harm the function of the containment dam. The containment dam face is thickly vegetated (PL-5). No maintenance needs were identified.

*PL-5. Face of Containment Dam and Outslope Area*

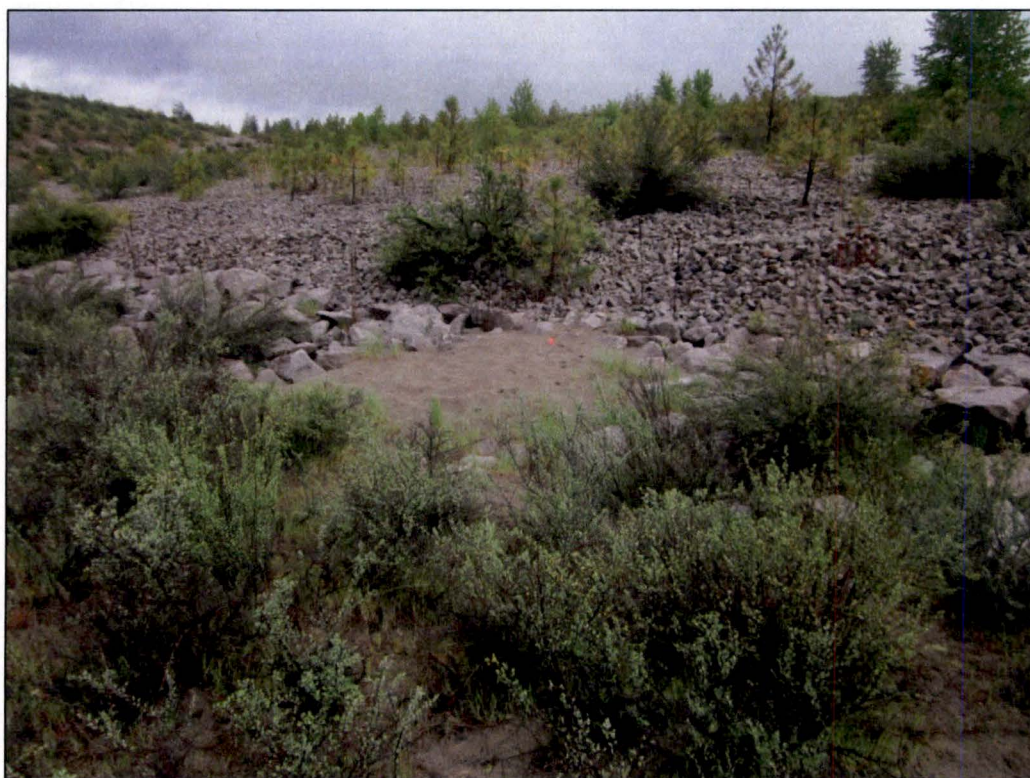
During the 2016 annual inspection, one area at the base of the rock-covered containment dam face was found to have a fan of sand that had washed out from underneath the rock cover (PL-6). A small rill could be traced from the containment dam base up approximately 50 feet under the cover. The rill ranged from 1 to 2 feet wide and 8 to 12 inches deep. A follow-up inspection was performed on October 4 and 5, 2016, to evaluate the cause, extent, and repair method of the erosion, if required. A report will be transmitted to NRC upon completion of the resulting engineering evaluation. This area was closely examined during the 2017 annual inspection, and several small holes were dug upslope to determine the edge of the actual embankment (PL-7, PL-8). It was determined that the washout area was in a portion of the containment dam defined as the outslope (Figure 5-1). This area, which consisted of a native sand formation, was graded, and protective rock was placed over the surface. The sandy material is not comparable to the compacted material used in the actual embankment. The sand deposit has not increased since October 2016, and the associated erosion does not threaten the containment dam. This area will be closely monitored during future inspections.

from the August forest fire. The washout was determined to be in an area below the actual embankment and posed no danger to the disposal cell embankment. No further erosion was noted during the May 2017 inspection. The area will continue to be monitored during annual inspections and repaired if erosion continues. The fire did not burn over the disposal cell and the only damage observed was a scorched perimeter sign that remained legible. No need for a follow-up inspection was identified.

*PL-6. Sand Deposition at Base of Outslope Area*
