# 2017 Annual Site Inspection and Monitoring Report for Uranium Mill Tailings Radiation Control Act Title II Disposal Sites

December 2017

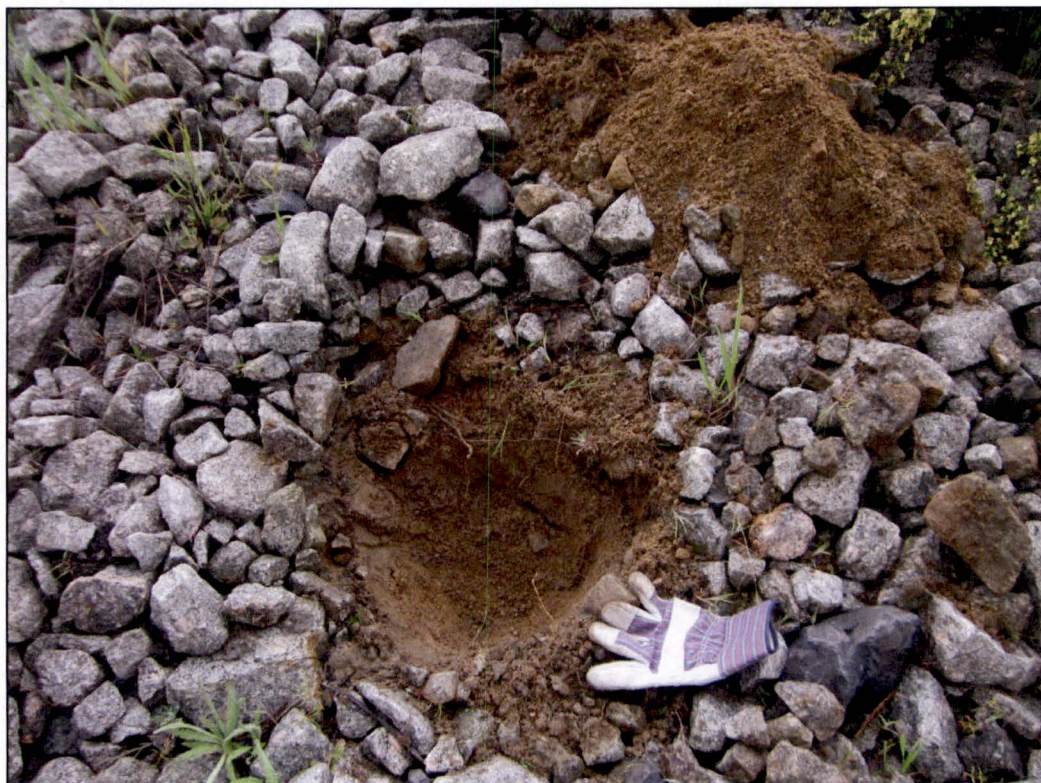
*PL-8. Test Hole in Embankment Material Above Washout Area*

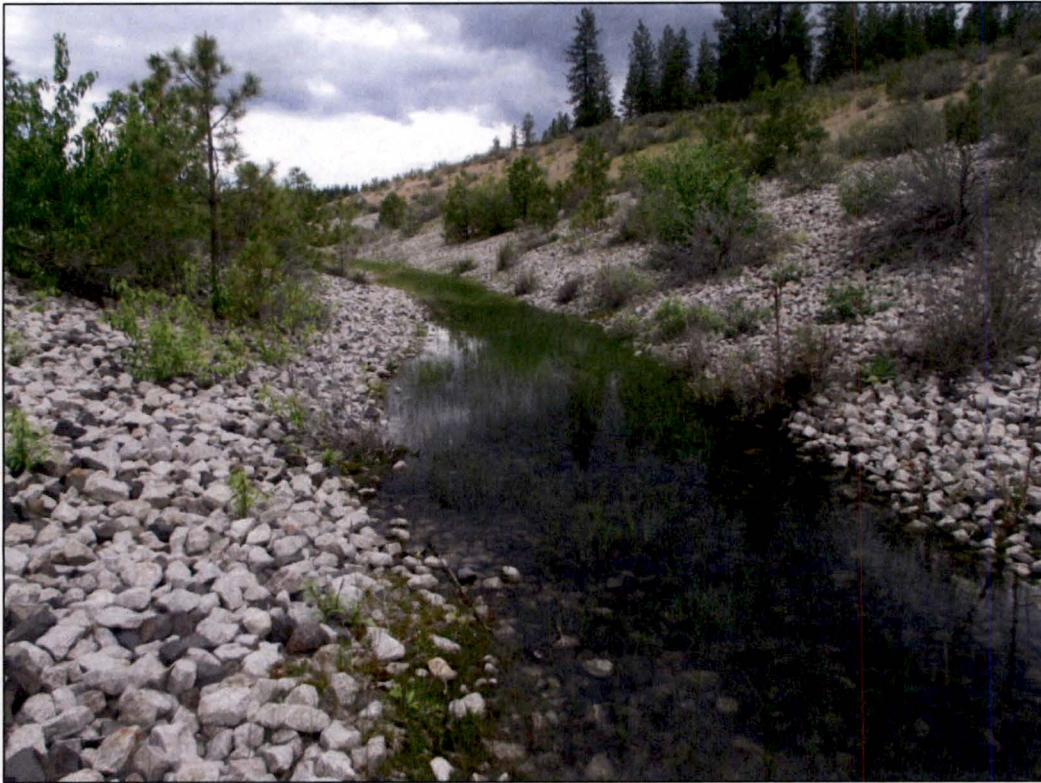
A riprap-armored diversion channel surrounds the disposal cell and diverts runoff away from the disposal cell surface. The diversion channel (PL-9) was designed to allow trees to grow and stabilize the surfaces, and their presence in the diversion channel is not expected to hinder the diversion channel's ability to convey design flows. The intrusion of volunteer plants, including trees, within the diversion channel is evident in most areas of the diversion channel. Sediment deposition is found in places on the west leg of the diversion channel but does not interfere with the diversion channel's design function. Upslope areas that have contributed to the sedimentation have stabilized with vegetation. Wildlife, buffalo, and horse trails cross the diversion channel at numerous locations and have caused displacement of the diversion channel riprap in several places. These disturbances will be visually monitored for erosion but are not in areas that would impact the disposal cell.

*PL-9. Diversion Channel with Ponded Water*

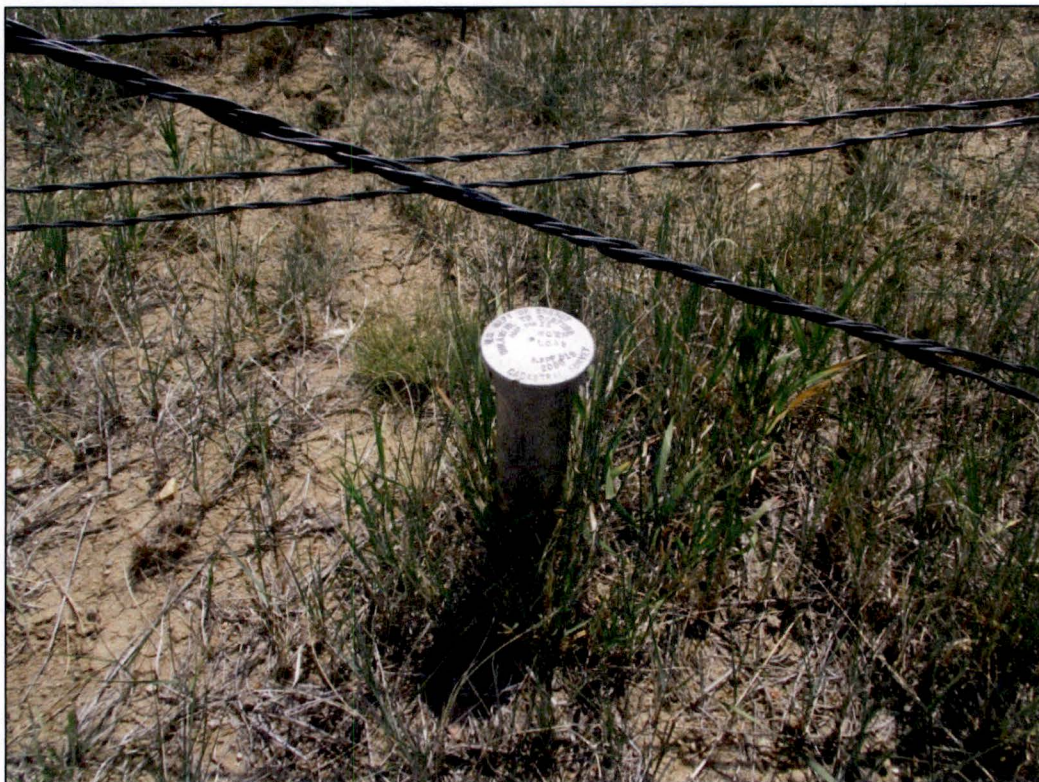
There are 26 boundary monuments delineating the site property boundary (PL-4). All boundary monuments were inspected. No maintenance needs were identified.

*PL-4. Boundary Monument BM-11 at the Site's East Boundary*

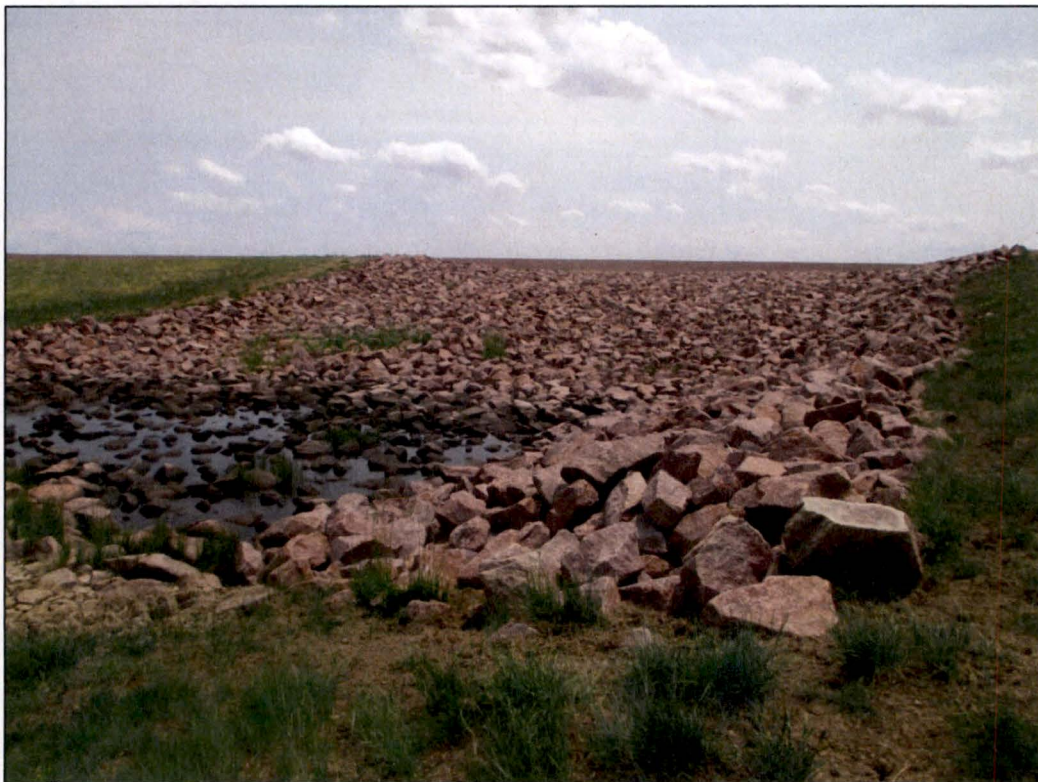
*PL-9. Water Collected at North Swale Discharge Point*
