REGULATORY INFORMATION DISTRIBUTION SYSTEM (RIDS)

SUBJECT: Forwards mgt-on-shift weekly rept.

Re: Turkey Point Units 3 and 4
Docket Nos. 50-250 and 50-251
Management-on-Shift Weekly Report

MANAGEMENT ON SHIFT (MOS)

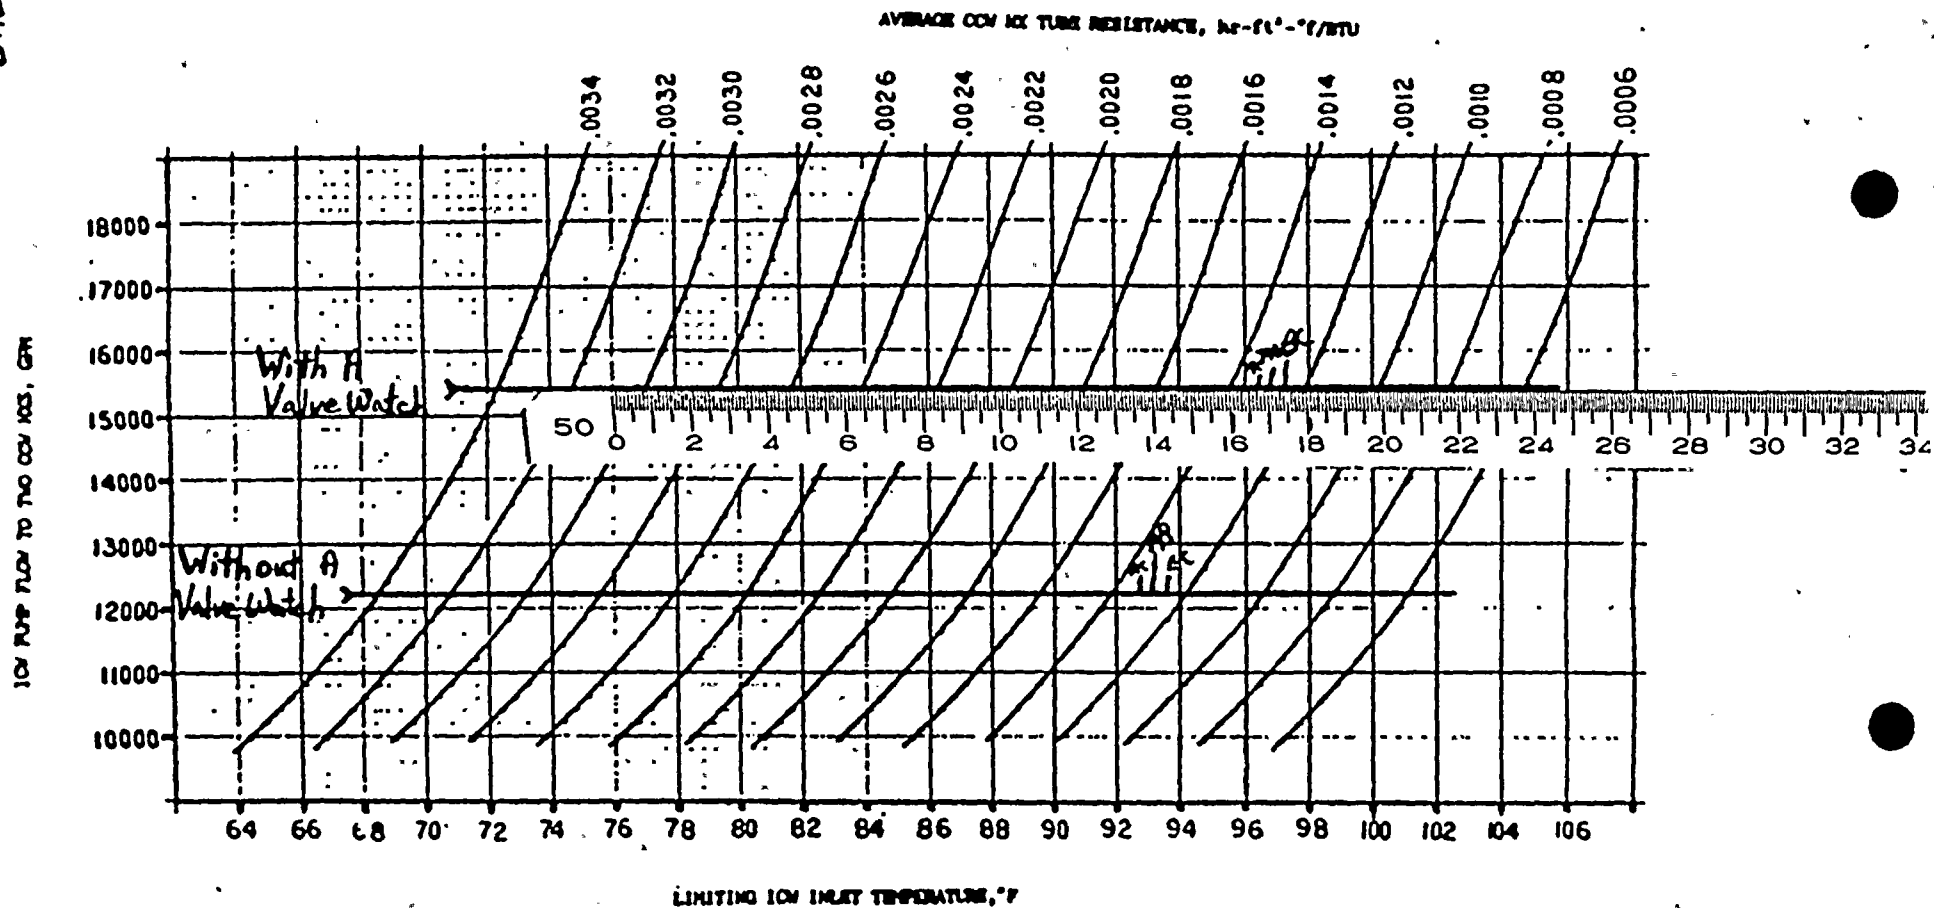
FIGURE 2: IGV FLOW VERSUS OCV KX TUBE RESISTANCE VERSUS IGV LIMITING INLET TEMPERATURE FOR HMA WITH TWO OCV KX OPERATION AND OX TUBE FLOCCAGE

Due to the current problem of Component Cooling Water (CCW) Heat Exchanger fouling the Technical Department must perform efficiency testing and plot "R" values against Intake Cooling Water (ICW) inlet temperature in which the CCW system will remove heat load for a Design Basis Accident. Tonight the on-shift Shift Technical Advisor (STA) reviewed the data from the efficiency testing and found by interpolation that it appeared the data supplied was giving less conservative values than his calculations. The test engineers felt that the STA was being over-conservative in his calculations. The PSN reviewed the "R" value curve and found that either party could be considered right. PSN found that the plotting chart supplied to Technical Department from JPE per JPE-LR-87-045 revision 1 has poor scaling which does not supply increments of tenths. The copies are of poor quality, too small, and force the test engineer to use a ruler using a scale of 50 to calculate allowable operating temperature. Calculations can be off by 2/10 degree Fahrenheit. During this hot weather, unit operation could easily be jeopardized by this much margin if the maximum temperature is reached.
