SUBJECT: Forwards requests relief from requirement of ASME Section XI, 1989 Edition, Paragraph IWA-5250(a)(2) to remove all bolting (studs) on 4B RCP.

Re: Turkey Point Units 3 and 4
Docket Nos. 50-250 and 50-251
Inservice Inspection Program
Third Ten Year Summary
Relief Request No. 19

RELIEF REQUEST NO. 19

Turkey Point Unit 4
"4B" Reactor Coolant Pump Studs

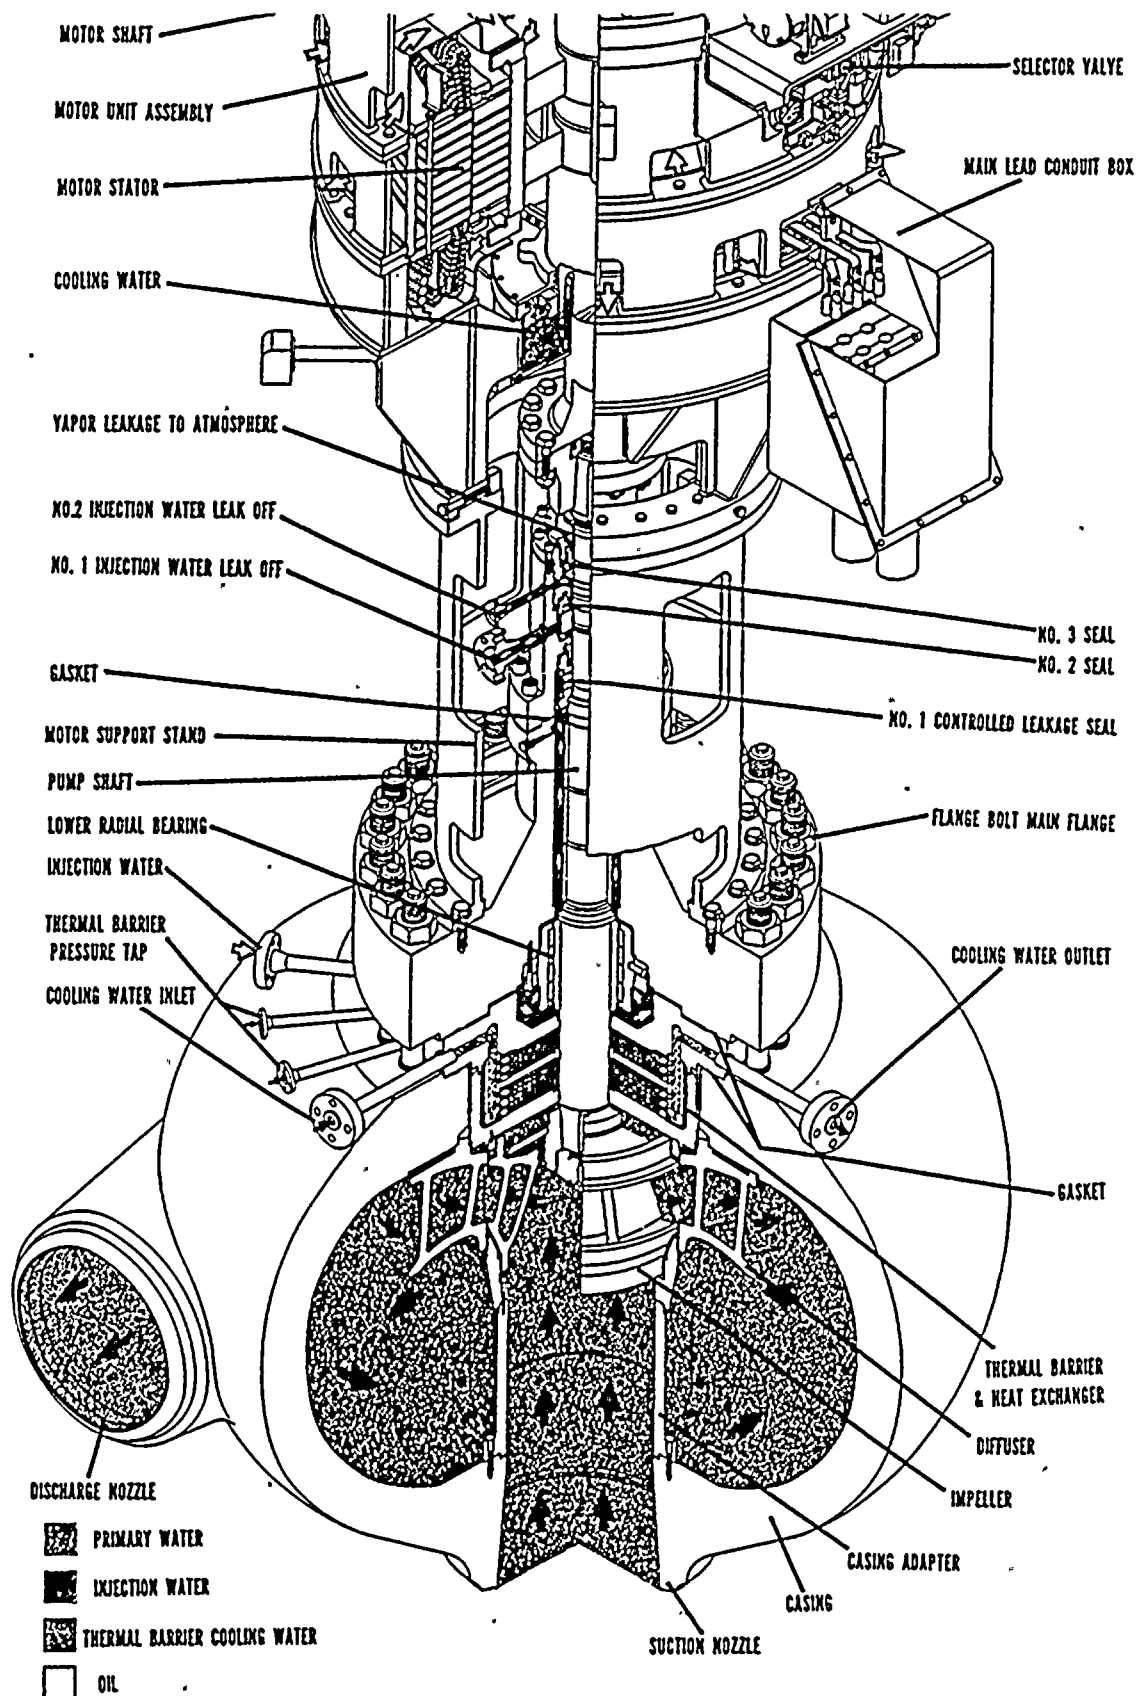
FIGURE 4

Figure 4 is a poor quality closeup of the boric acid visible between studs 7 and 8.

FPL proposes to perform a VT-1 visual examination on the remaining reactor coolant pump studs while they are still installed. This is deemed reasonable, since preliminary examinations have shown no visible corrosion damage at the interface between the threaded stud and the flange top surface. Based on the tight thread fit, measurable corrosion damage is not credible in the engaged threaded stud hole without corresponding indication of damage at the first exposed threads. Approximately five inches of each stud is threaded into the pump flange. The remainder of the studs (84% of the surface area) are accessible for visual examination. This VT-1 visual examination will be used as part of the evaluation in order to determine whether the studs are acceptable for continued service or must be removed. If boric acid degradation is found on any of the in place studs, that stud will be evaluated for continued service or replacement.

FPL will perform a VT-1 visual examination of the flange in accordance with the requirements of Code Item No. B6.190 at this time. This will ensure no damage is present on the flange seal surface. A volumetric examination of the 24 studs will be performed in accordance with Code requirements during this outage, to insure the integrity of the removed studs and the in place studs.
