Client: NextEra Energy-Seabrook **Project No.** 170444.02
Project: Support for Prompt Operability Determinations (PODs), NextEra Energy Seabrook Station, NH

Report No.: 170444-SVR-01-R0
Report Type: Site Visit Report
Title: September 2017, Threshold Inspections for the North Wall of the Containment Enclosure Ventilation Area (CEVA), NextEra Energy Seabrook Facility, Seabrook, NH

To report September 2017 threshold measurement results of the lower portion of the North Wall of the Containment Enclosure Ventilation Area (CEVA) and to determine whether the threshold limits for the CEVA North Wall have been exceeded.

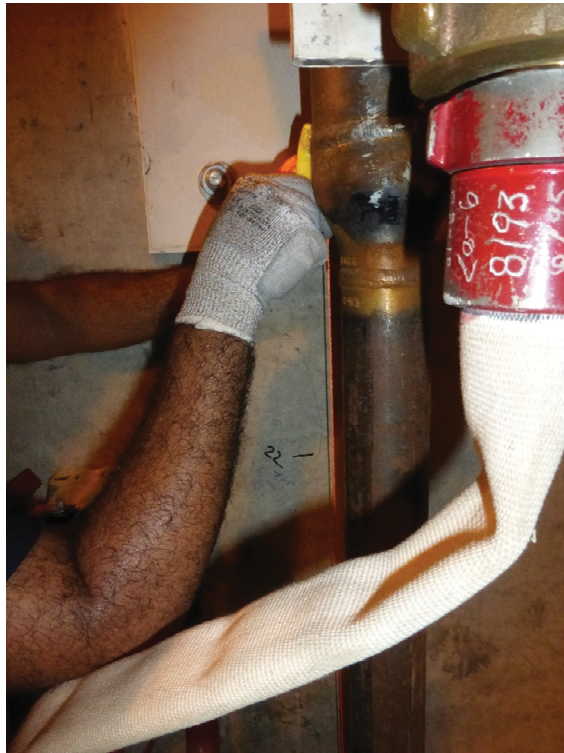
Photo 1

SGH measured the out-of-plumbness of the north face of the north wall from EL +4 ft to EL +26 ft using a plumb bob and a tape measure. SGH suspended the plumb bob from a string running along the wall surface from EL +27 ft to EL +3 ft (top of the Mech. Pen.) and measured the distance from the wall surface to the center of the string, starting at EL +4 ft (1 ft from the top of the Mech. Pen) and continuing to EL +26 ft (3.5 ft above the top of the base slab of the CEVA Building) (Photos 1 and 2). SGH performed the measurements from both sides of the stairs, which are located near the center of the wall.

SGH measuring the plumbness of the wall with a plumb bob attached to a string.

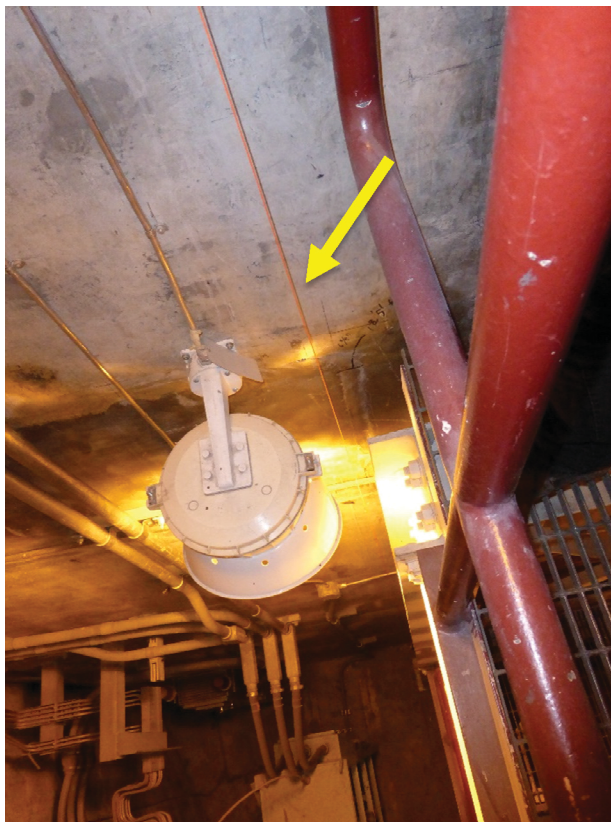
Photo 2

View down the plumb bob string (yellow arrow) extending from EL +27 ft to +3 ft.
