Summary of LaSalle SIT exit (the team made it clear to the licensee that info presented was based upon management review)

Operating Experience Spring 2017 Counterparts Briefing

LaSalle 2 – HPCS Injection Valve Failure – Stem-Disc Separation

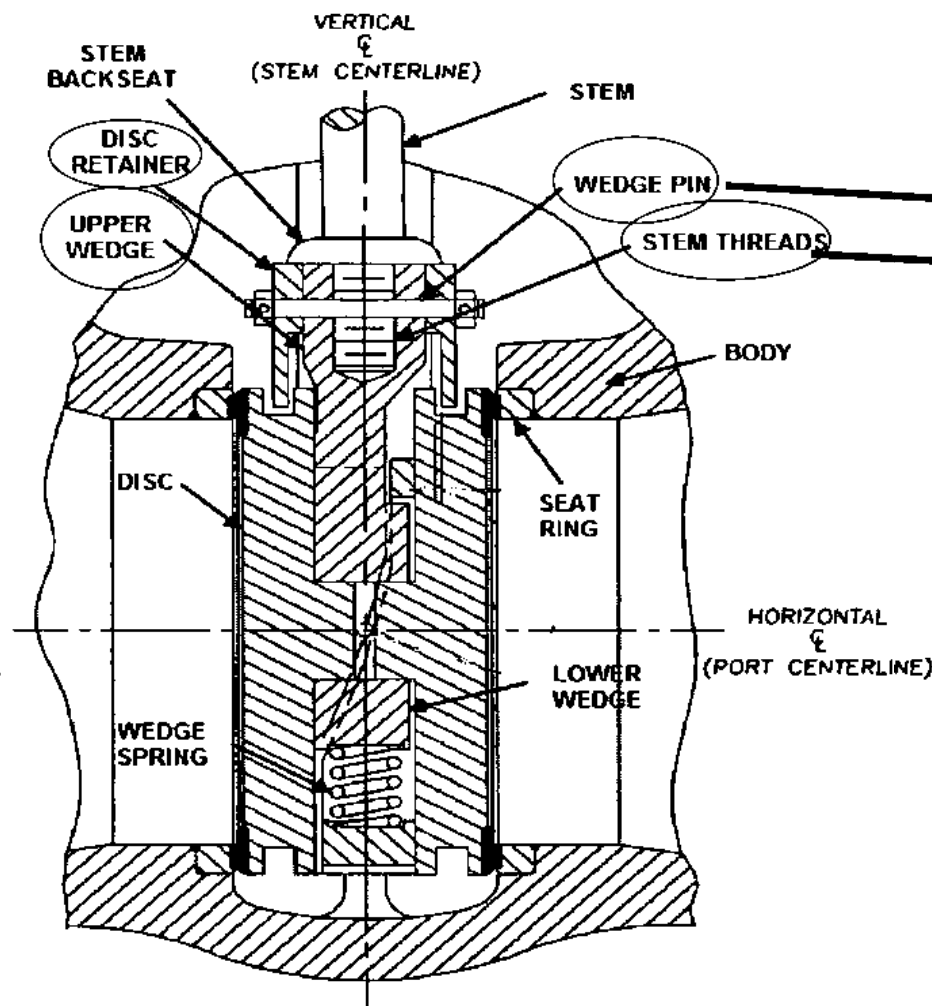
Anchor Darling DDGV Internals

- The stem-to-upper wedge threaded connection is torqued into the upper wedge, and then the anti-rotation (wedge) pin is inserted
- If operating torque exceeds stem torque, the stem can loosen during valve opening, eventually leading to wedge pin failure
