SUBJECT: Forwards SEA-CW-037, "Root Cause Failure Analysis of B & C Diesels: 1989."

SUSQUEHANNA STEAM ELECTRIC STATION
DIESEL GENERATOR CRANKCASE EXPLOSIONS
ROOT CAUSE ANALYSIS REPORT
PLA- 3321 FILE S024, R41-2

ROOT CAUSE FAILURE ANALYSIS OF "B" AND "C" DIESELS: 1989**I. ABSTRACT**

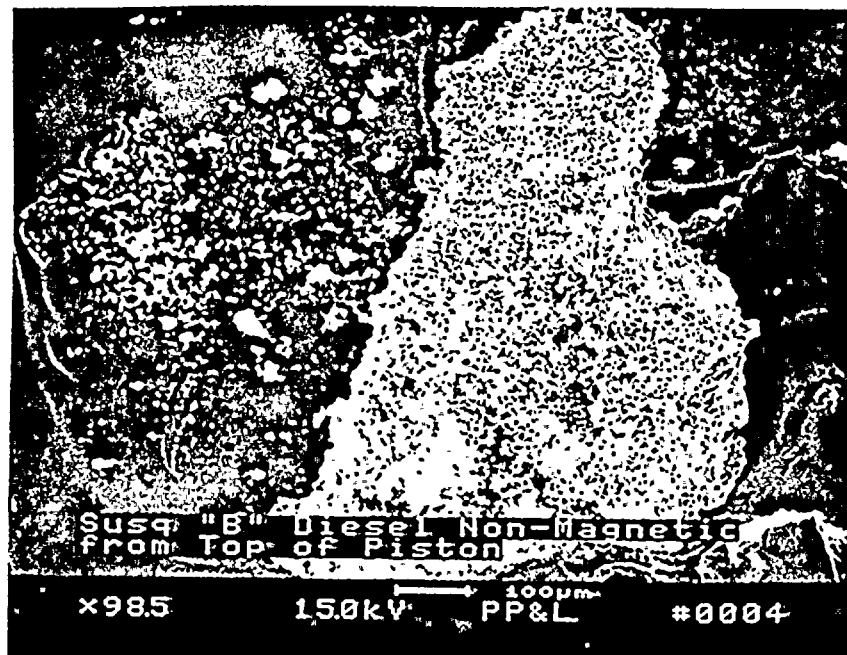
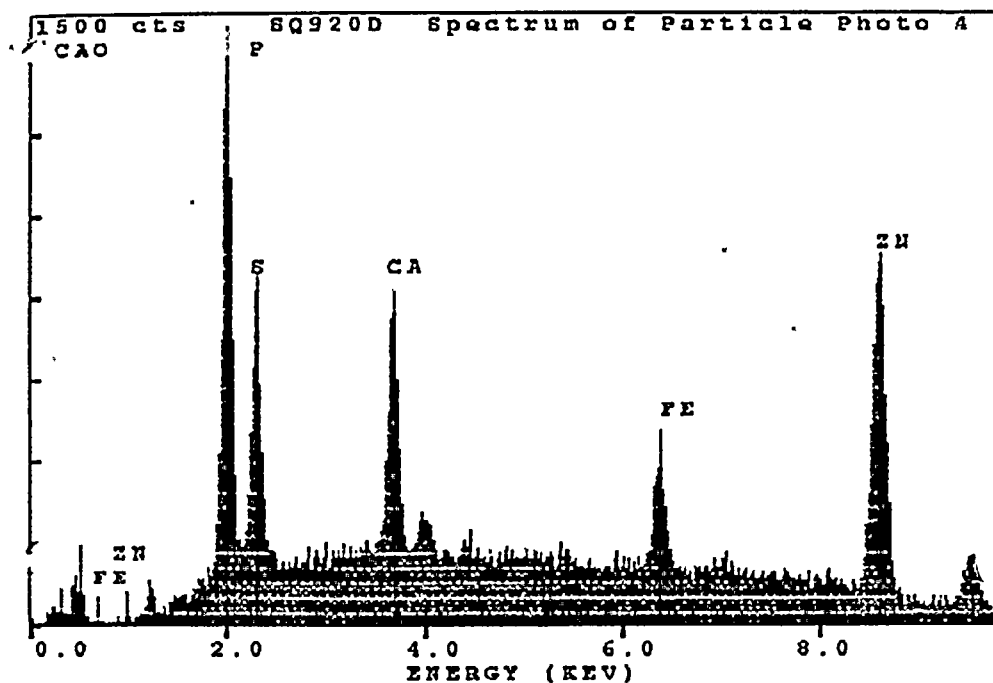
Figure B-4. Micrograph and EDS analysis results of non-magnetic debris taken from the head of the B diesel 7L piston.

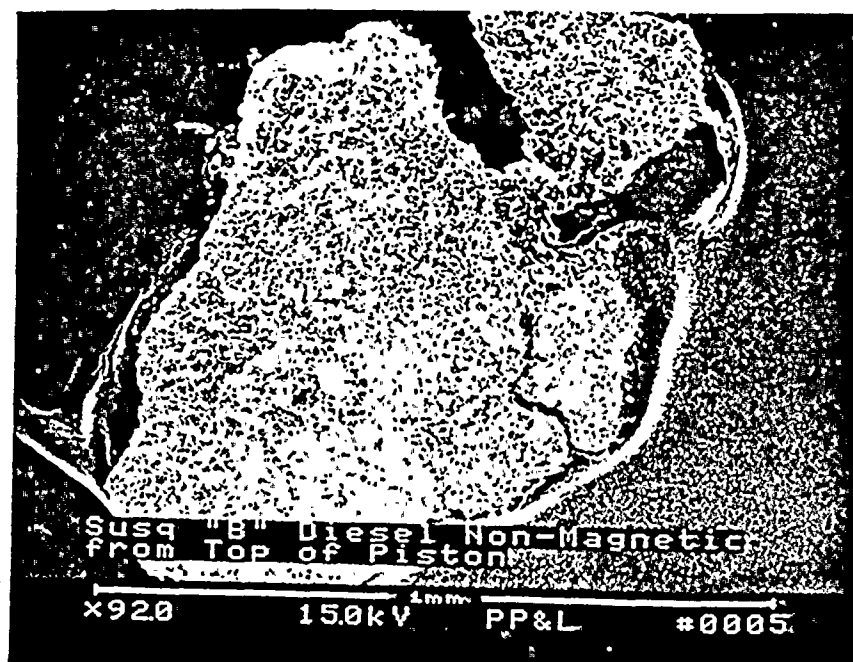
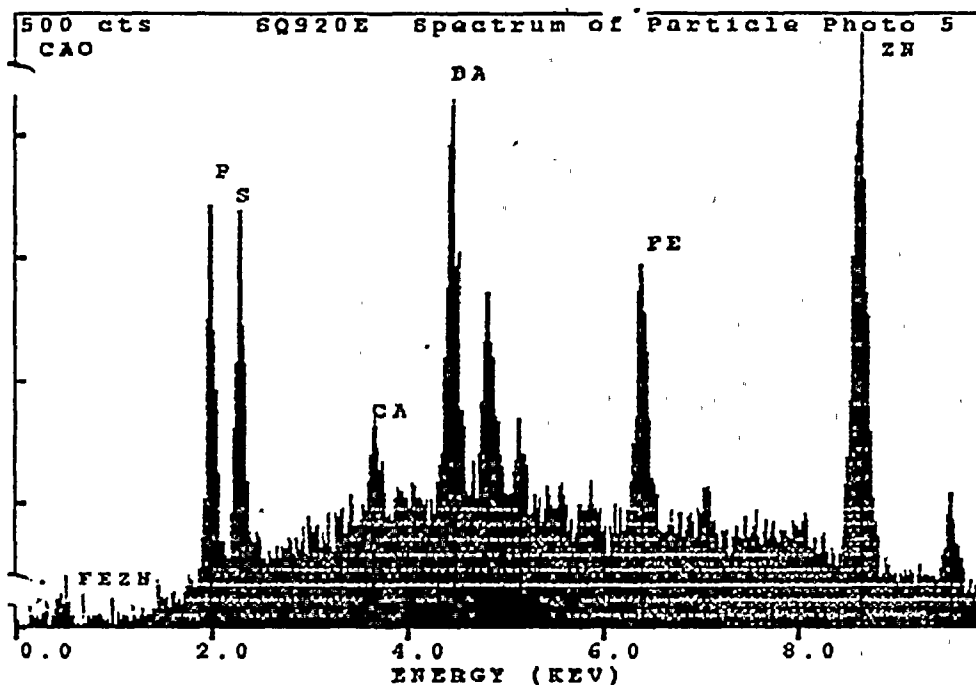
Figure B-5. Micrograph and EDS analysis results of non-magnetic debris taken from the head of the B diesel 7L piston on another particle from that analyzed in the figure B-4.

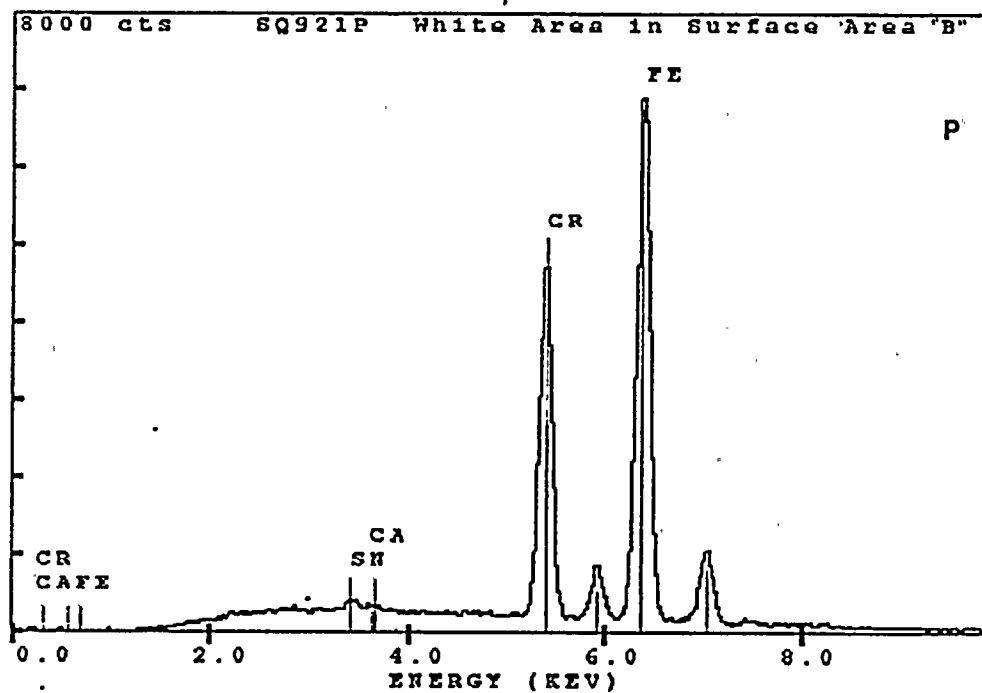
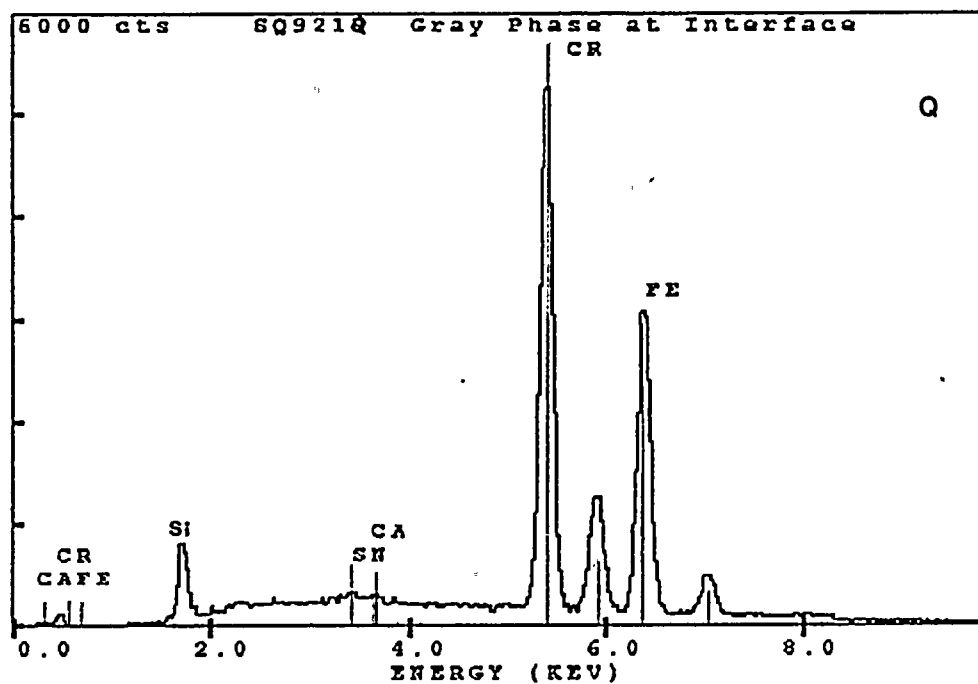
Figure B-8. EDS analysis of areas 'P' and 'Q' in figures B-7 and B-6.

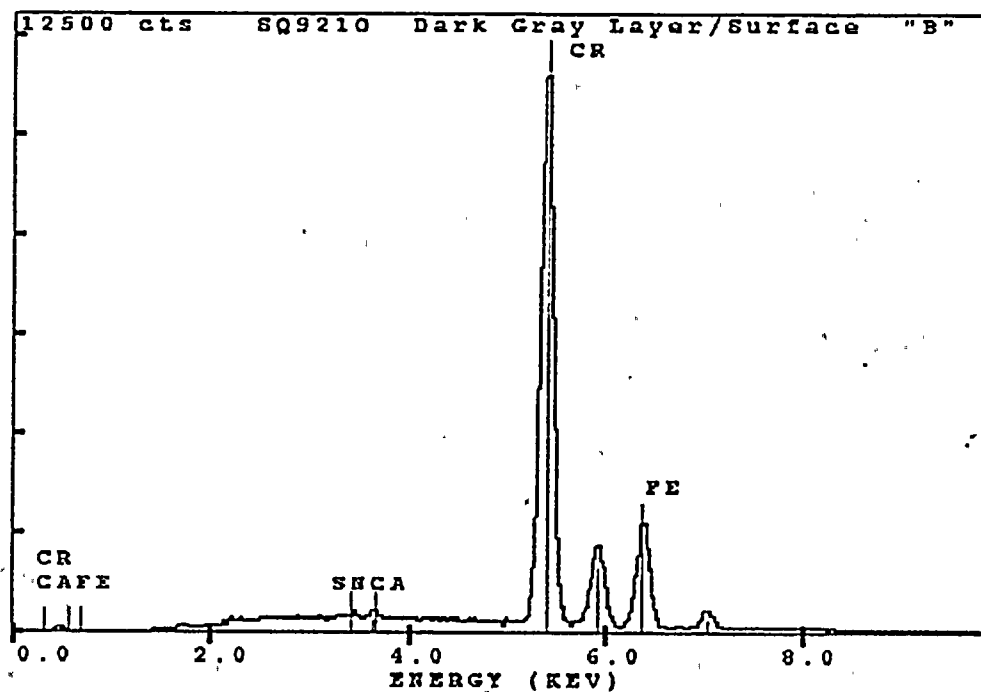
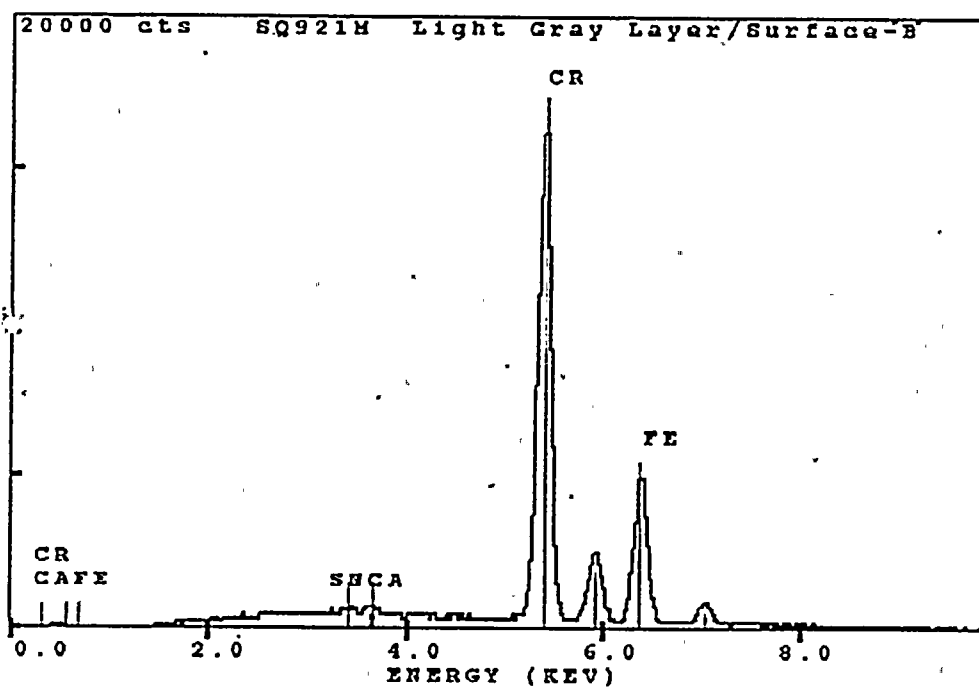
Figure B-9. Spectra of the light and dark phases in figure B-7.

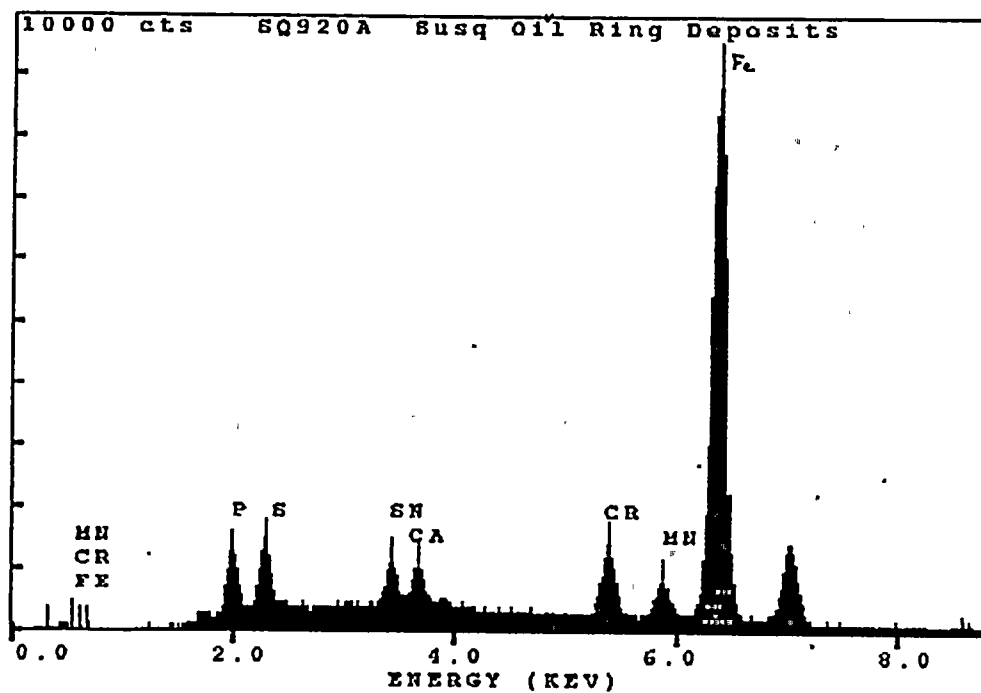
2.2.1.3 Debris from the coil spring behind the lower oil ring was sampled and analyzed for elemental composition. The elements Fe, Cr, P, S, Sn, Ca, Mn and Si were found in the loose debris and also on the surface of the metal itself as shown in Figure B-14. The elements P, S, and Ca are commonly found in the nonmetallic debris in these engines from oil decomposition.

Figure B-14. Debris EDS analysis from the spring behind the lower oil ring from the B diesel 7L piston.

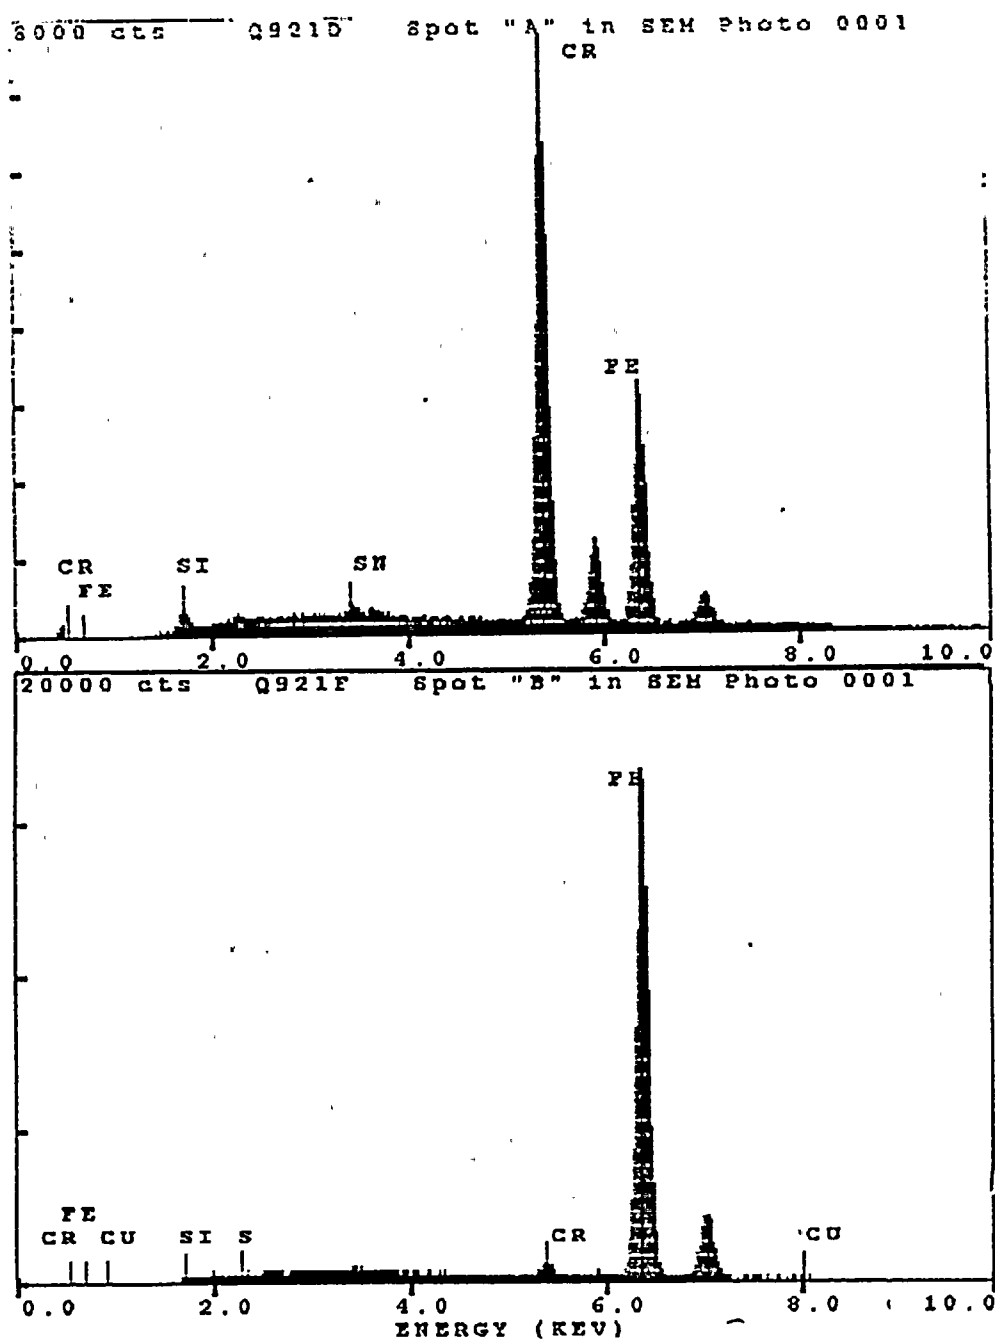
2.2.2.1 The fourth compression ring from the top of the piston was examined to show the condition of the surface in contact with the liner. Figure B-15 shows that there was some unknown material embedded in the surface identified as spot "A." It was found to be mostly chromium with some Fe, Sn and Si mixed in. Spot "B" in the same figure was identified to be the base material which consists mostly of iron. Figure B-16 shows the EDS analysis curves of both of these spots.

Figure B-16. EDS analysis of the #4 compression ring from the B diesel 7L piston in areas 'A' and 'B' of Figure B-15.

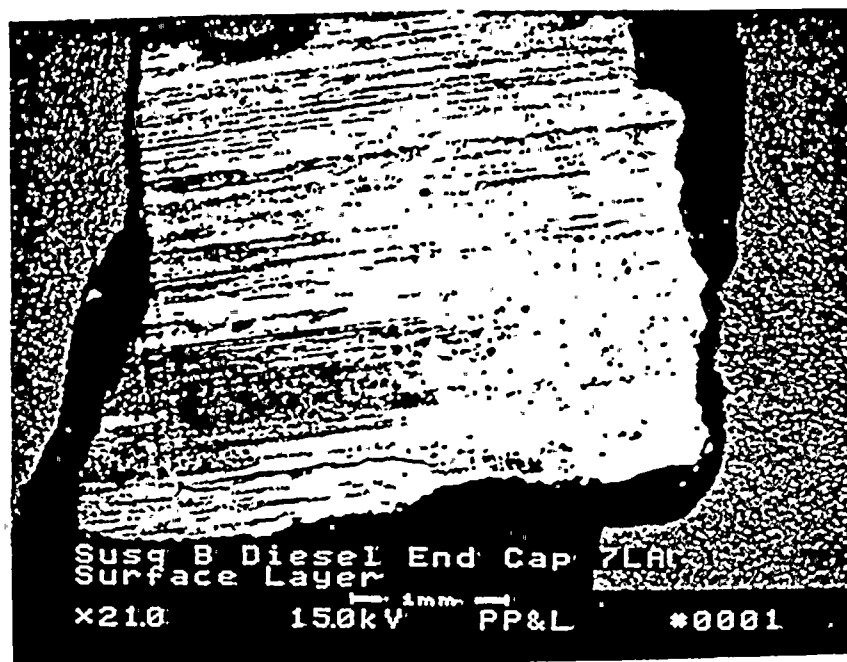
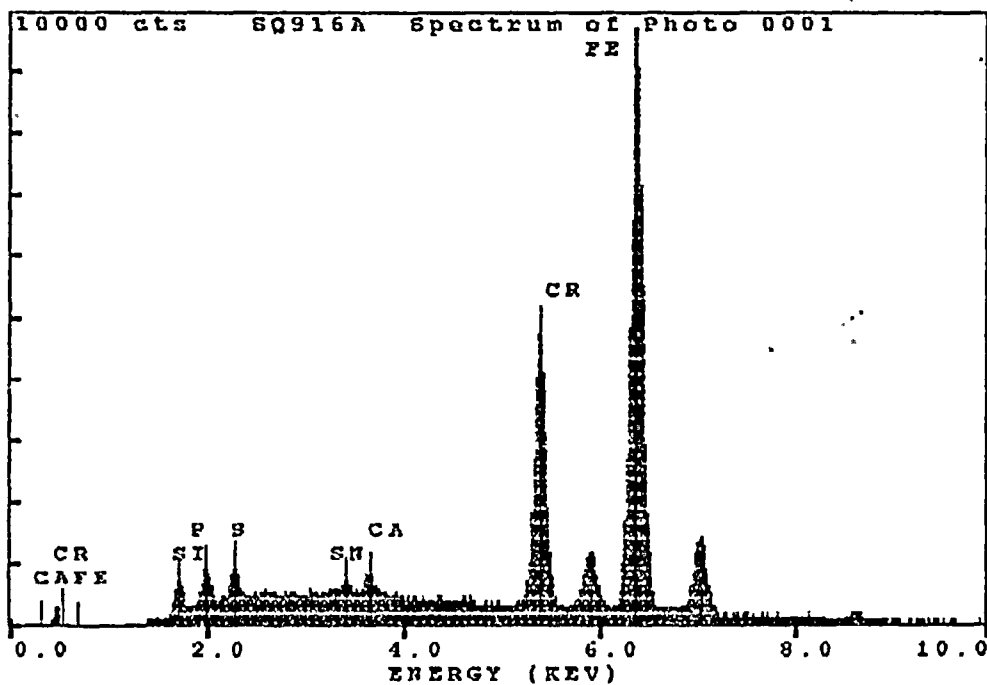
Figure B-19. Picture and EDS analysis of a piece of smeared metal removed from end cap 'A' from the B diesel 7L piston.

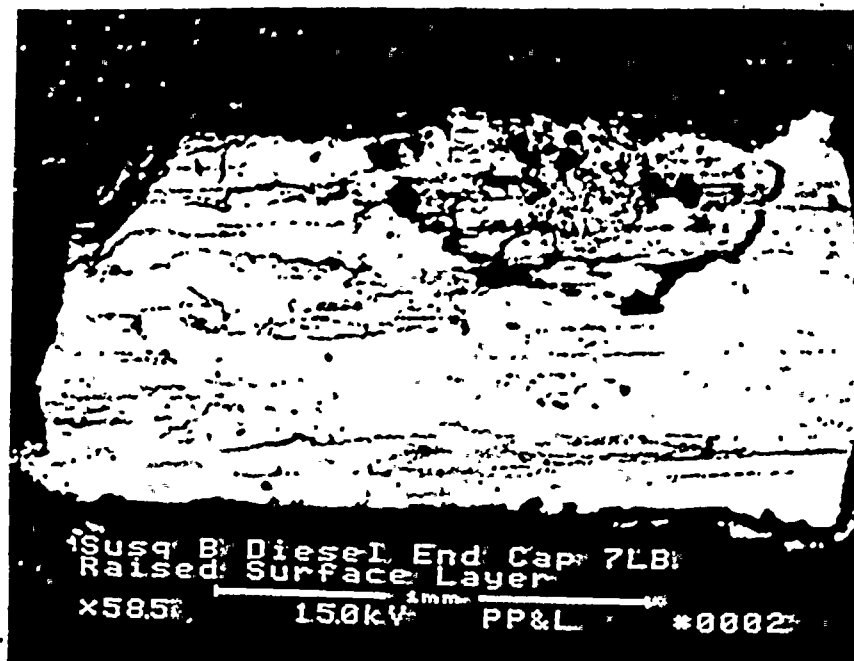
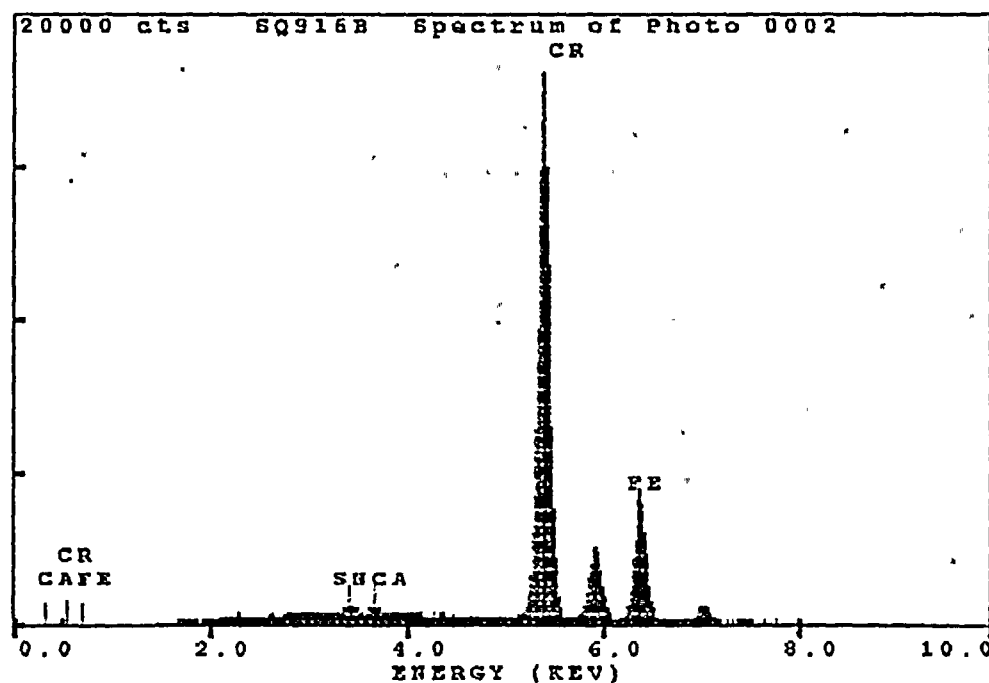
Figure B-20. Particle of smeared metal removed from pin end cap 'B' from the B diesel 7L piston. The EDS analysis shows that it consists primarily of Cr with some Fe and a trace of Ca and Sn.

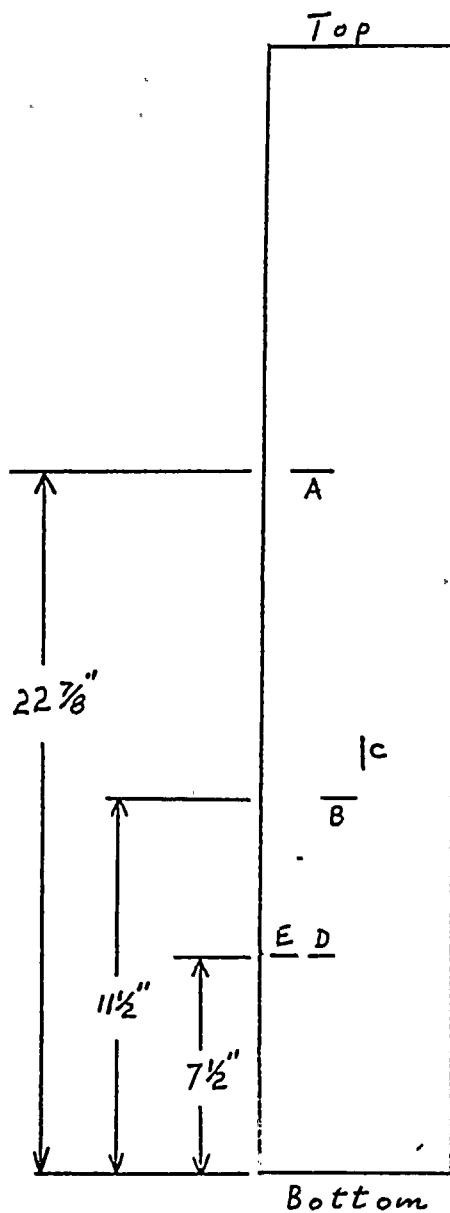
Figure B-26. Sketch of the thrust side of the B diesel 7L liner showing the location and orientation of the sections removed for metallurgical cross-sectioning (part labeled B-1).

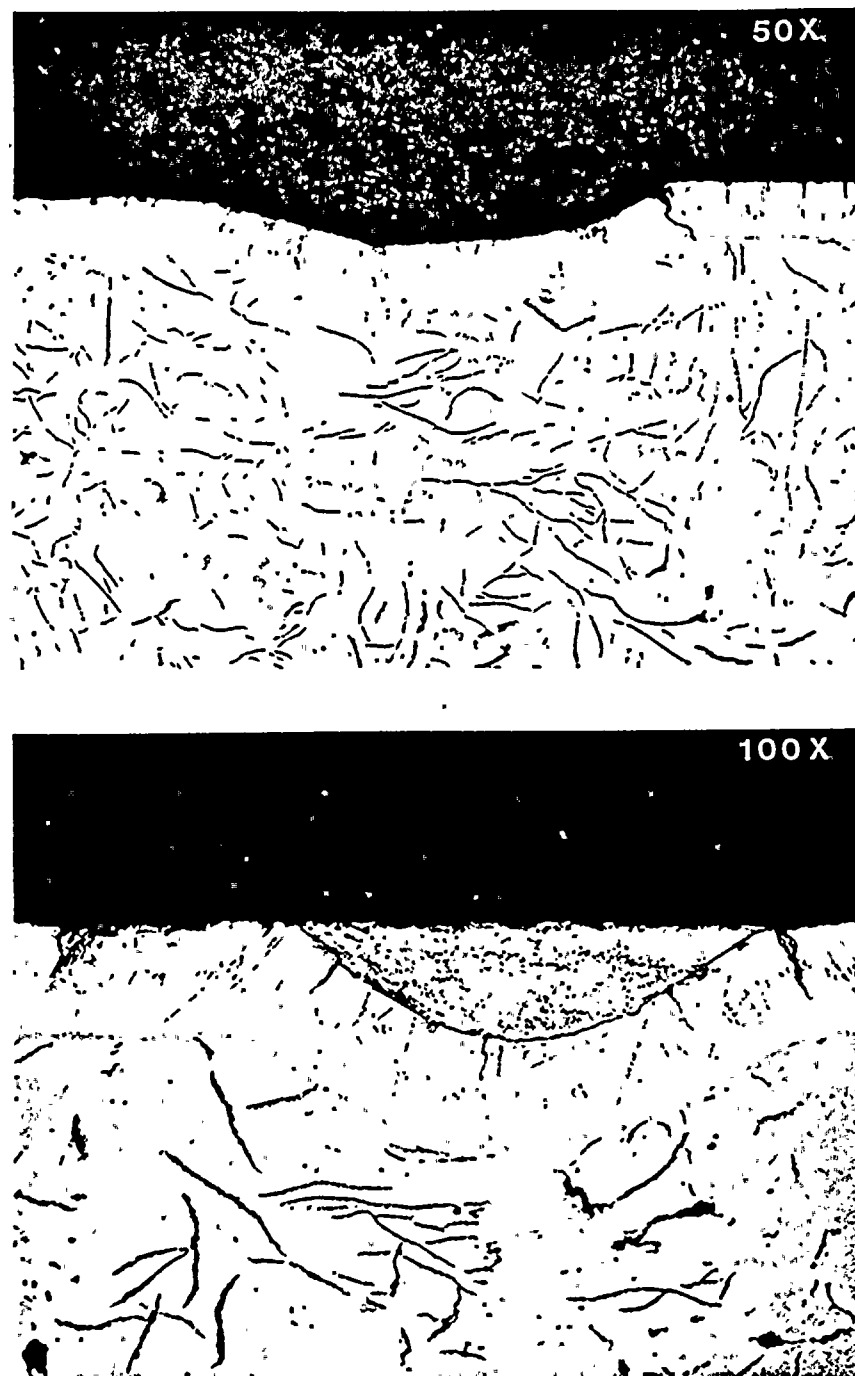
Figure B-31. Transverse cross-section (Labeled area 'E') of the thrust side of the B diesel 7L liner taken 7 1/2 inches from the bottom showing depressions in the Cr plating and deposited metal.

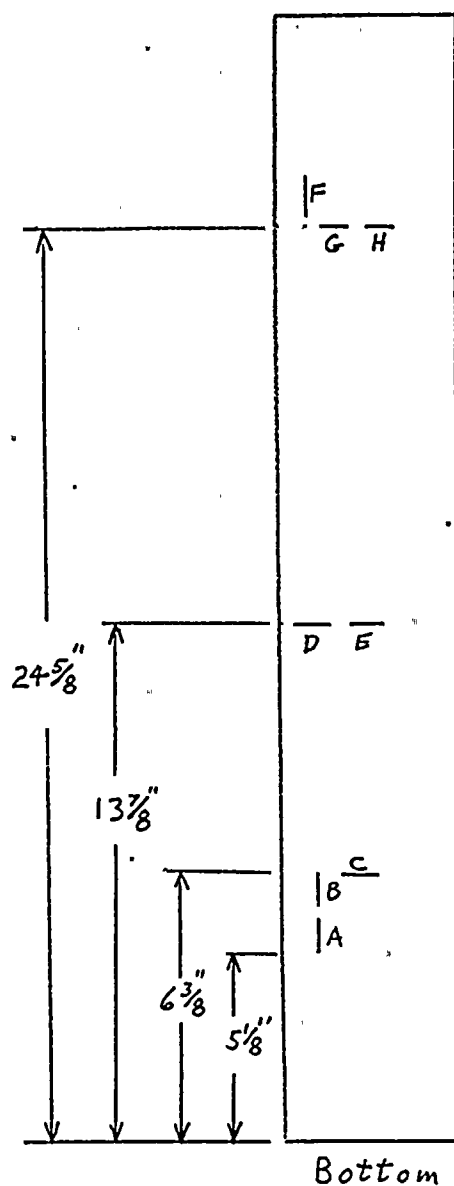
Figure B-33. Sketch of the end cap side of the 'B' diesel 7L liner showing the locations of the metallurgical samples taken for cross-sectional examinations(part labeled B-2).

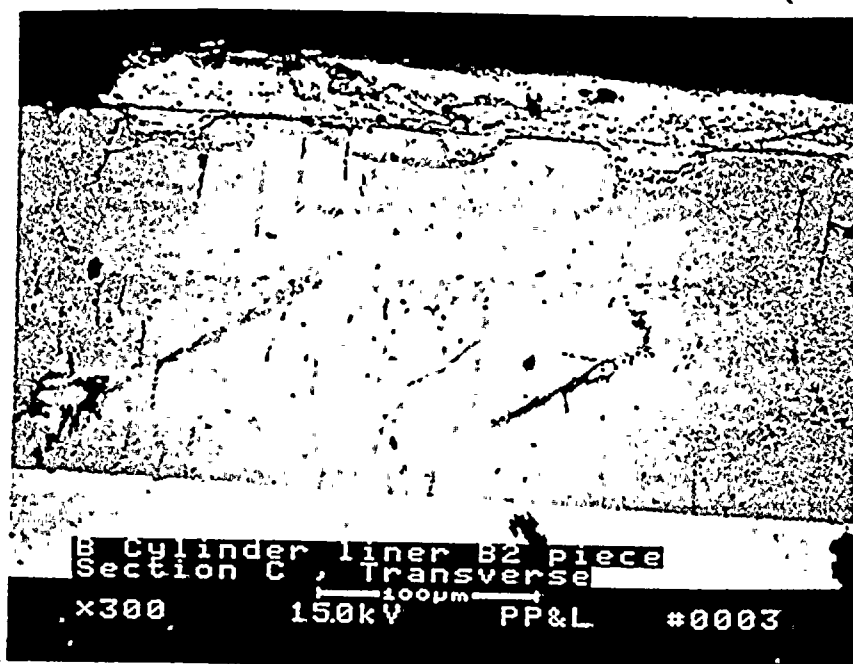
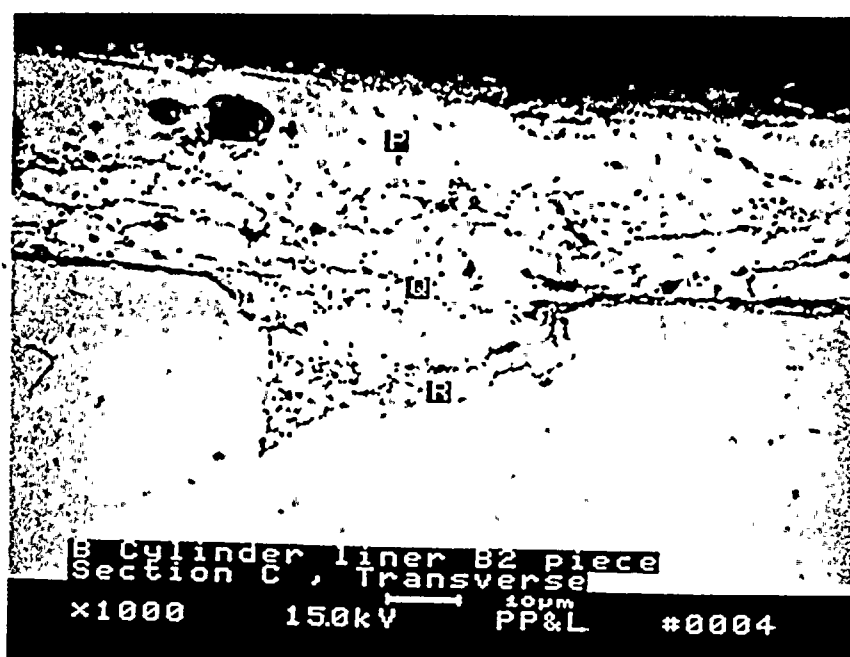
Figure B-35. Transverse cross-section of the B diesel 7L liner (labeled 'C' of part B-2) showing areas of metal buildup and filling of pores with Cr,Sn and Fe.

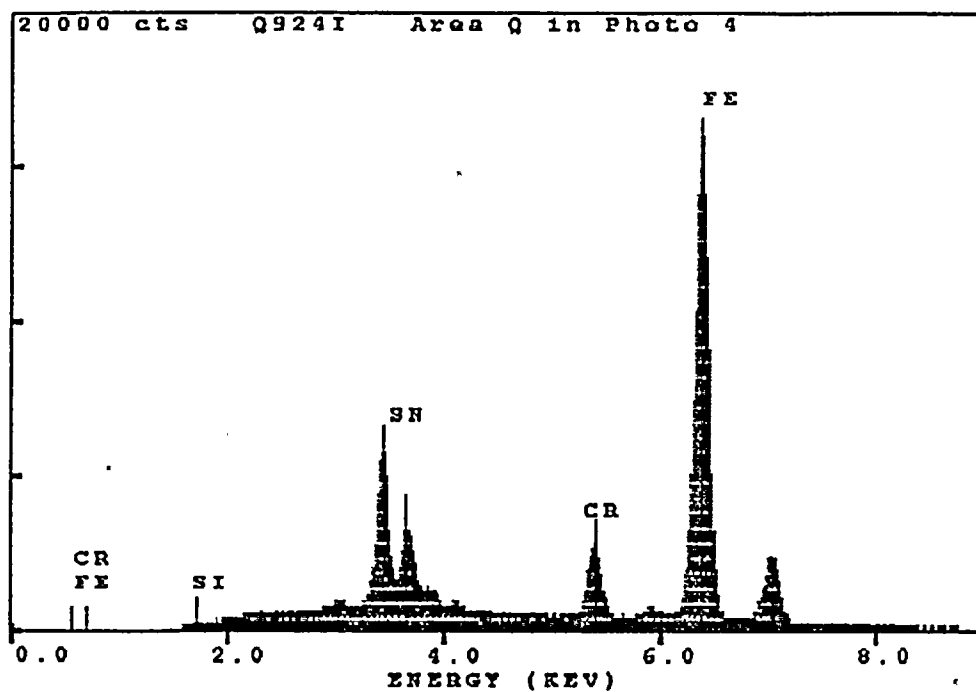
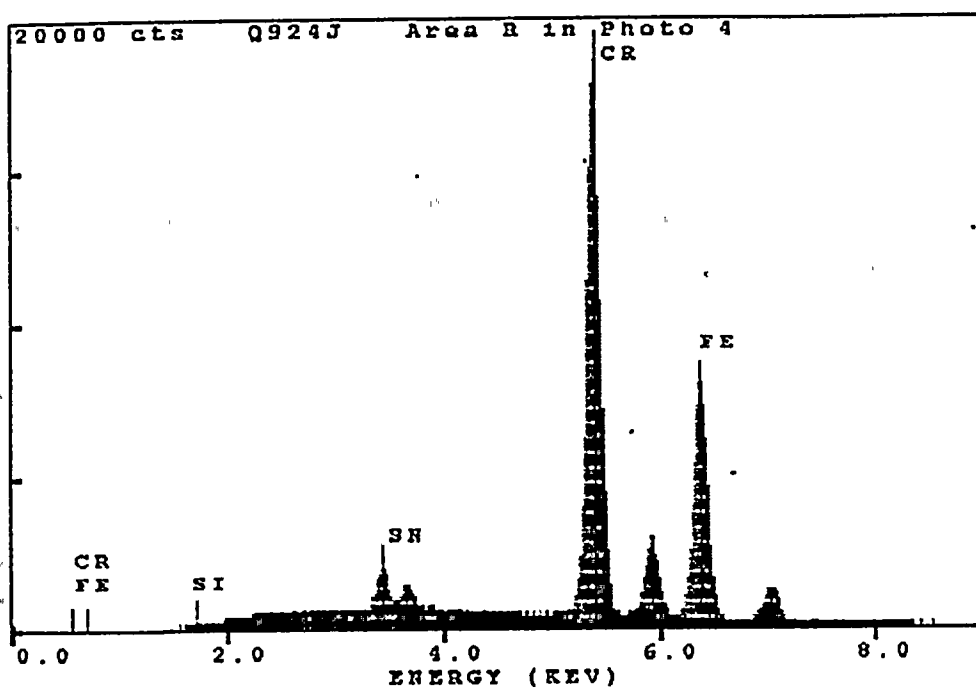
Figure B-36. EDS analysis of areas Q and R shown in figure B-35.

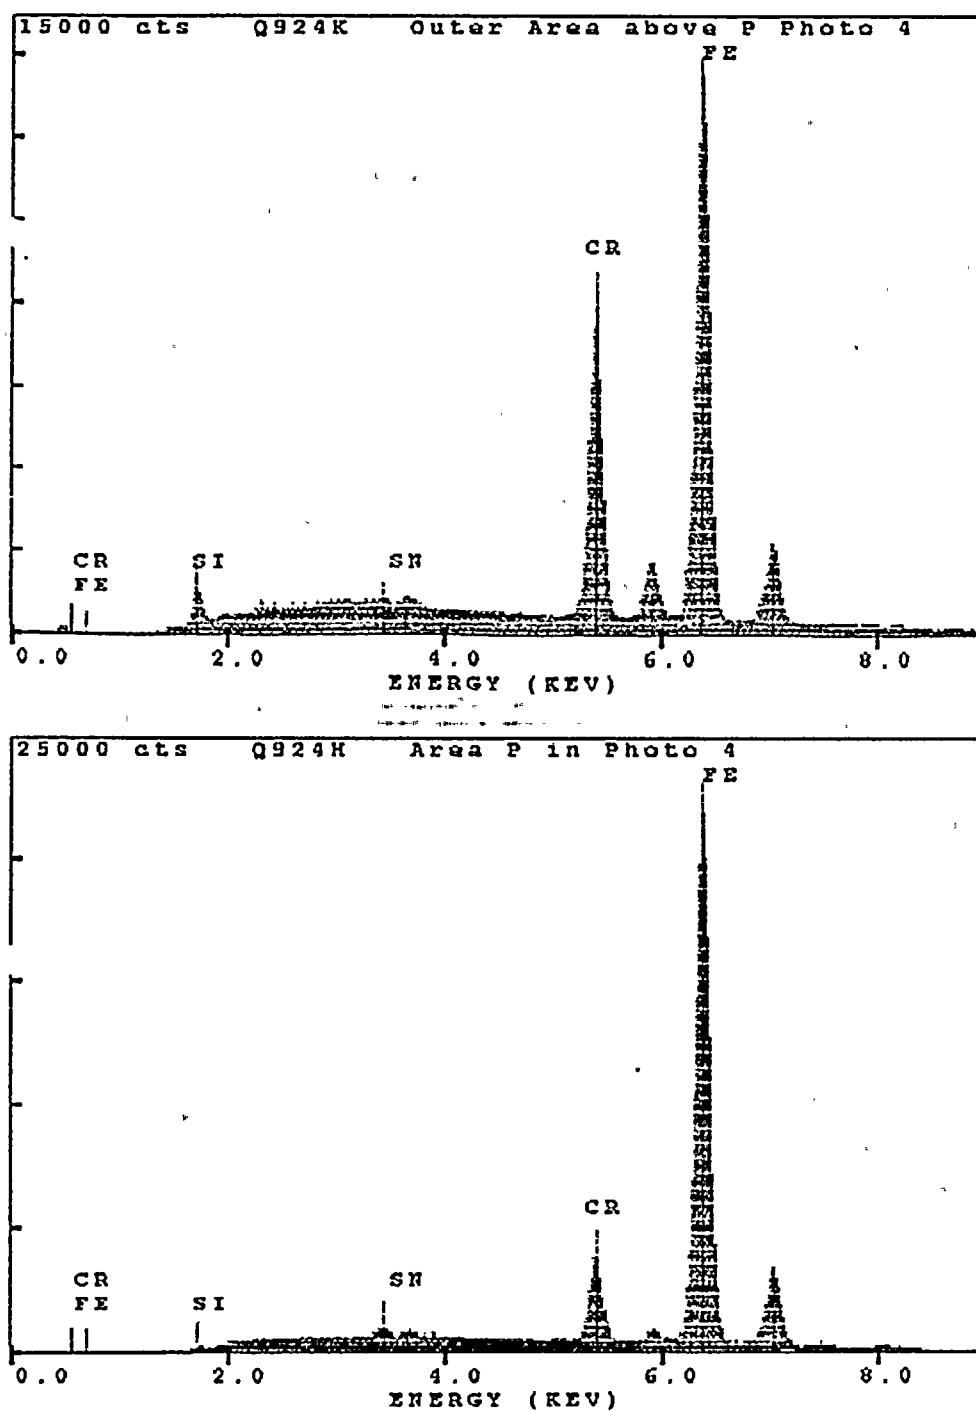
Figure B-37. EDS analysis of area P and the Dark layer above P in figure B-35.

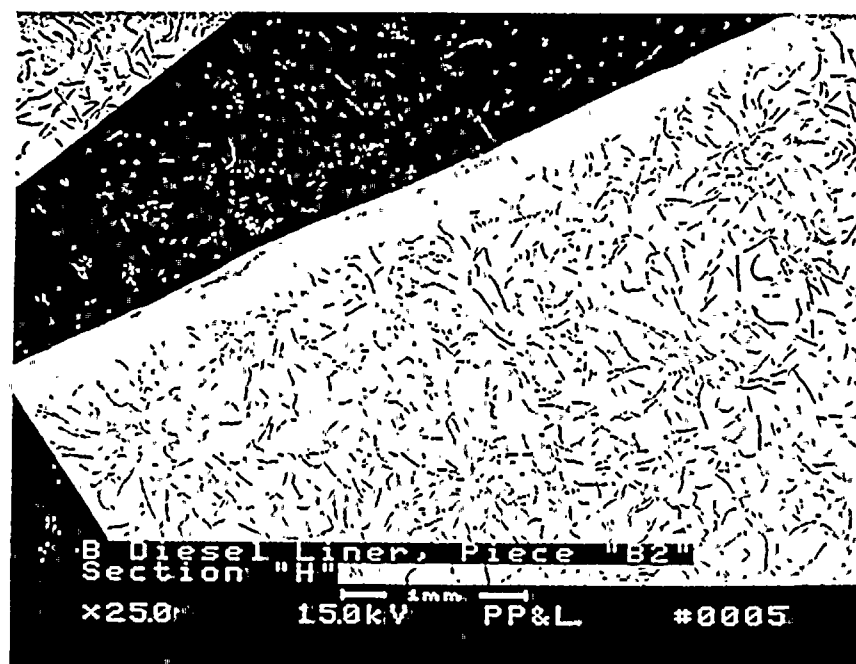
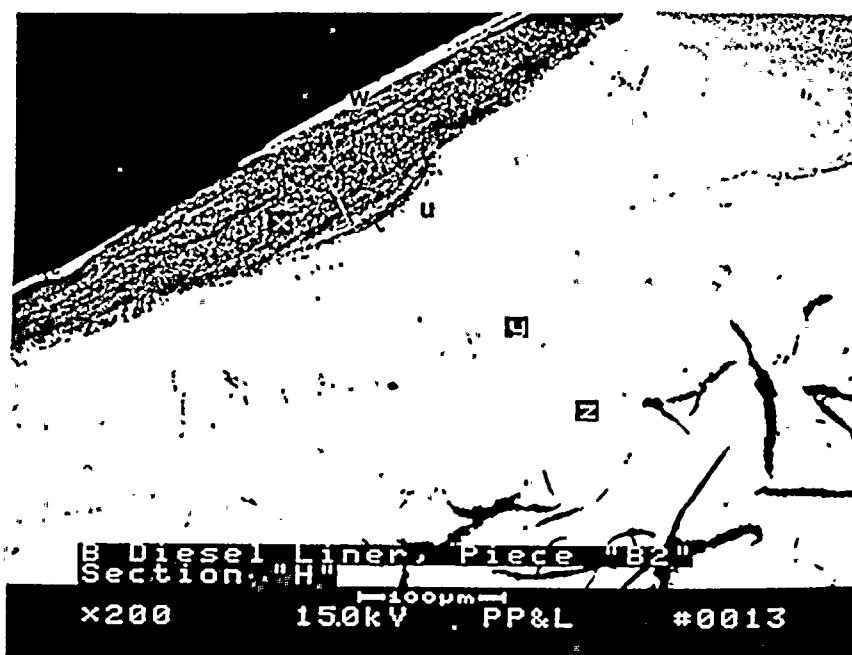
Figure B-39. Longitudinal section of B diesel 7L liner taken from the end cap side 24.625 inches from the bottom showing the layer of deposited metal and the EDS analysis of the lighter grey area.

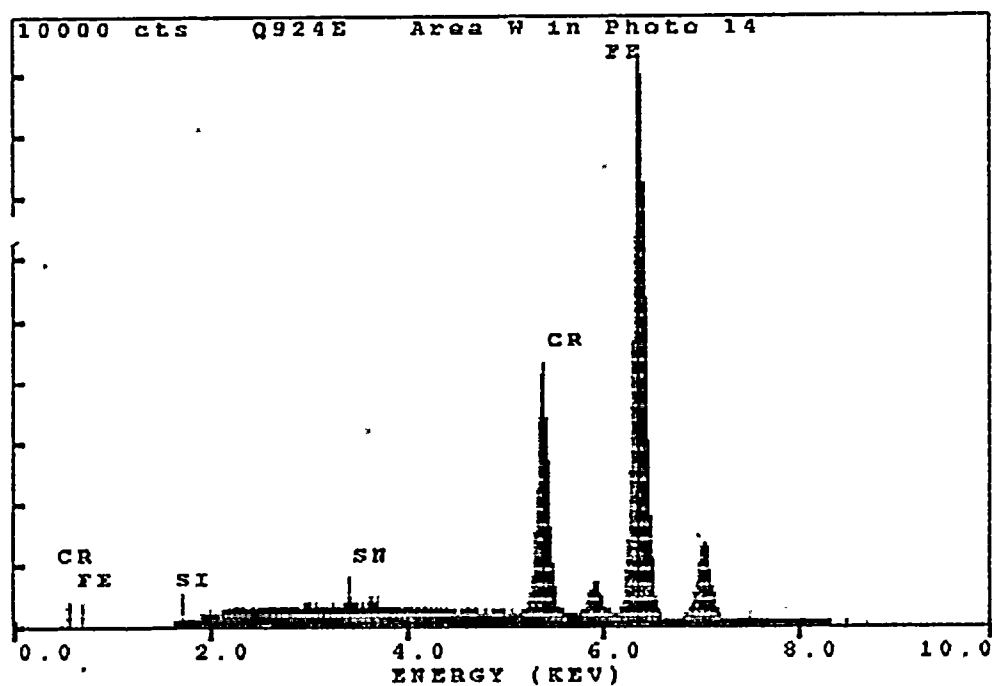
Figure B-41. EDS analysis of areas U and W shown in figure B-40.

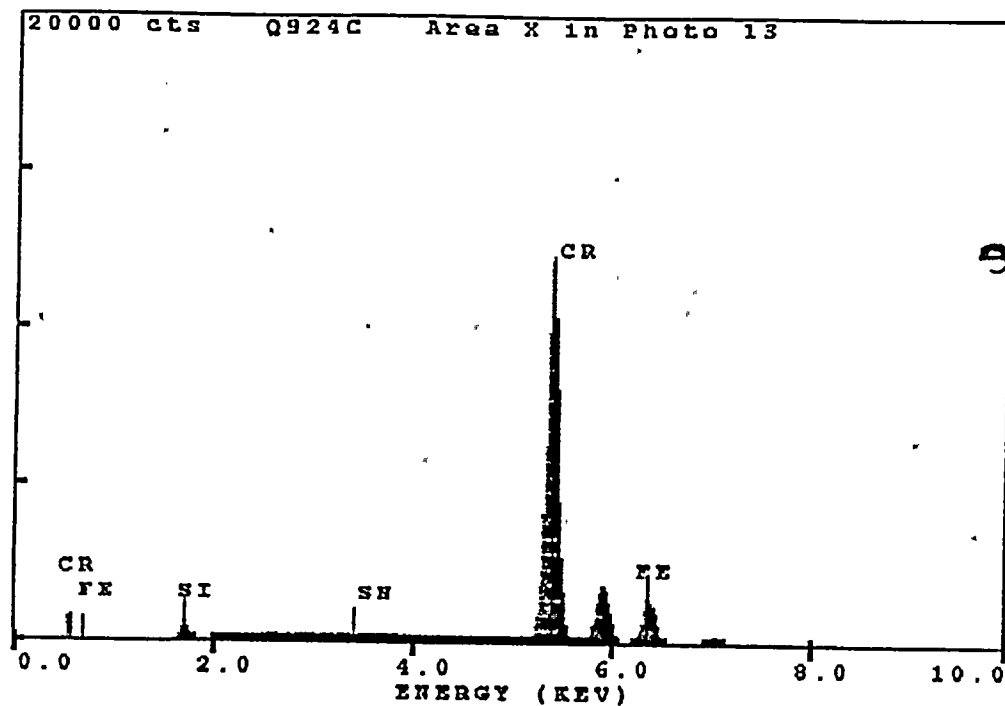
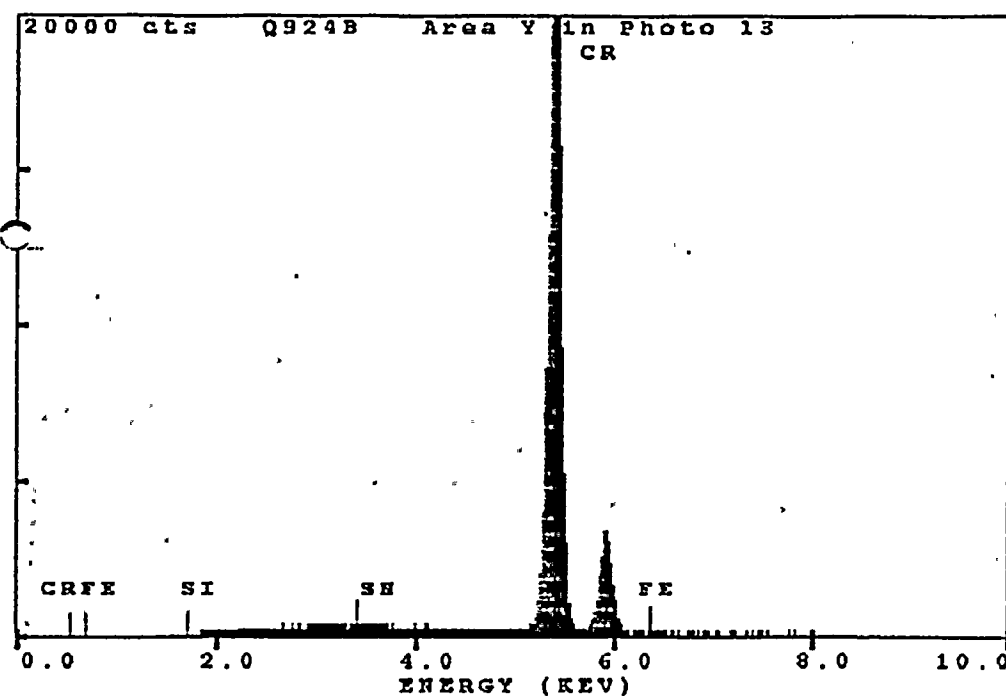
Figure B-42. EDS analysis of areas x and y shown in figure B-41.

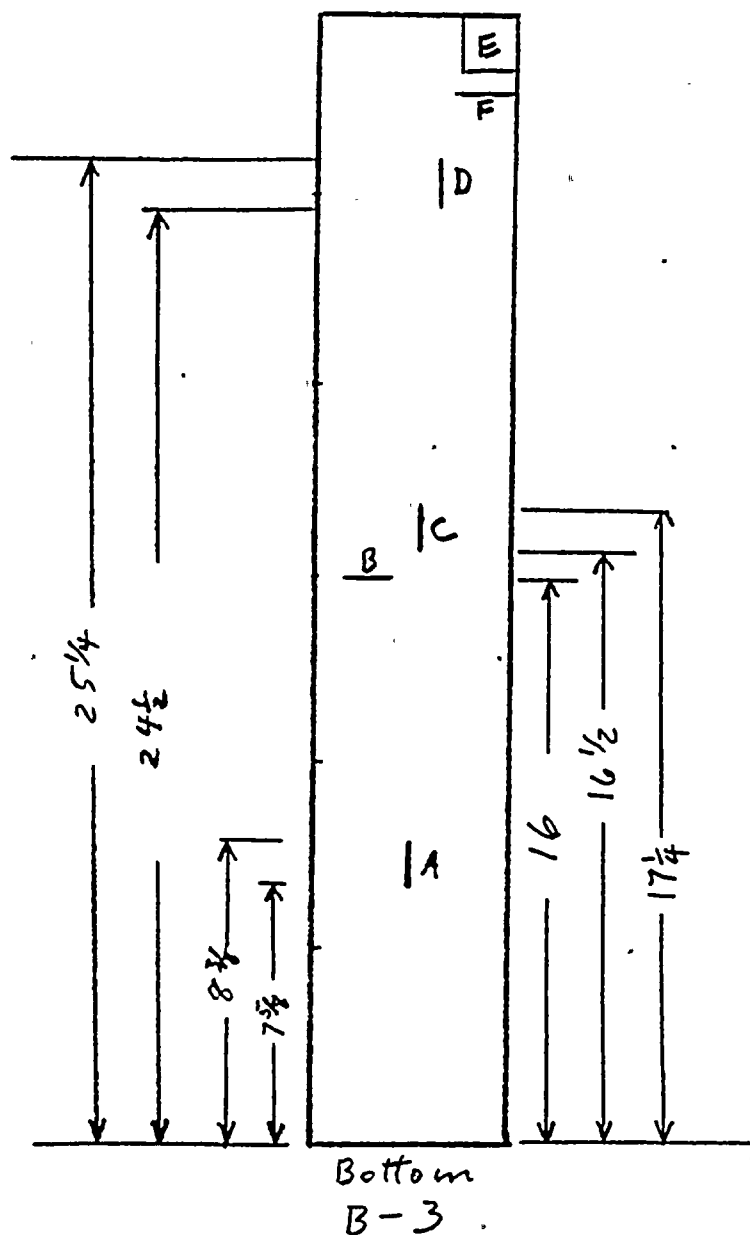
Figure B-45. Sketch of the non-thrust side of the B diesel 7L liner (designated B-3), showing the location and orientation of the metallurgical sections A, B, C, D, E, and F. Section E was for surface examinations, while the others were for cross-sections.

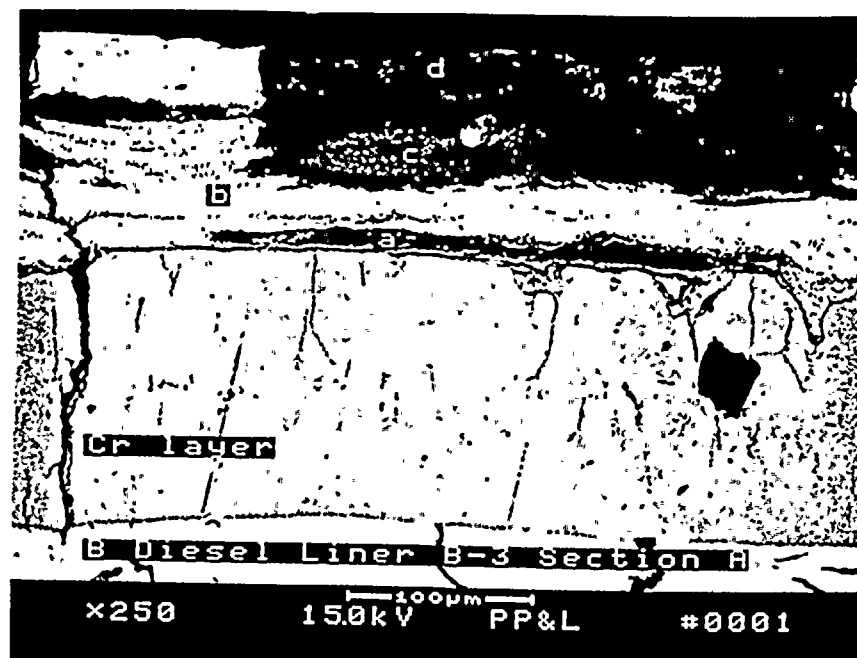
Figure B-46. Longitudinal section of the B diesel 7 L liner taken from an area 7 5/8 to 8 3/8 inches from the bottom. EDS analysis results are shown in figures B-47 and B-48.

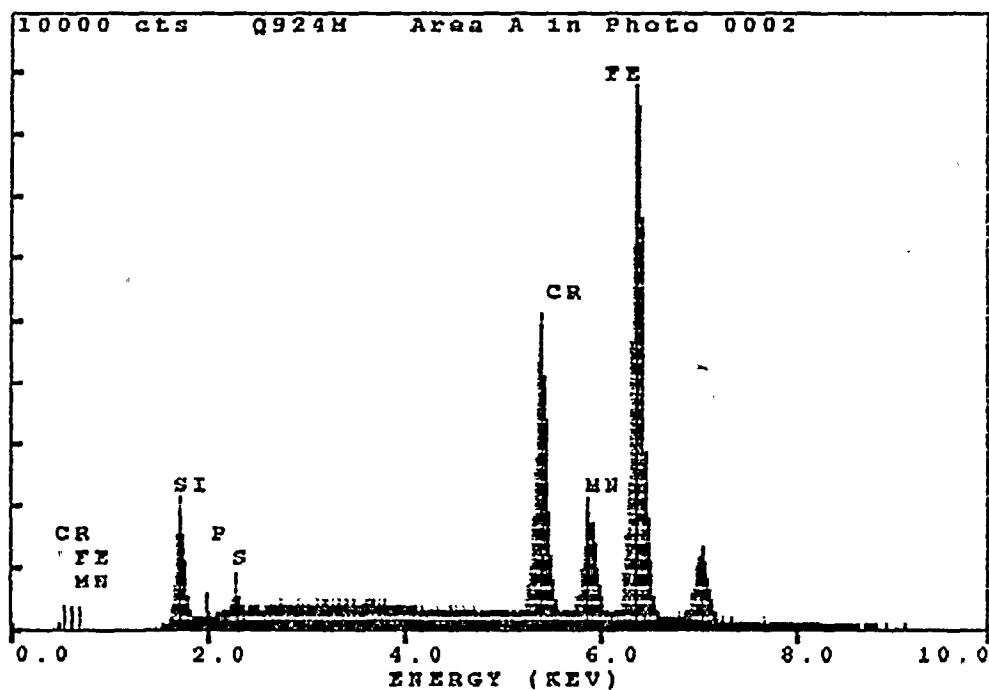
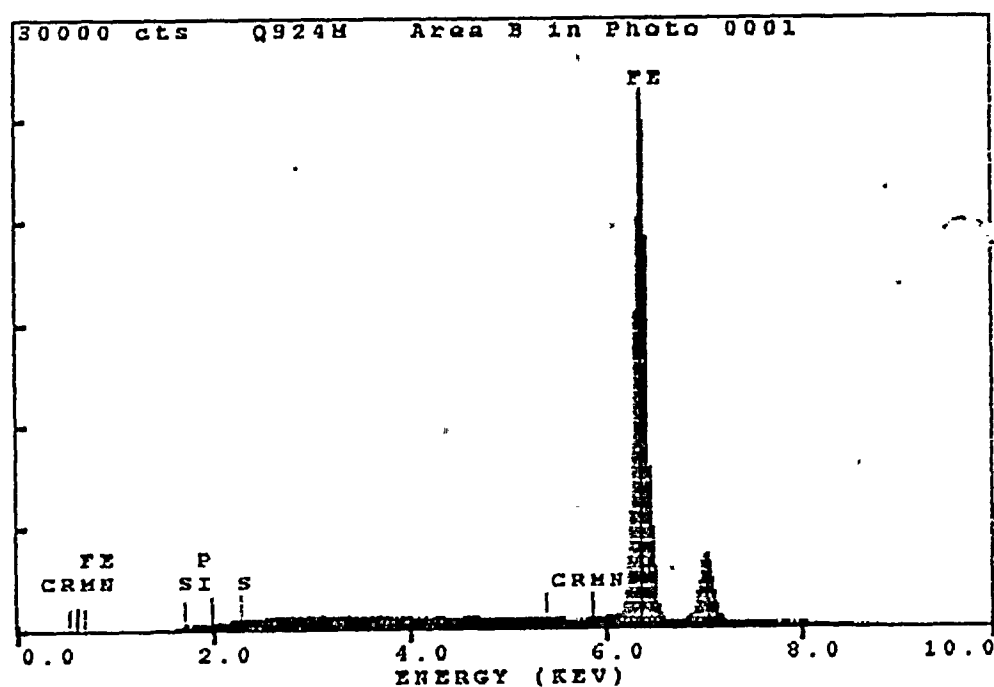
Figure B-47. EDS analysis of areas a and b in figure B-46.
