SUBJECT: Forwards SEA-CW-037, "Root Cause Failure Analysis of B & C Diesels: 1989."

SUSQUEHANNA STEAM ELECTRIC STATION
DIESEL GENERATOR CRANKCASE EXPLOSIONS
ROOT CAUSE ANALYSIS REPORT
PLA- 3321 FILE S024, R41-2

ROOT CAUSE FAILURE ANALYSIS OF "B" AND "C" DIESELS: 1989**I. ABSTRACT**

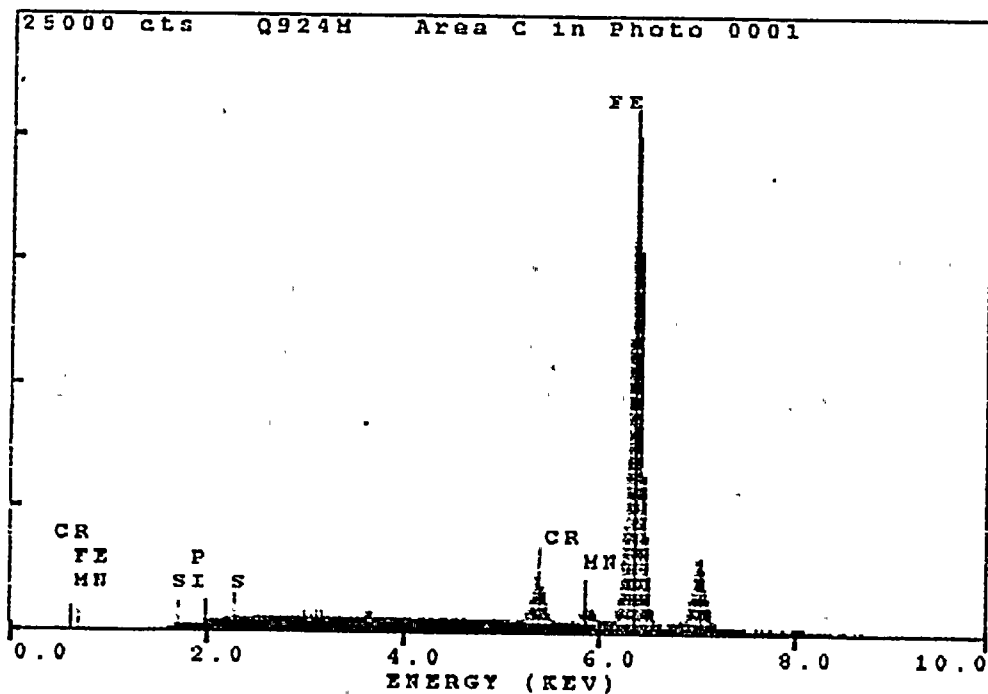
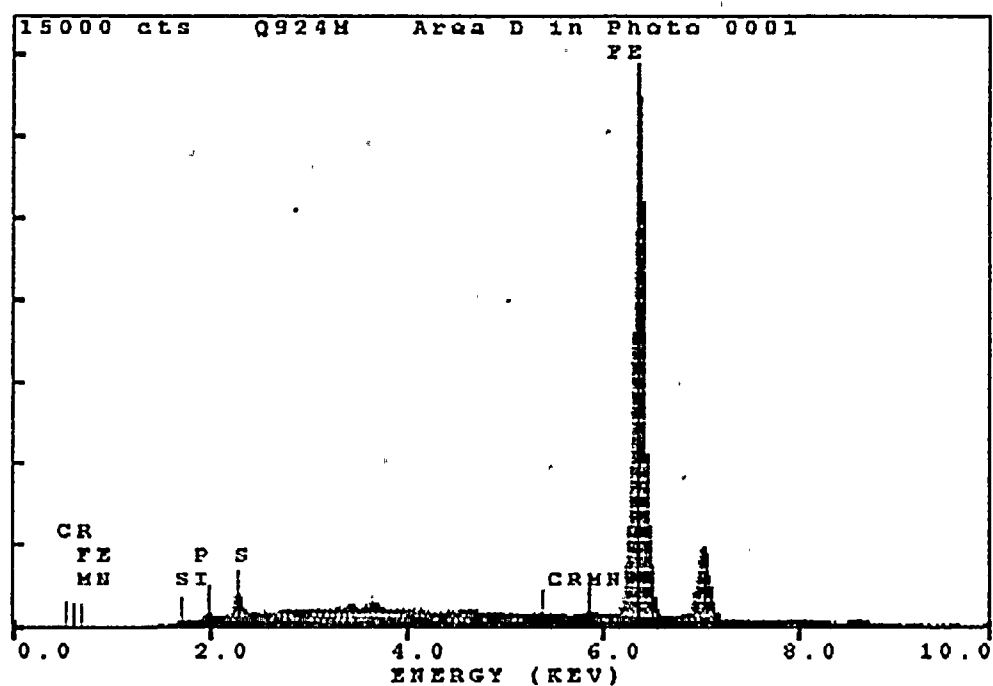
Figure B-48. EDS analysis of areas c. and d in figure B-46.

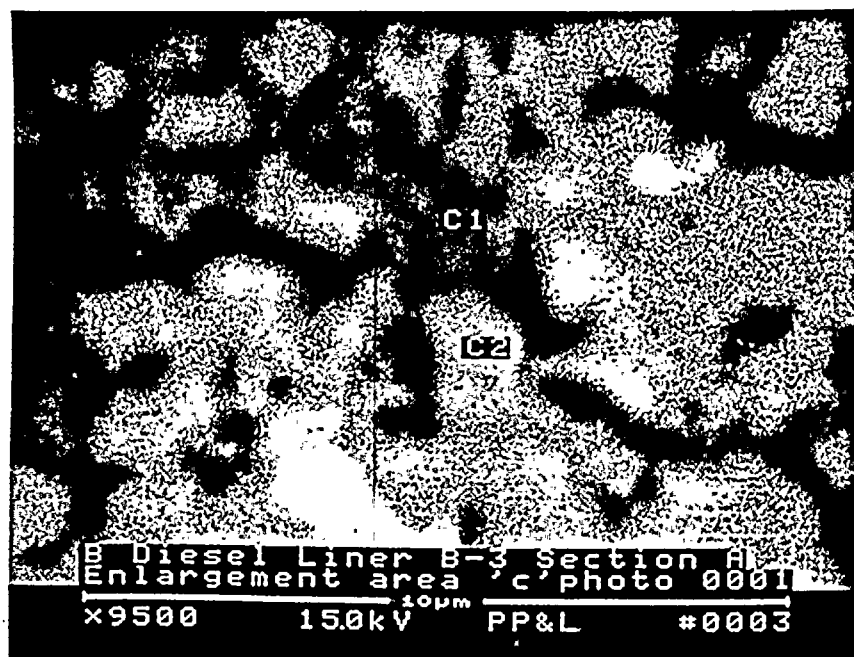
Figure B-49. Enlargement of area c in figure B-46 showing light and dark phases present. EDS analysis of these areas are shown in figure B-50.

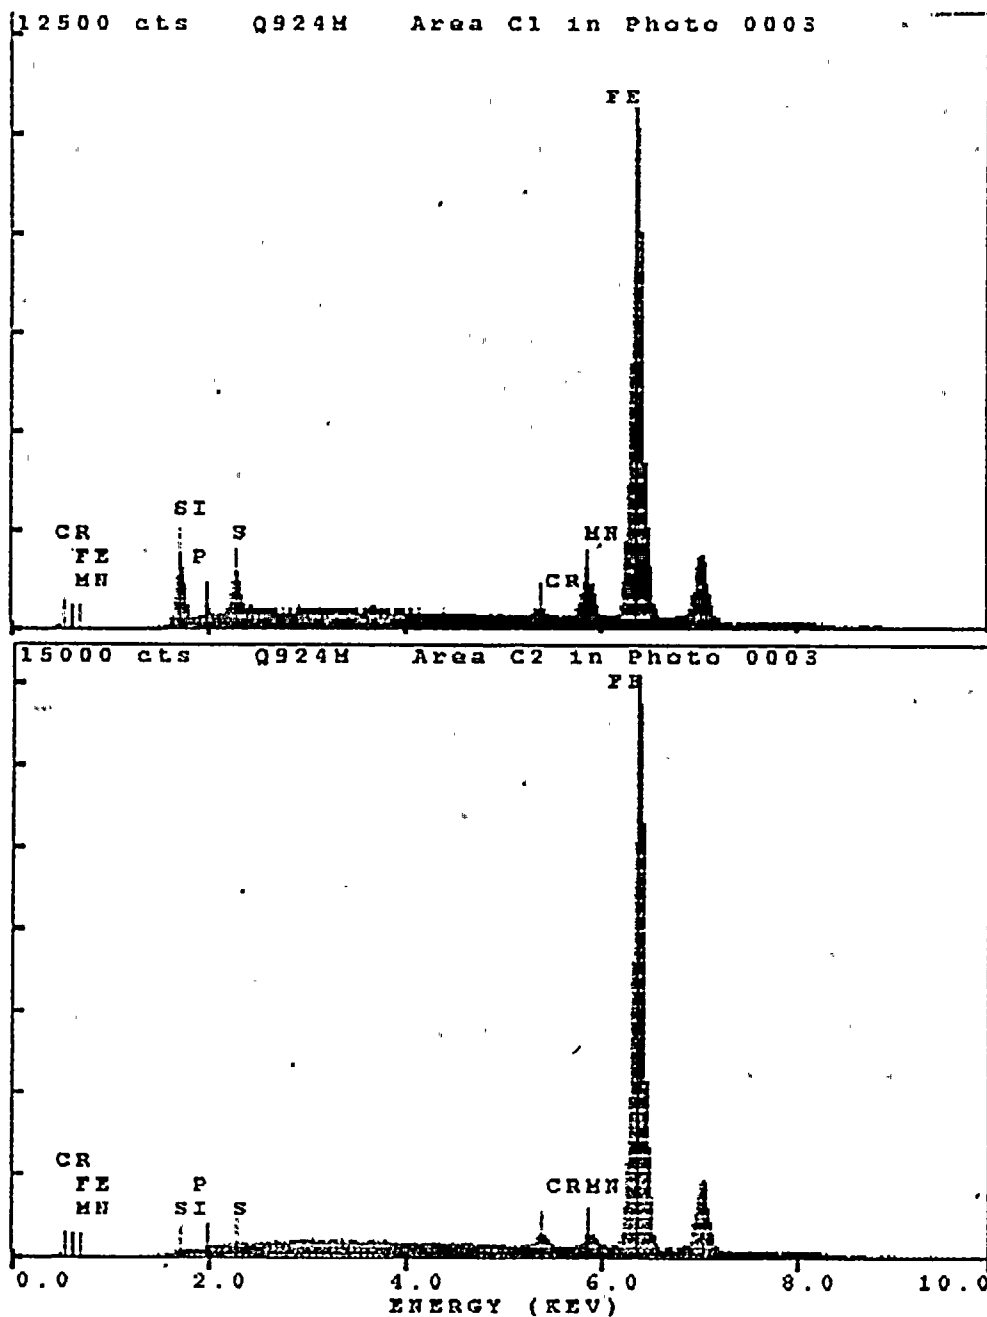
Figure B-50. Analysis of the pore from figure B-46 center right, showing that it contains mainly iron with only a trace of the elements Cr, S and Mn.

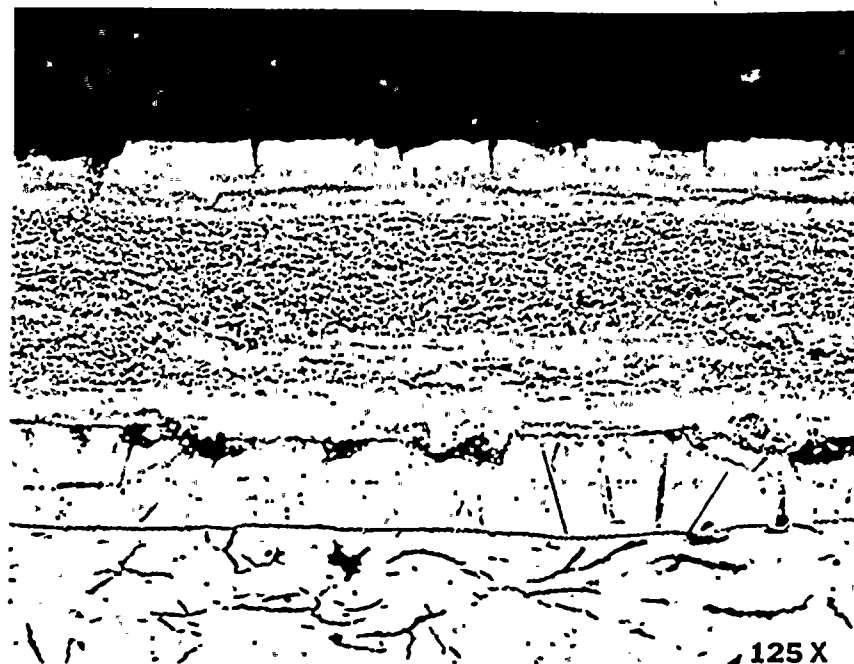
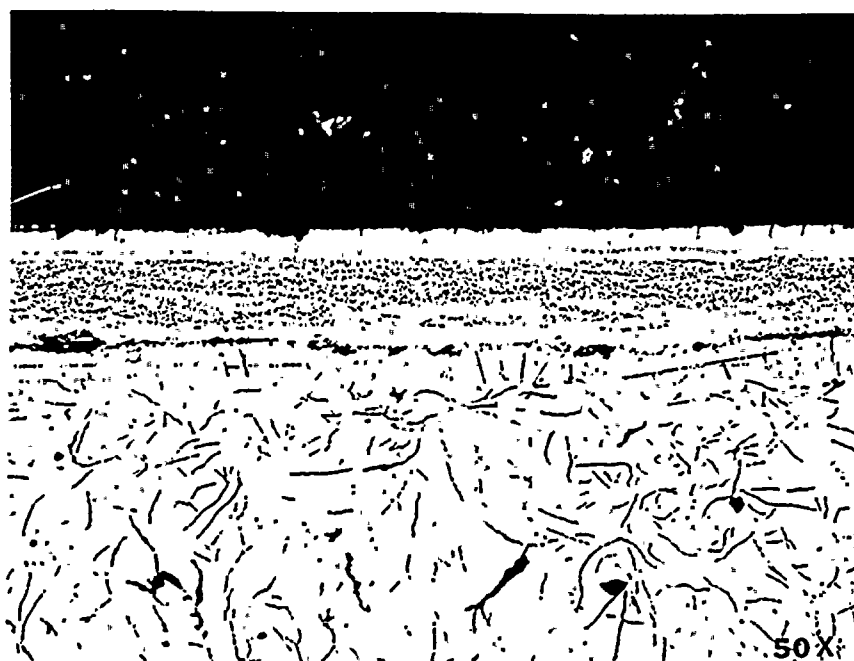
Figure B-51. Longitudinal cross-section of the B diesel 7L liner taken 7 5/8 inches from the bottom showing a very thick layer of metallic deposits covering the chromium plating.

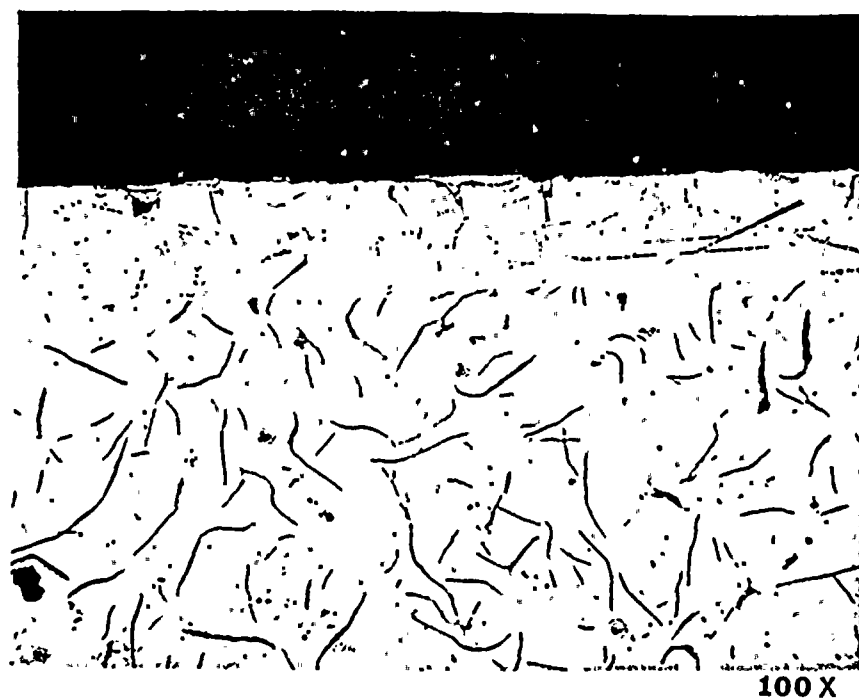
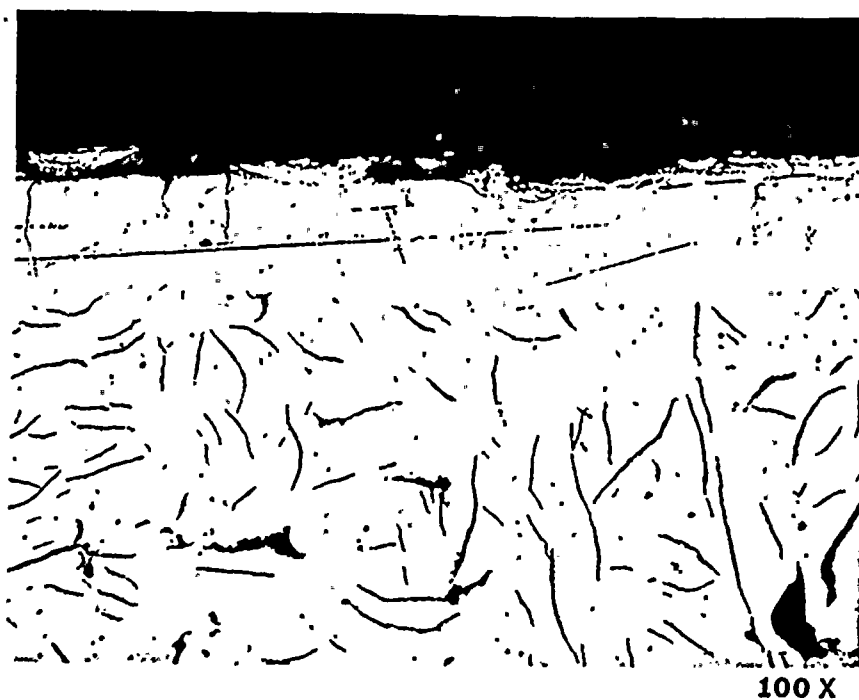
Figure B-52. Transverse cross-section of a typical area of the non-thrust side of B diesel 7L liner 16 inches from the bottom (B-3 area B) showing the filled pores and the deposited metal from this location.

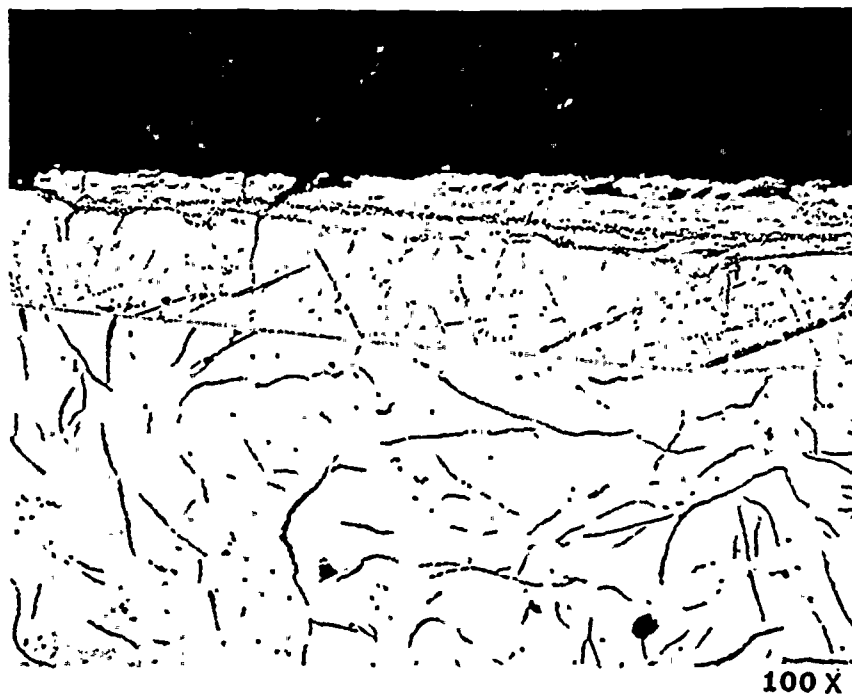
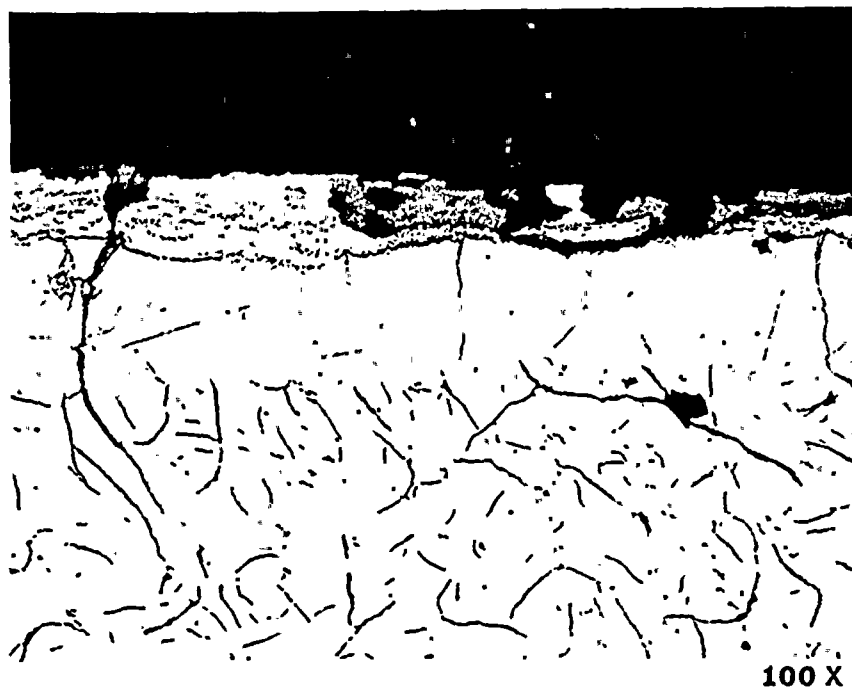
Figure B-53. Longitudinal cross-section of the non-thrust side of the B diesel 7L liner taken 16.5 inches from the bottom of the liner. Typical examples of the metal deposited from the piston and rings on the Cr plating.

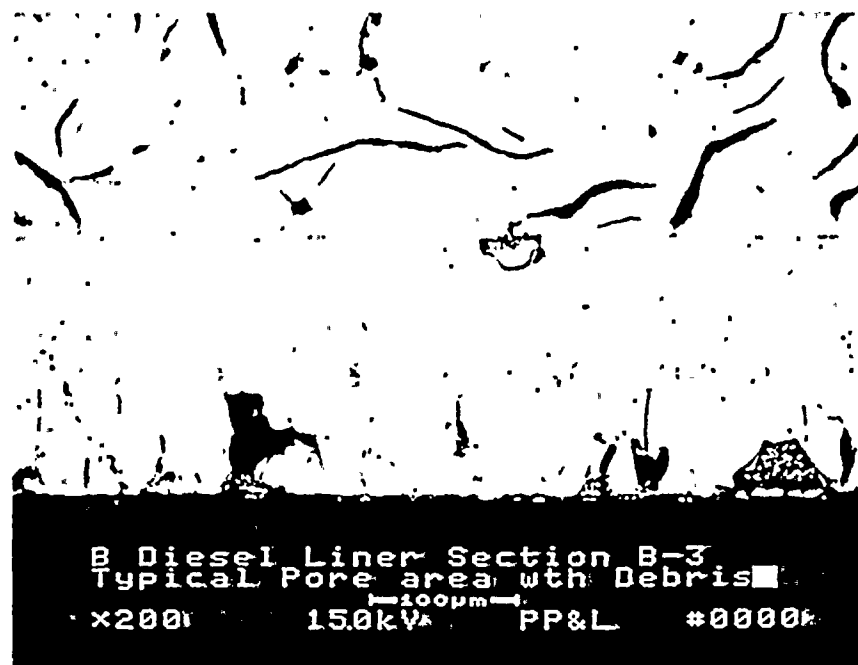
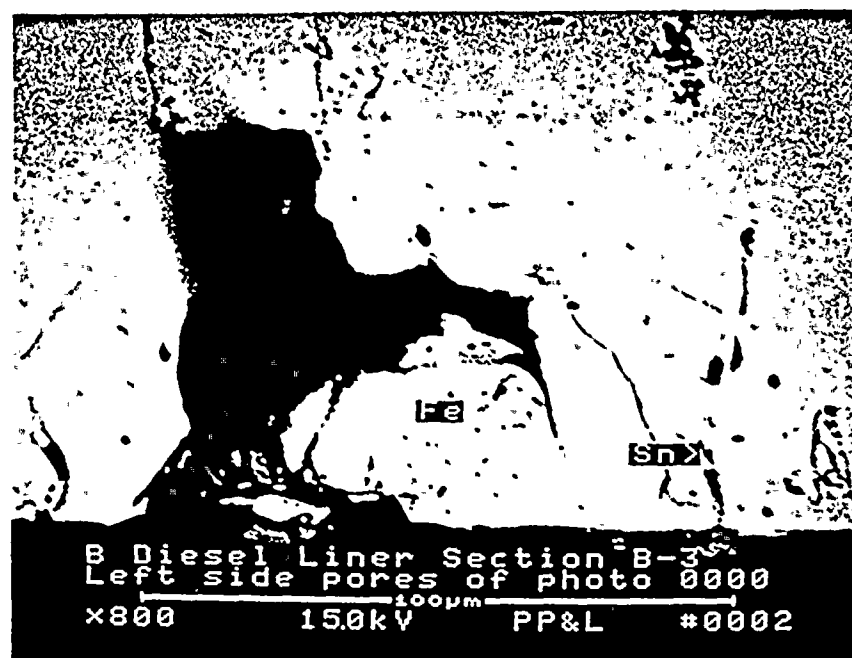
Figure B-54. SEM micrographs of longitudinal cross-section 'C' part B-3 of the B diesel liner at a level 16.5 inches from the bottom. Elements shown were identified as being present in the pores indicated.

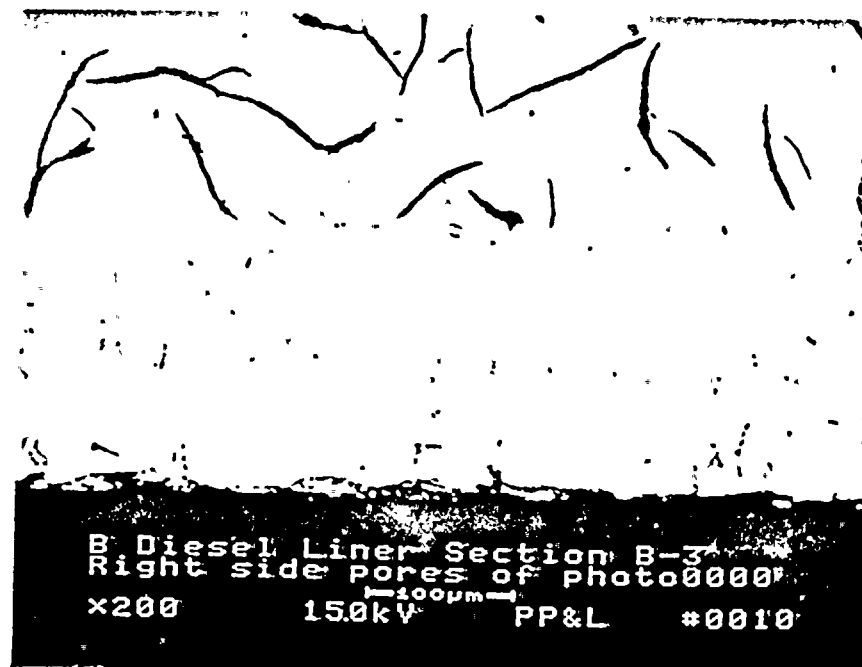
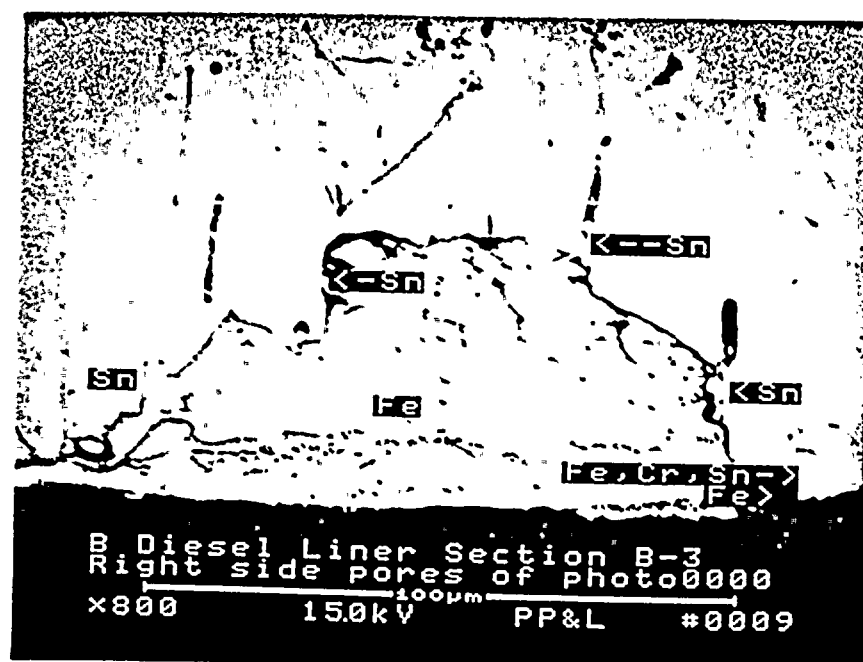
Figure B-56. Various elements and their location found in a pore from the B diesel liner 7L, part B-3, area 'C'.

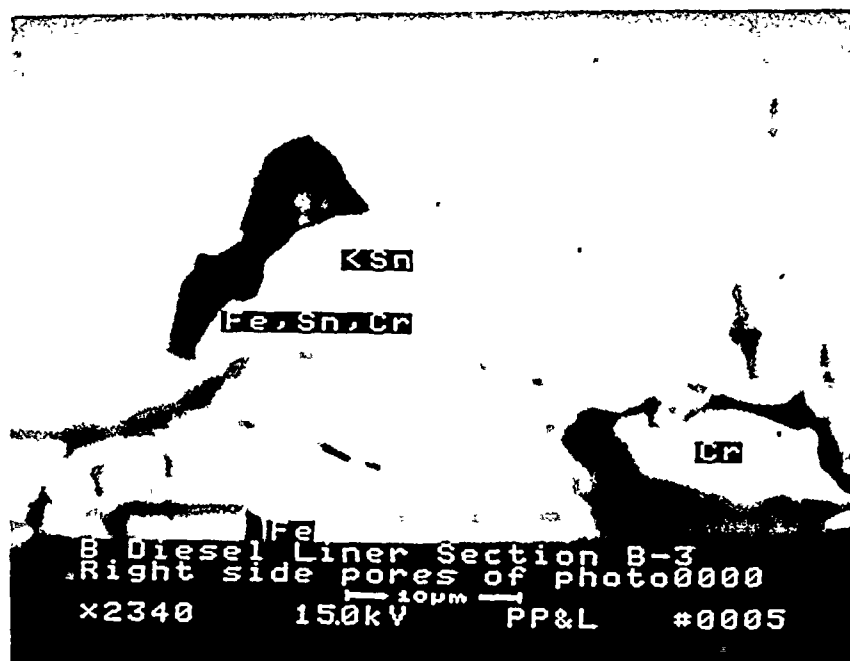
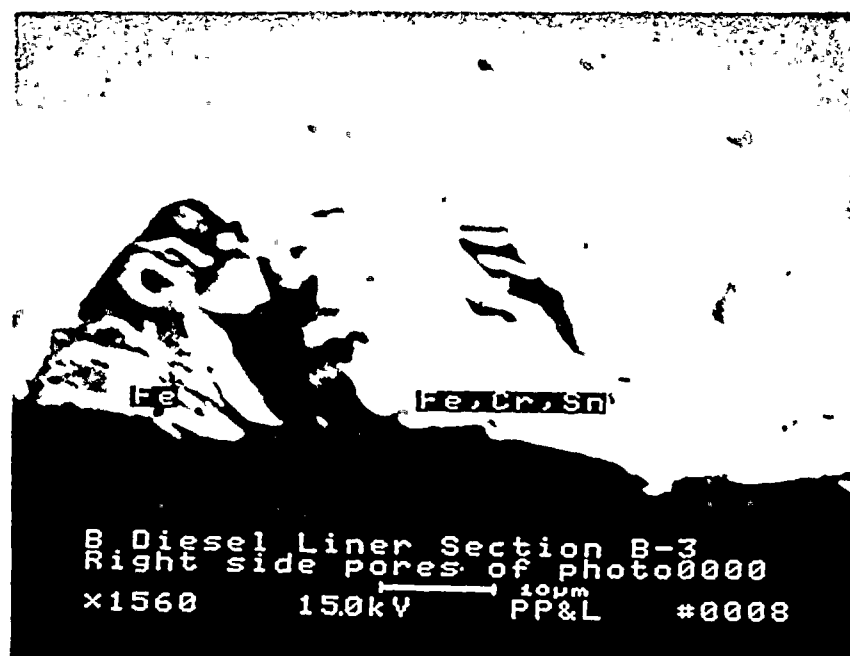
Figure B-57. Elemental contents of two pores filled with metal in the B diesel 7L liner 16.5 inches from the bottom of part B-3, area 'C'.

- 4.2 Tin and iron were the elements found in the liner pores analyzed to date. They indicate wear products were generated from the rings and piston surface and were deposited there early in the failure process.

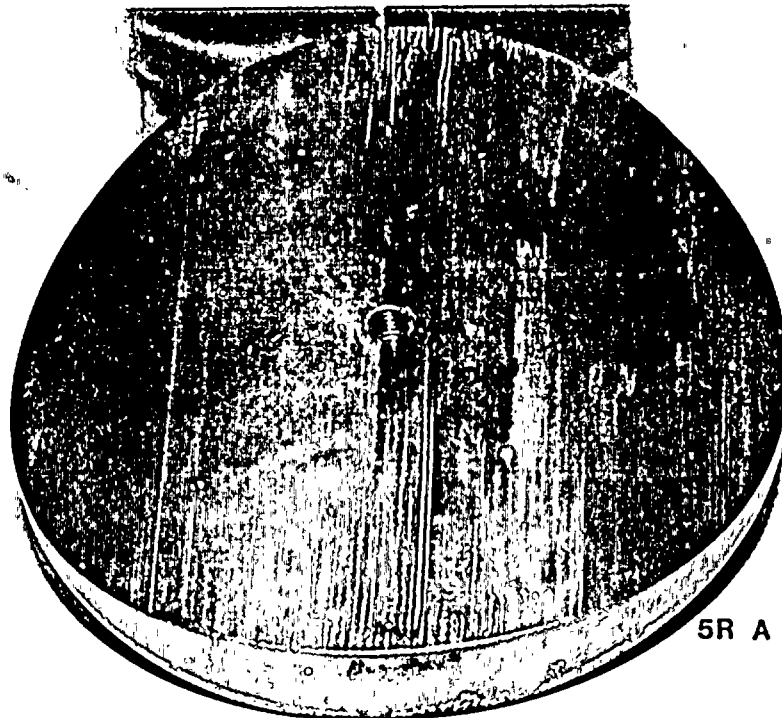
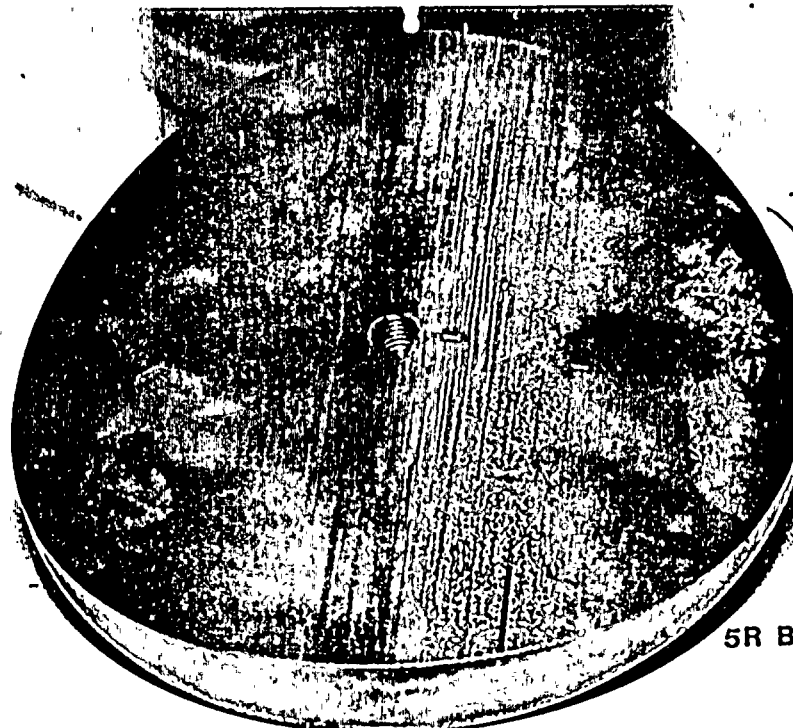
- 4.0 Conclusions
- 4.1 Heavy damage was found on the cylinder liner surface, piston, compression rings, oil rings, pin and pin bushing of the "C" diesel 5R cylinder. Since the piston end caps suffered only slight scoring, it can be concluded that the damage was due to the failure, not a cause like the end caps in the "B" diesel.

Figure C-2. Photographs of the 5R end caps, C diesel, showing the discoloration and minor scoring.

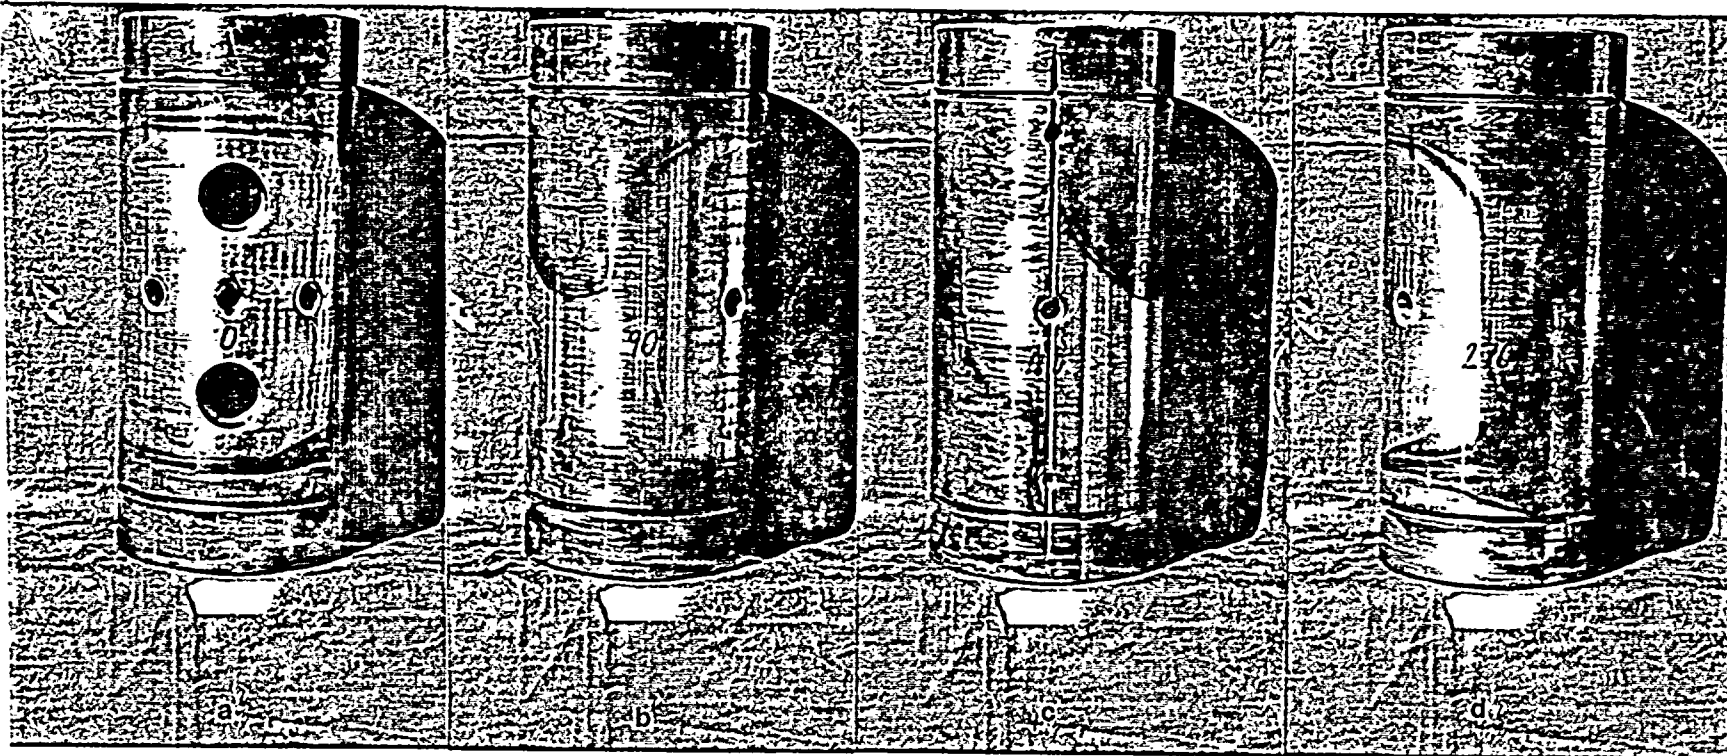
1.2.1 The 5R piston characteristics were similar to those of the 7L piston from the "B" D/G failure on September 16, 1989 - the blackened areas with scratched and smeared metal, worn rings, rings with caked debris, piston skirt cracking. The piston damage caused by the lack of lubrication and overheating is shown in photographs in Figures C-6, C-7 and C-8. The major differences were (1) the end caps were only slightly scratched, (2) the piston skirt contained two deep holes, and (3) the piston wrist pin and its bushing suffered major overheating (bluing). The bushing had broken free from its bore in the piston due to the contact between the pin and bushing caused by the pin expansion and loss of lubrication from the heating. From the heat, the bushing flowed into the shape of the oil grooves at the pin ends. There was so much contact between the pin and bushing that they had to be cut apart. The pin exhibited normal wear patterns at the interface between the pin and connecting rod, indicating no loose connections (Figure C-5a). Photos in Figures C-3, C-4 and C-5 show the damage to the pin and bushing.

- 4.3 The piston pin and the bushing sustained major damage from overheating due to the pin expansion causing contact with the bushing and ultimately freezing of the pin in the bushing. This type of failure of the pin/bushing would create a malfunctioning of the motion of the piston initiating a failure process.

Figure C-5. a) thru d) Photographs of the discoloration (bluing at various positions around the pin from the 5R piston, C diesel.

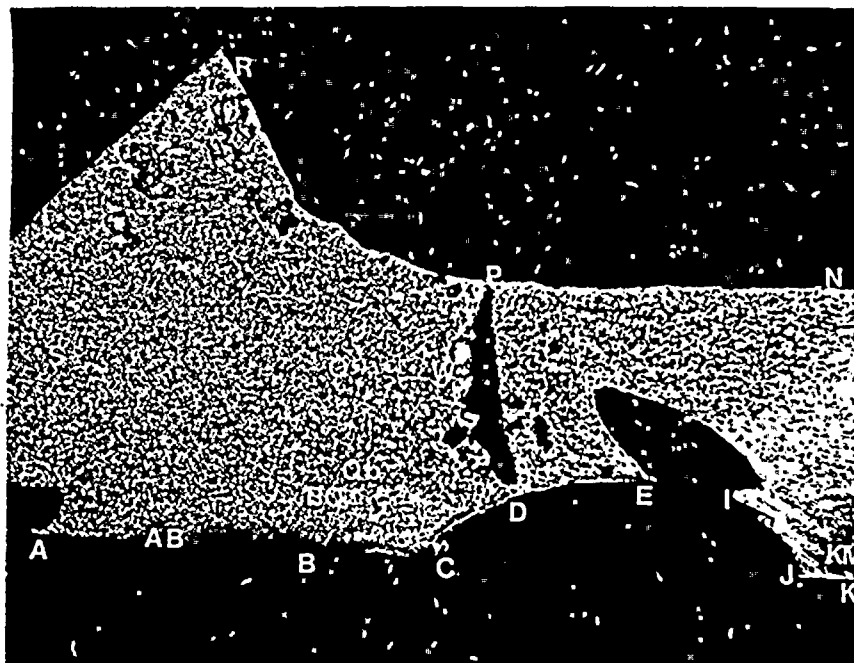
- 3.2 The piston skirt contained two holes in the non-thrust side. These holes were created as part of the casting process for the piston. The presence of a lead/tin eutectic indicated that this area was repaired with solder during the manufacturing process. Cooper's QC records indicated that solder was used to fill the voids in the piston skirt. Also this portion of the liner extends beyond the bottom of the skirt at the end of the downstroke and any debris from this area would eject into the sump. Thus, these holes in the piston skirt had no impact on the failure.

Figure C-10. A microphotograph of the cross section of the 5R piston skirt. Hole 'A'; in Figure C-9. The letters designate the areas evaluated metallurgically.

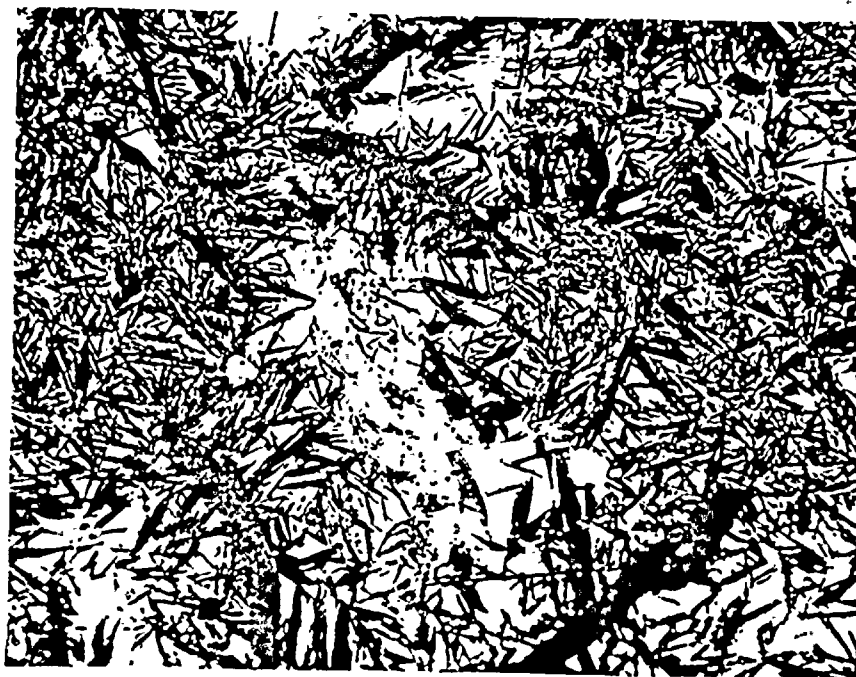
11b

Figure C-11. . Microphotographs of typical areas around hole 'A' in the 5R piston skirt. See Figure C-10 for locations, a) Area KM at 800C showing a coarse martensitic structure; b) Area K-J at 50X showing coarse martensitic and smear metal layer of iron chrome and tin on surface of hole 'A' c) Area H-G at 50X showing transition from a martensitic to a pearlite structure; d) Area C-B at 800X showing coarse martensitic structure; e) Area B-Q at 800X showing pearlite structure around graphite stringers; f) Area A-B at 50X showing a mixed structure of fine pearlite and martensite.

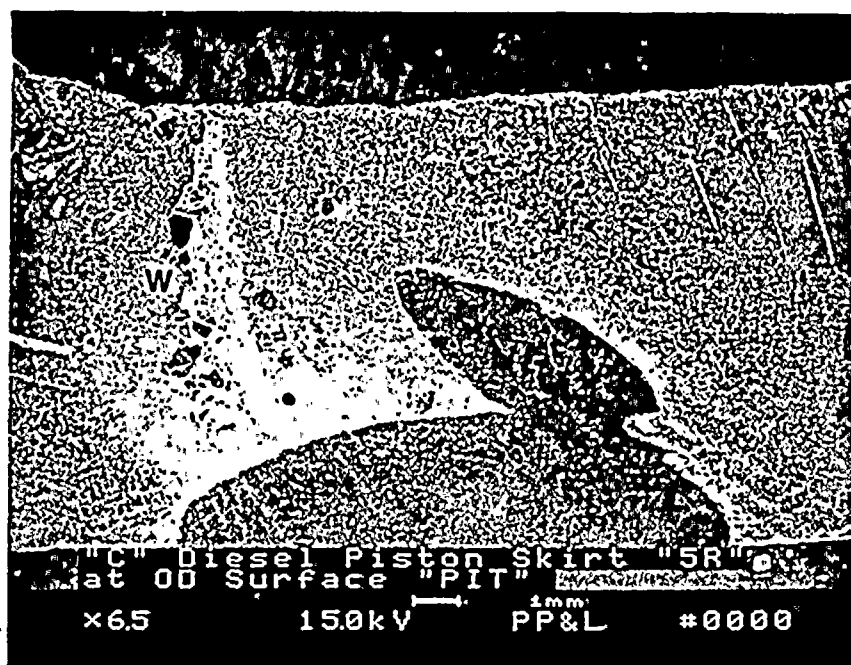
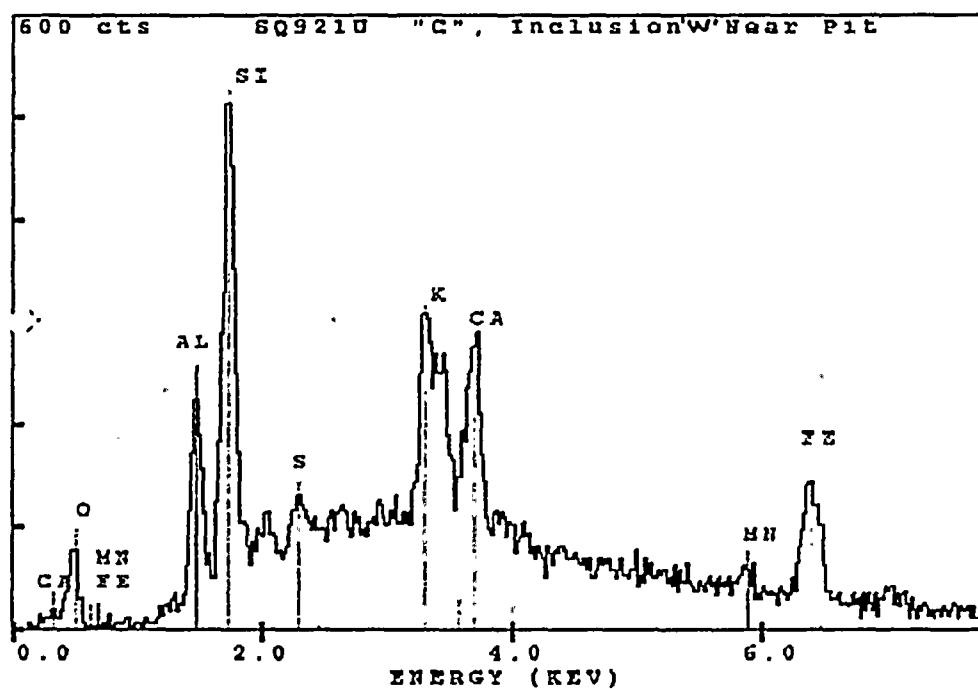
Figure C-12. S.E.M./E.D.S. analysis of inclusion 'W' below hole 'A' in 5R piston skirt a) SEM photo at 6.5X showing inclusion 'W' b) Spectrum of the elements in the inclusion 'W'.

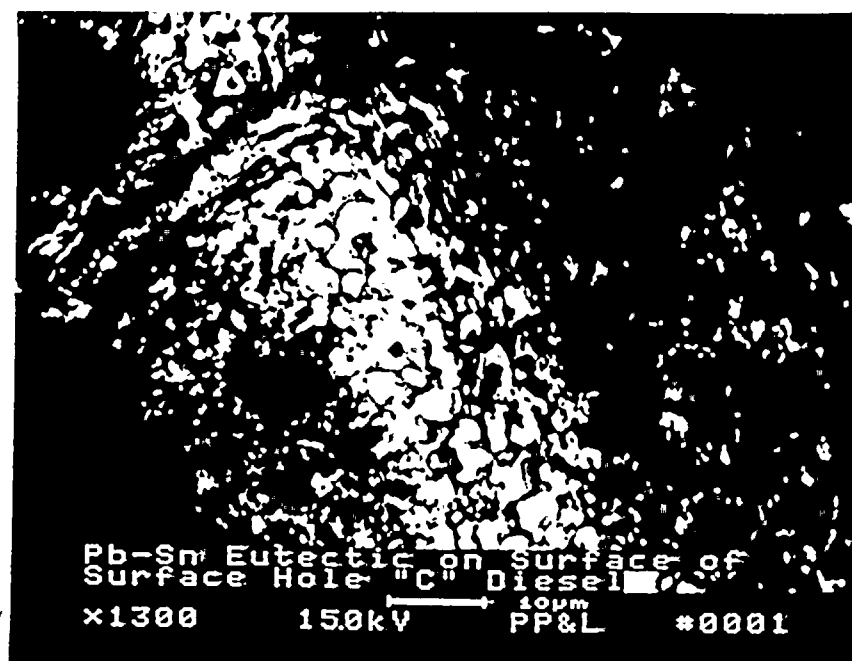
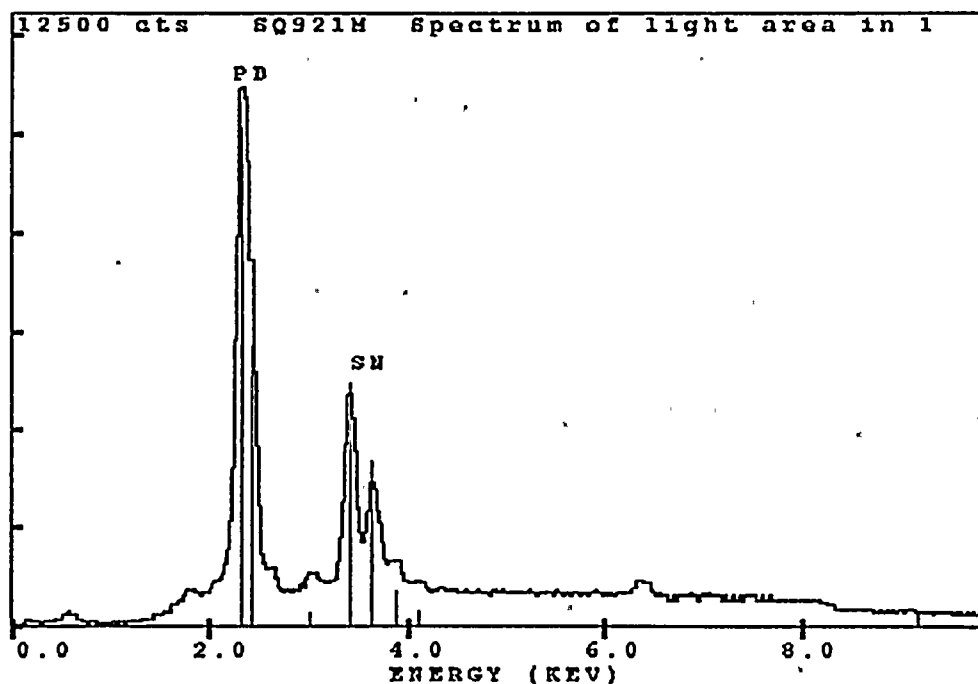
Figure C-13. S.E.M./E.D.S. analysis of the Lead-Tin Eutectic on the surface of hole 'A' in 5R piston skirts a) SEM photo at 1300X showing the Pb-Sn Eutectic on surface of hole; b) Spectrum of the elements in the light area in a above.

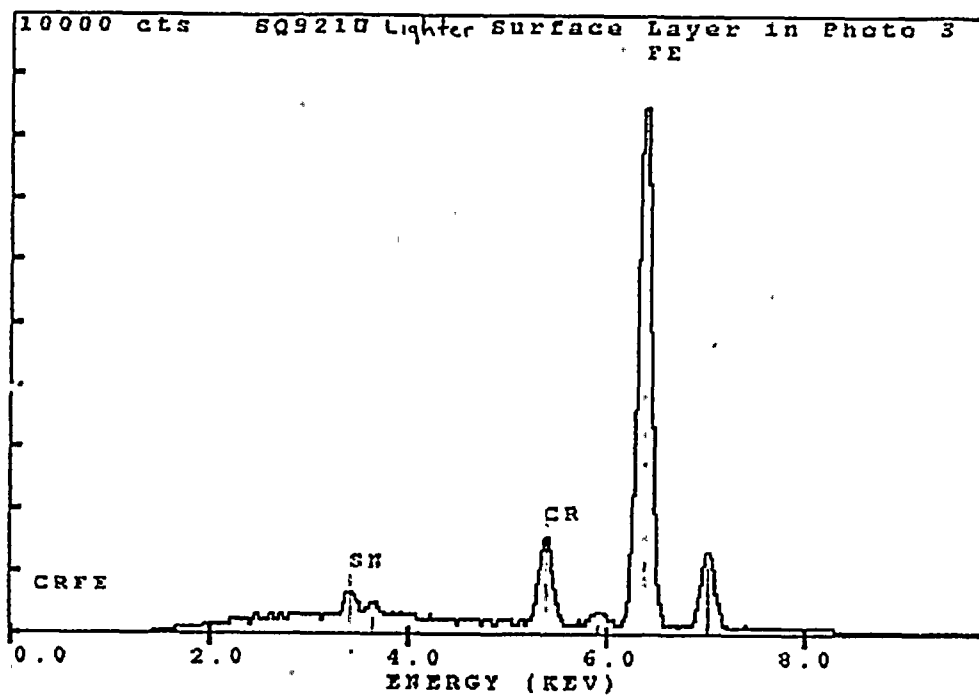
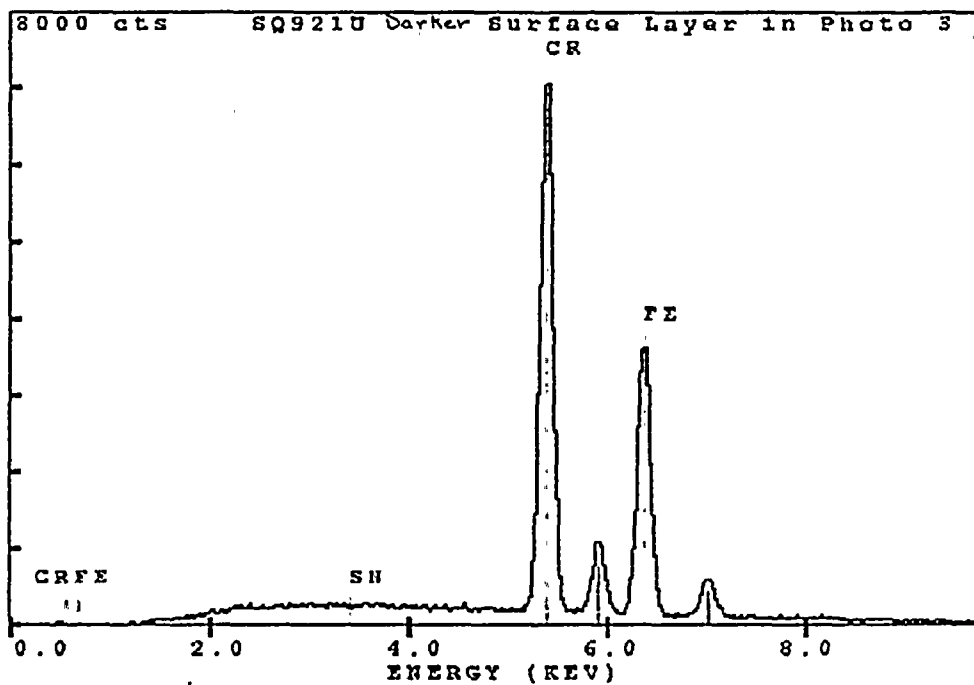
Figure 14. Continued.

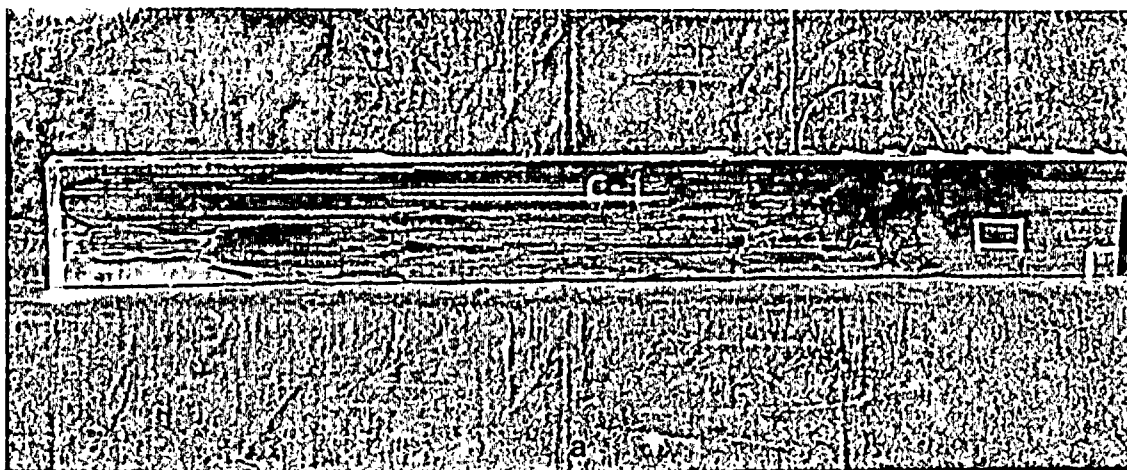
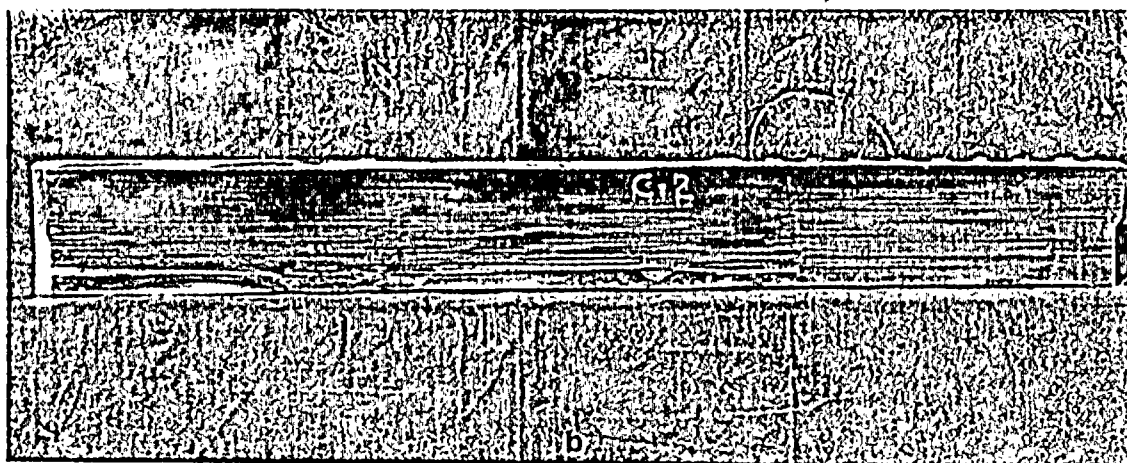
Figure C-15. Photos of 5R liner sections C-1, C-2 and C-3; a) liner section C-1 longitudinal section taken from thrust side; b) Liner section C-2 longitudinal section taken from end cap side; c) Liner section C-3, longitudinal section taken from the non-thrust side.

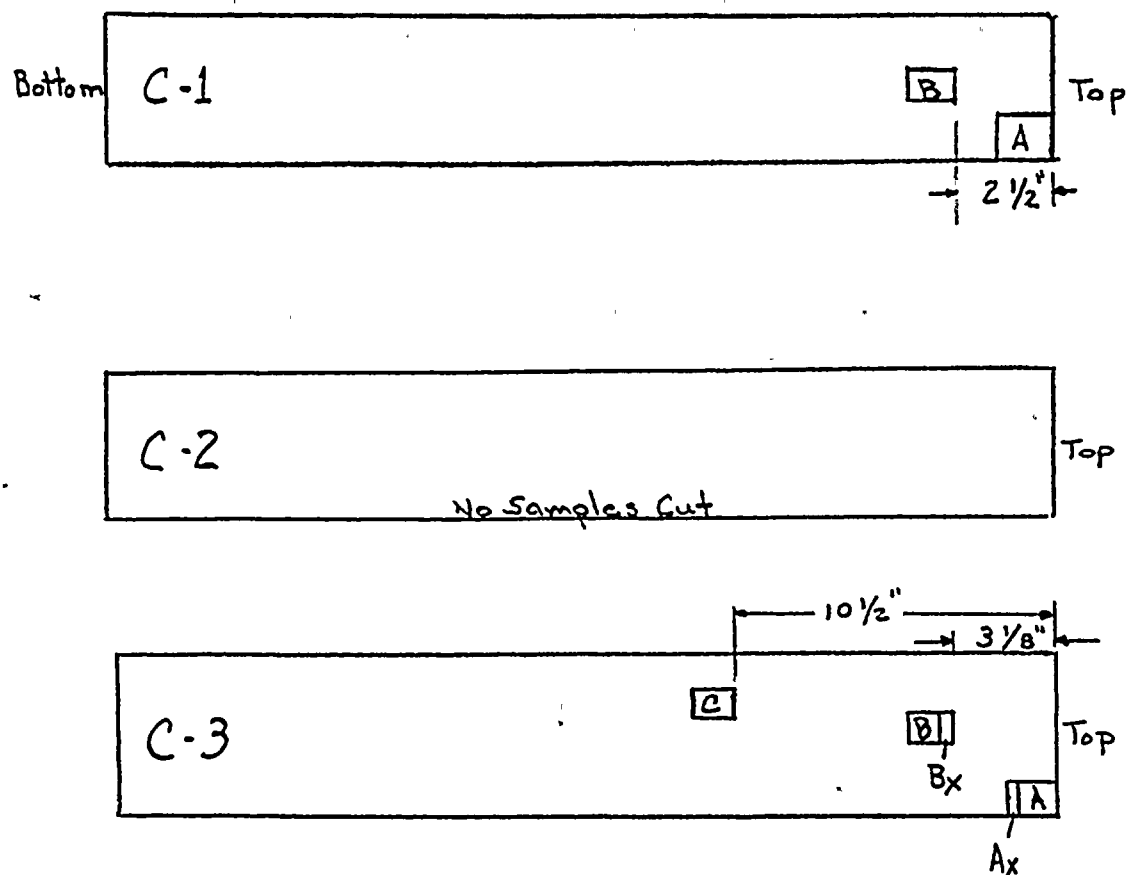
5R Cylinder Liner

Figure C-16. Sketch of sections taken from liner pieces.

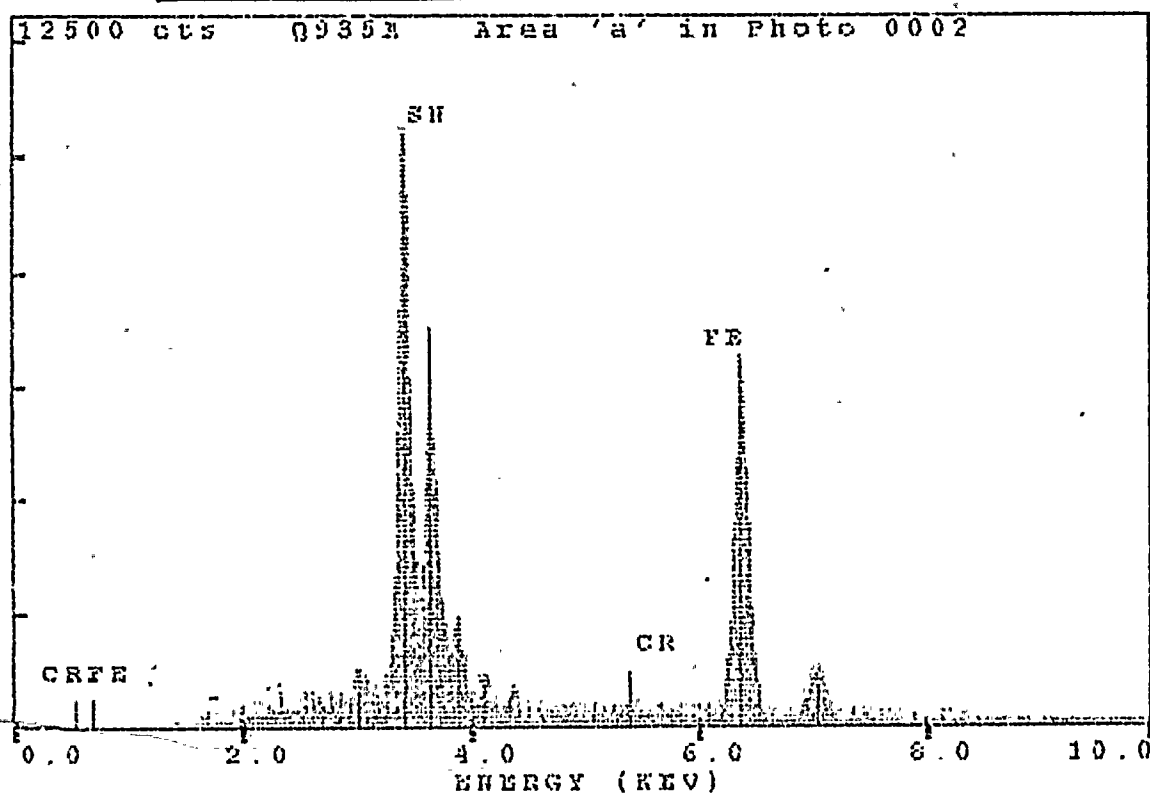
Figure C-17. S.E.M./E.D.S. analysis of the debris in the pores in liner section C-3B (see Fig. C-16); a) S.E.M. photo at 100X of section C-3 denotes area a, b, & c for analysis on E.D.S.; b) Spectrum of area 'a' showing the presence of mostly tin and iron; c) Spectrum of area 'b' showing mostly tin and iron with a small peak of chrome; d) Spectrum of area 'c' showing mostly iron and tin with a small peak of chrome.

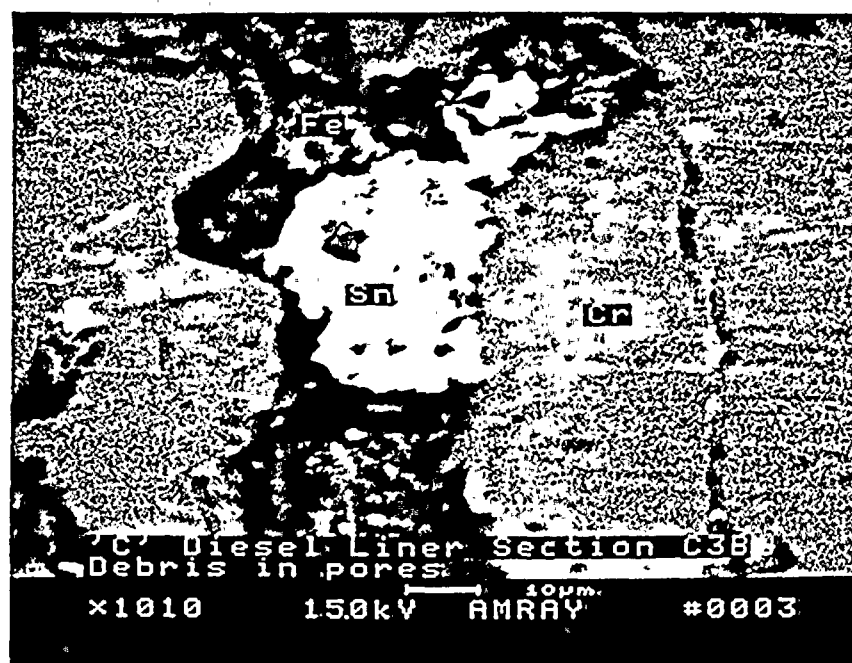
Figure C-18. Microphoto from S.E.M. 1010X showing the iron and tin particles in a pore in the chrome layer on liner section C-3B.
