SUBJECT: Forwards SEA-CW-037, "Root Cause Failure Analysis of B & C Diesels: 1989."

SUSQUEHANNA STEAM ELECTRIC STATION
DIESEL GENERATOR CRANKCASE EXPLOSIONS
ROOT CAUSE ANALYSIS REPORT
PLA- 3321 FILE S024, R41-2

ROOT CAUSE FAILURE ANALYSIS OF "B" AND "C" DIESELS: 1989**I. ABSTRACT**

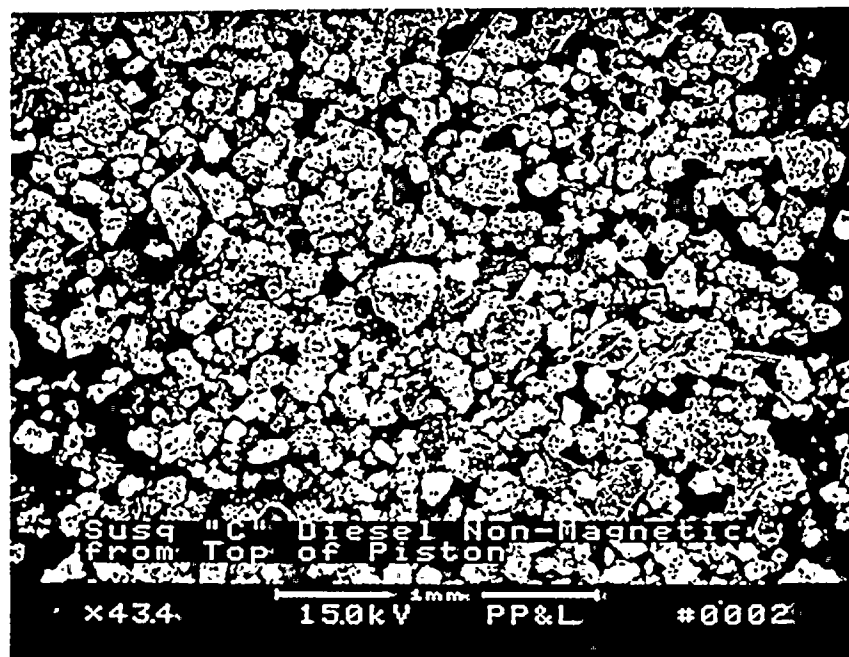
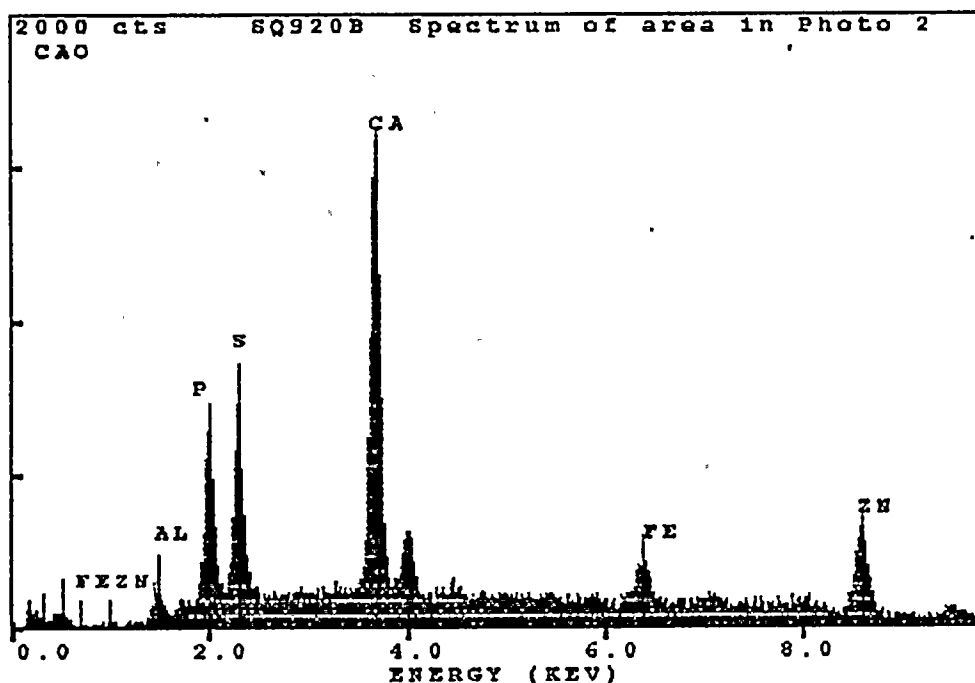
Figure C-19. S.E.M./E.D.S. analysis of non-magnetic particles taken from the top of the 5R piston, C diesel; a) S.E.M. photo of 43.4X of non-magnetic particles; b) Spectrum of area in the S.E.M. photo.

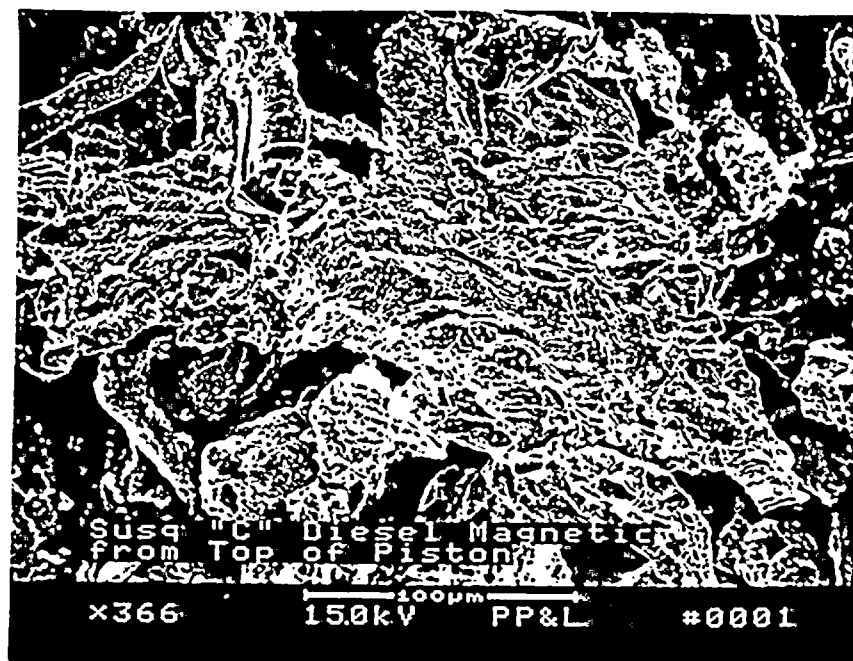
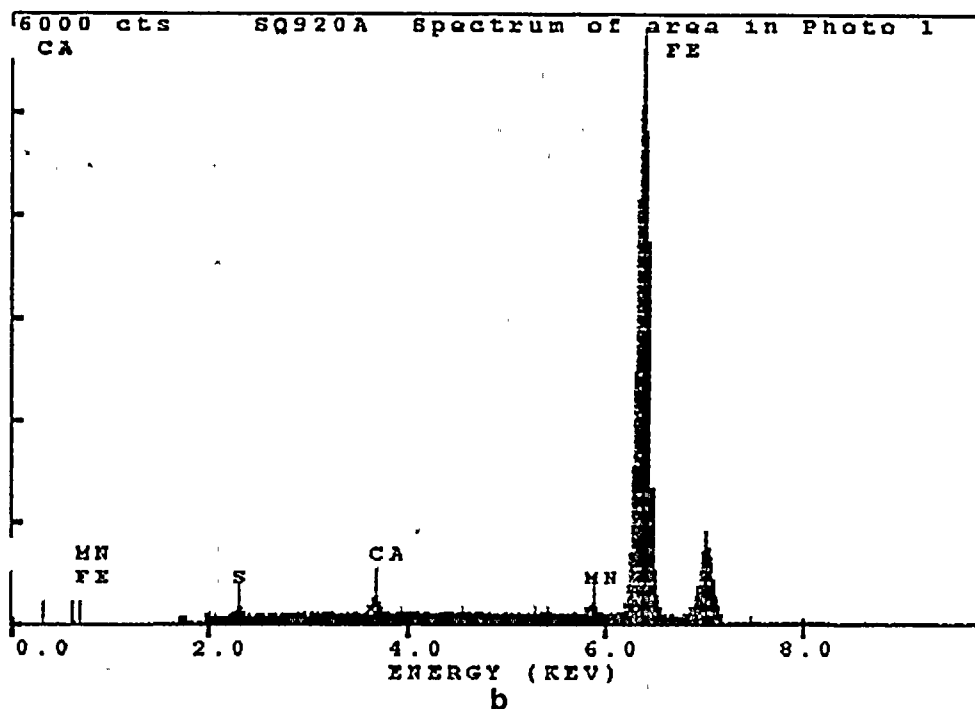
Figure C-20. S.E.M./E.D.S. analysis of magnetic particles taken from the top of the 5R piston, C diesel, a) S.E.M. photo at 366X of magnetic particles; b) Spectrum of area in S.E.M. photo.

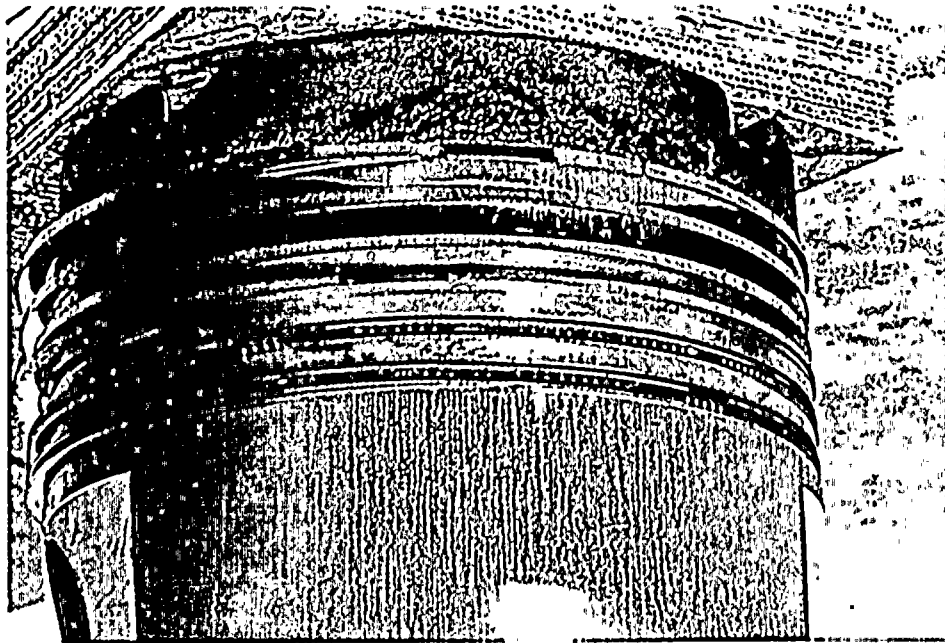
15

Figure D-1. (a) Non-thrust side of 8R piston showing wear between No. 1 and No. 2 compression rings. (b) Head view of 8R piston.

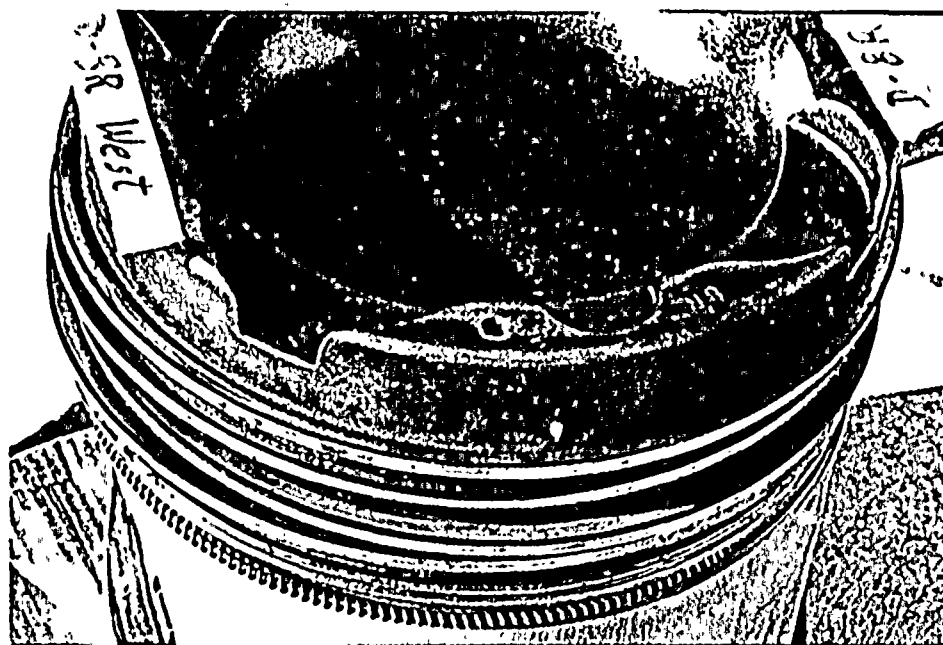
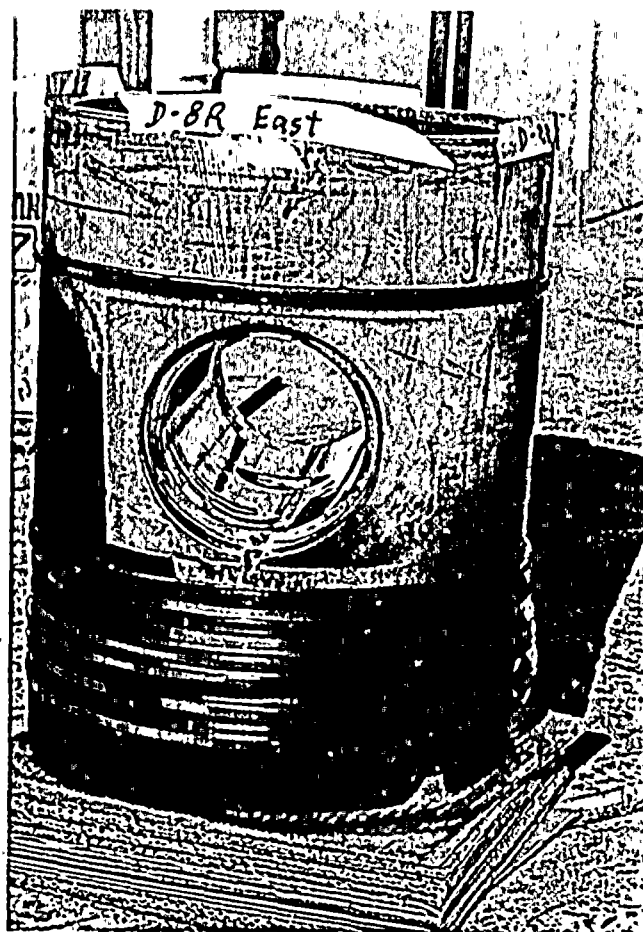
Figure D-1. (c) Thrust (south) side of 8R piston showing no deposits on head. (d) East (generator end) of 8R piston - note complete removal of tin coating on left side.

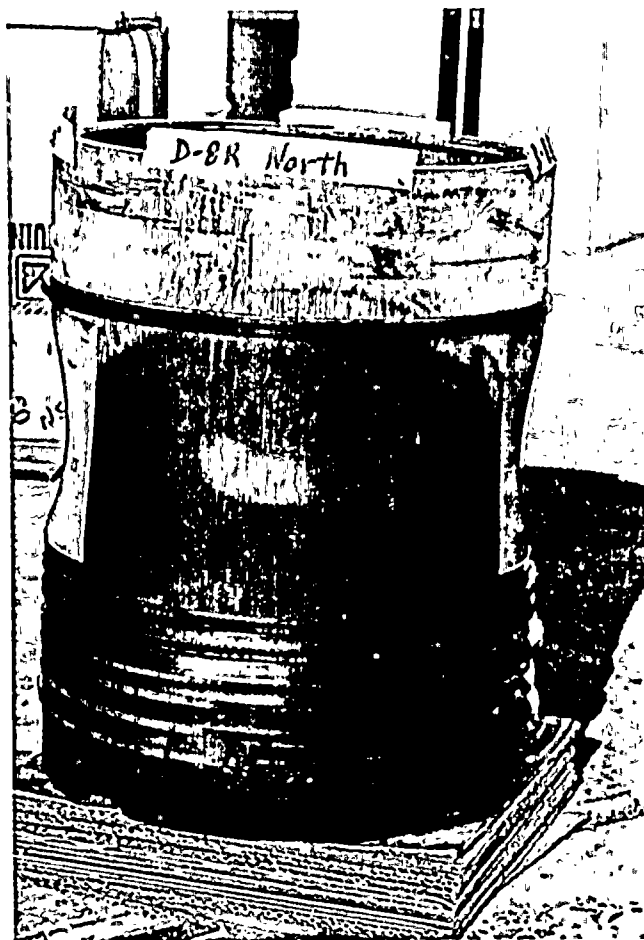
e

Figure D-1. (e) Non-thrust (north) side of 8R piston showing removal of tin and scoring of piston surface.

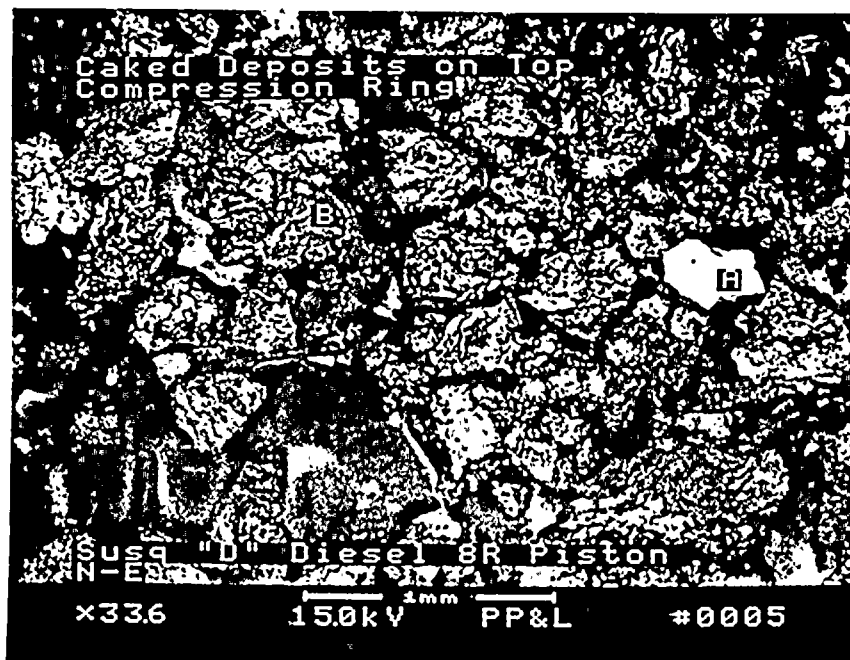
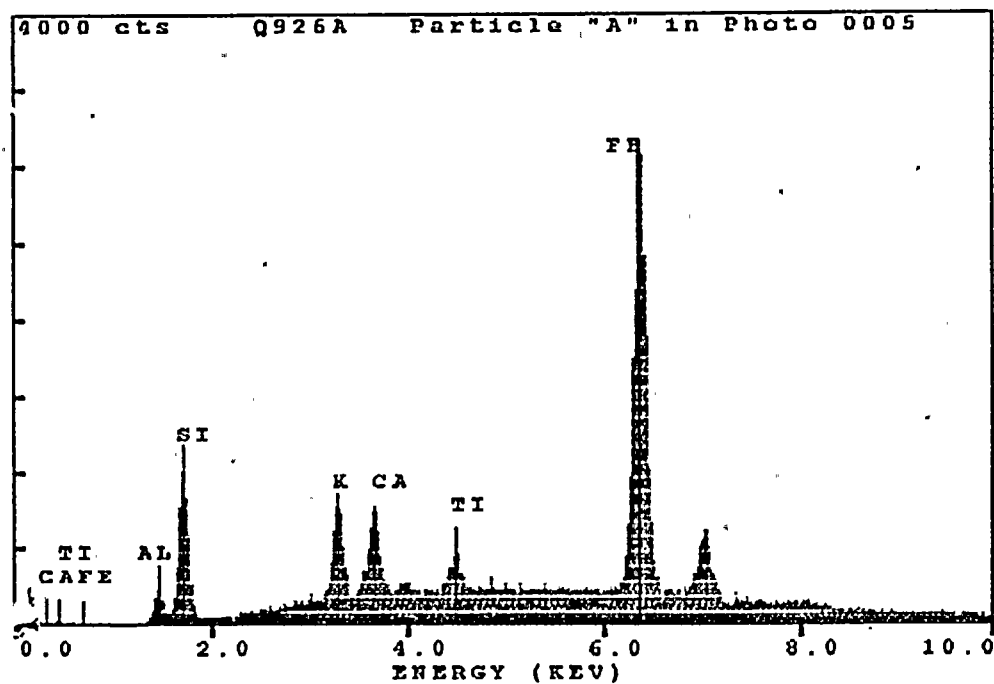
Figure D-2. (a) Caked deposits from the top compression ring of the 8R cylinder. (b) EDS analysis of deposits from area "A."

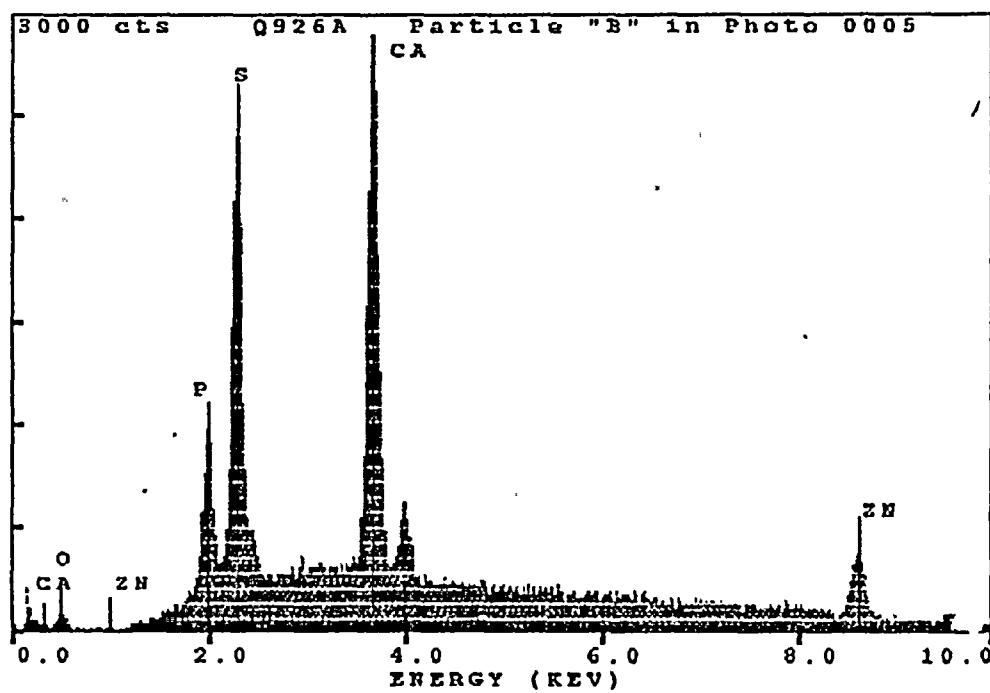
Figure D-2c. EDS analysis from area "B" of Figure D-2A.

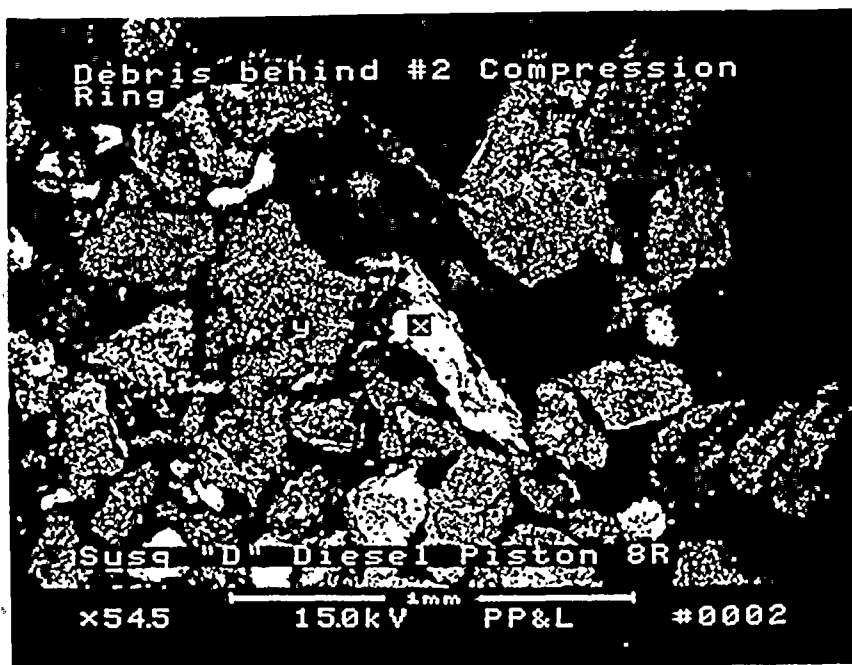
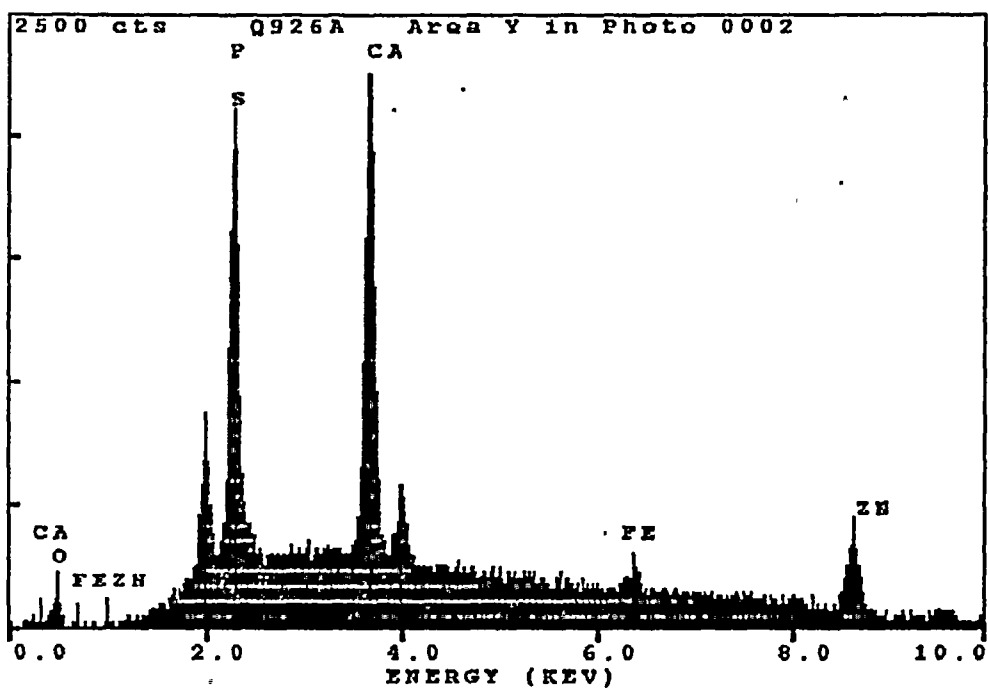
Figure D-3. (a) Debris from behind the No. 2 compression ring. (b) EDS of debris (area "Y") showing presence of P, S, Ca, and Zn.

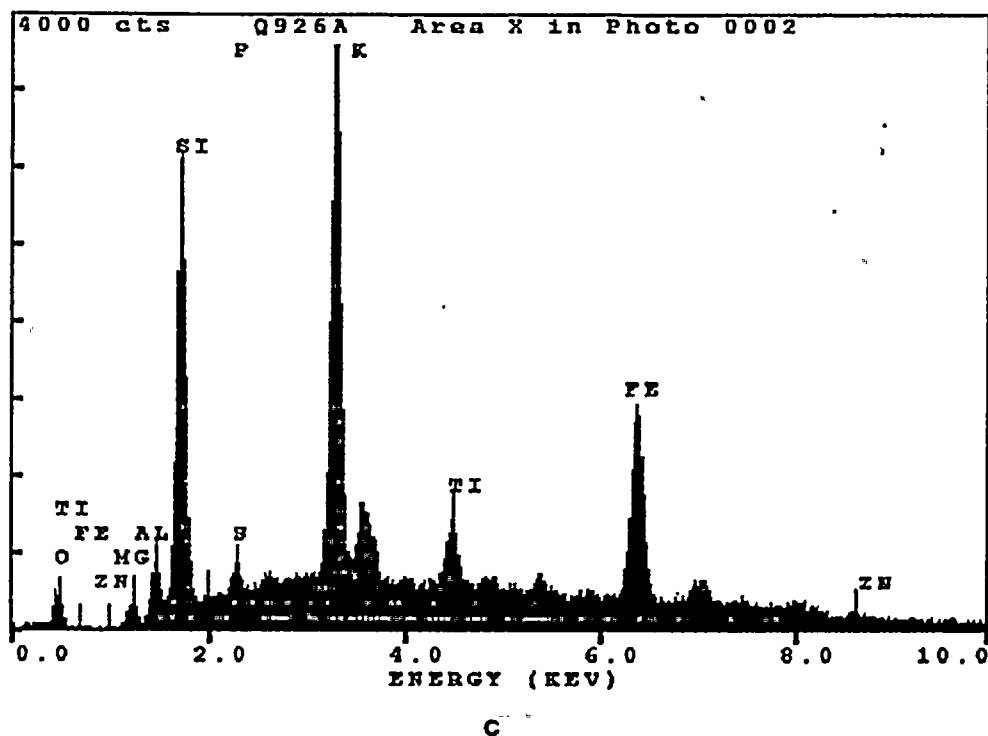
Figure D-3C. EDS of debris (area "X") in Figure D-3a showing the presence of K, Si, Fe, Ti, S, Al and Mg.

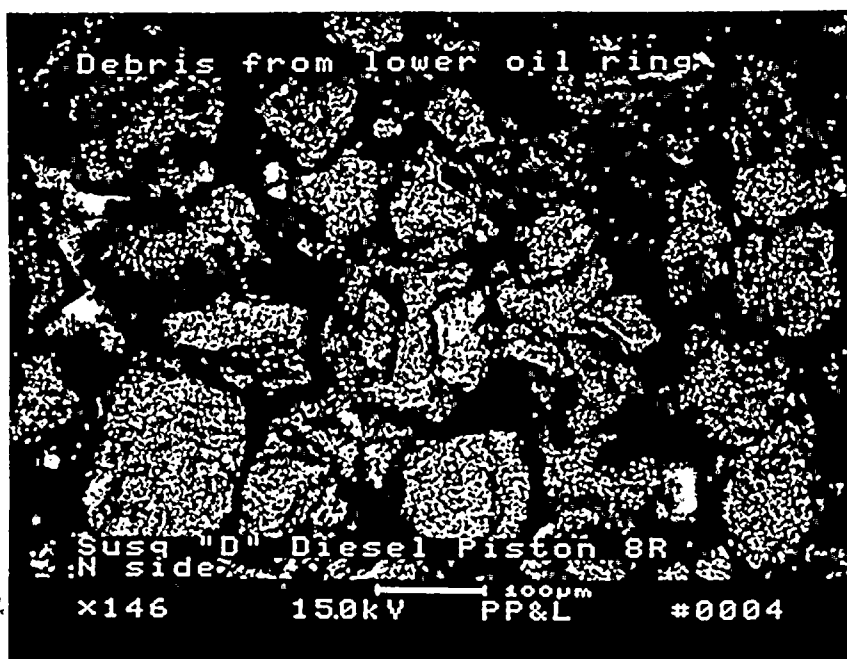
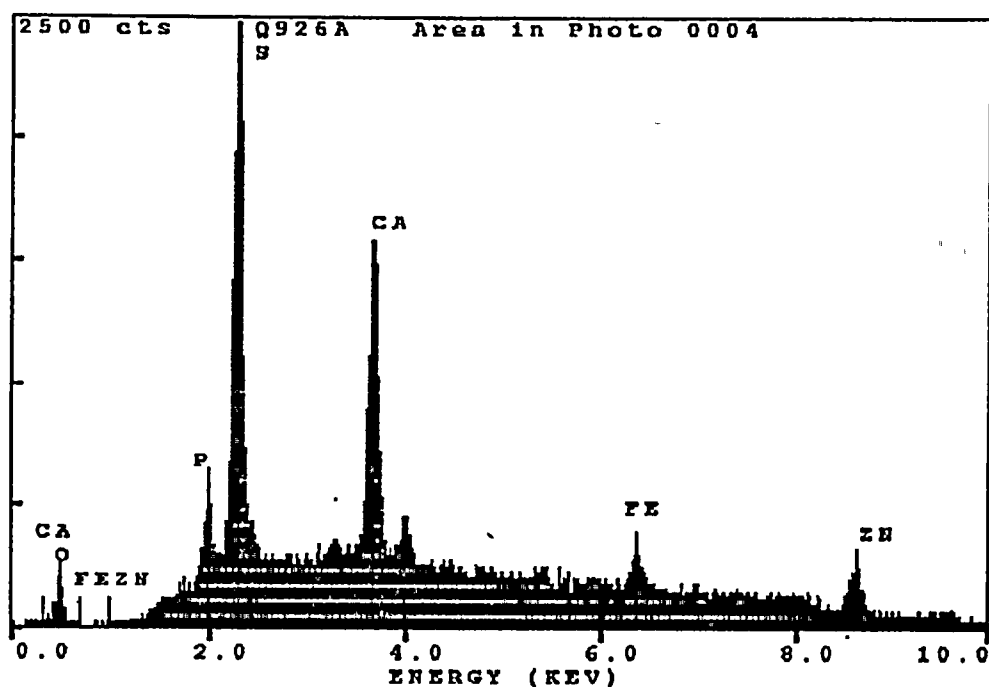
Figure D-4. (a) Debris from the lower oil ring of the "D" diesel 8R cylinder. (b) EDS analysis showing the elemental content of the debris in (a).

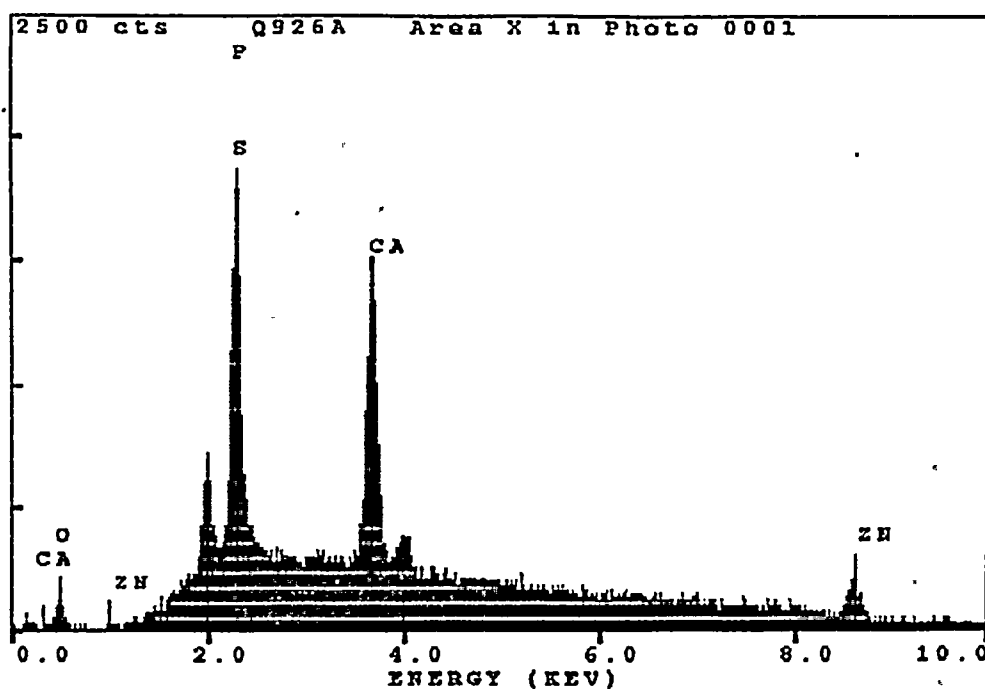
Figure D-5. (a) Oil deposits from the top compression ring of the "D" diesel 8R piston. (b) EDS analysis of particle "X" in picture (a) showing the presence of S, Ca, P and Zn.

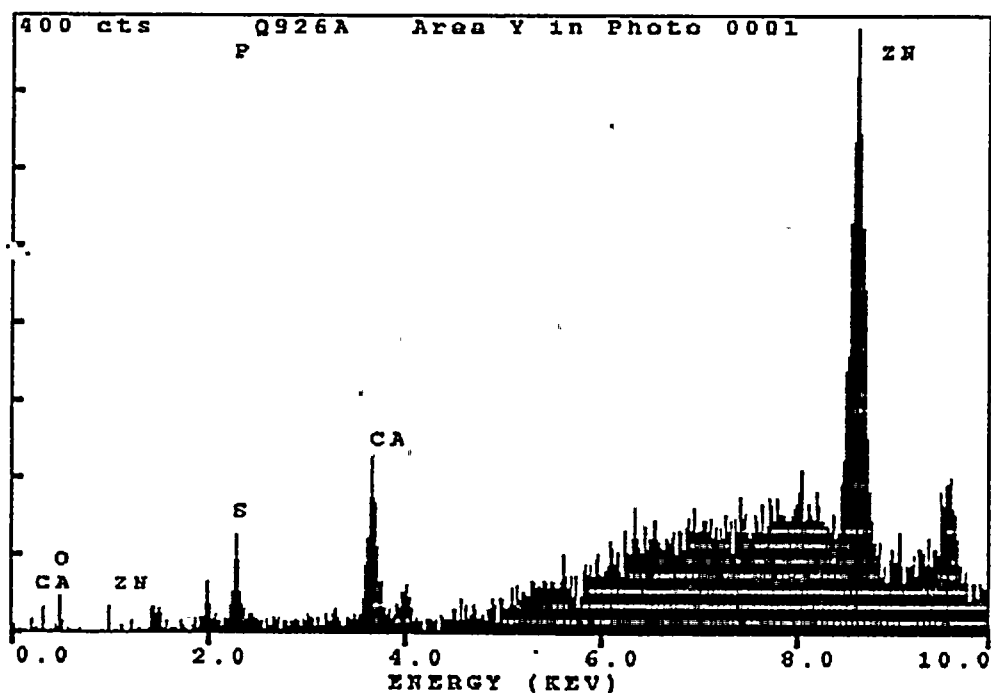
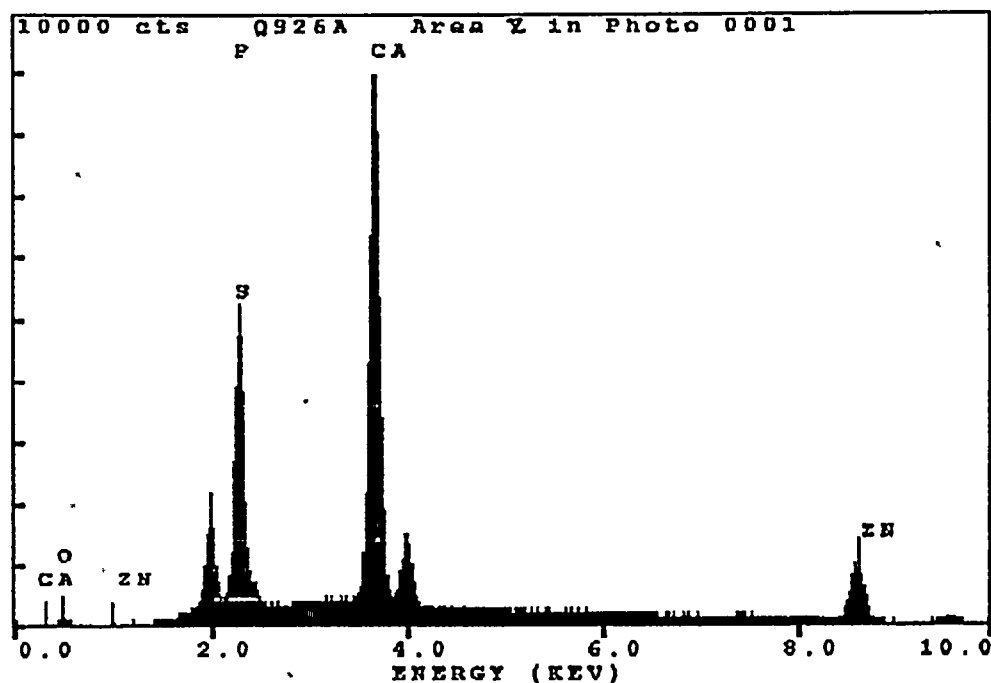
Figure D-5. (c) EDS elemental content of area "Y" in (a) showing the presence of Zn, Ca and S. (d) EDS elemental content of area "Z" in (a) showing the presence of Ca, S, P and Zn.

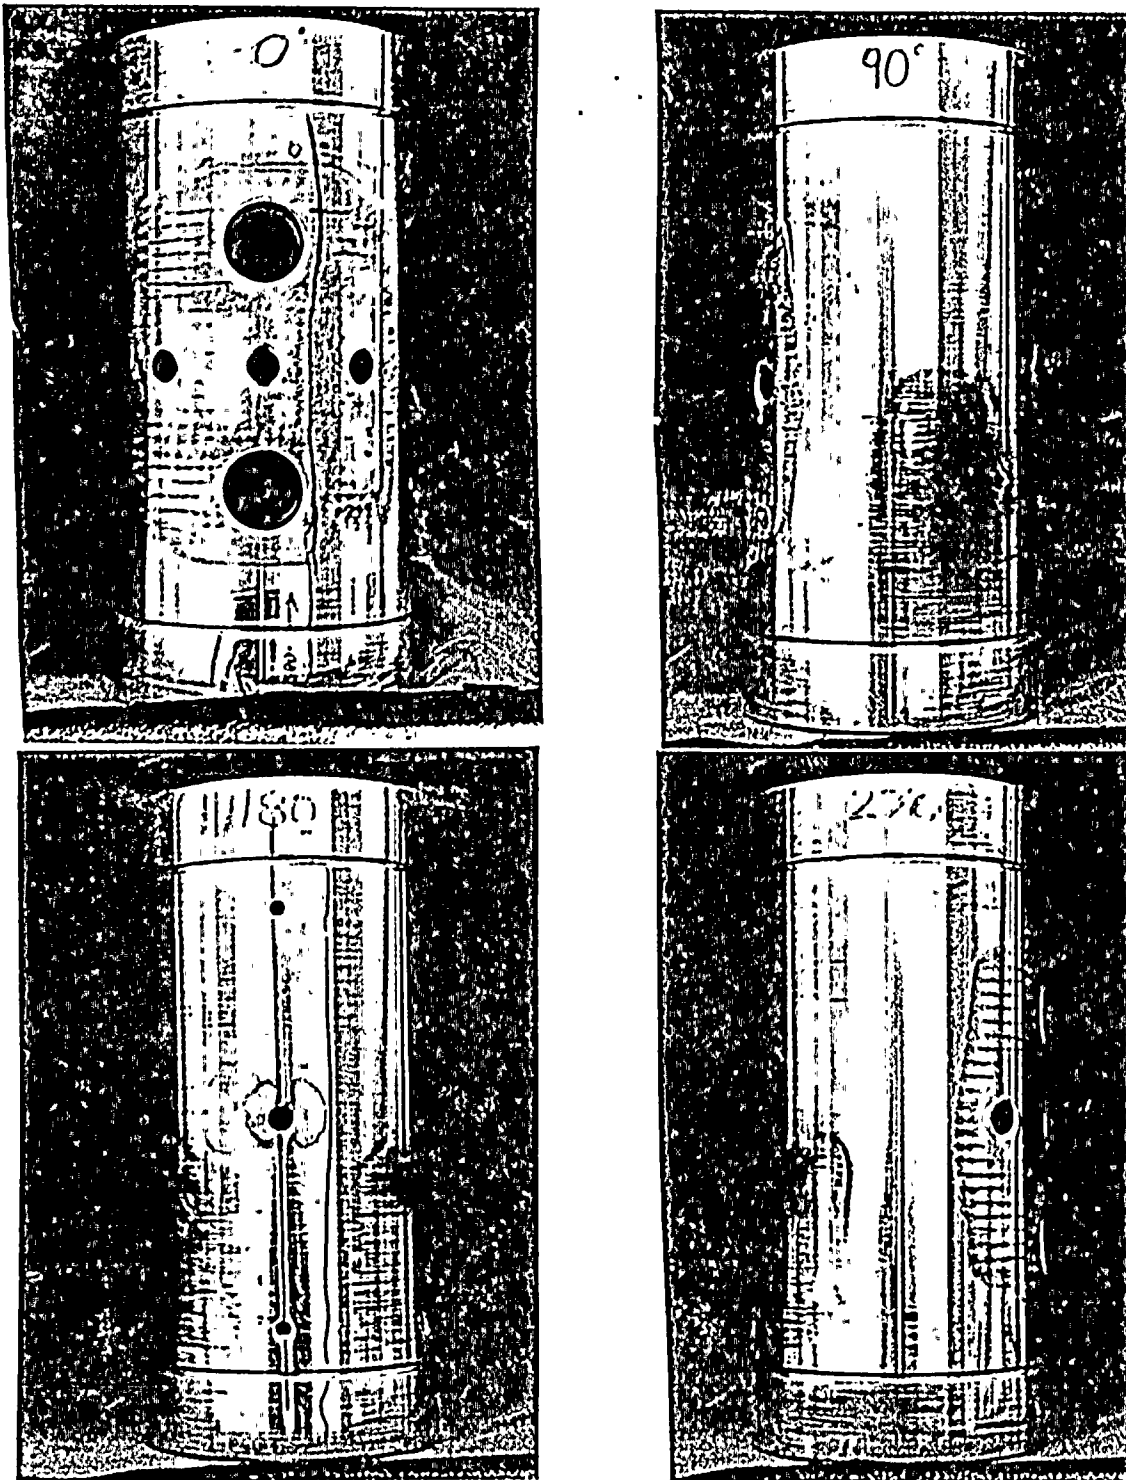
The pins from the 1R and 7R pistons were found to have areas of "bluing," indicating overheating. The pins were tested for hardness. The areas of overheating were softer, 20-25 Rc, than the remainder of the pin, 50 Rc. The 1R pin was bent .002" between the bolt holes and .004" across the length 180° from the bolt holes. The pins were analyzed on a Texas Nuclear Alloy Analyzer with the results of SAE #5046 material. Photos of the discoloration on the 1R piston pin can be seen in Figure A-4.

Figure A-4. Piston pin from the 1R piston. The largest amount of discoloration is along each of the axes 90° to either side of the bottom of the pin.
