# 2017 Annual Site Inspection and Monitoring Report for Uranium Mill Tailings Radiation Control Act Title I Disposal Sites

March 2018

**2017 Annual Site Inspection and Monitoring Report  
for  
Uranium Mill Tailings Radiation Control Act  
Title I Disposal Sites**

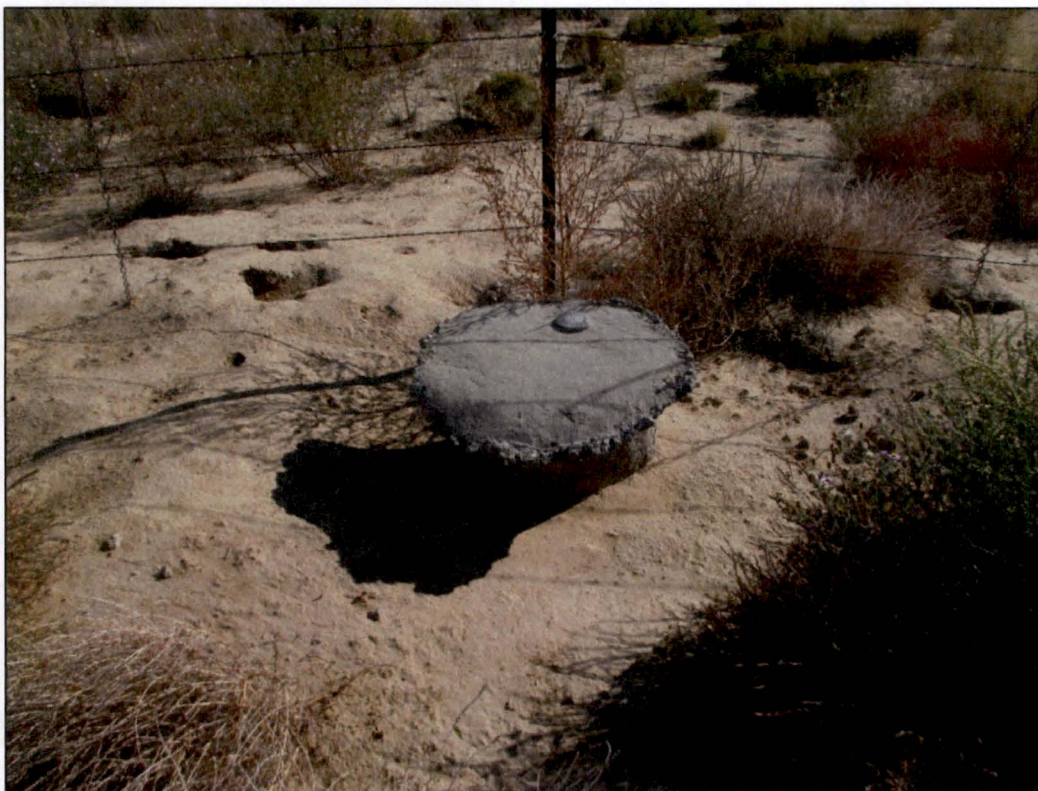
*PL-3. Erosion at Boundary Monument BM-8*

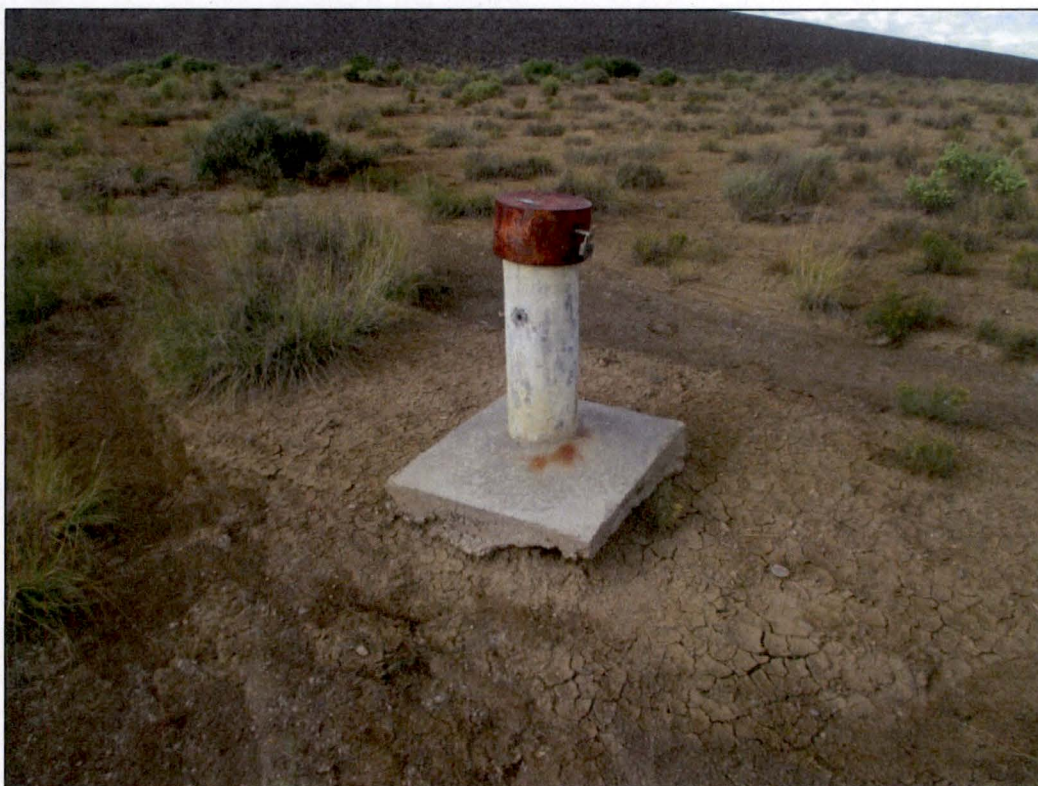
*PL-4. Monitoring Well 0678 with Gullies*

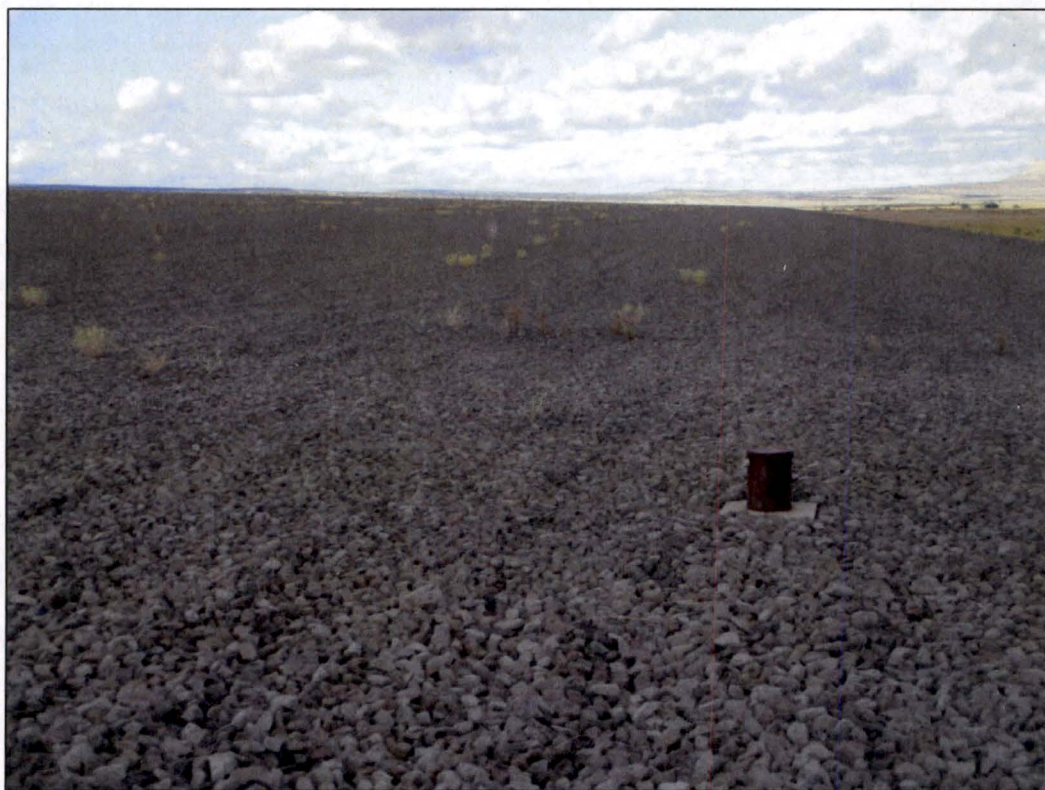
*PL-6. View of Settlement Plate SP-4 and Nearby Settlement*

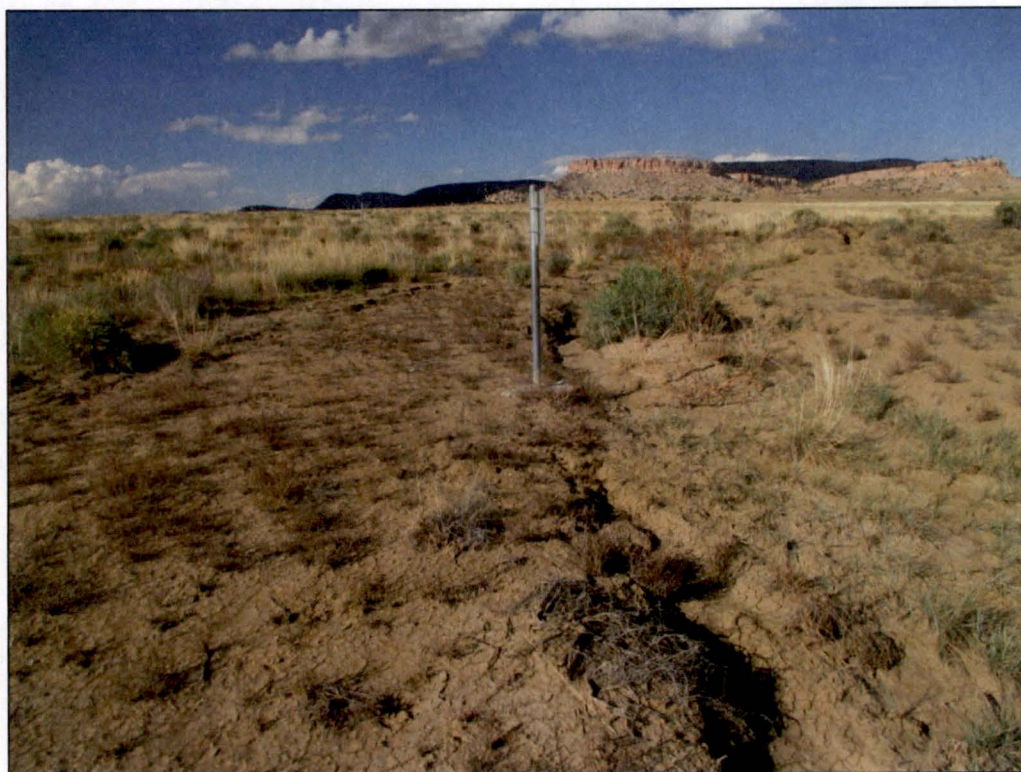
*PL-8. Gullies at the Site Boundary*

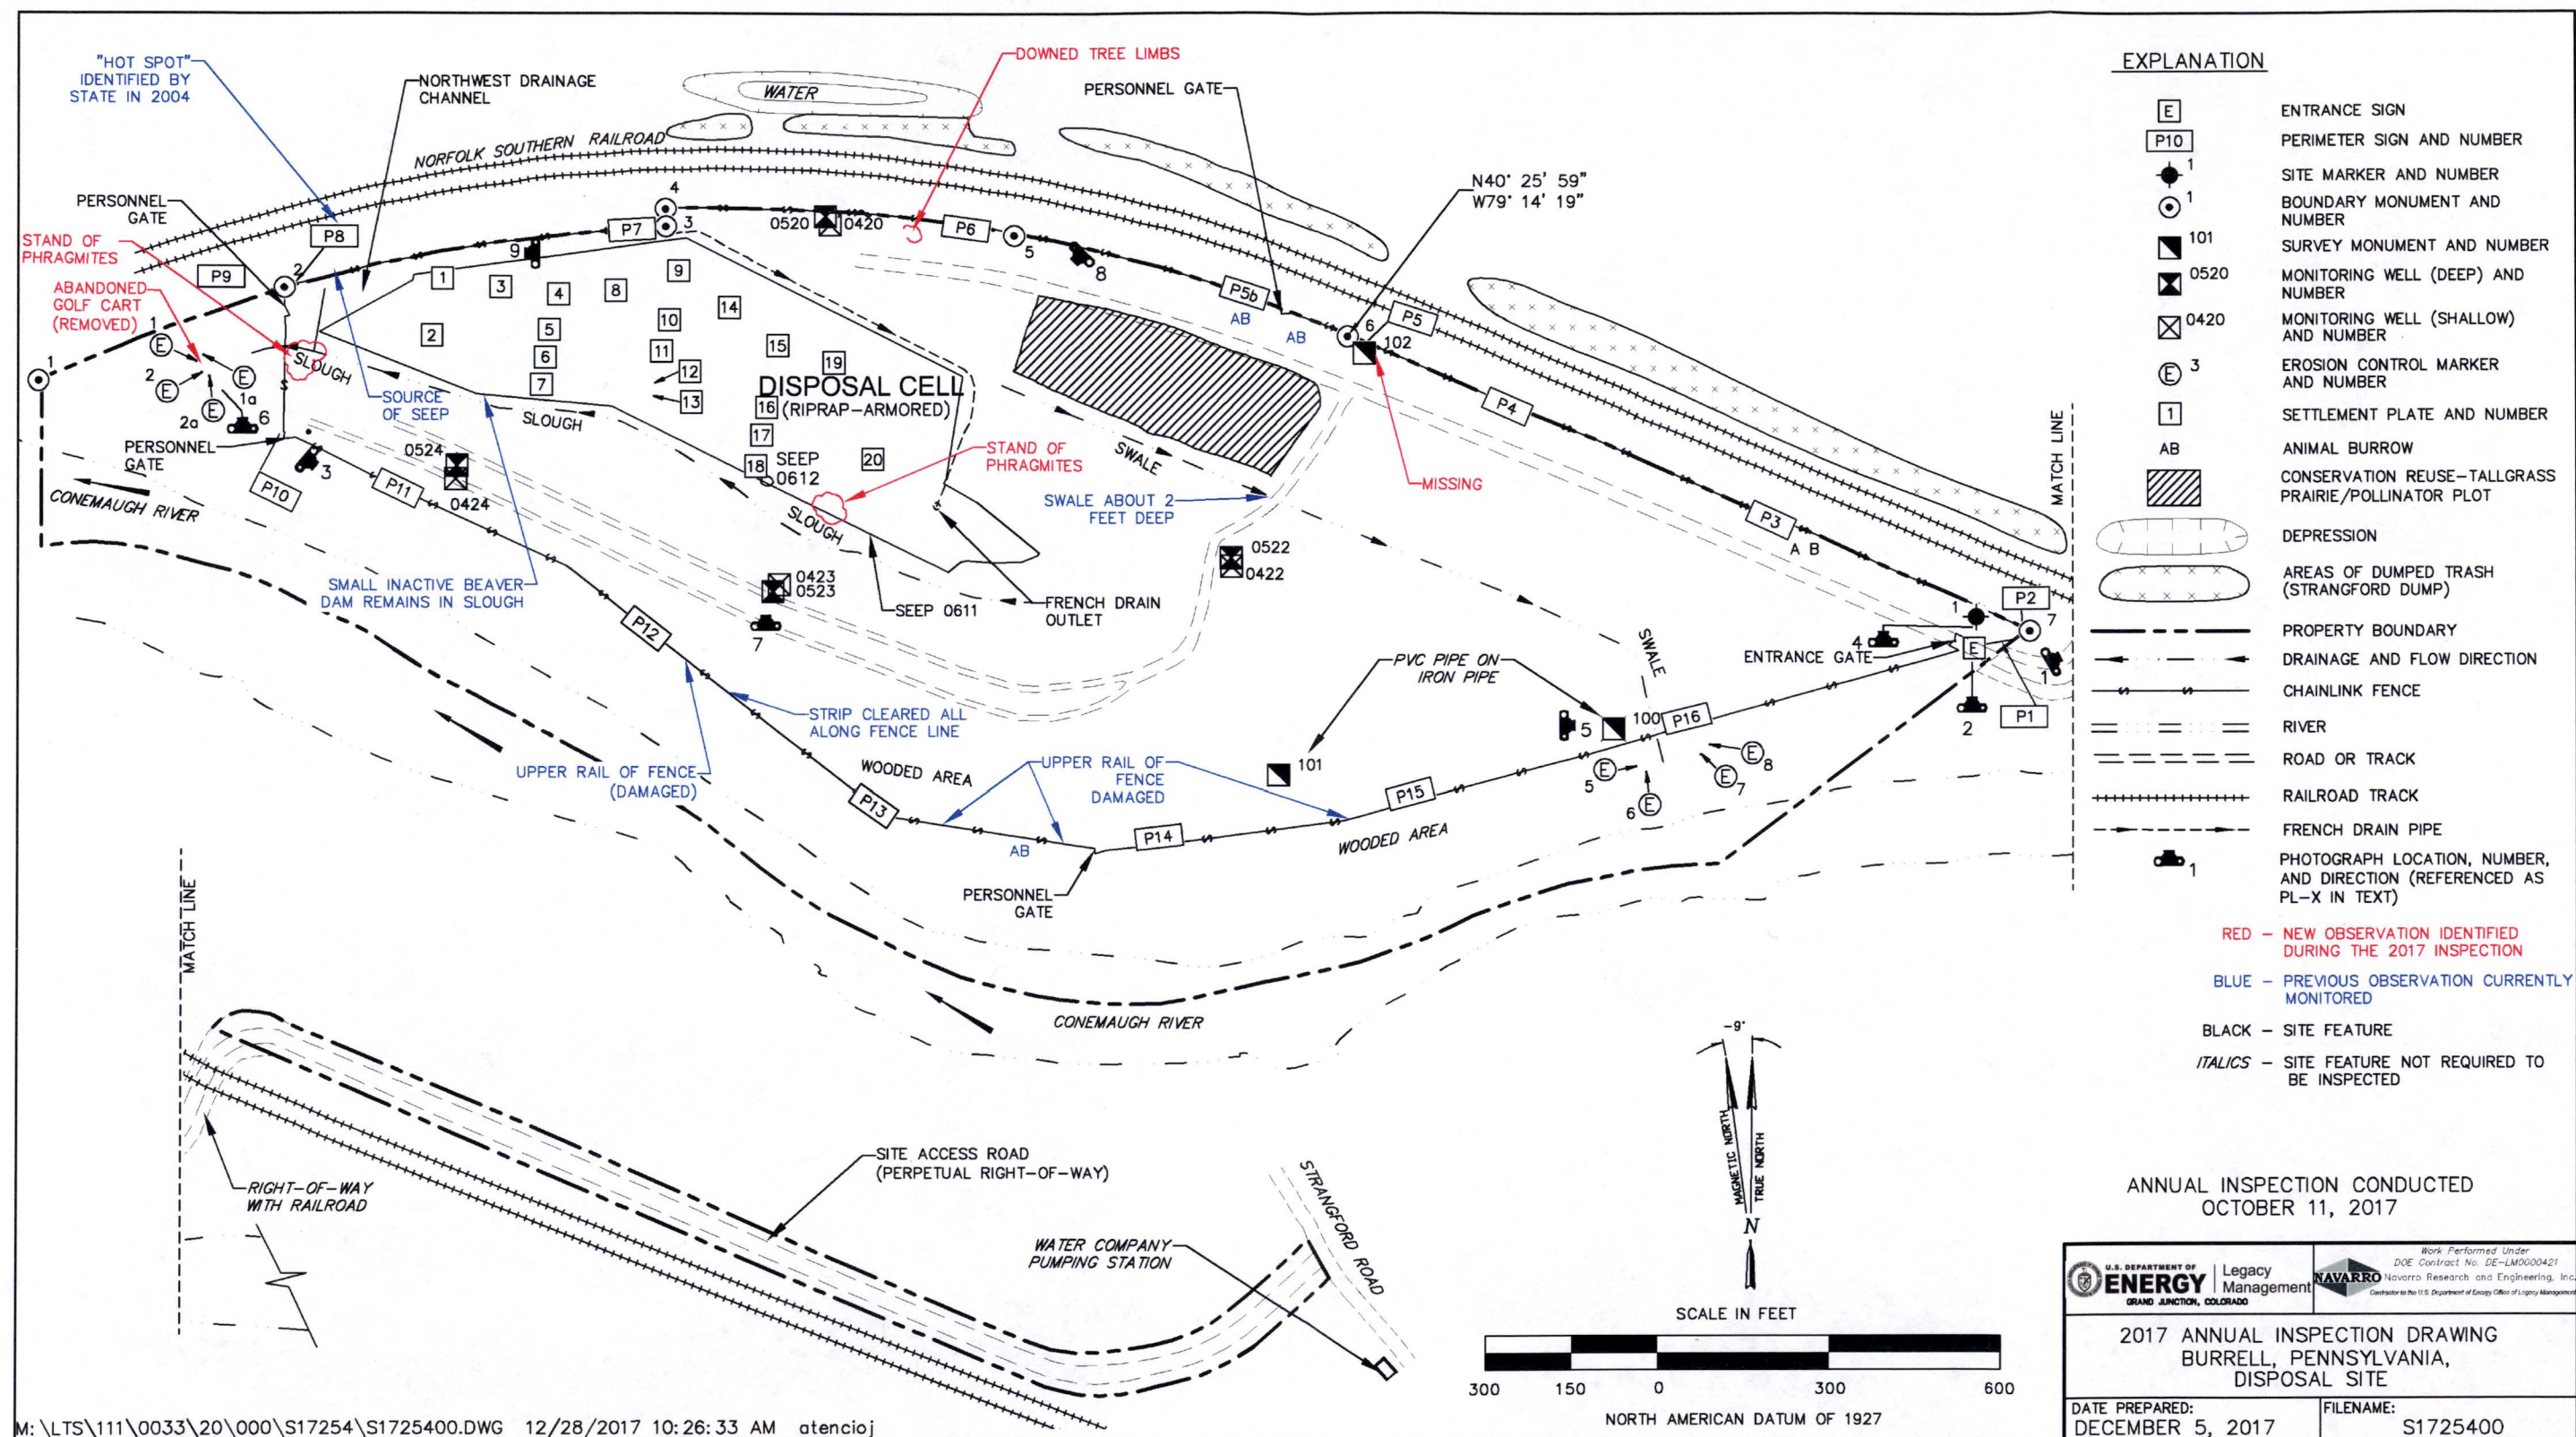
Figure 2-1. 2017 Annual Inspection Drawing for the Burrell, Pennsylvania, Disposal Site

Figure 2-1 shows in black the locations of site features, including site surveillance features and inspection areas. Site features that are present but not required to be inspected are shown in italic font. Observations from previous inspections that are currently monitored are shown in blue text, and new observations identified during the 2017 annual inspection are shown in red. Inspection results and recommended maintenance activities associated with site surveillance features are included in the following subsections. Photographs to support specific observations are identified in the text and in Figure 2-1 by photograph location (PL) numbers. The photographs and photograph log are presented in Section 2.10.

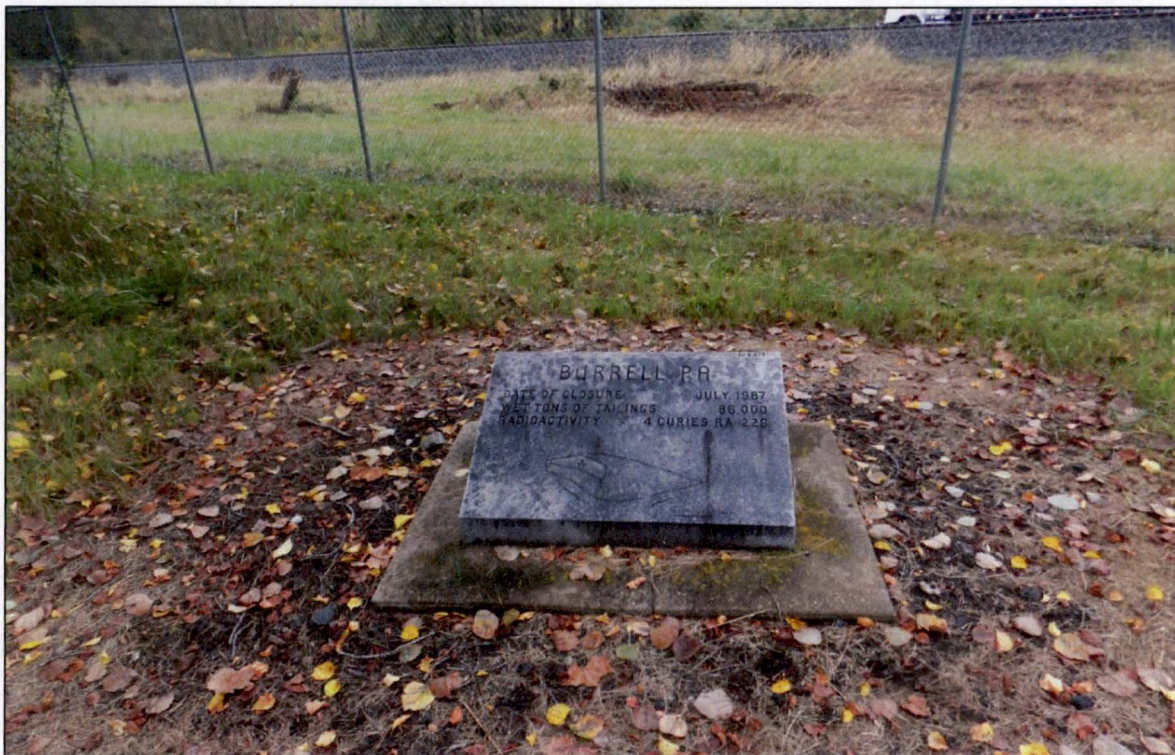
*PL-4. Site Marker SMK-1*

The site has one granite site marker just inside the main entrance gate (PL-4). No maintenance needs were identified.

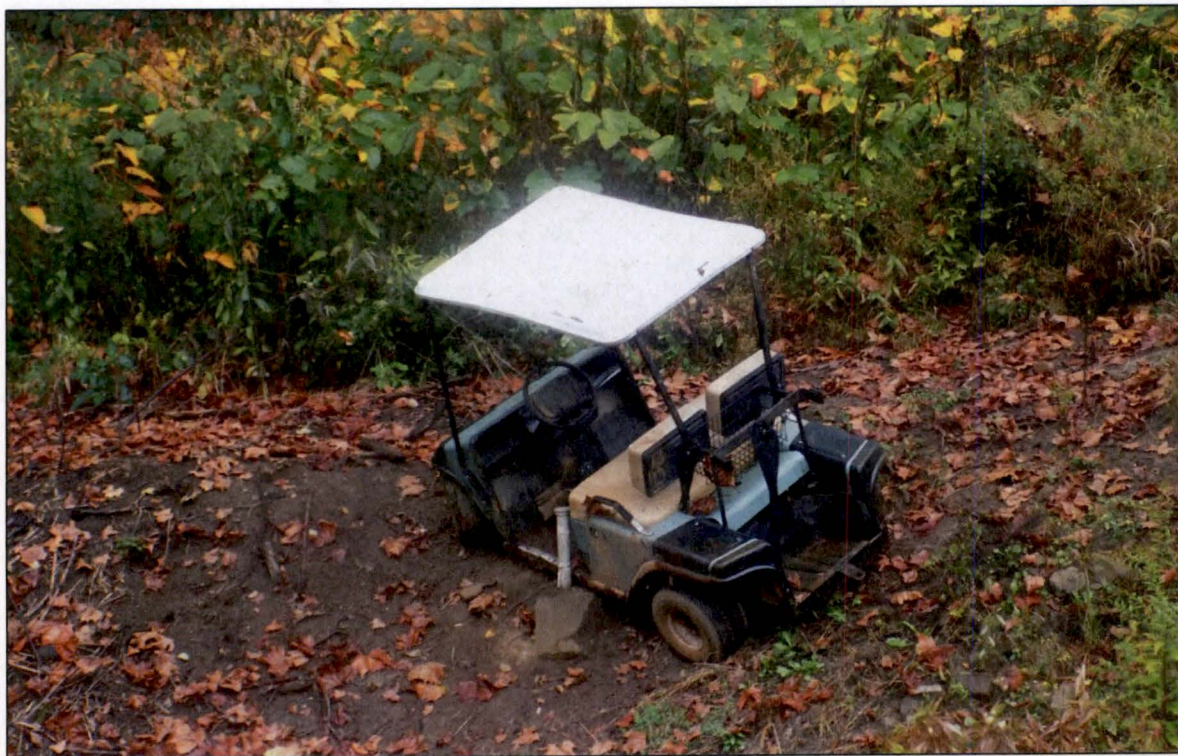
*PL-6. Abandoned Golf Cart Resting Against Erosion-Control Marker (Removed)*

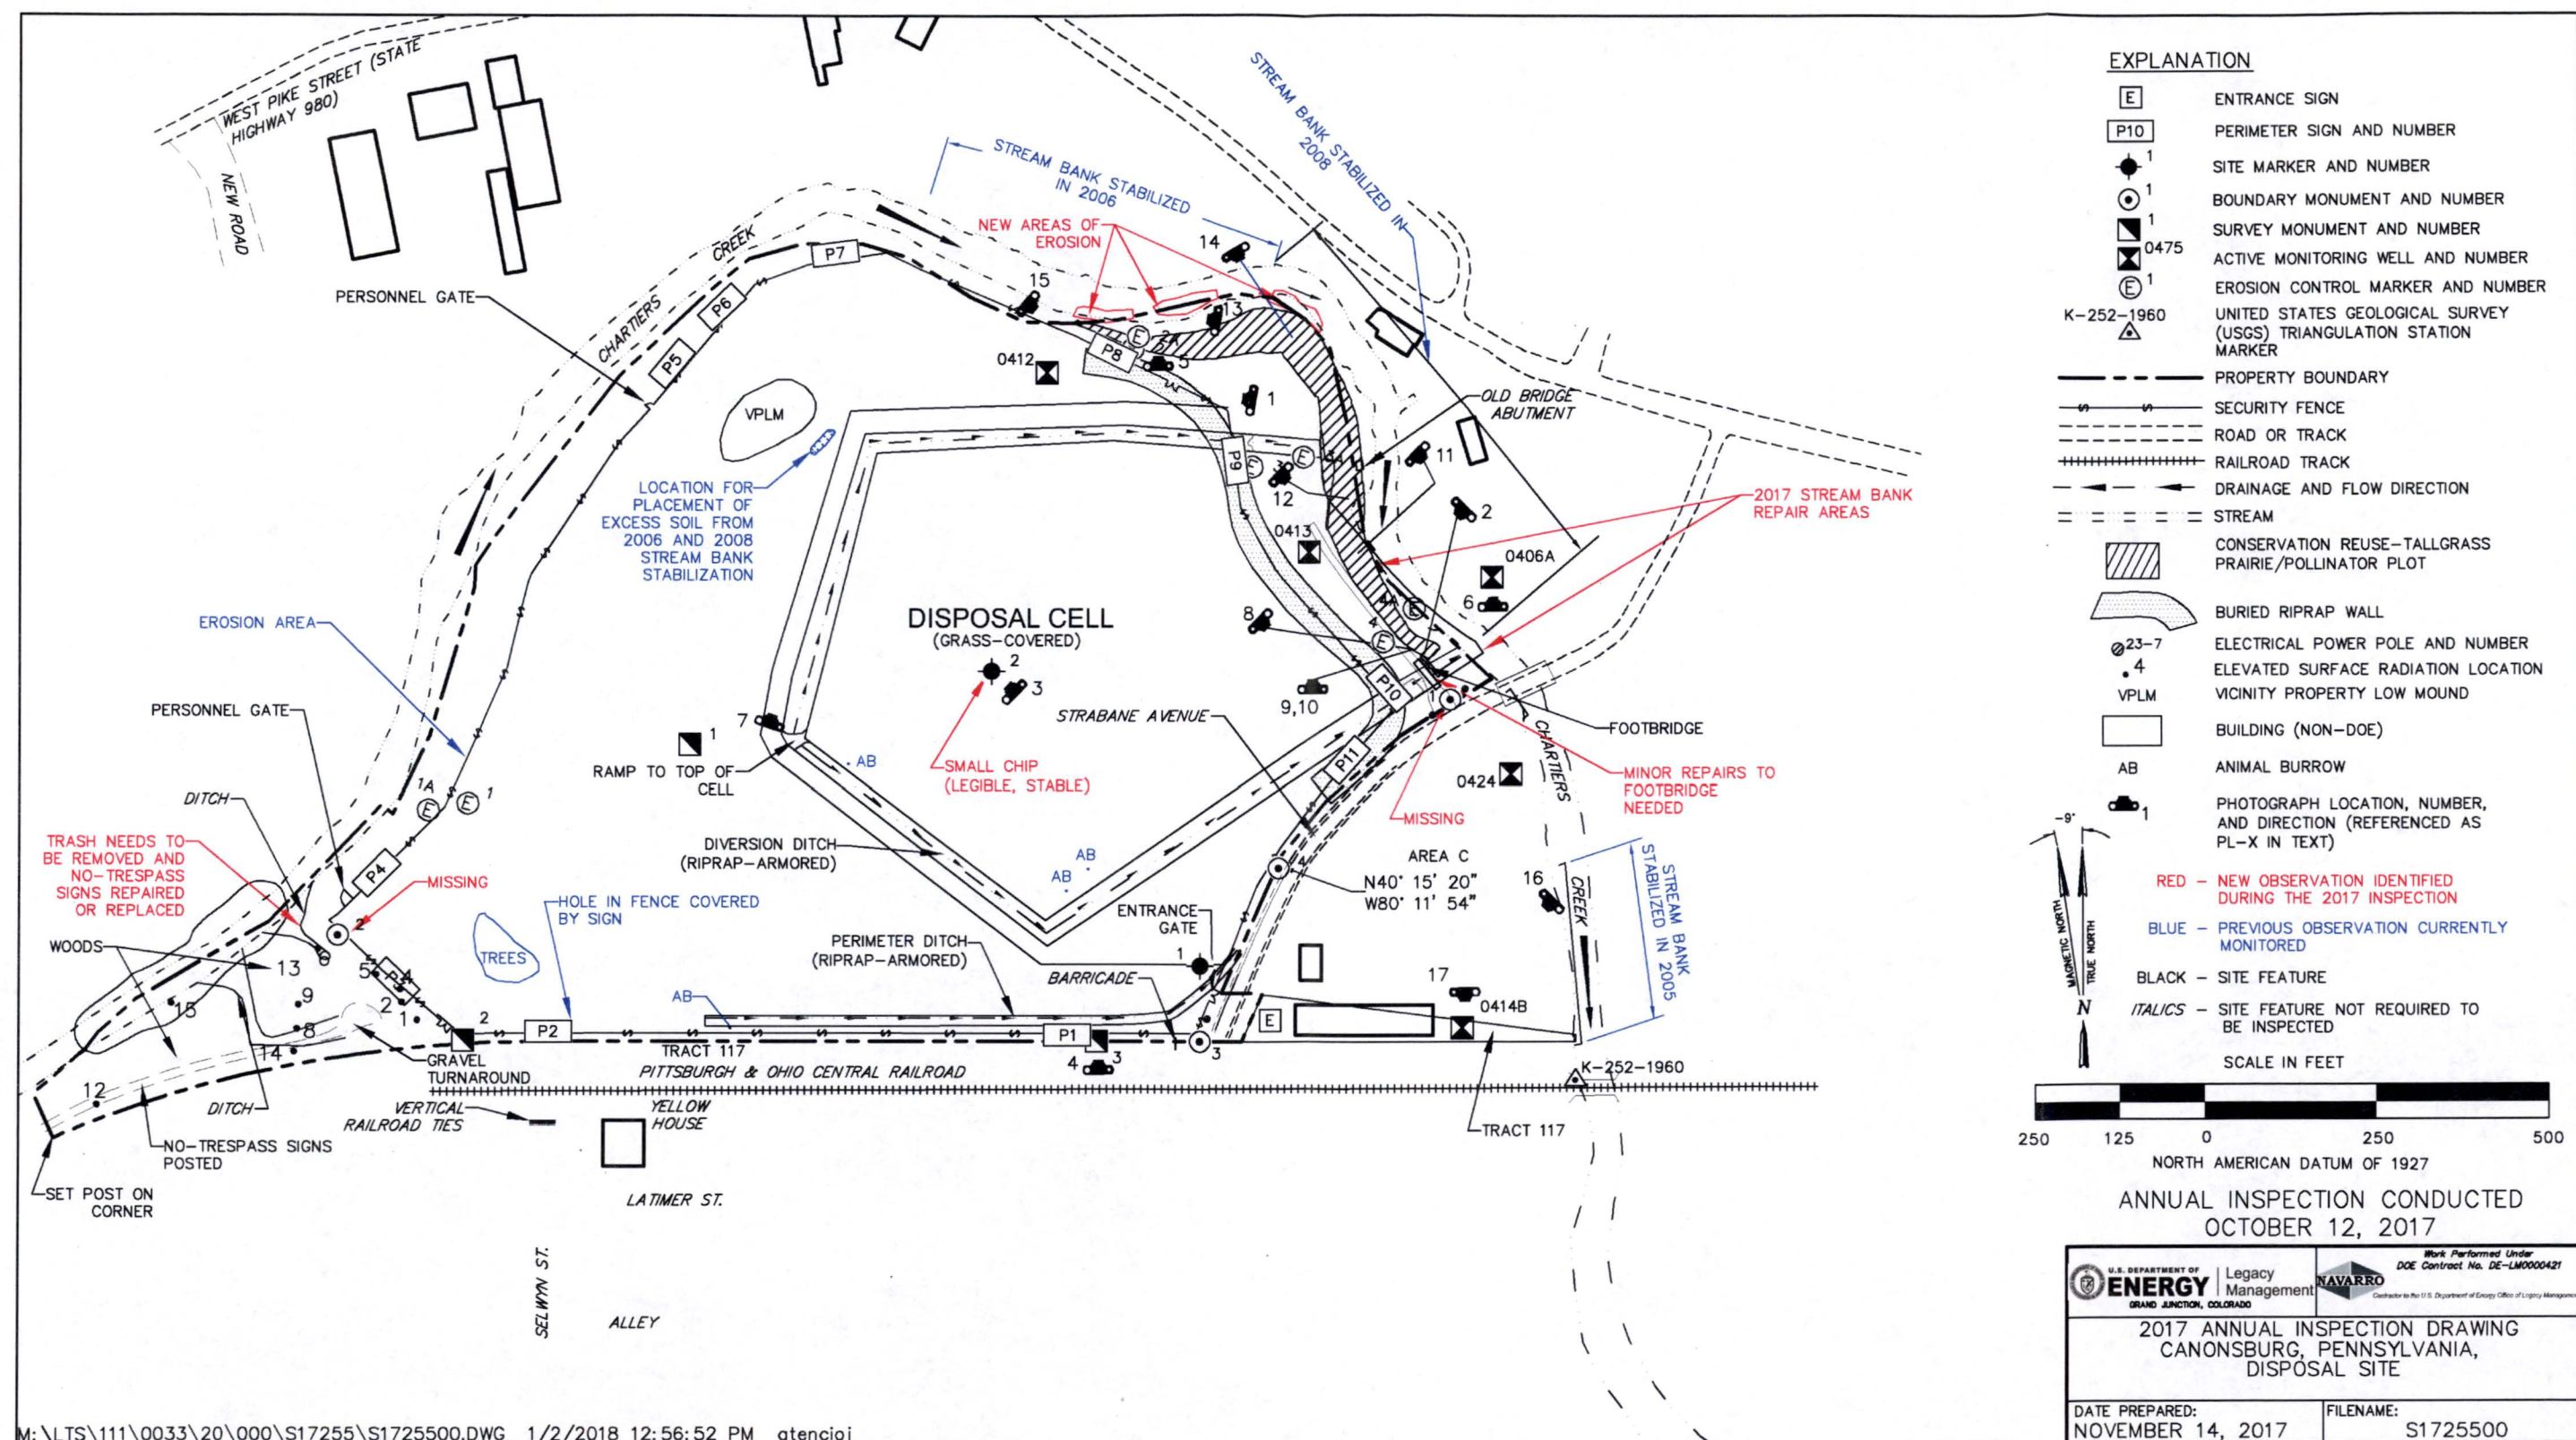
Figure 3-1. 2017 Annual Inspection Drawing for the Canonsburg, Pennsylvania, Disposal Site

Figure 3-1 shows in black the locations of site features, including site surveillance features and inspection areas. Site features that are present but not required to be inspected are shown in italic font. Observations from previous inspections that are currently monitored are shown in blue text, and new observations identified during the 2017 annual inspection are shown in red. Inspection results and recommended maintenance activities associated with site surveillance features are included in the following subsections. Photographs to support specific observations are identified in the text and in Figure 3-1 by photograph location (PL) numbers. The photographs and photograph log are presented in Section 3.10.

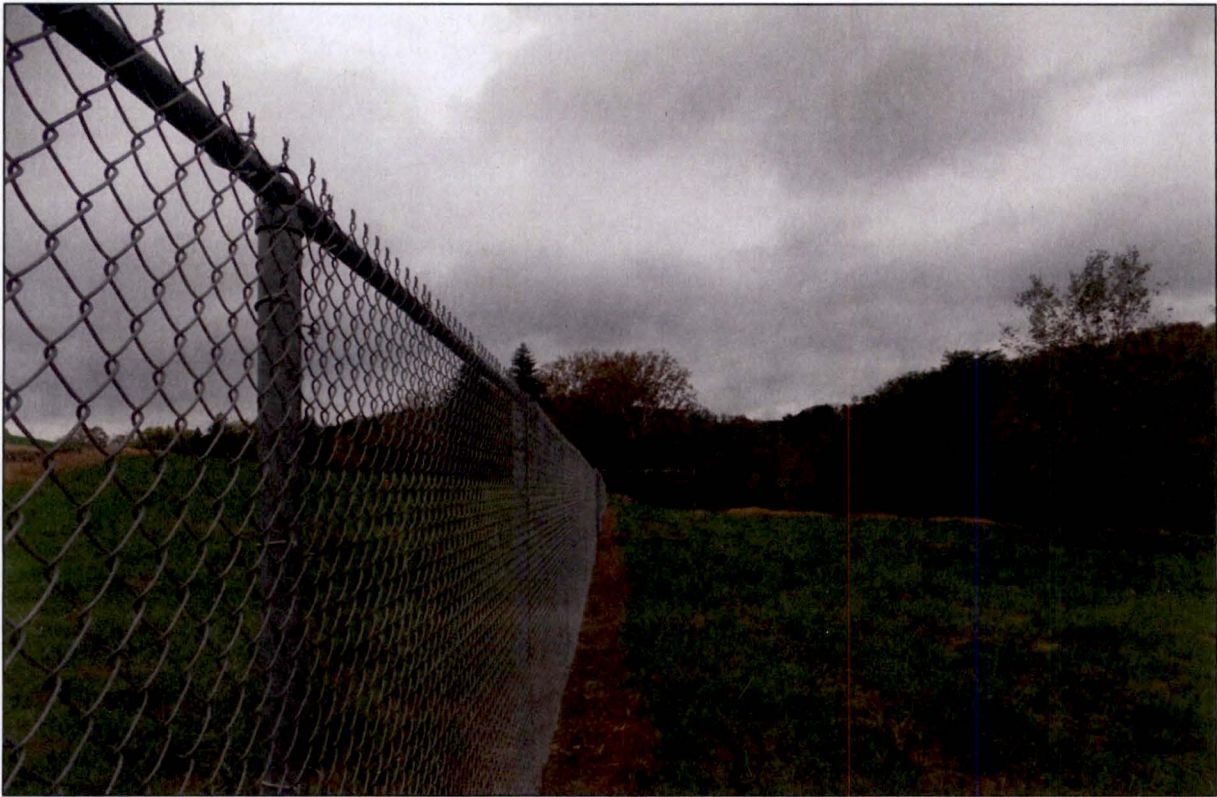
*PL-1. Northwest Down the Security Fence Line*

A chainlink security fence encloses most of the site (PL-1). A vegetation-free buffer zone is maintained around the entire security fence. An area of erosion under the west security fence remains. The area appears to be stable and has not grown in several years. For added security, slats were installed in 2016 across the area beneath the fence to help fill in the gap. There are 11 perimeter signs attached to the security fence (PL-2). No maintenance needs were identified.

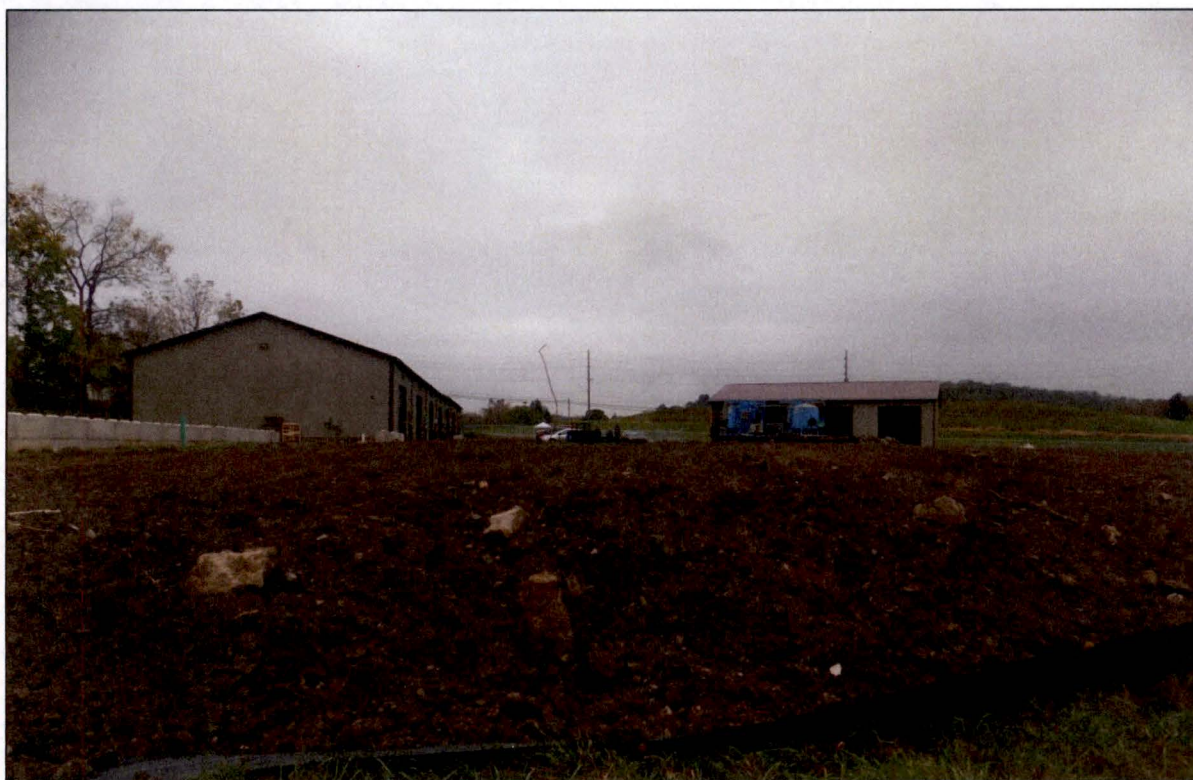
*PL-16. New Fill Being Placed on Area C*

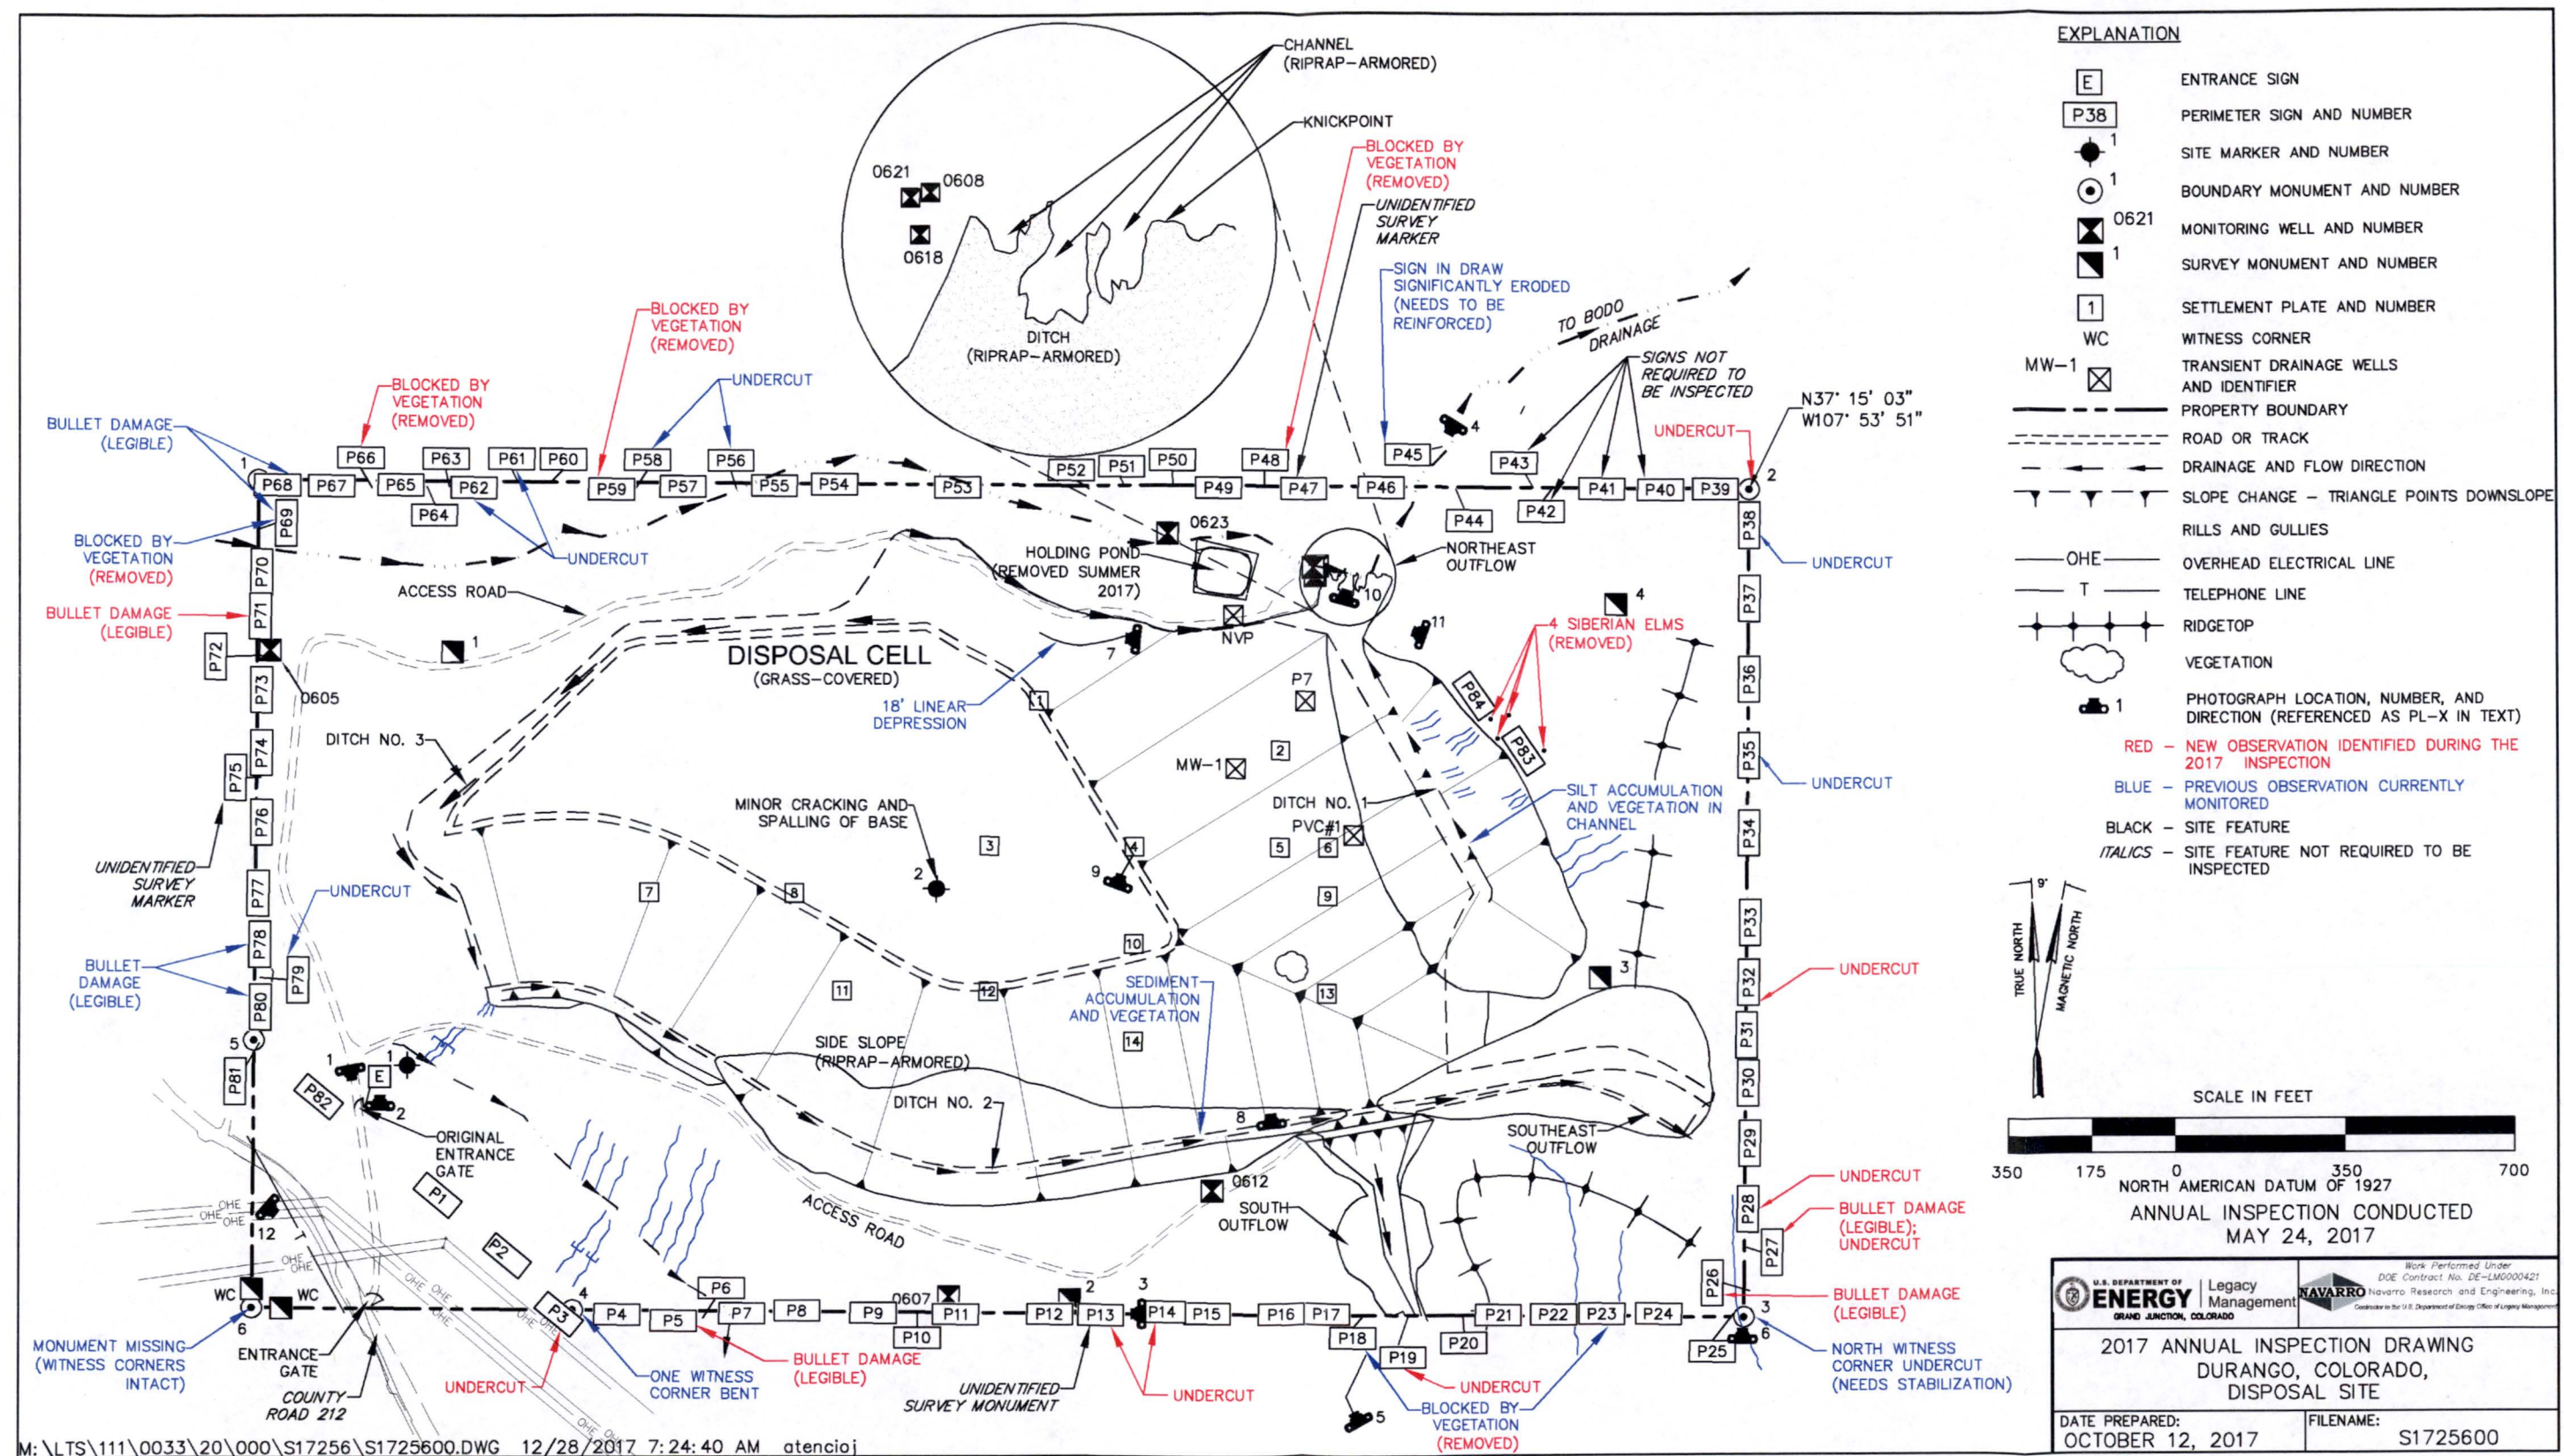
Figure 4-1. 2017 Annual Inspection Drawing for the Durango, Colorado, Disposal Site

Figure 4-1 shows in black the locations of site features, including site surveillance features and inspection areas. Site features that are present but not required to be inspected are shown in italic font. Observations from previous inspections that are currently monitored are shown in blue text, and new observations identified during the 2017 annual inspection are shown in red. Inspection results and recommended maintenance activities associated with site surveillance features are described in the following subsections. Photographs to support specific observations are identified in the text and in Figure 4-1 by photograph location (PL) numbers. The photographs and photograph log are presented in Section 4.11.

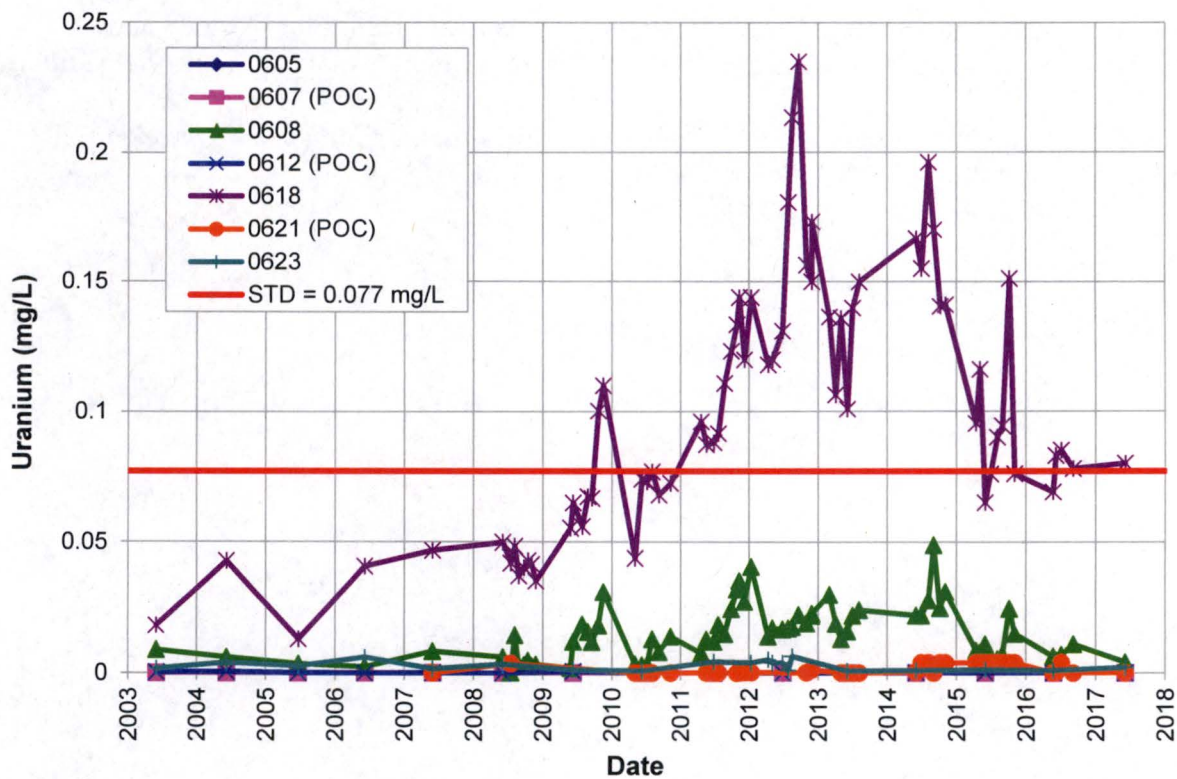
Figure 4-5. Uranium in Groundwater at the Durango, Colorado, Disposal Site

Though not required for compliance, monitoring wells completed in the alluvium are monitored as a best management practice. Uranium concentrations in monitoring well 0618 have consistently been higher than concentrations in the other wells onsite. To monitor the elevated and variable uranium concentrations observed in monitoring well 0618, monitoring wells 0608, 0618, and 0621 are sampled monthly as weather permits. Monthly monitoring was not conducted during summer 2017 while the evaporation pond removal was in progress. Sampling resumed in October 2017. Figure 4-5 shows an overall decreasing trend in uranium concentrations in well 0618 since 2014, with concentrations varying around 0.08 mg/L since 2016. Because well 0618 is not a POC well and not screened in the uppermost aquifer, the concentrations in this well do not affect compliance with the LTSP and do not pose a risk to human health and the environment. The potential cause of variability in this well continues to be investigated.

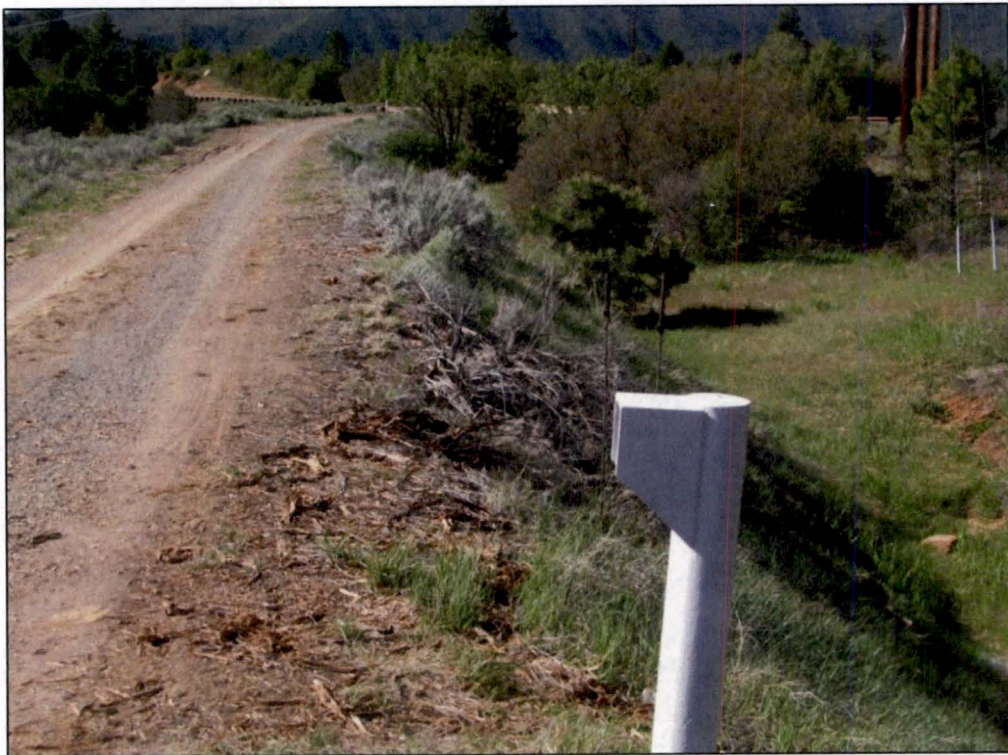
*PL-1. Access Road, Recently Mowed, and Original Entrance Gate Post, Newly Painted*

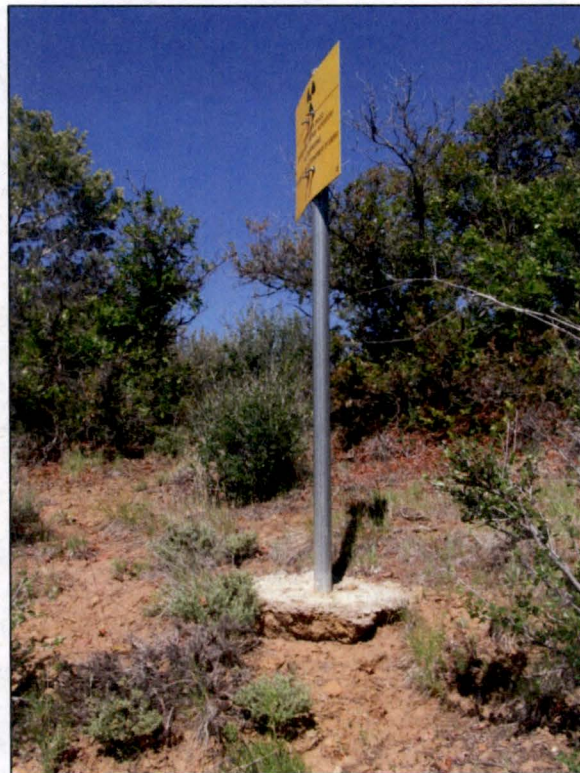
*PL-3. Perimeter Sign P13, Undercut by Erosion*

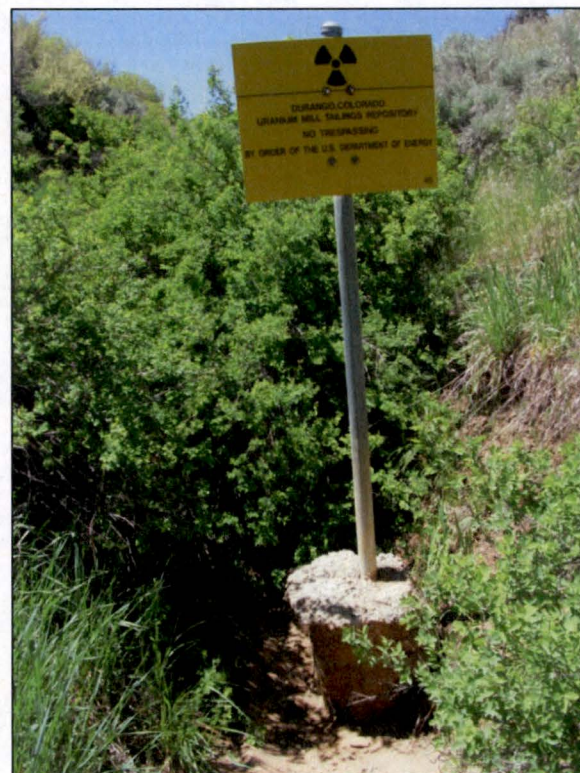
*PL-4. Perimeter Sign P45 in Drainage, Entire Base Nearly Standing Free*

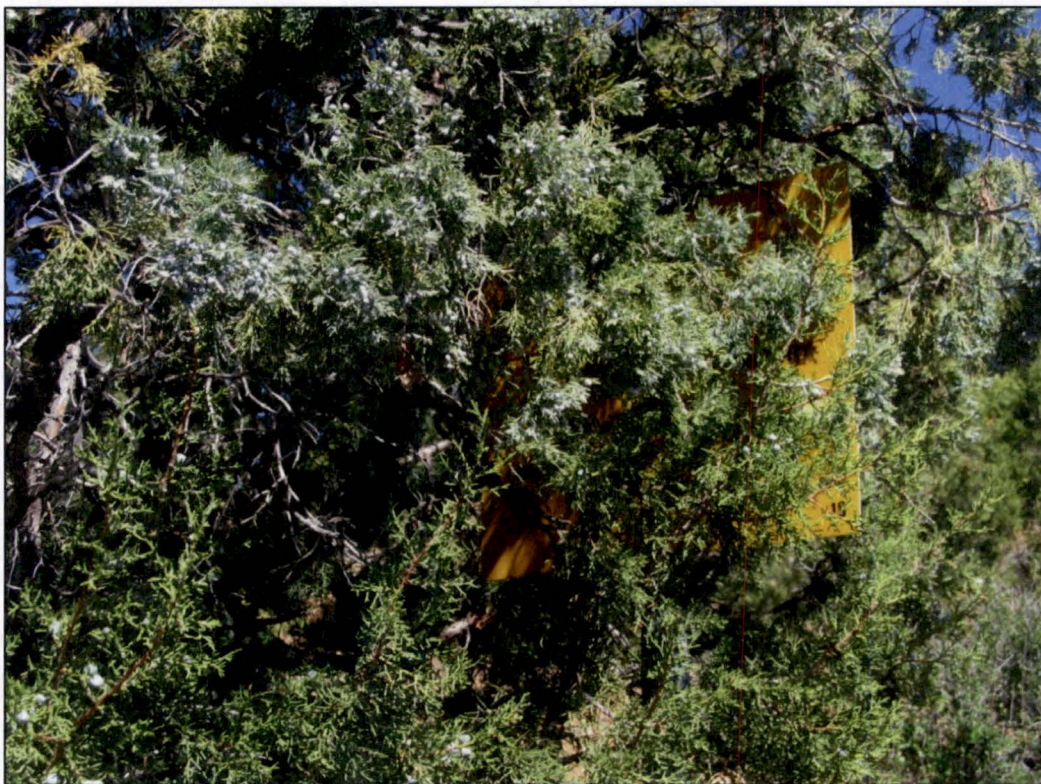
*PL-5. Perimeter Sign P18, Blocked by Vegetation (Removed)*
