# 2017 Annual Site Inspection and Monitoring Report for Uranium Mill Tailings Radiation Control Act Title I Disposal Sites

March 2018

**2017 Annual Site Inspection and Monitoring Report  
for  
Uranium Mill Tailings Radiation Control Act  
Title I Disposal Sites**

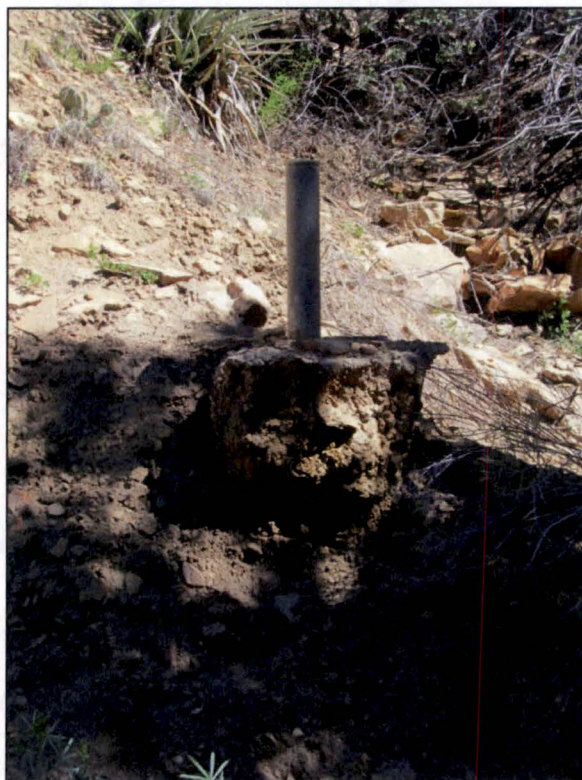
*PL-6. North Reference Marker at Boundary Monument BM-3, Erosion at Base; Needs Stabilization*

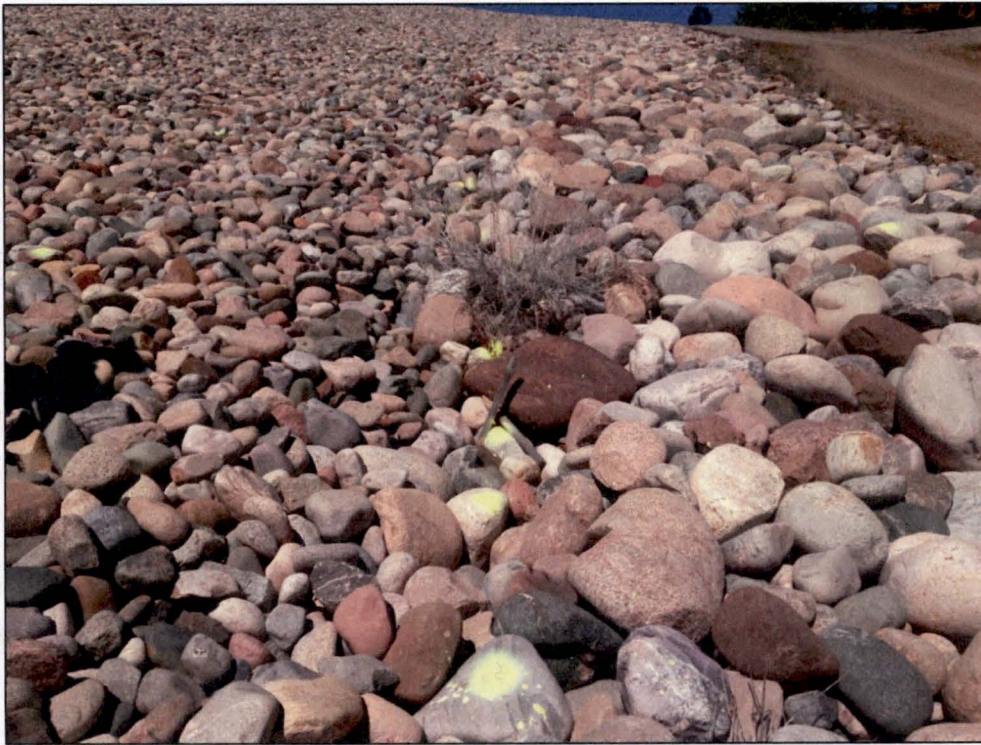
*PL-7. View Uphill of 18-Foot Linear Depression on Toe of Northeast Disposal Cell Side Slope  
(Yellow Paint Marks Centerline of the Depression)*

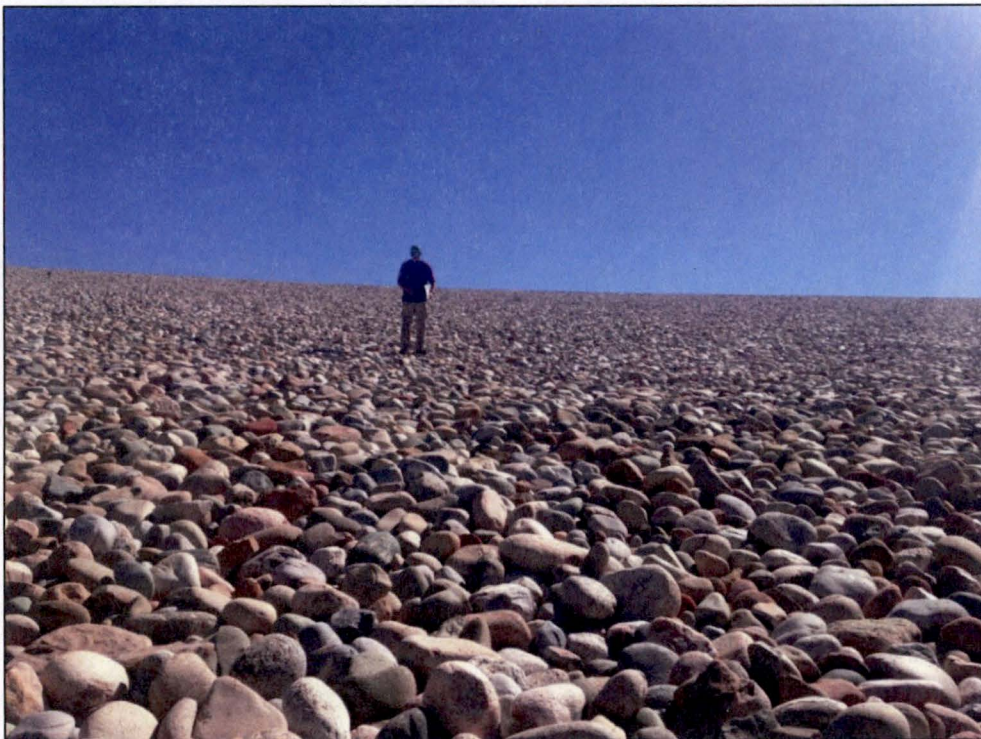
*PL-8. Slight Topographic Irregularities on the South Side Slope of the Disposal Cell*

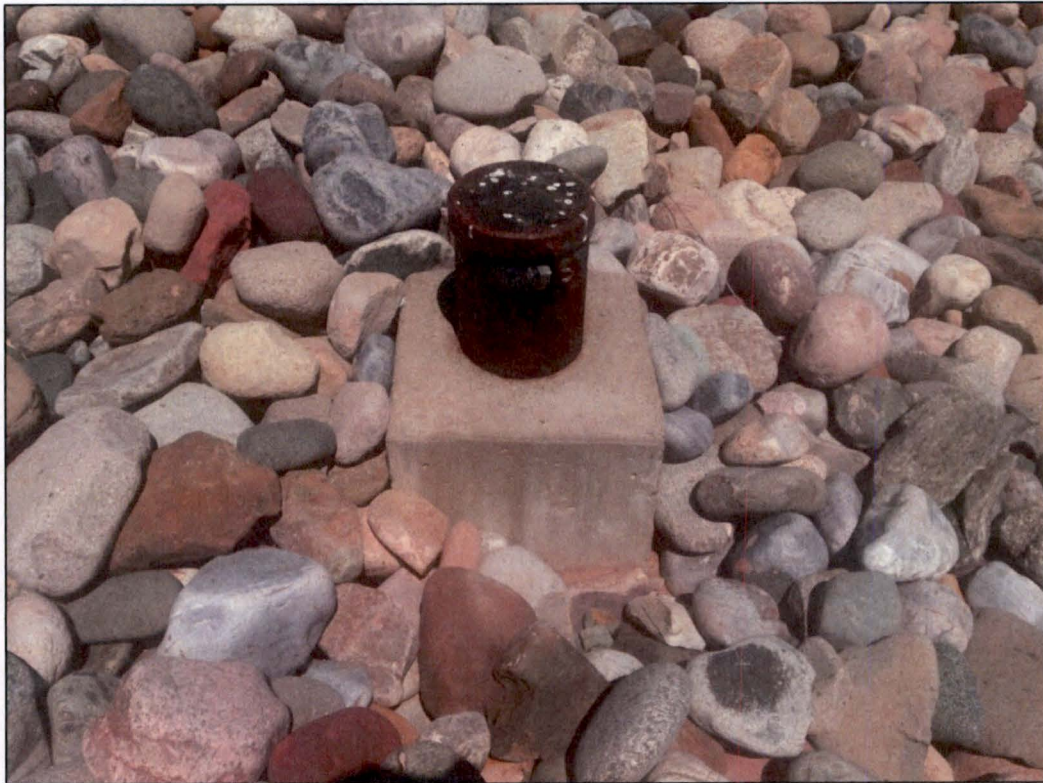
A dug-out hole was observed around settlement plate 4 on the east-facing side slope (PL-9). It was likely dug out by a large animal. Inspectors replaced the rock around the settlement plate. No maintenance needs were identified.

*PL-9. Rocks Dug Out Around Settlement Plate 4, Likely by a Large Animal*

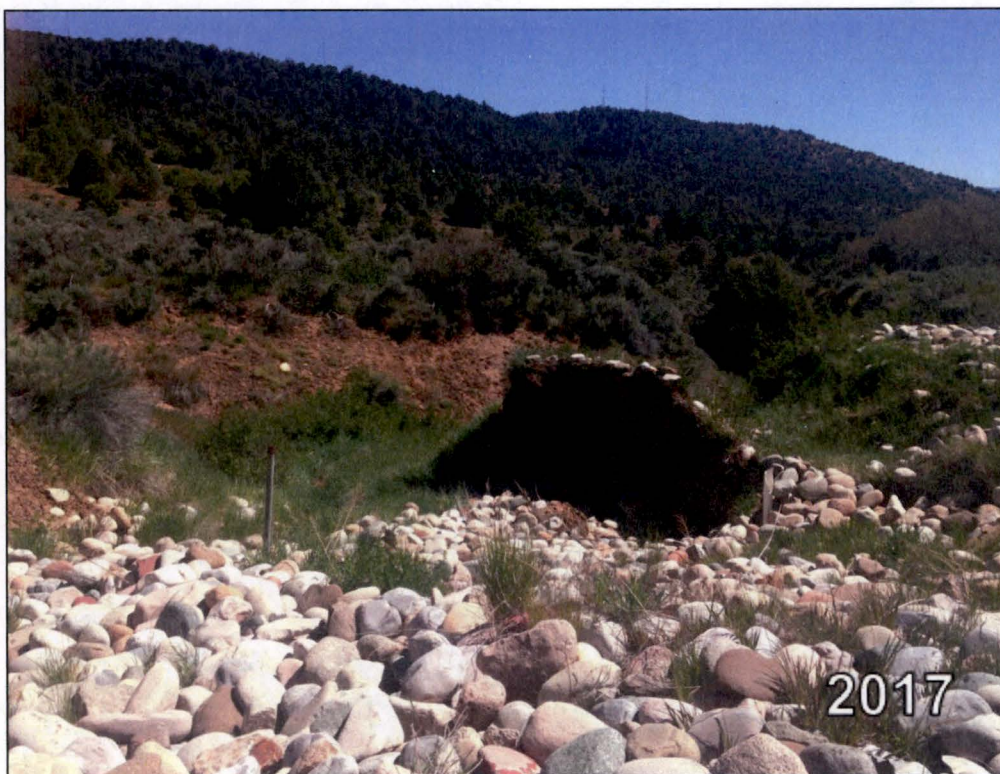
*PL-10. (a) Northeast Outflow Channel Bottom Is Stable, Whereas Upland Area on Right Is Slowly Eroding, 2017*

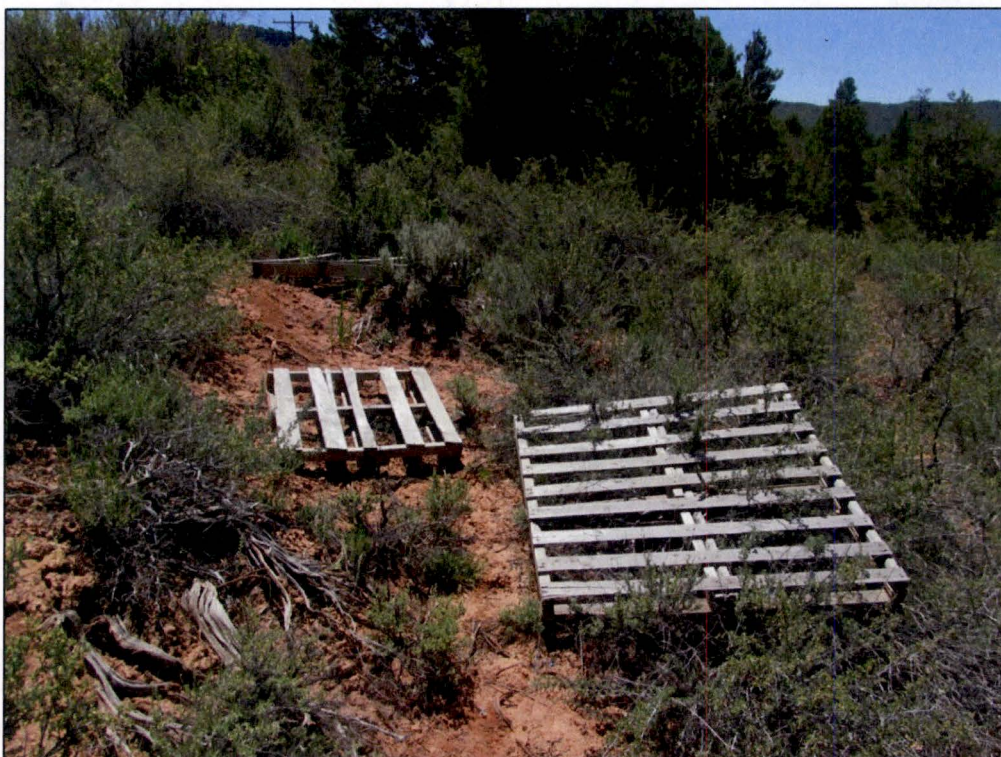
*PL-12. Trash Near Boundary Monument BM-6*

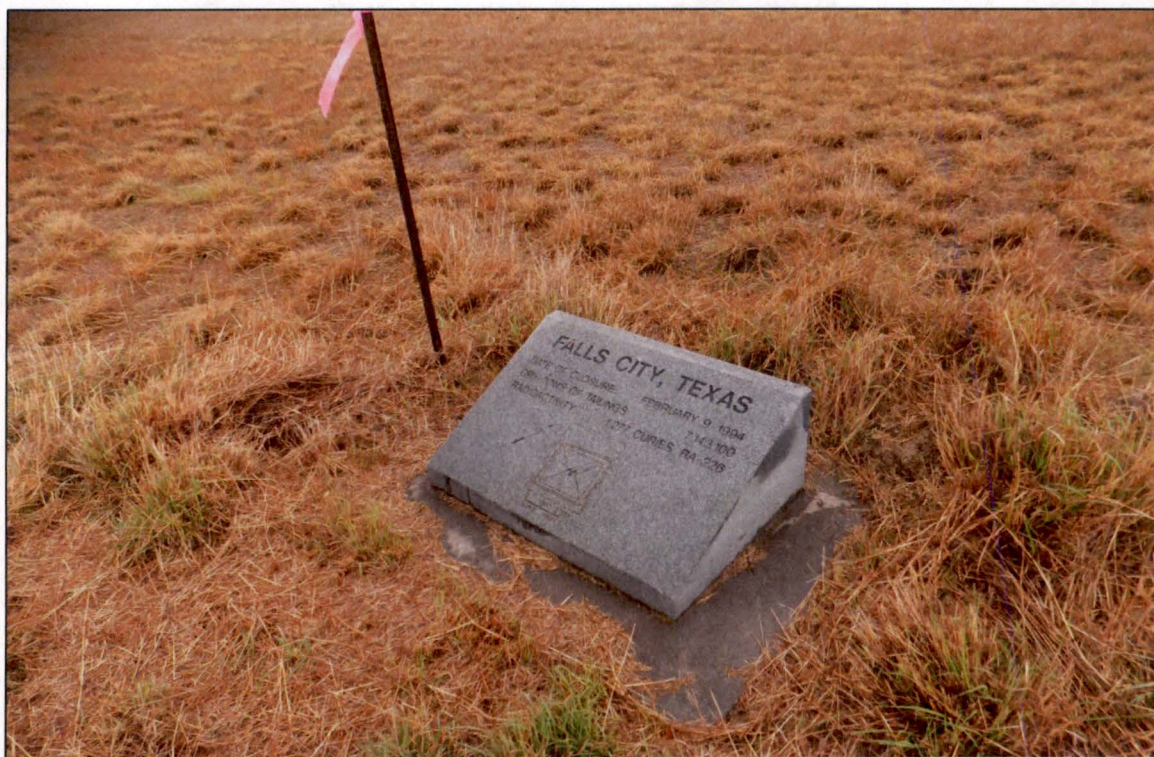
The site has two granite site markers. Site marker SMK-1 is just inside the entrance gate; its concrete base has several minor cracks, but they do not compromise the integrity of the base, and repairs are not necessary at this time. Site marker SMK-2 is on the top slope of the disposal cell (PL-3). No immediate maintenance needs were identified.

*PL-3. Site Marker SMK-2 on the Top Slope of the Disposal Cell*

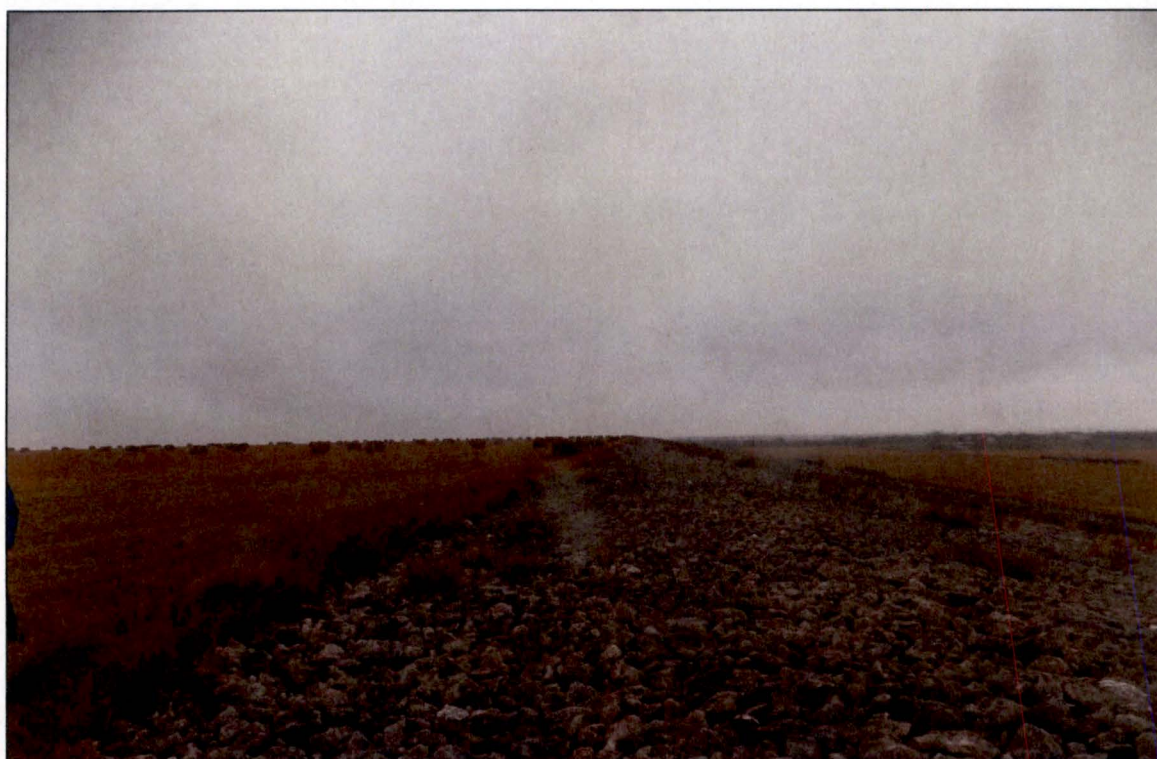
The side slopes of the disposal cell are armored with riprap (PL-4). Since shortly after disposal cell construction, vegetation has been observed growing on the side slopes. Much of the vegetation observed in 2017 was dead or dormant grass. The grass does not affect disposal cell performance. Deep roots of woody vegetation could penetrate the radon barrier, so woody vegetation is controlled annually through cutting and applying herbicide. DOE has monitored several small depressions on the northwest side slope of the disposal cell since 2010. These depressions do not compromise the performance of the riprap-armored side slope, and no changes have been observed since 2010. Inspectors will continue to monitor these areas.

Fractured riprap has been observed on the disposal cell side slopes since it was completed. Pieces of riprap are fractured in place, indicating that the fracturing occurred after placement. Fracturing is likely a consequence of mechanical placement or thermal expansion and contraction; the riprap condition does not appear to be worsening. During the inspection, photos were taken of riprap at the base of T-post 4, on the west corner of the disposal cell (PL-5), and these photos were compared to photos taken in previous years (PL-5, from 2010) at this location. There is no indication that the riprap is degrading, but its durability will continue to be monitored. If the number of fractured rocks appears to be increasing, DOE will establish a more quantitative monitoring program.

*PL-4. View Northeast Along the Top of the Southeast Side Slope*

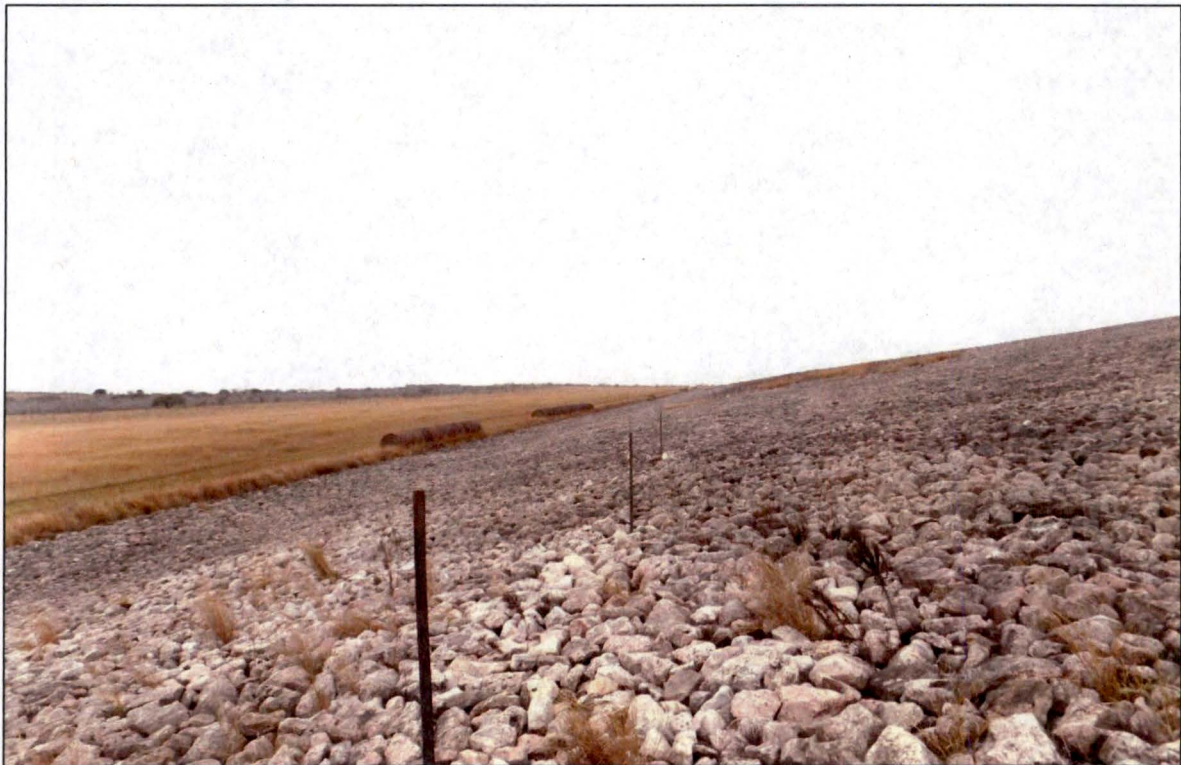
In 2007, inspectors noted possible subsidence in the riprap at the toe of the south corner of the side slope. In 2008, three T-posts were installed in a straight line running at an orientation of 317° to monitor side slope movement. Each post was installed at a vertical pitch of 90°. These three posts provide reference points to assess whether the area is undergoing movement: If a post moves out of line with the other two posts or the pitch of an individual post changes, it indicates possible movement. The three posts remain in the same straight line in which they were installed and are at the same vertical pitch (PL-6).

*PL-6. Three T-Posts Installed on the South Corner of the Disposal Cell*

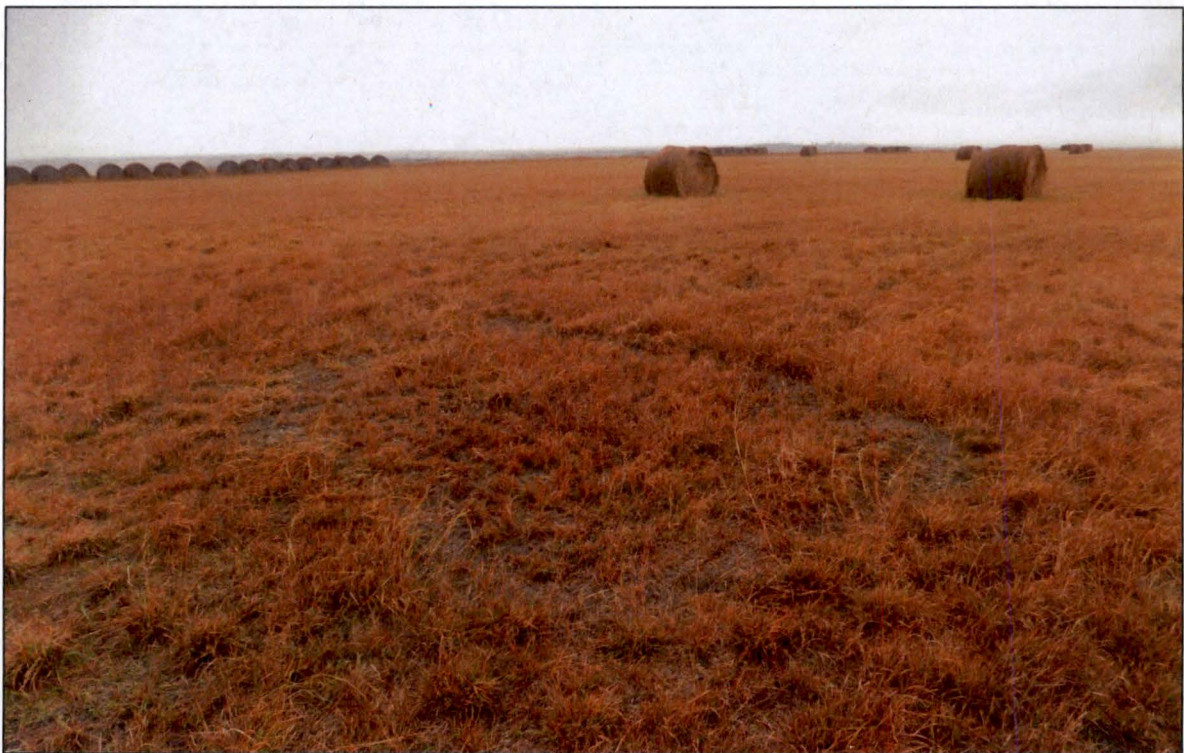
researchers excavated through the cover materials (cover soil and underlying radon barrier) at six locations to measure radon flux and document soil structure (Figure 5-1). Although significant soil structure was developing, radon flux did not exceed the U.S. Environmental Protection Agency (EPA) standard. Vegetation is becoming reestablished at test pit locations TP1 through TP4 on the top slope of the disposal cell (PL-7). Test pit locations TP5 and TP6 are located on the southwest side slope of the disposal cell within the riprap (PL-8). DOE will continue to monitor these locations to confirm that positive drainage is preserved and vegetation continues to thrive.

*PL-7. Restoration at TP1*

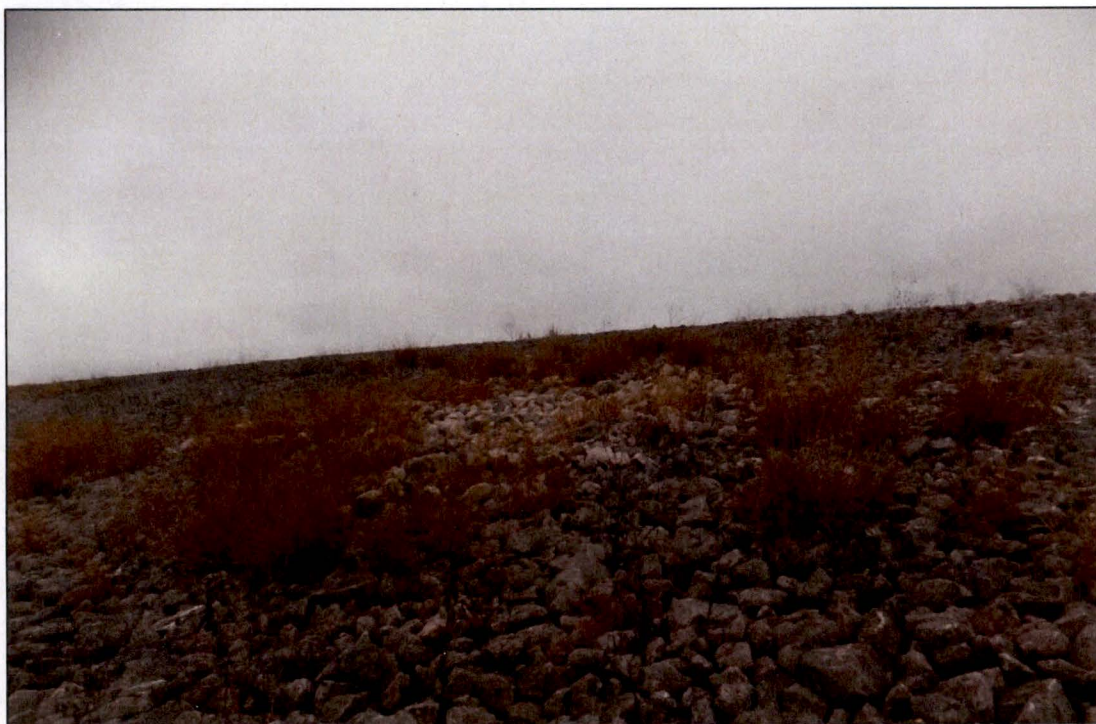
*PL-8. Restoration at TP6*

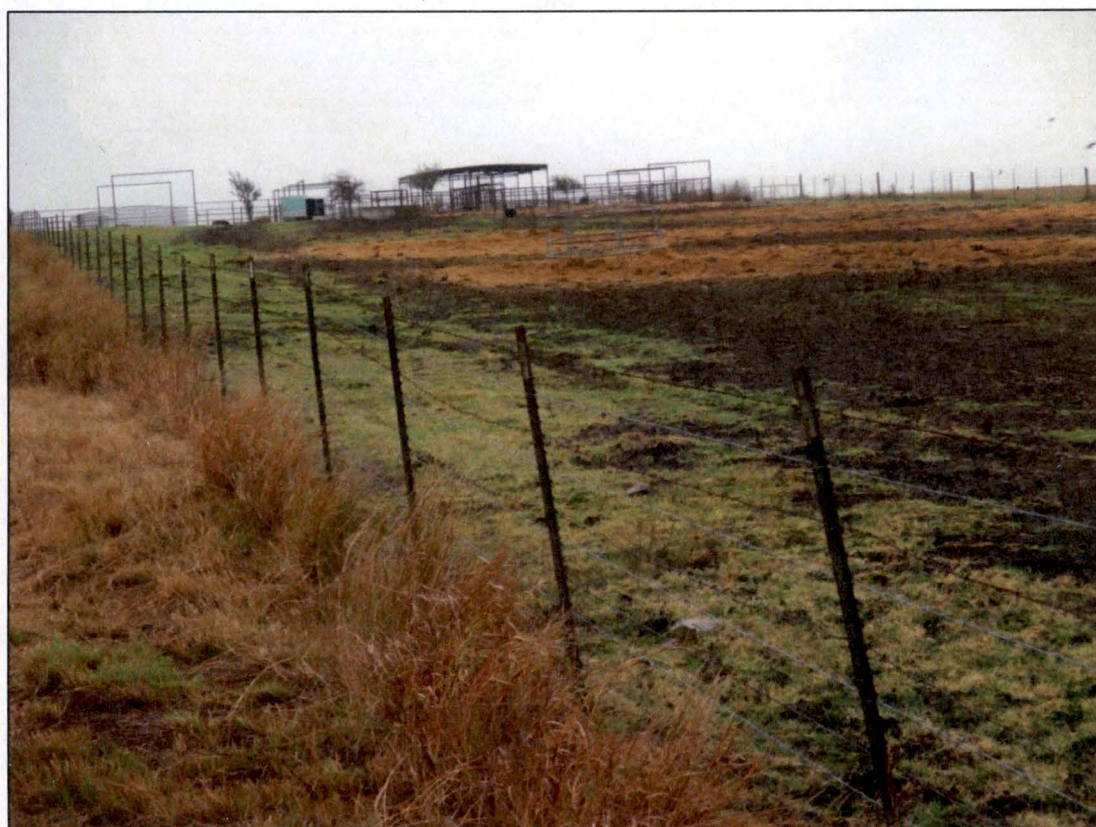
The area beyond the site boundary for a distance of 0.25 mile was visually observed for erosion, changes in land use, or other phenomena that might affect the long-term integrity of the site. No such impacts were observed. The remainder of the former processing site is used for occasional livestock grazing. The owners have removed some of the brush to facilitate grazing. In 2013, the landowner southeast of the site constructed corrals and gates, stock watering facilities, and equipment and hay storage structures on former State-owned land that was acquired as part of the original processing site (PL-9).

*PL-9. Development Across Southeast Perimeter Fence*

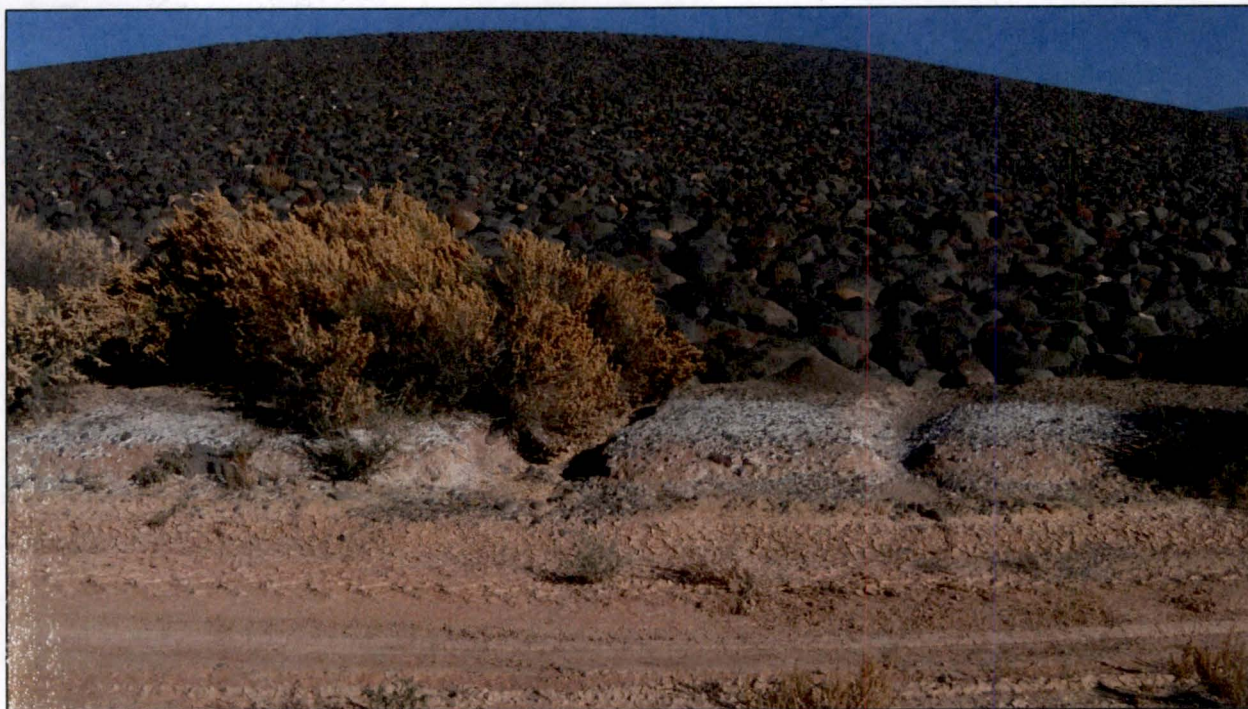
*PL-5. Erosion Rills at Bottom of Southwest Corner of Disposal Cell*

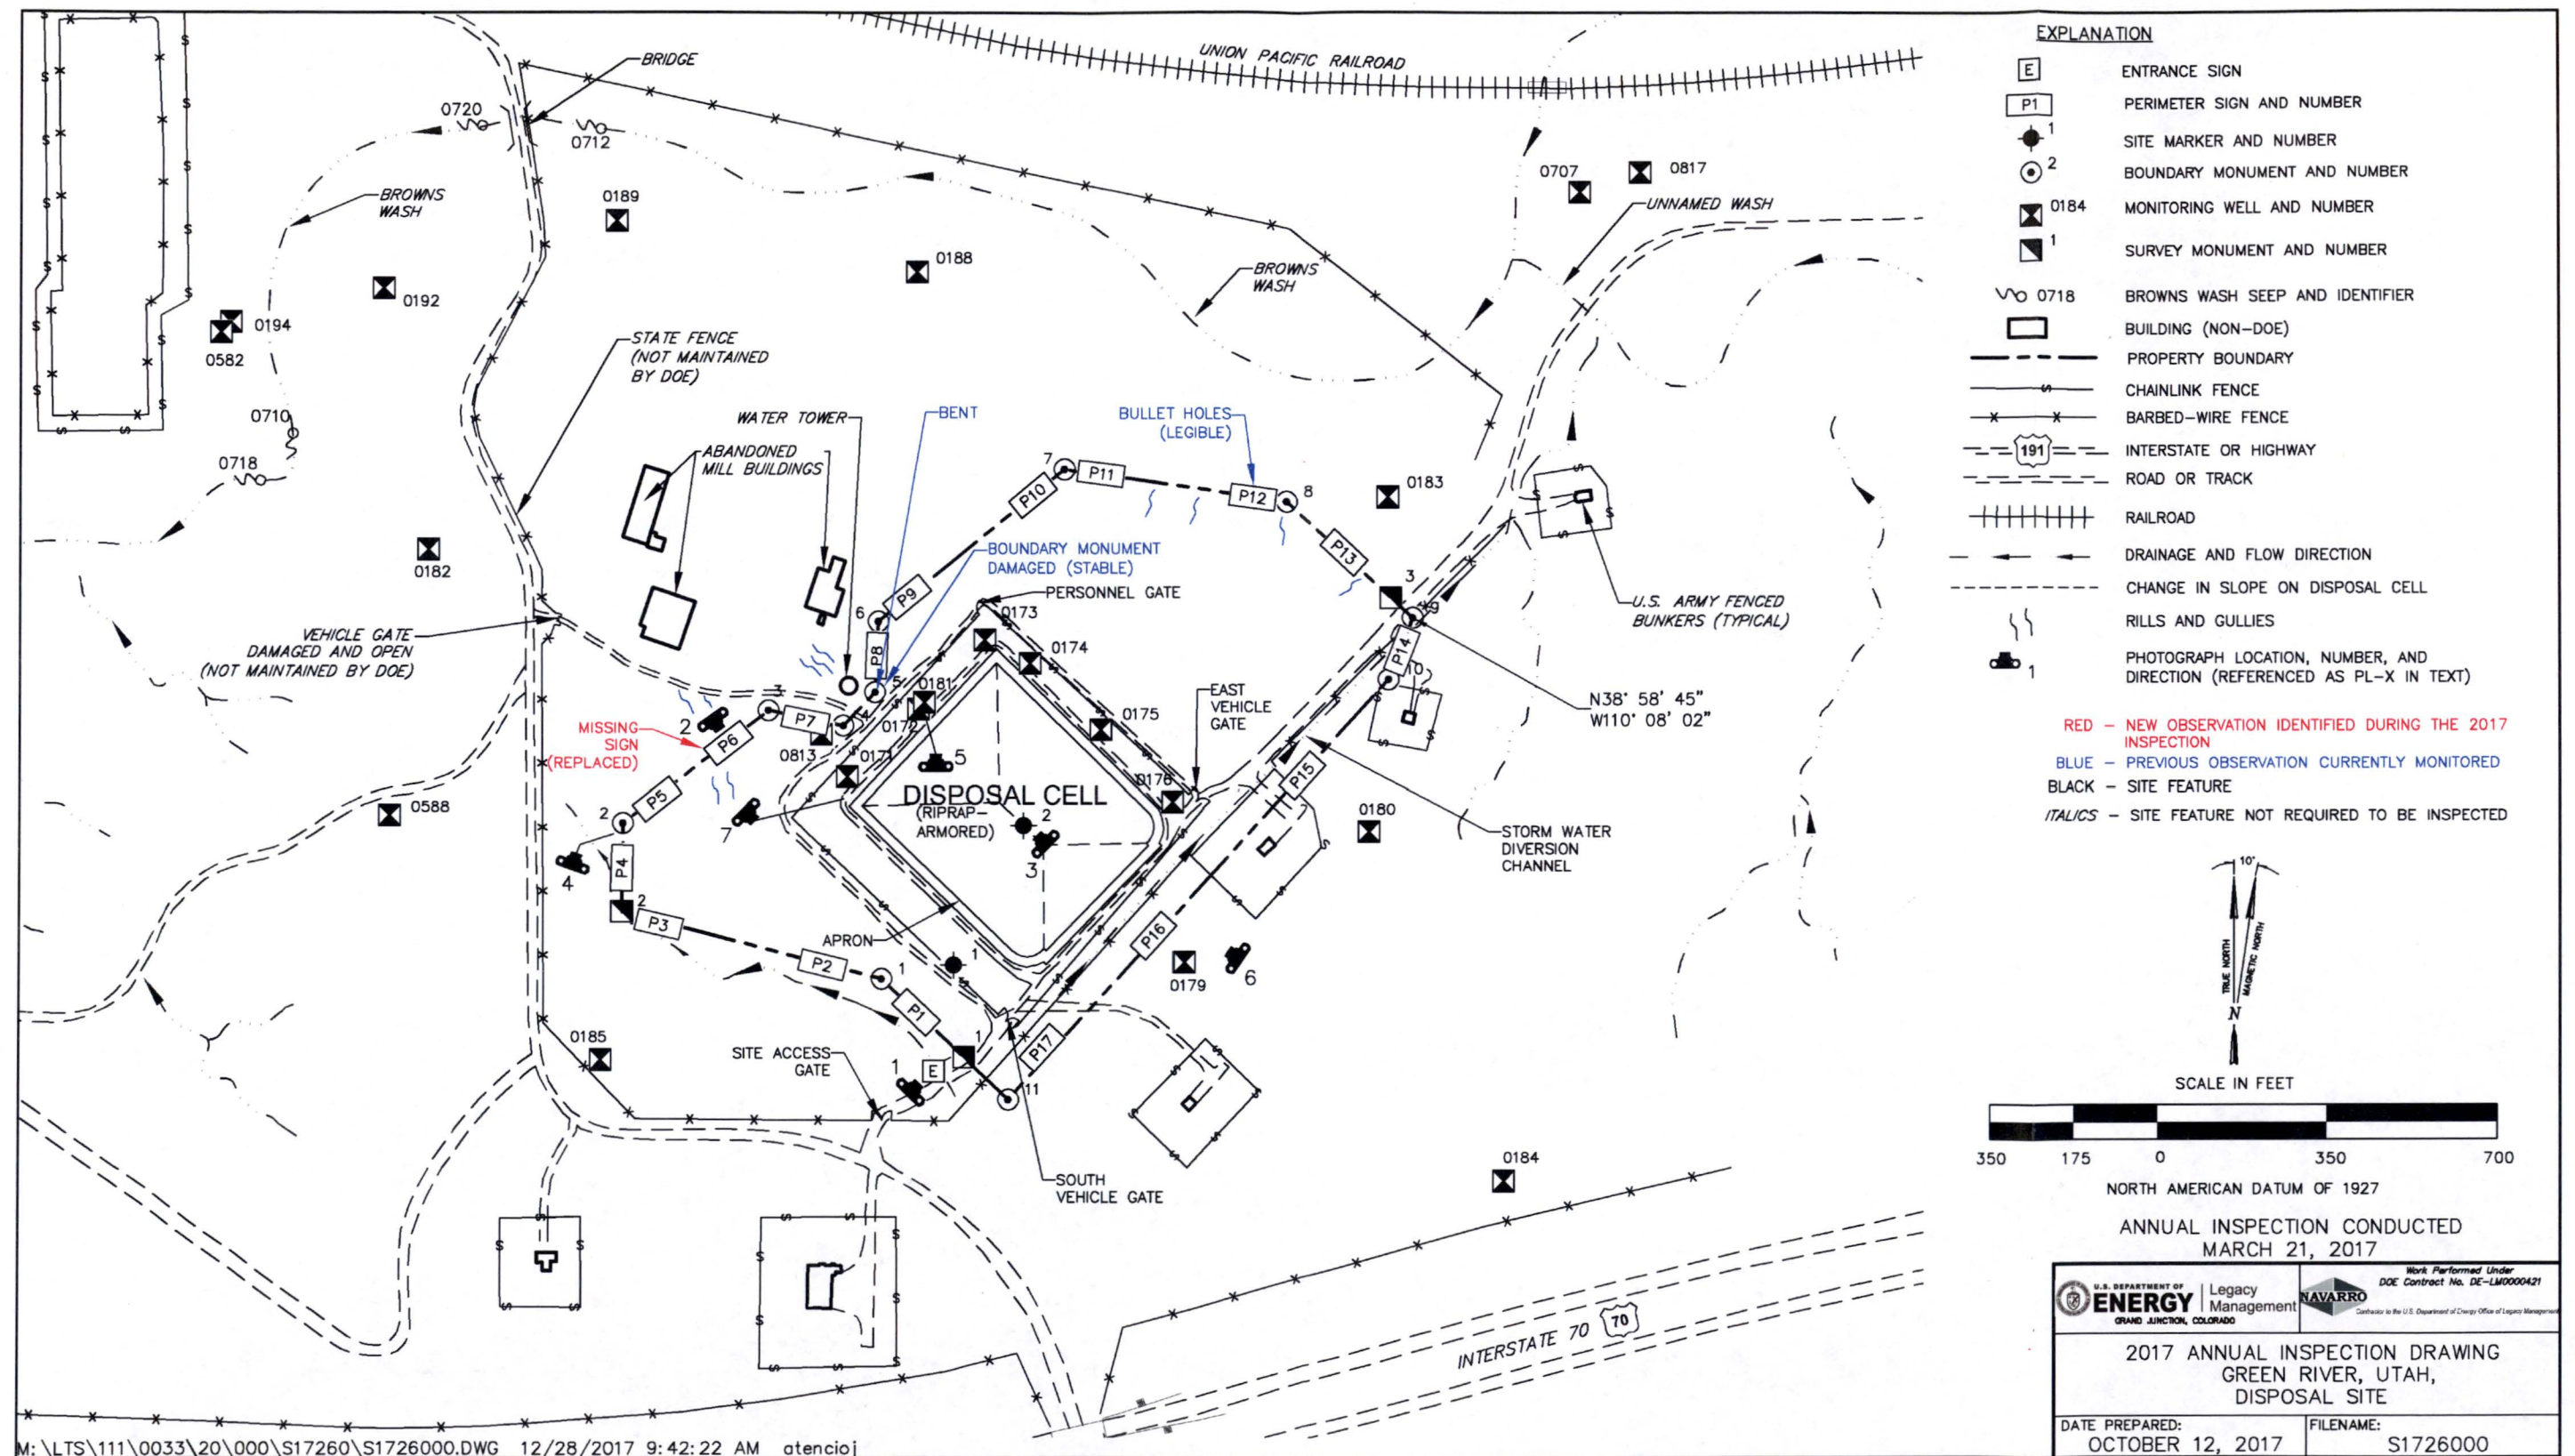
Figure 7-1. 2017 Annual Inspection Drawing for the Green River, Utah, Disposal Site

Figure 7-1 shows in black the locations of site features, including site surveillance features and inspection areas. Site features that are present but not required to be inspected are shown in italic font. Observations from previous inspections that are currently monitored are shown in blue text, and new observations identified during the 2017 annual inspection are shown in red. Inspection results and recommended maintenance activities associated with site surveillance features are described in the following subsections. Photographs to support specific observations are identified in the text and in Figure 7-1 by photograph location (PL) numbers. The photographs and photograph log are presented in Section 7.10.

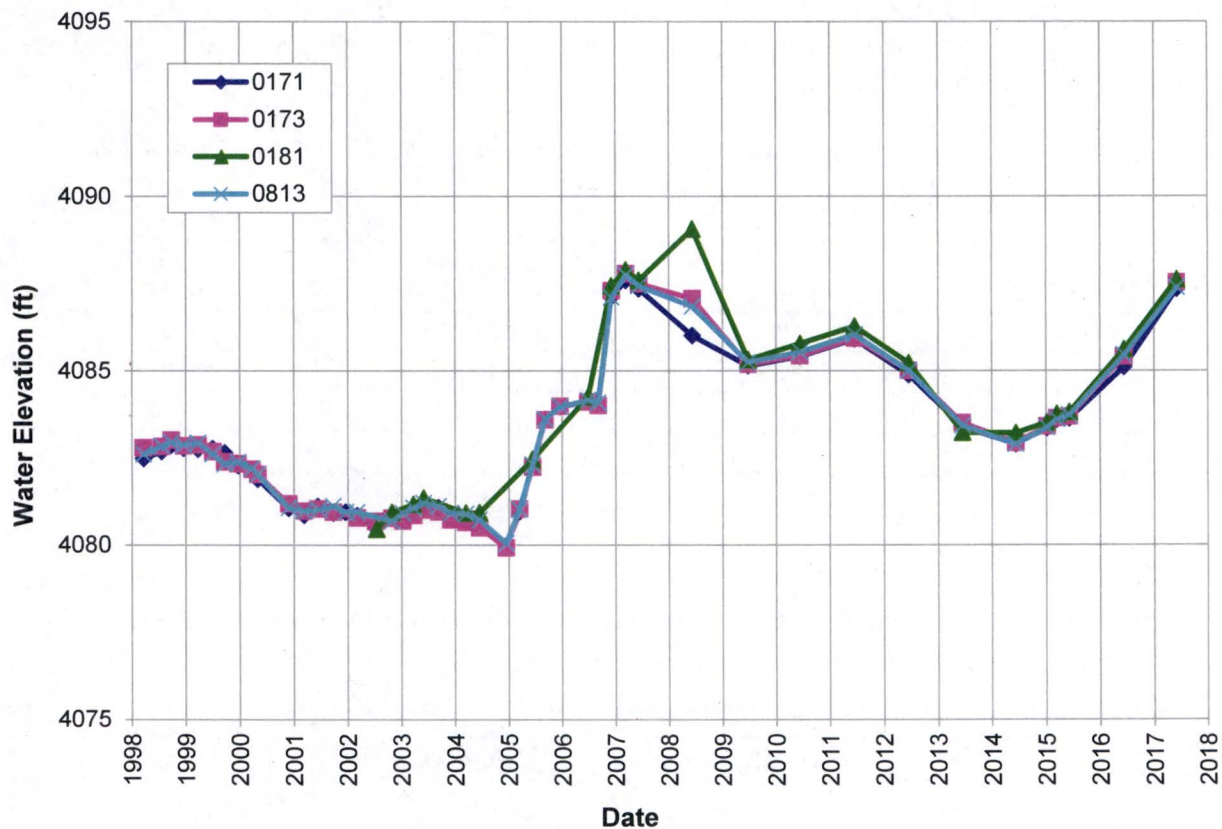
Figure 7-3. Groundwater Elevations at the Green River, Utah, Disposal Site

Water levels in the POC wells have increased steadily since 2014, returning to 2007 levels. Historically, the groundwater levels in these wells decreased approximately 3 ft overall from 1998 through 2004 and then increased approximately 8 ft between 2004 and 2007. Water level decreases ranged from 4 to 5 ft from 2007 through 2014. Since 2014, water levels have increased approximately 5 ft (Figure 7-3). The higher water levels are not believed to result from liquid releases from the disposal cell. Rather, general increases in river stage and hydraulic heads in upgradient parts of the middle sandstone aquifer are considered more likely causes of the apparent rise in groundwater elevation.

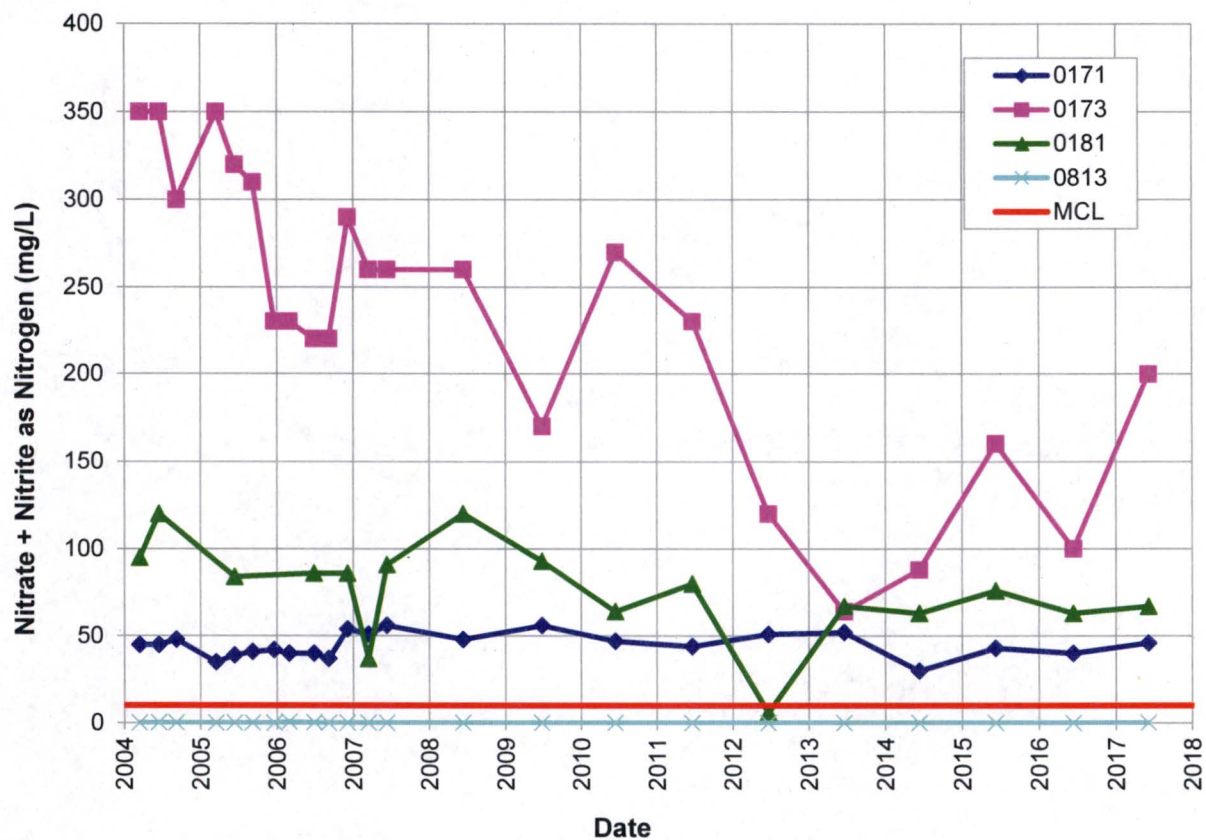
Figure 7-4. Nitrate at Point of Compliance Wells at the Green River, Utah, Disposal Site

Nitrate concentrations continued to exceed the LTSP concentration limits in POC wells 0171 and 0173 but are below the GCAP proposed risk-based ACL of 1000 mg/L. The 2017 nitrate concentrations were within the range of historical values for all POC wells (Figure 7-4).

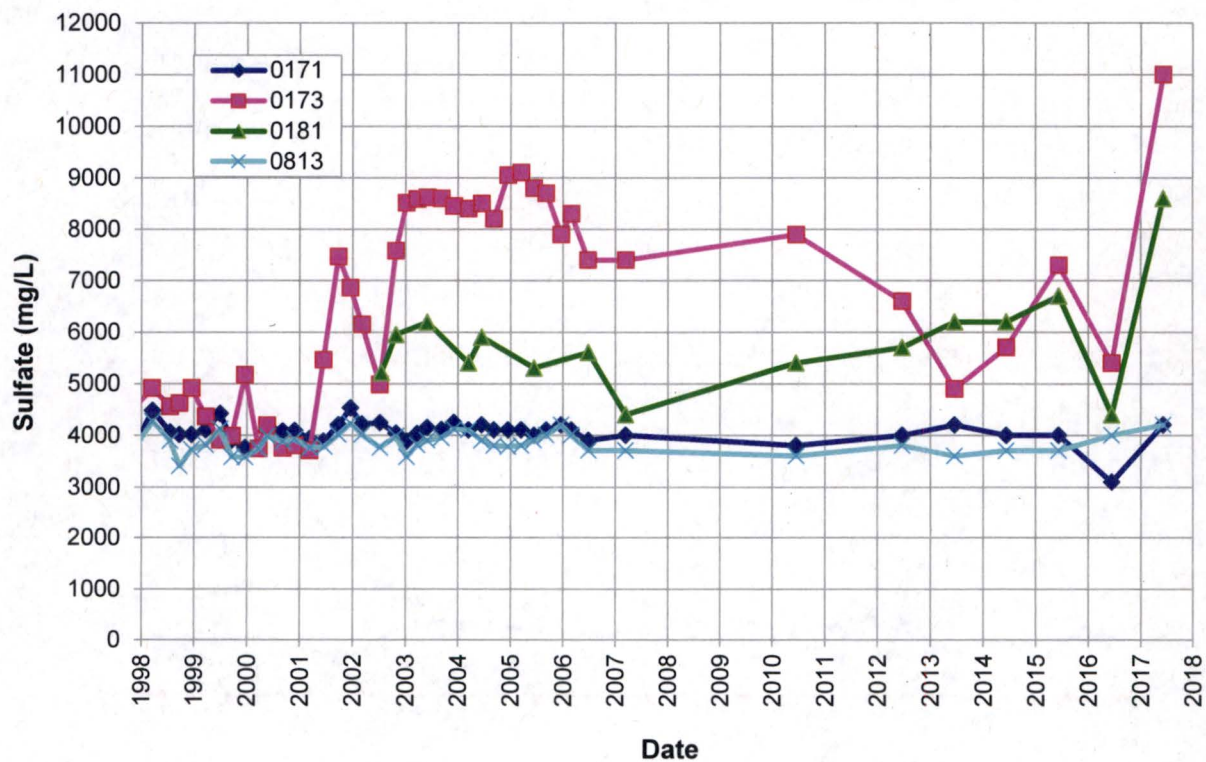
Figure 7-5. Sulfate at Point of Compliance Wells at the Green River, Utah, Disposal Site

Sulfate concentrations exceeded the LTSP concentration limits in all POC wells except POC well 0813. The 2017 sulfate concentrations exceed historical values in POC wells 0173 and 0181 (Figure 7-5).

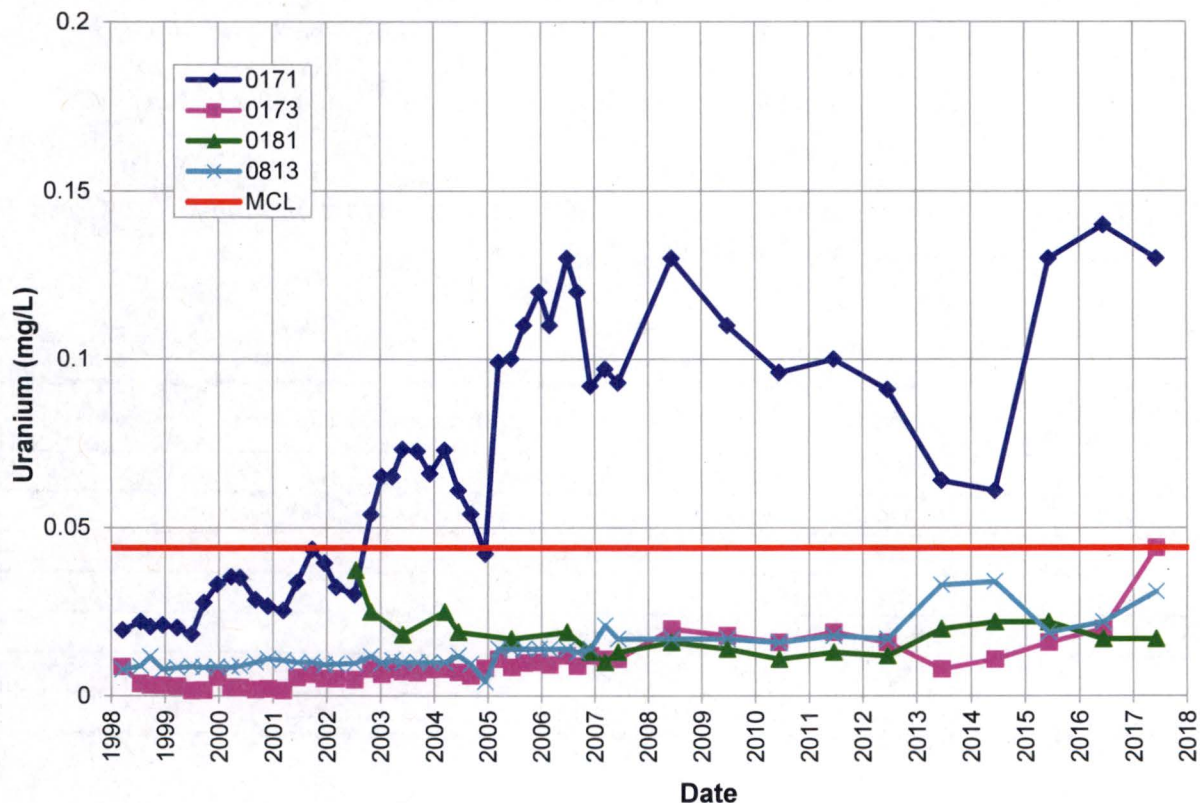
Figure 7-6. Uranium at Point of Compliance Wells at the Green River, Utah, Disposal Site

Uranium concentrations remain below the LTSP concentration limits in all POC wells except POC wells 0171 and 0173 and below the GCAP proposed risk-based ACL of 4.4 mg/L in all POC wells (Figure 7-6). Uranium concentrations at POC well 0171 have varied considerably, ranging from a low of 0.0184 mg/L in 1999 to a high of 0.14 mg/L in 2016. No conclusions have been reached regarding the variability of uranium concentrations in POC well 0171. The 2017 uranium concentrations were within the range of historical values for all POC wells with the exception of POC well 0173, where uranium concentrations increased to 0.044 mg/L from a concentration of 0.02 mg/L in 2016.

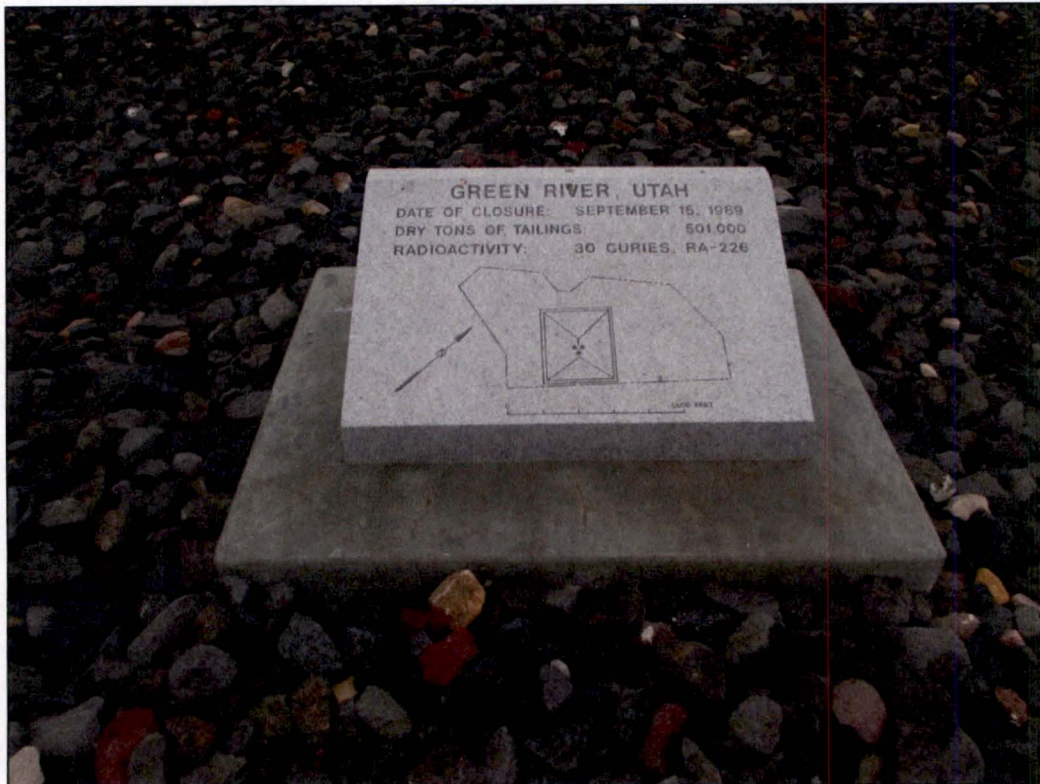
*PL-3. Site Marker SMK-2*

The site has two granite markers. Site marker SMK-1 is inside the security fence near the southwest corner of the site. Its concrete base has several minor cracks, but they do not compromise the integrity of the base, and repairs are not necessary at this time. Site marker SMK-2 is on the crest of the disposal cell (PL-3). No maintenance needs were identified.

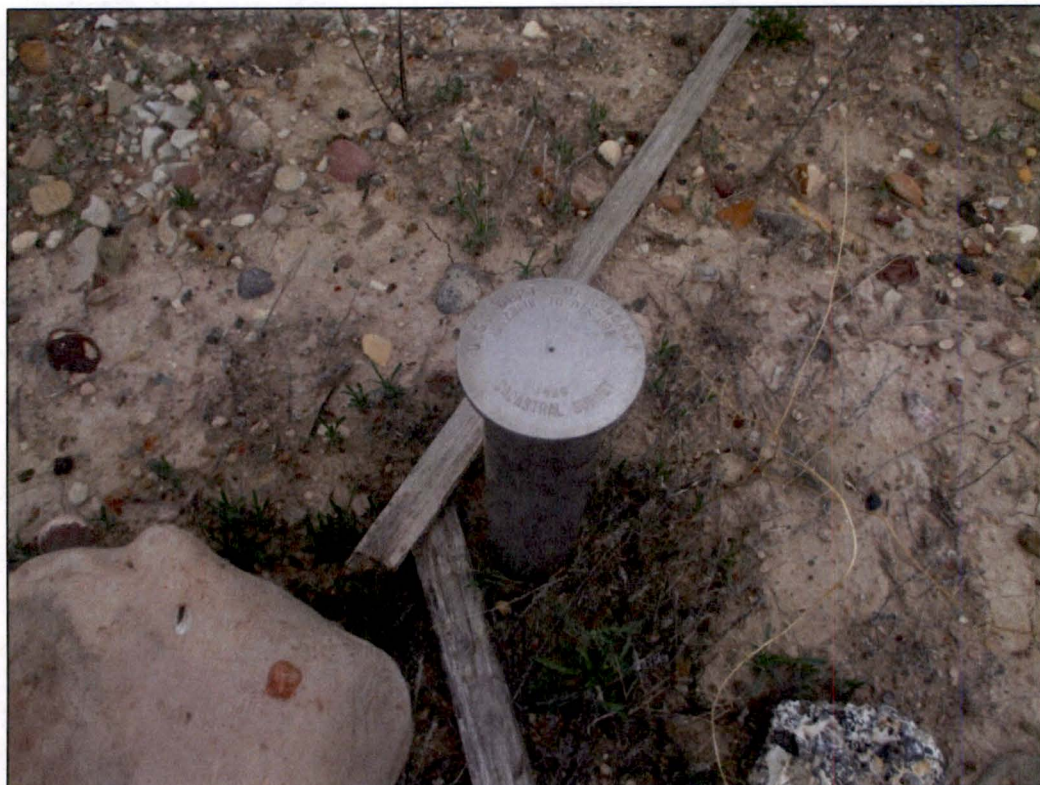
*PL-4. Boundary Monument BM-2*

Eleven boundary monuments (PL-4) and three survey monuments delineate the property boundary. Boundary monument BM-5 is damaged (it is bent due to being hit by a vehicle), but its condition does not require repair. No maintenance needs were identified.

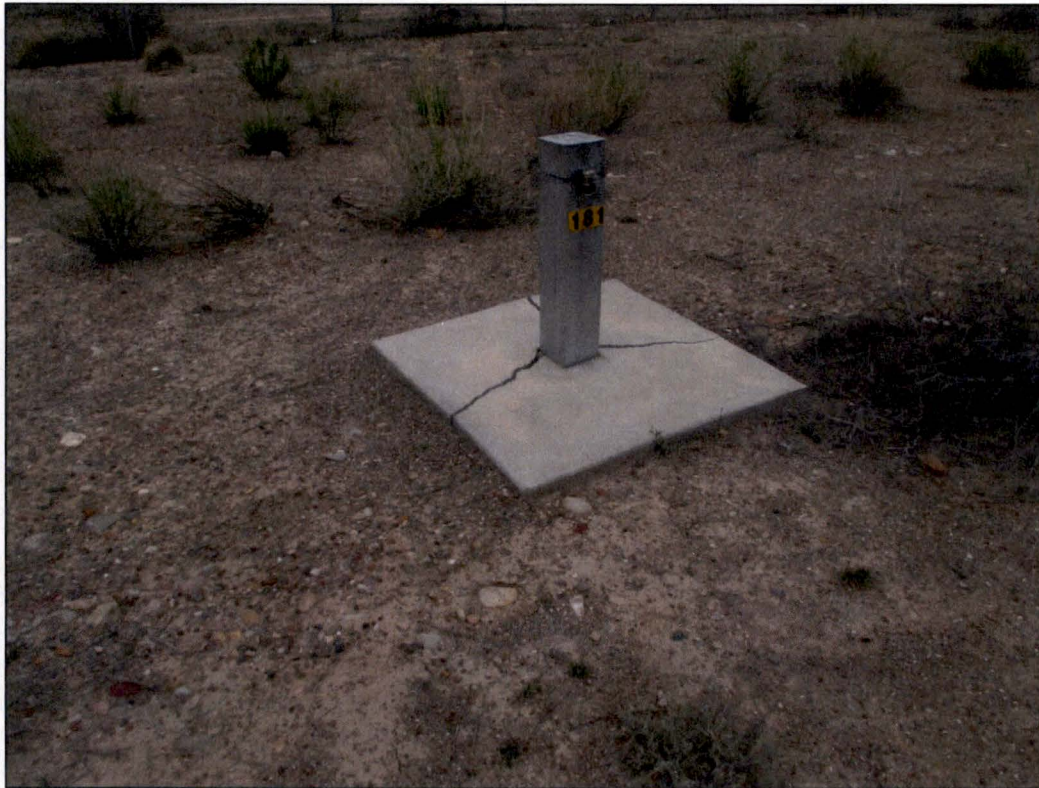
*PL-5. Monitoring Well 0181*

There are 22 monitoring wells on or near the site. Monitoring wells were inspected during the June 2017 sampling event. All wellhead protectors observed during the inspection were undamaged and locked. Some of the concrete monitoring well collars are cracked (PL-5), but the wellhead protectors are stable and repairs are not necessary. No maintenance needs were identified.
