# 2017 Annual Site Inspection and Monitoring Report for Uranium Mill Tailings Radiation Control Act Title I Disposal Sites

March 2018

**2017 Annual Site Inspection and Monitoring Report  
for  
Uranium Mill Tailings Radiation Control Act  
Title I Disposal Sites**

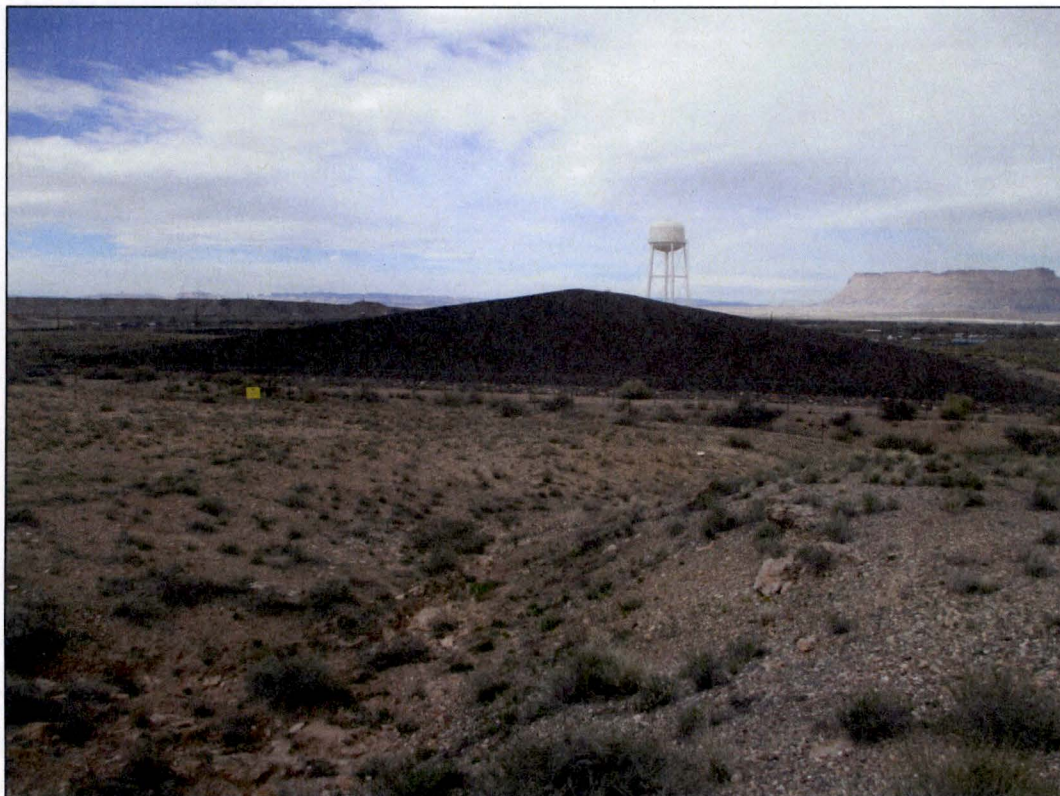
*PL-6. Disposal Cell*

The disposal cell, completed in 1989, occupies 6 acres. The slopes of the disposal cell cover are armored with riprap, consisting primarily of competent basalt with a small fraction of sedimentary rocks, to control erosion (PL-6). A small percentage of the rock, including basalt and sedimentary rocks, has degraded, but the riprap cover is functioning as designed. There was no evidence of settling, slumping, erosion, or any other modifying process that might affect the integrity of the disposal cell.

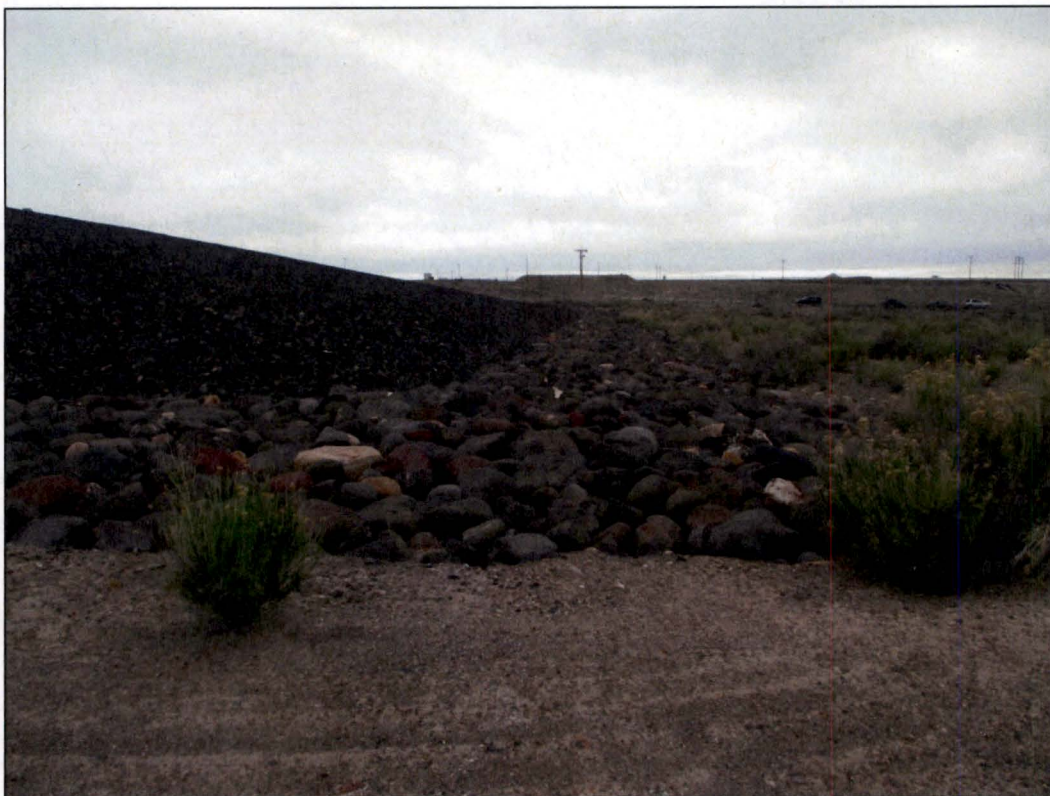
*PL-7. Apron Along Southwest Side of Disposal Cell*

A boulder-filled trench, known as an apron, surrounds the disposal cell (PL-7). The apron was intact and stable, with no observed erosion along the base of the side slopes. Small erosion rills are present along portions of the outside edge of the apron. The rills form as storm water runoff along the disposal cell perimeter road drains into the disposal cell apron. This occurrence is not a concern because the erosion is minor and sedimentation in the apron has not adversely affected the performance of the apron (the sediment has not filled the apron or become visible in the apron). Inspectors will continue to monitor the area.

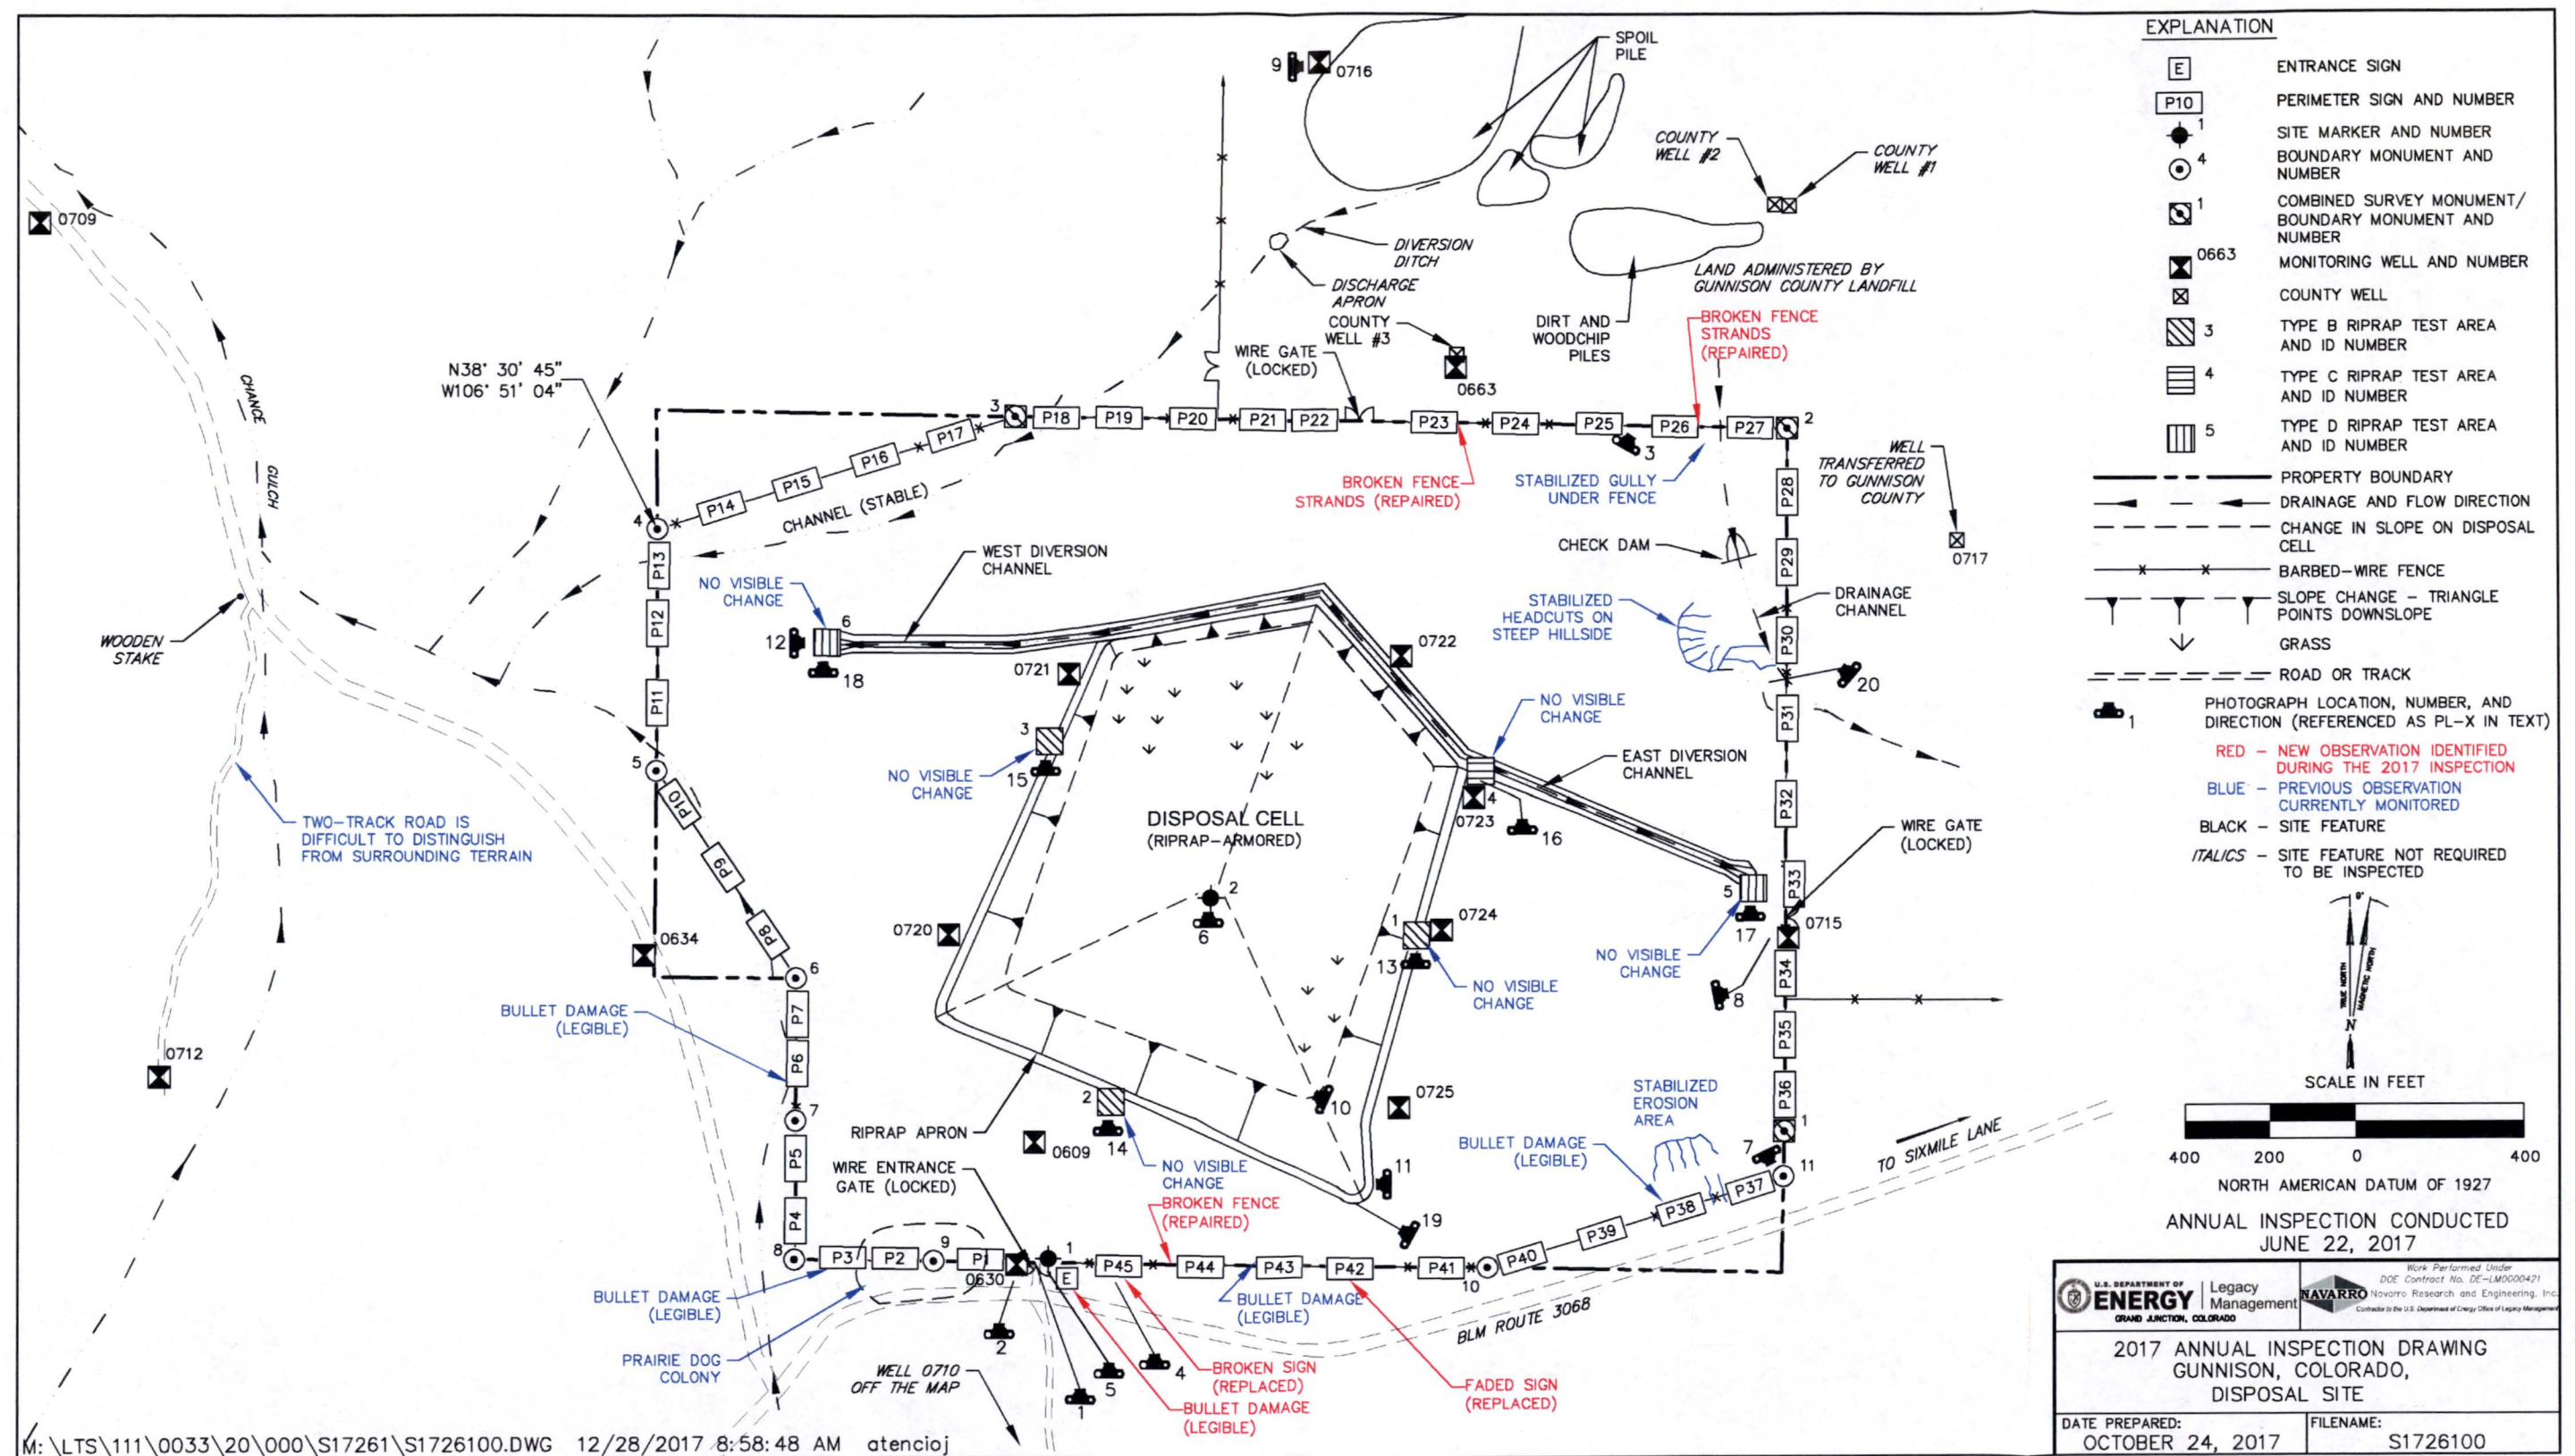
Figure 8-1. 2017 Annual Inspection Drawing for the Gunnison, Colorado, Disposal Site

Figure 8-1 shows in black the locations of site features, including site surveillance features and inspection areas. Site features that are present but not required to be inspected are shown in italic font. Observations from previous inspections that are currently monitored are shown in blue text, and new observations identified during the 2017 annual inspection are shown in red. Inspection results and recommended maintenance activities associated with site surveillance features are included in the following subsections. Photographs to support specific observations are identified in the text and in Figure 8-1 by photograph location (PL) numbers. The photographs and photograph log are presented in Section 8.10.

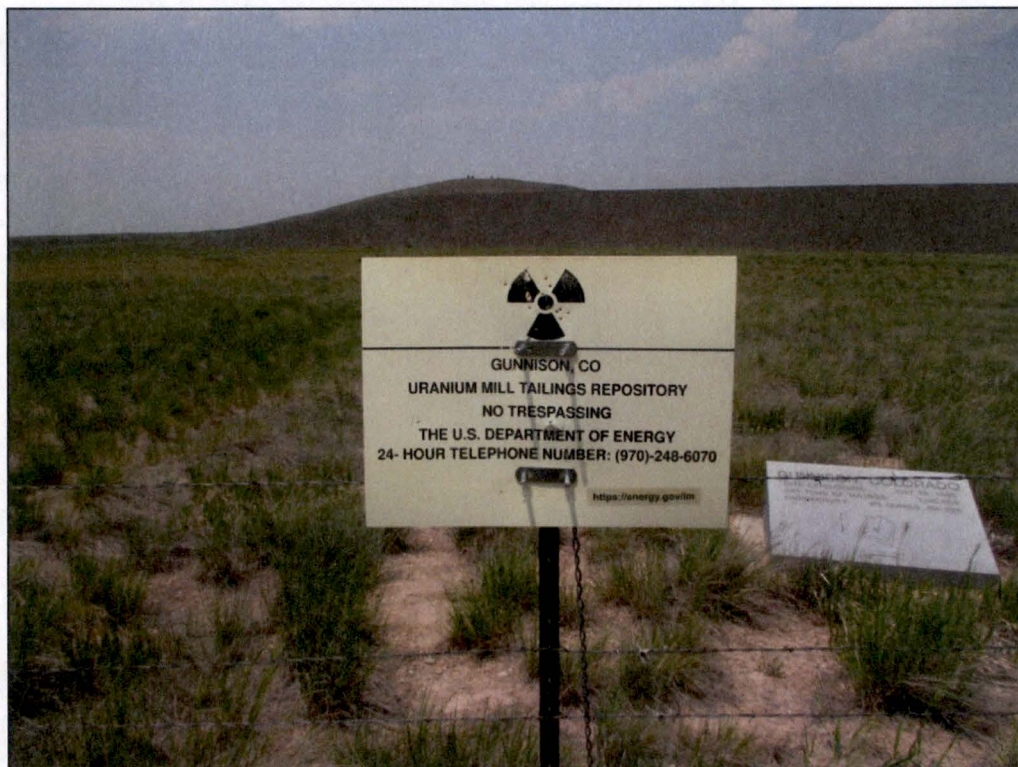
*PL-2. Entrance Sign*

Access to the site is from Gunnison County Road 42 onto U.S. Bureau of Land Management (BLM) Road 3068. The road to the site is a gravel road maintained by BLM. Entrance to the site is through a locked gate that is part of the perimeter fence. The entrance gate was locked and functional (PL-1). The entrance sign is bolted to a perimeter fence post next to the entrance gate (PL-2). The entrance sign has bullet damage but remains legible. No maintenance needs were identified.

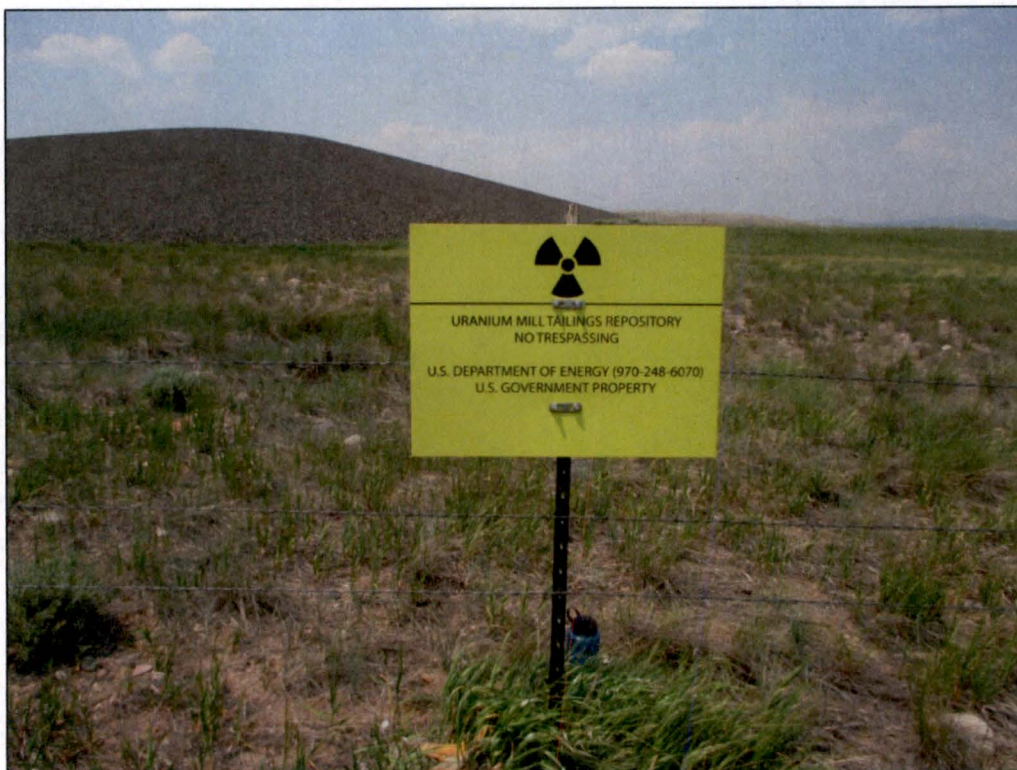
A three-strand barbed-wire perimeter fence encloses the site; most of it is set along the property boundary. The perimeter fence was intact except for three locations with broken strands that were repaired during the inspection (PL-3). Two barbed-wire gates—one on the north fence line and the other on the east fence line—provide access to offsite monitoring wells; both gates were locked. There are 45 perimeter signs bolted to the perimeter fence posts. Several perimeter signs (P3, P6, P38, and P43) have bullet damage but remain legible. Perimeter sign P45 was damaged, and perimeter sign P42 was faded; replacement signs were installed during the inspection (PL-4). No other maintenance needs were identified.

*PL-4. New Perimeter Sign P45*

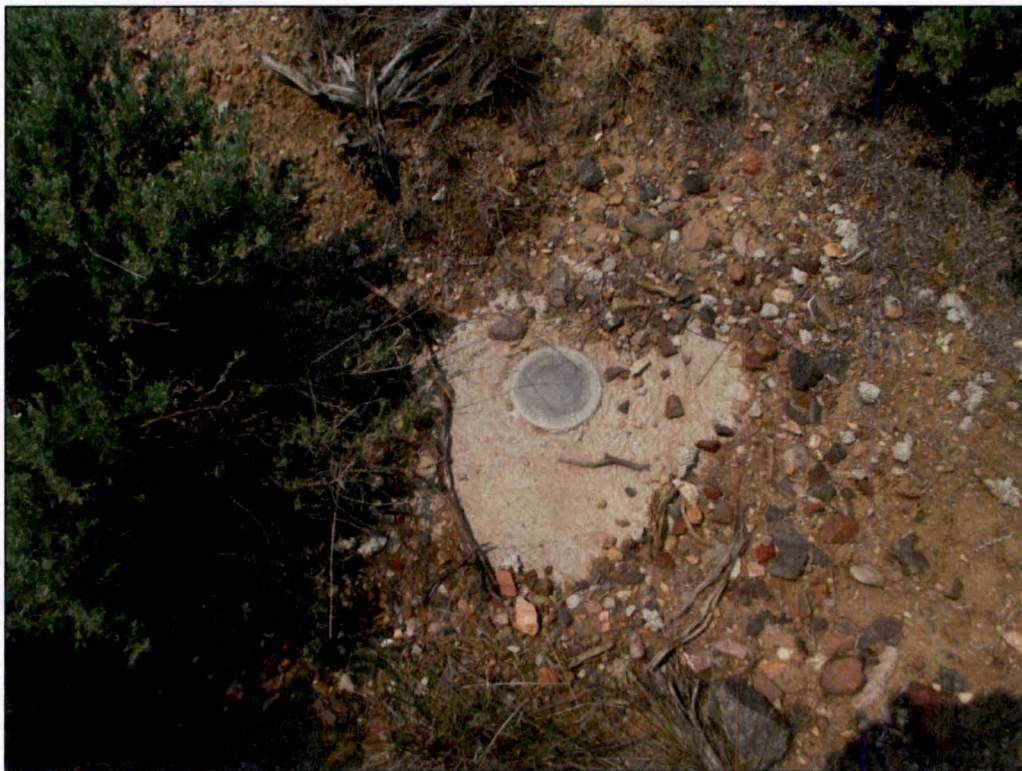
Three combined survey and boundary monuments and eight additional boundary monuments delineate the property boundary (PL-7). No maintenance needs were identified.

*PL-7. Boundary Monument BM-11*

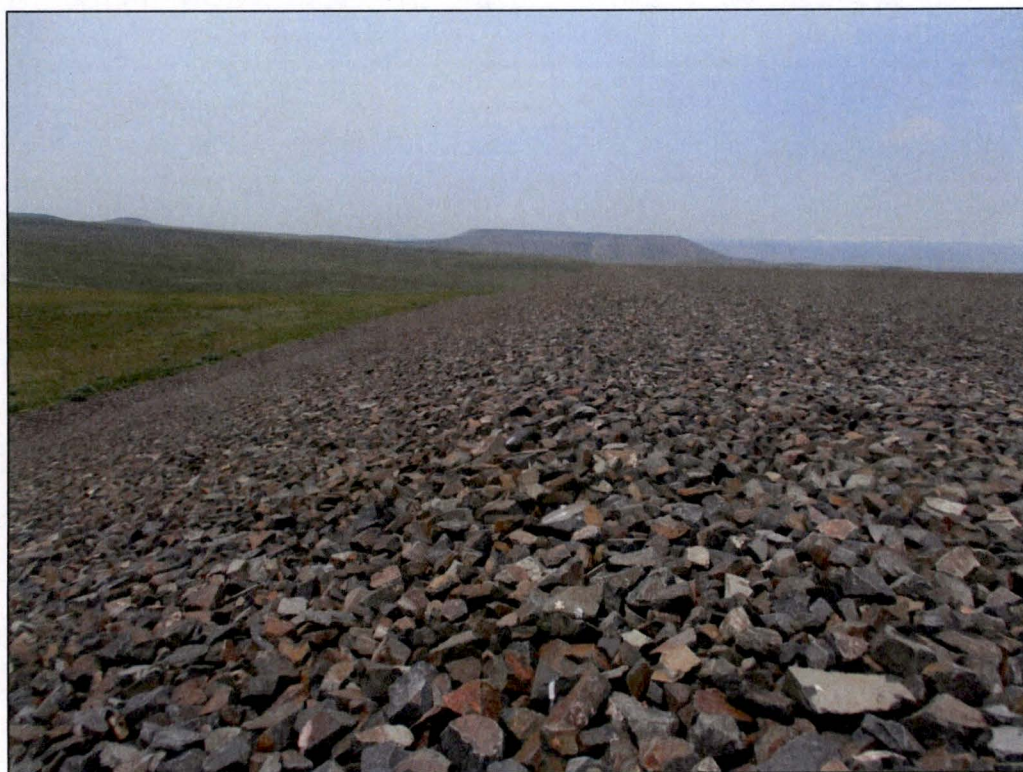
The disposal cell, completed in 1995, occupies 29 acres. The disposal cell is armored with basalt riprap to control erosion. There was no evidence settling, slumping, erosion, or any other modifying process that might affect the integrity of the top of the disposal cell. Several isolated patches of grass have established on the top slope; however, these shallow-rooted plants do not degrade the performance of the radon barrier. No maintenance needs were identified.

*PL-10. Disposal Cell Top and Southwest Side Slope*

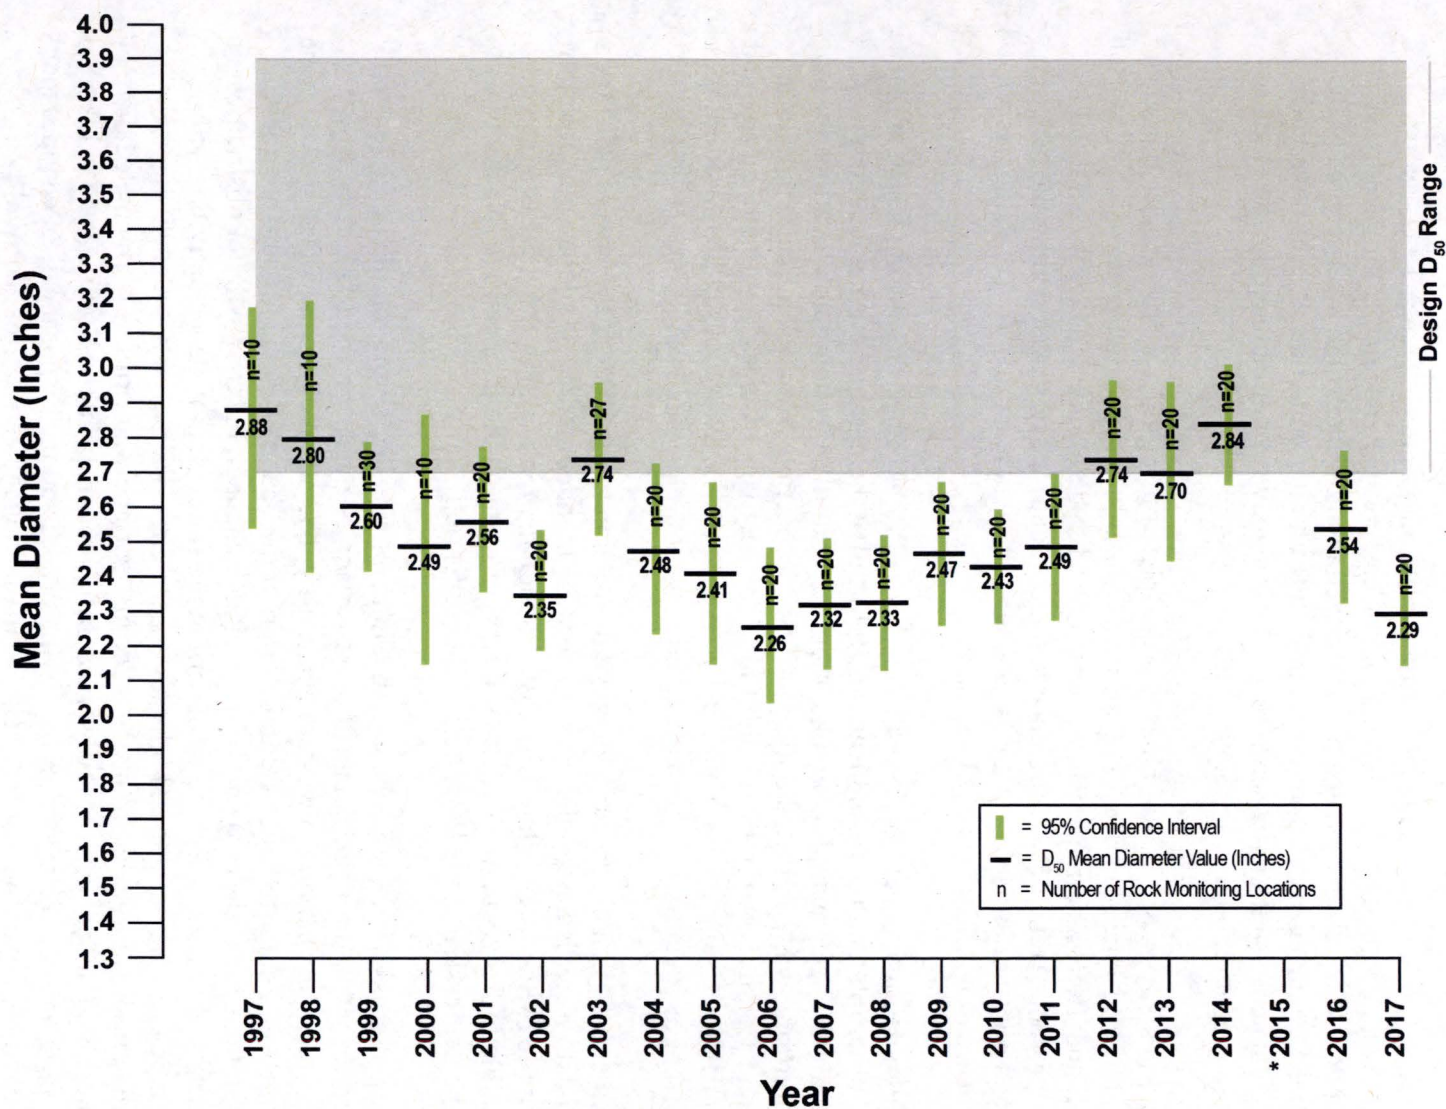
Figure 9-2 is a graph that shows the results of the gradation monitoring since 1997. (Note: During the 2015 annual inspection, the rock monitoring approach deviated from the normal procedure, at NRC's request, by using a preestablished monitoring grid in a subset area of the west side slope. This changed the sampling approach from random to biased, thus potentially compromising data comparability. Therefore, the 2015 data were not included on the graph of historical riprap gradation monitoring  $D_{50}$  values.)

A statistical trend analysis of the  $D_{50}$  values was completed using EPA's ProUCL 5.1 statistical software (last updated June 20, 2016) (<https://www.epa.gov/land-research/proucl-software>). Both Mann-Kendall and Theil-Sen trend tests were performed to determine if a significant trend in rock size was present. At the 95% confidence level, no trend was observed. While the lack of a significant trend does not indicate a static  $D_{50}$  value, it does indicate that the  $D_{50}$  value has not significantly decreased in 21 years of observation.

Figure 9-2. Historical Riprap Gradation Monitoring  $D_{50}$  Values

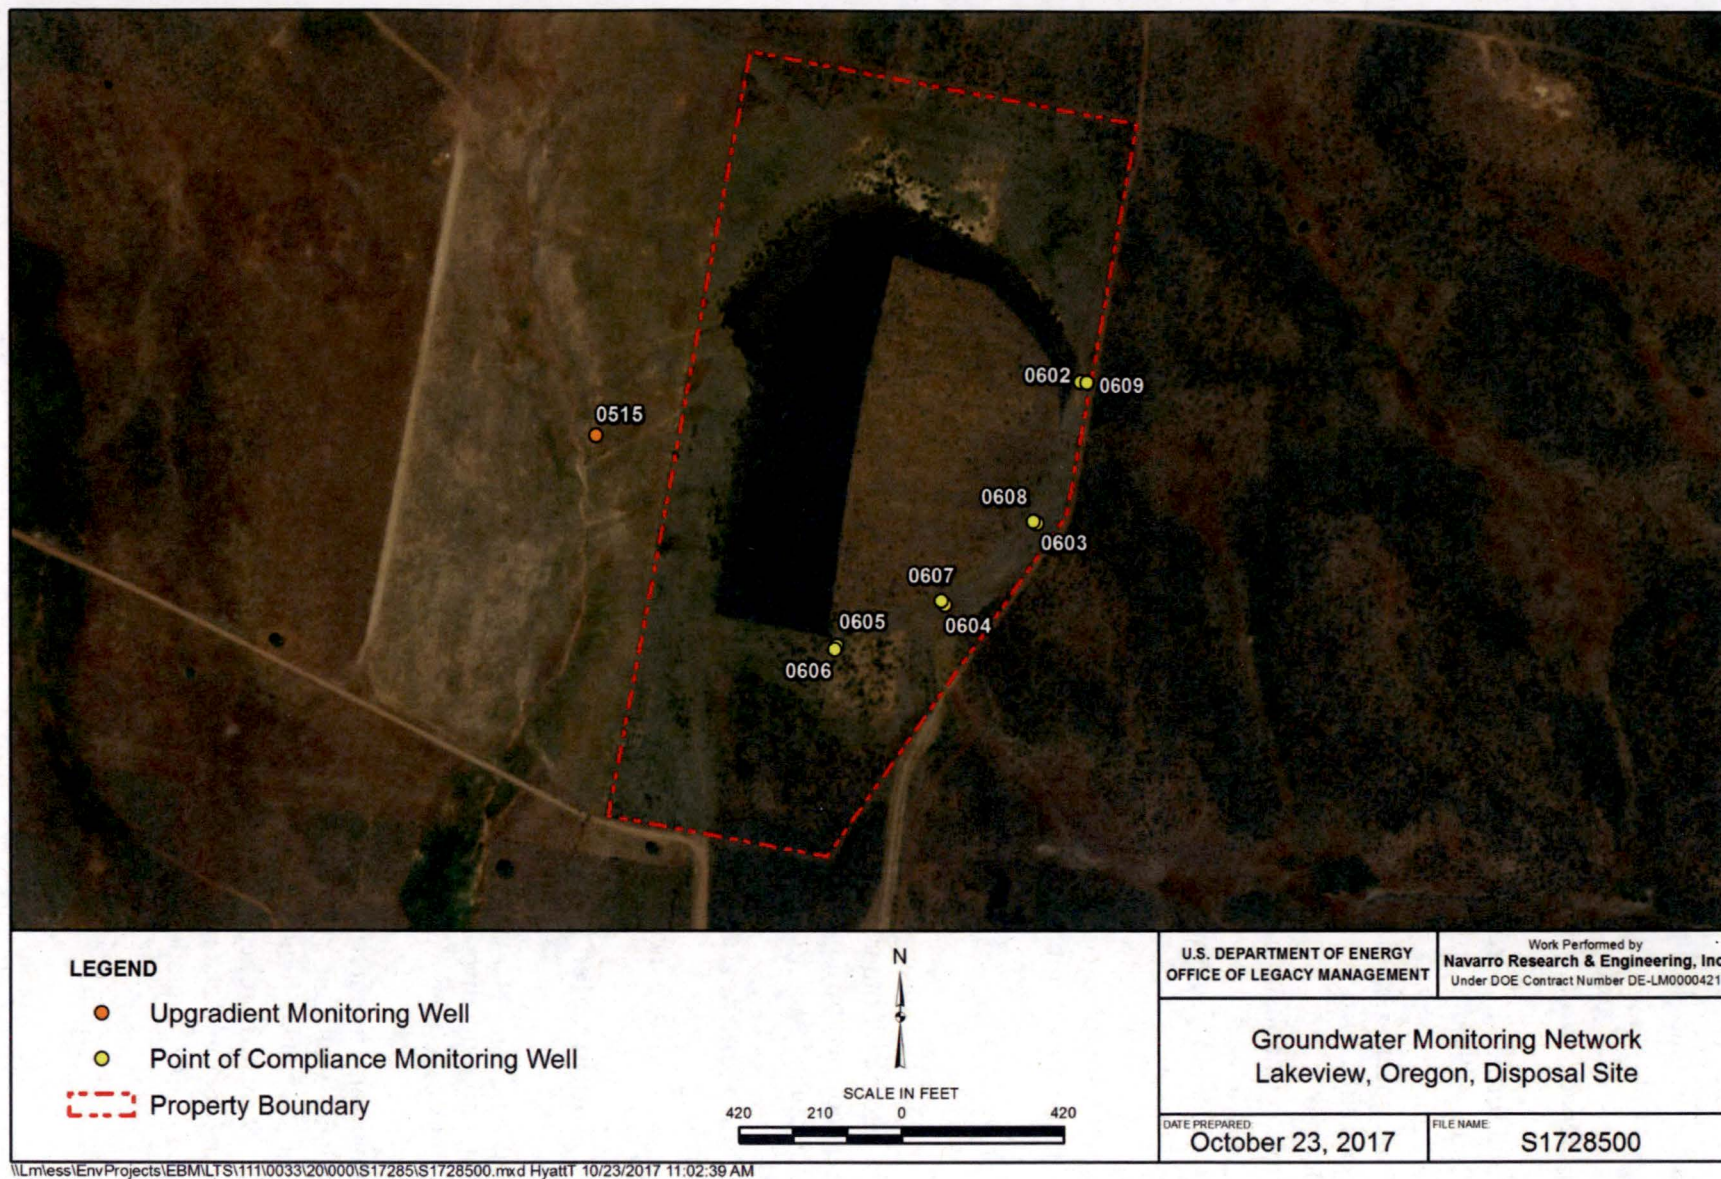
The groundwater monitoring network consists of nine monitoring wells, including eight point of compliance wells and one upgradient monitoring well (Figure 9-3 and Table 9-2). Seven additional DOE-owned monitoring wells (0513, 0514, 0516, 0520, 0521, 0522, and 0523) exist on privately owned property near the site but are not sampled because they are not part of the groundwater compliance monitoring network. Groundwater is sampled for arsenic, cadmium, and uranium. EPA established MCLs for these analytes in groundwater in 40 CFR 192 Table 1 Subpart A (40 CFR 192 Table 1 Subpart A).

Figure 9-3. Groundwater Monitoring Network Lakeview, Oregon, Disposal Site

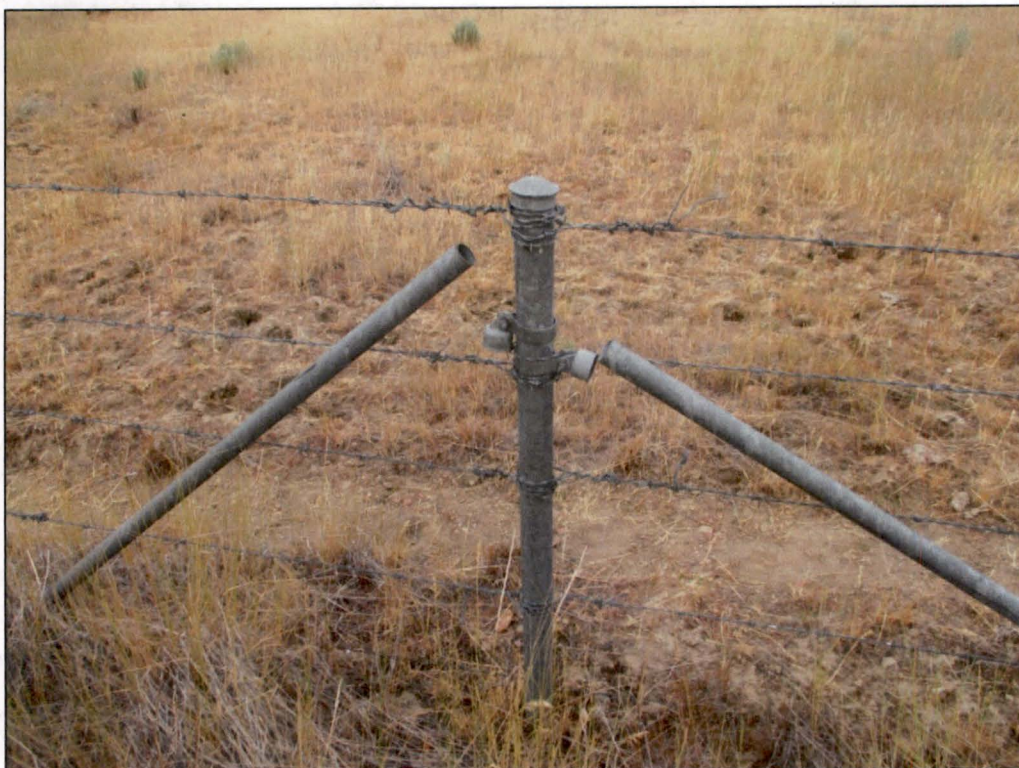
*PL-3. Perimeter Fence Support Braces Detached*

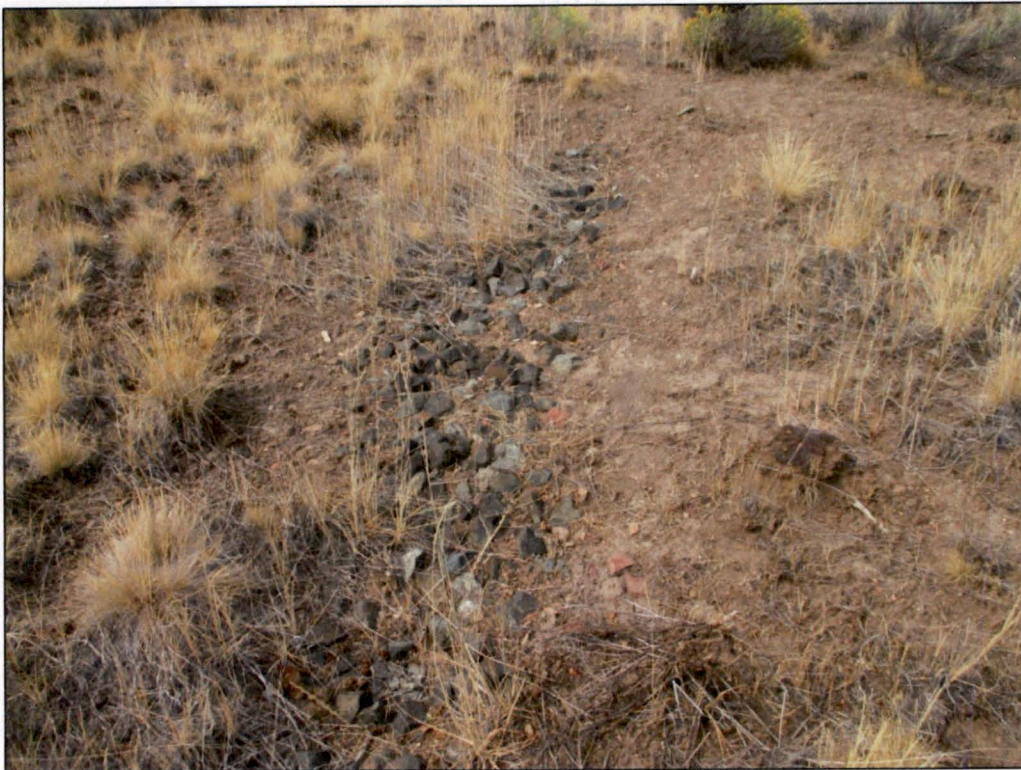
The disposal cell, completed in 1988, occupies 16 acres. At the time of disposal cell construction, the entire top slope of the disposal cell was covered in 12 inches of Type B size riprap. At the request of the State of Oregon, 4 inches of soil was added over the riprap to allow a vegetative cover to be established and help minimize the visual effects of the disposal cell (PL-6). The design for the top of the disposal cell has created conditions that favor the growth of deep-rooted plants. The growth of shrubs on the disposal cell top slope is favored by movement of precipitation through the riprap, bedding, and compacted soil (radon barrier) layers. Grasses and forbs growing on the top slope have gradually increased over the years, but some areas remain sparsely vegetated, consistent with surrounding offsite areas. Riprap was observed through the soil on the top slope in several small areas during the inspection (PL-7). These areas are sporadic across the top slope and are likely caused by the soil infilling the riprap-void spaces. No structural or disposal cell performance concerns are associated with the riprap becoming visible on the top slope.

*PL-7. Exposed Riprap on Disposal Cell Top Slope*

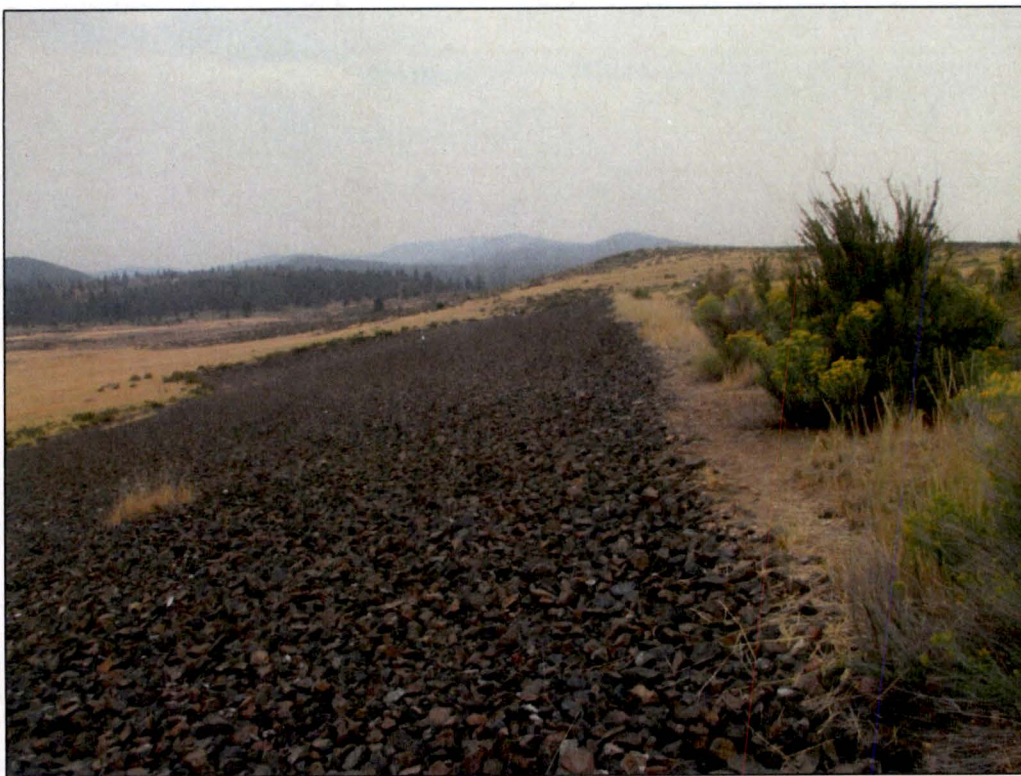
The contact boundary between the disposal cell top and side slopes (PL-8) was inspected and generally appears stable and uniform except at the northwest corner of the disposal cell top slope, where erosion has transported some soil from the top slope. No structural or disposal cell performance concerns are associated with this minor erosion, because the riprap rock cover is continuous beneath the top slope soil cover, slope crests, and side slopes. No erosion was observed during the inspection at the crest of the west side slope and the disposal cell top slope, which appears to be stable. Inspectors will continue to monitor the transition zone between the disposal cell top slope and the west side slope. There was no evidence of settling, slumping, erosion, or any other modifying process on the top of the disposal cell that might affect the integrity of the disposal cell.

*PL-8. Intersection of Disposal Cell Top Slope and West Side Slope*

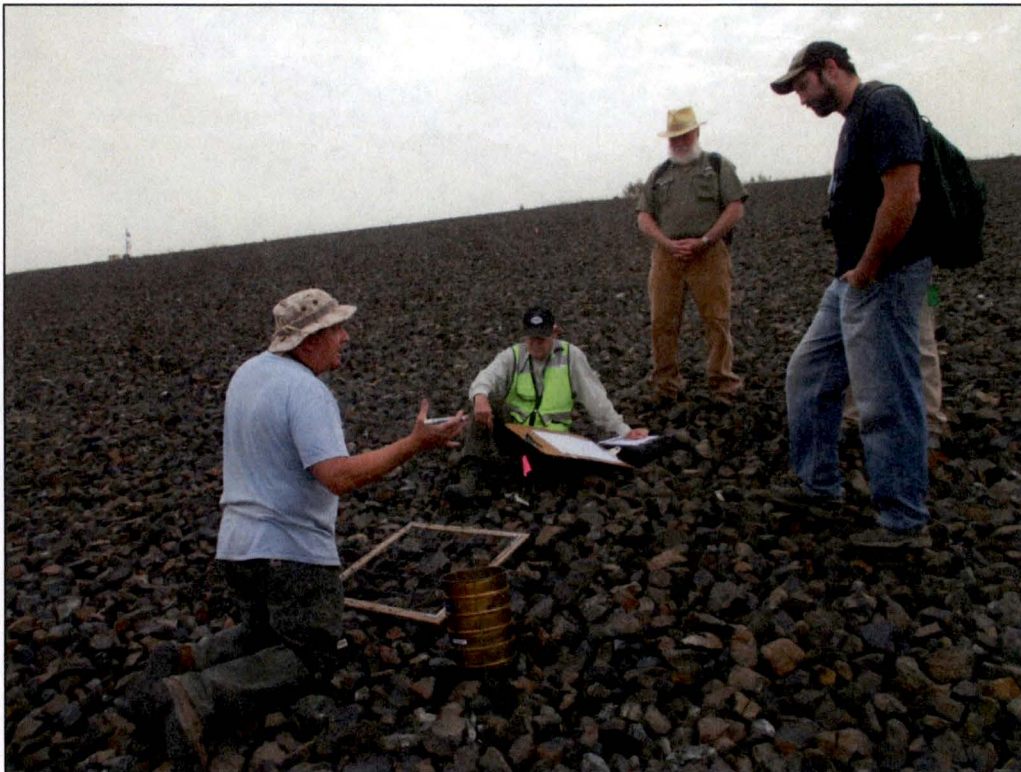
Deterioration of the basalt riprap armoring the disposal cell side slopes is a result of physical and chemical weathering processes. Deterioration monitoring at the site consists of rock gradation monitoring on the side slopes and photographic monitoring in the energy dissipation area (EDA) in accordance with the LTSP. Addendums to the LTSP commit the DOE to annually determine the mean diameter ( $D_{50}$ ) value of the riprap on the west side slope through gradation monitoring to ensure the riprap is large enough to protect the disposal cell from erosion during a major precipitation event.

*PL-9. Rock Riprap Gradation Monitoring on West Side Slope of Disposal Cell*

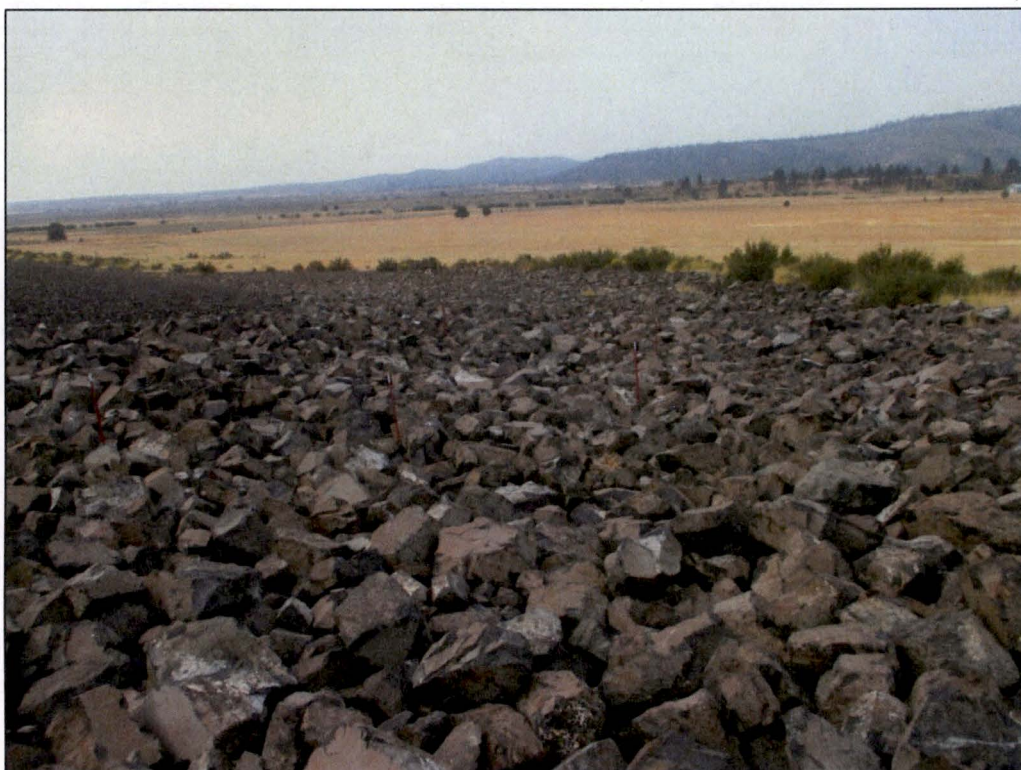
Minor rock degradation has been observed in the EDA (PL-10) since monitoring began at the original 10 photograph locations established in 1997 and at the eight additional locations established in 2000. The annual photographic monitoring of the 18 photograph locations for long-term rock monitoring was conducted during the 2017 inspection. The rock at photo monitoring locations 10 and 12 are shown in PL-11 and PL-12, respectively. The rock used in the EDA and drainage channel areas is much more homogeneous than the varied rock used on the side slopes, and no significant degradation has been observed.

In the past, water has been observed in the large depression in the EDA at the lower end of the drainage channel. Water is a potential concern because inundation may accelerate deterioration of the large riprap by the freeze–thaw process, although the rock used in the EDA is apparently not as susceptible to freeze–thaw as other rock types present on the disposal cell. No water was observed in the depression in the EDA during the inspection.

*PL-10. Energy Dissipation Area Outlet*

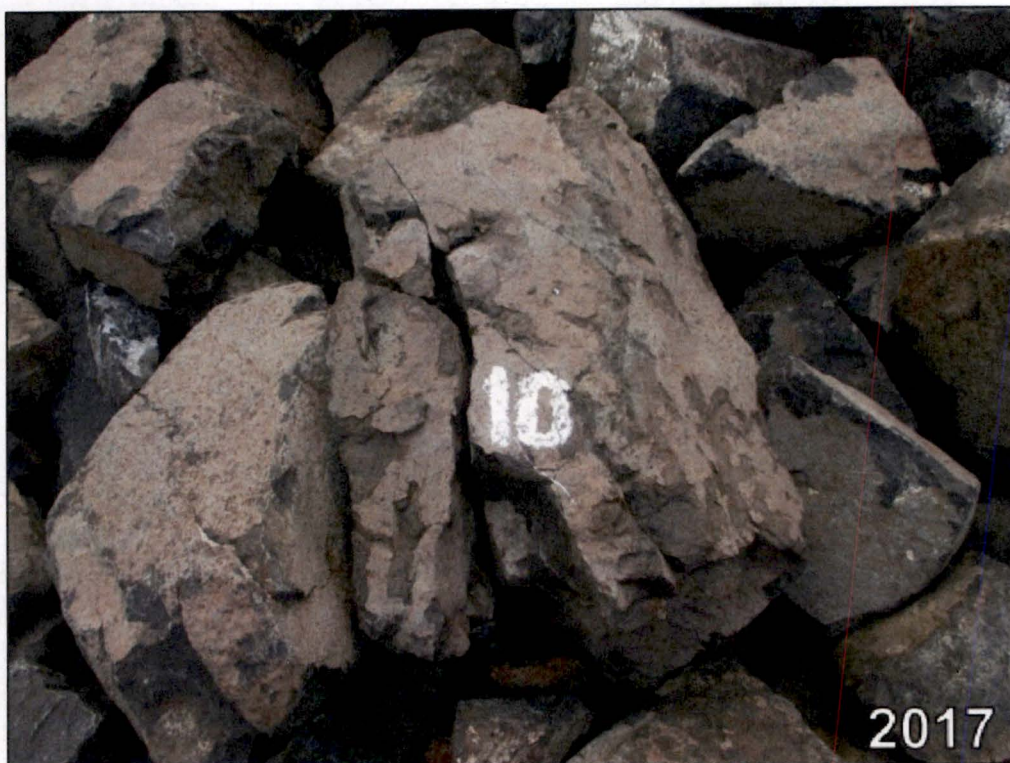
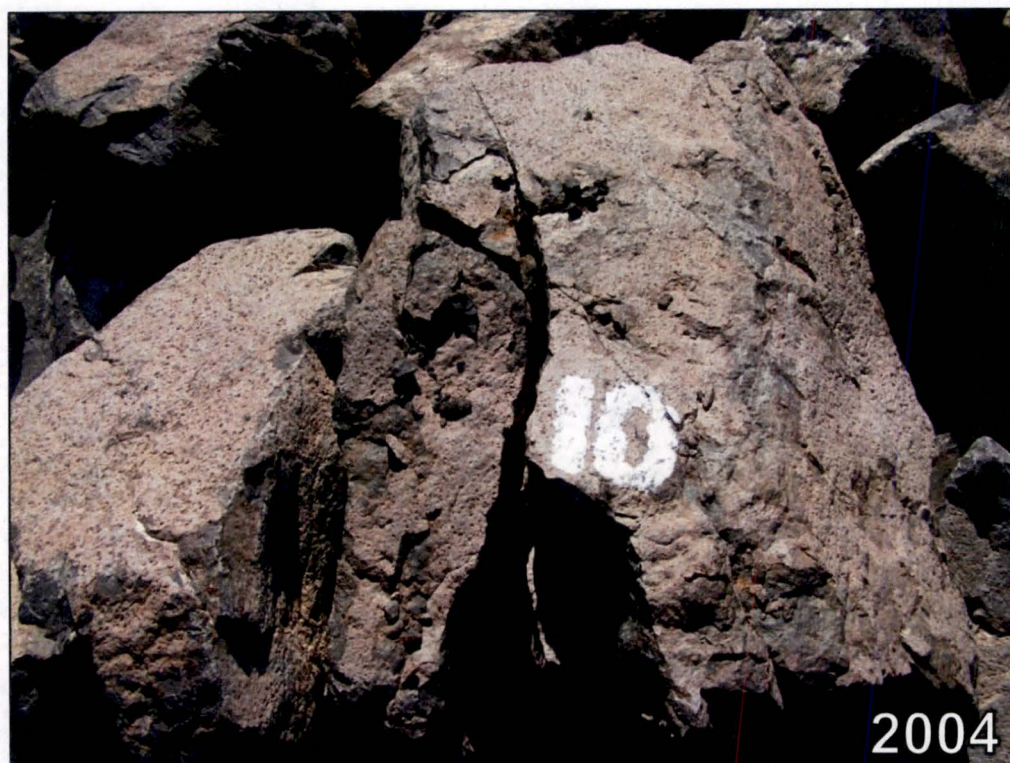
PL-11. (a) Riprap Monitoring Location No. 10 in the Energy Dissipation Area–2017

PL-11. (b) Riprap Monitoring Location No. 10 in the Energy Dissipation Area–  
2004 Photo for Comparison

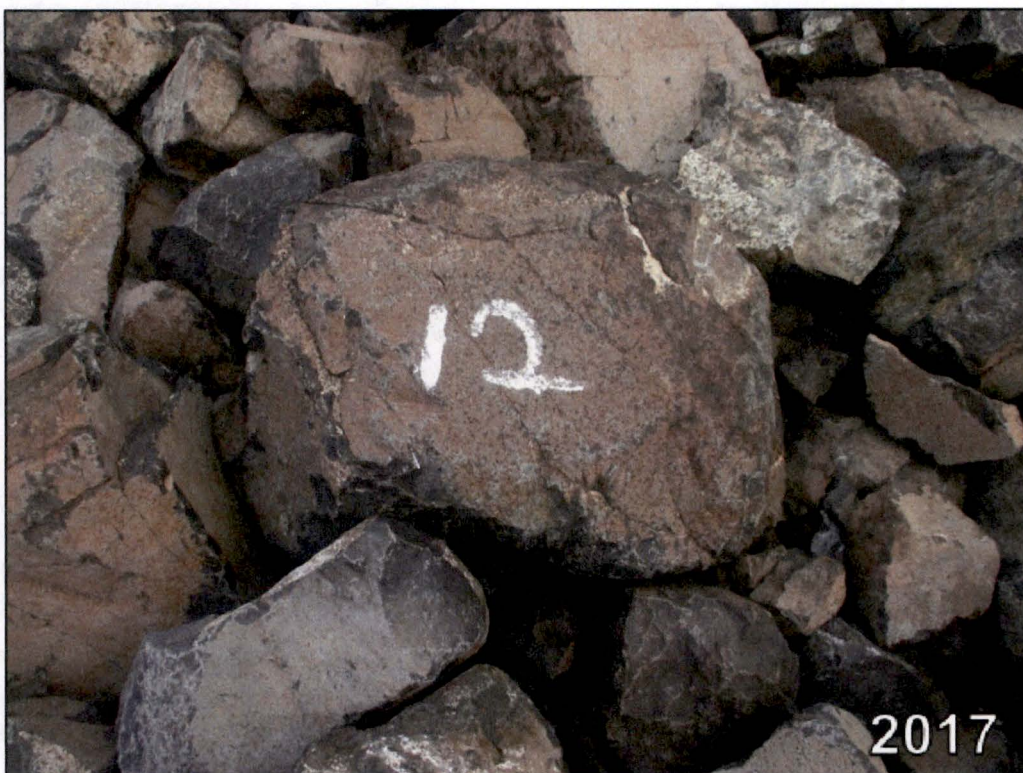
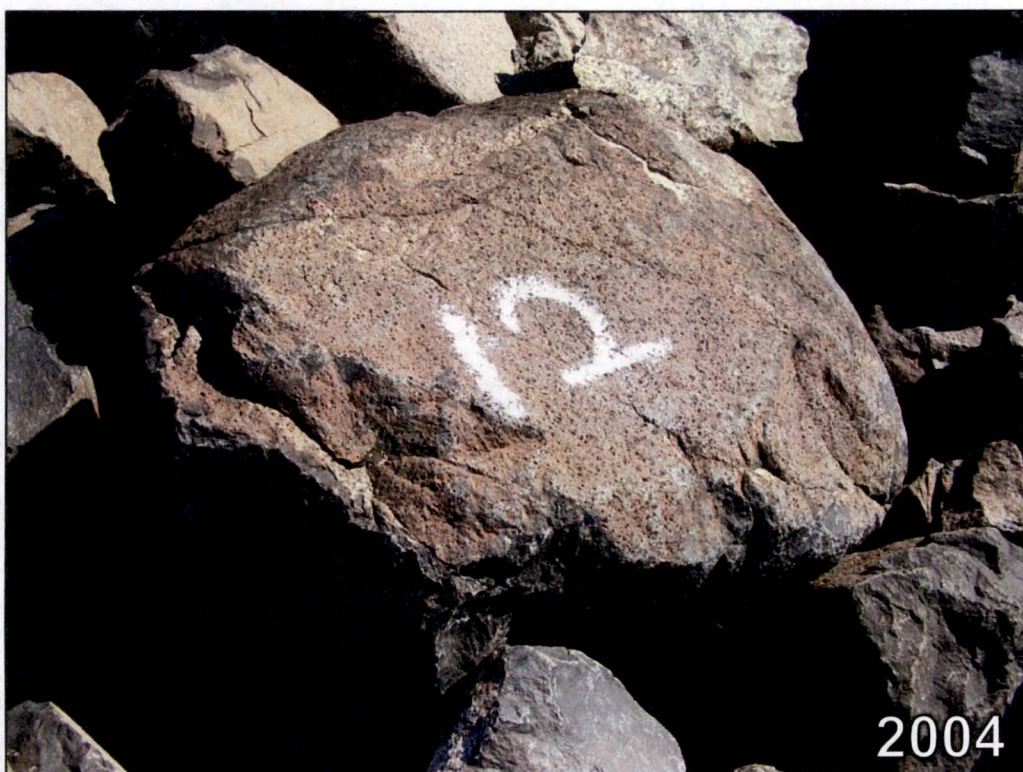
*PL-12. (a) Riprap Monitoring Location No. 12 in the Energy Dissipation Area–2017*

*PL-12. (b) Riprap Monitoring Location No. 12 in the Energy Dissipation Area–  
2004 Photo for Comparison*
