# 2017 Annual Site Inspection and Monitoring Report for Uranium Mill Tailings Radiation Control Act Title I Disposal Sites

March 2018

**2017 Annual Site Inspection and Monitoring Report  
for  
Uranium Mill Tailings Radiation Control Act  
Title I Disposal Sites**

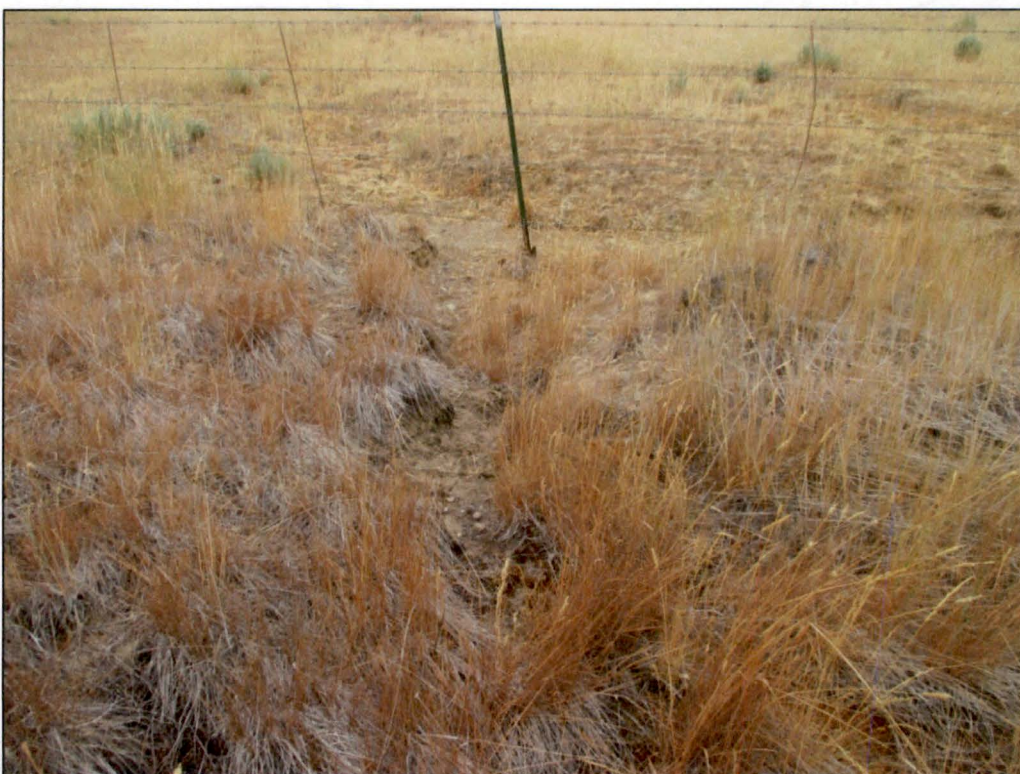
Gullies that formed in seeded areas extending west of trench drains 1 through 5 were filled with rock in 2000. Although the rock has generally arrested the headcutting that was advancing eastward from the private property onto DOE property, some minor headcutting is still evident but did not appear to be recent (PL-14). Several small gullies have been observed offsite in the heavily grazed areas downslope of the perimeter fence line onto the private property. Several small rills and shallow gullies were also observed onsite in the area north of the disposal cell where grass reestablishment has been limited, in a drainage area on the site north of perimeter sign P7, and in the southwest corner of the site. These gullies and rills were identified during previous annual inspections, and no significant changes were observed in 2017. The gullies do not pose a threat to disposal cell integrity, and inspectors will continue to monitor these areas. Inspectors also observed a pile of cut telephone poles (PL-15) and signposts with cement bases (PL-16) in the southwest corner of the site. These were identified during the 2016 annual inspection and do not impact site integrity. No maintenance needs were identified.

*PL-14. Small Gully Along Perimeter Fence Downgradient of Apron Toe Drain No.5*

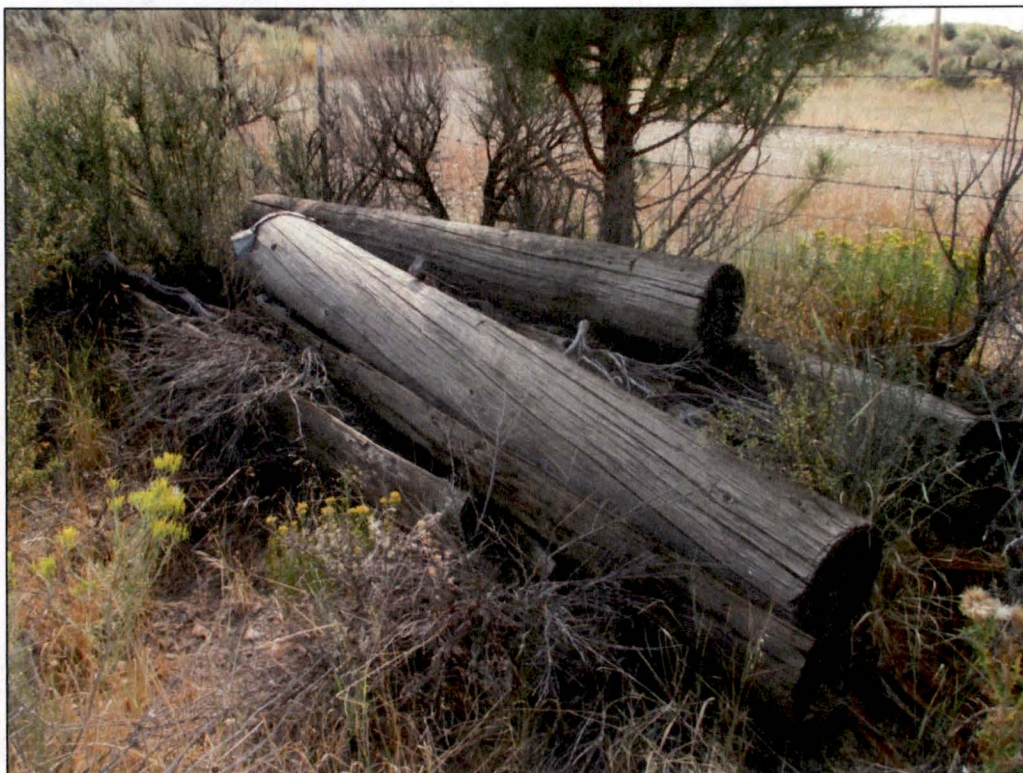
*PL-15. Old Wooden Power Pole Sections Inside Perimeter Fence*

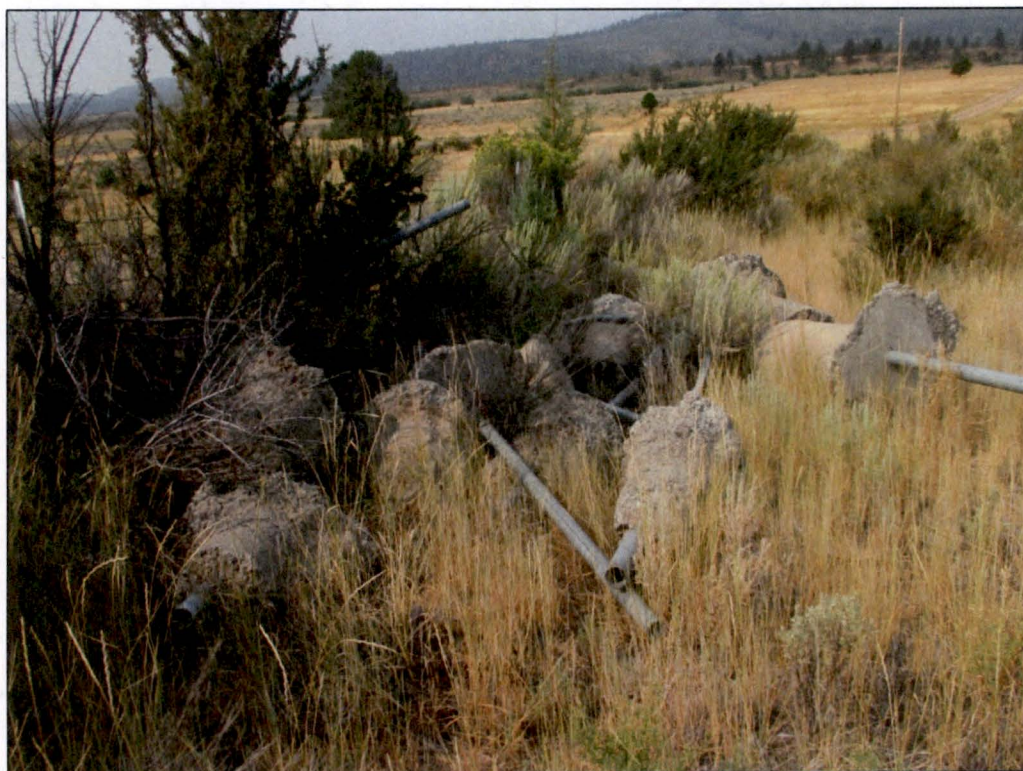
*PL-16. Abandoned Posts With Concrete Bases Near Southwest Corner of Site*
