## LICENSEE EVENT REPORT (LER)

## Improper Routing of Appendix R Related Cables

**May 19, 1987**  
**Enforcement Conference**

**Improper Routing of Appendix "R"**  
**Related Cables in Surry Unit 2**  
**Cable Vault and Tunnel**

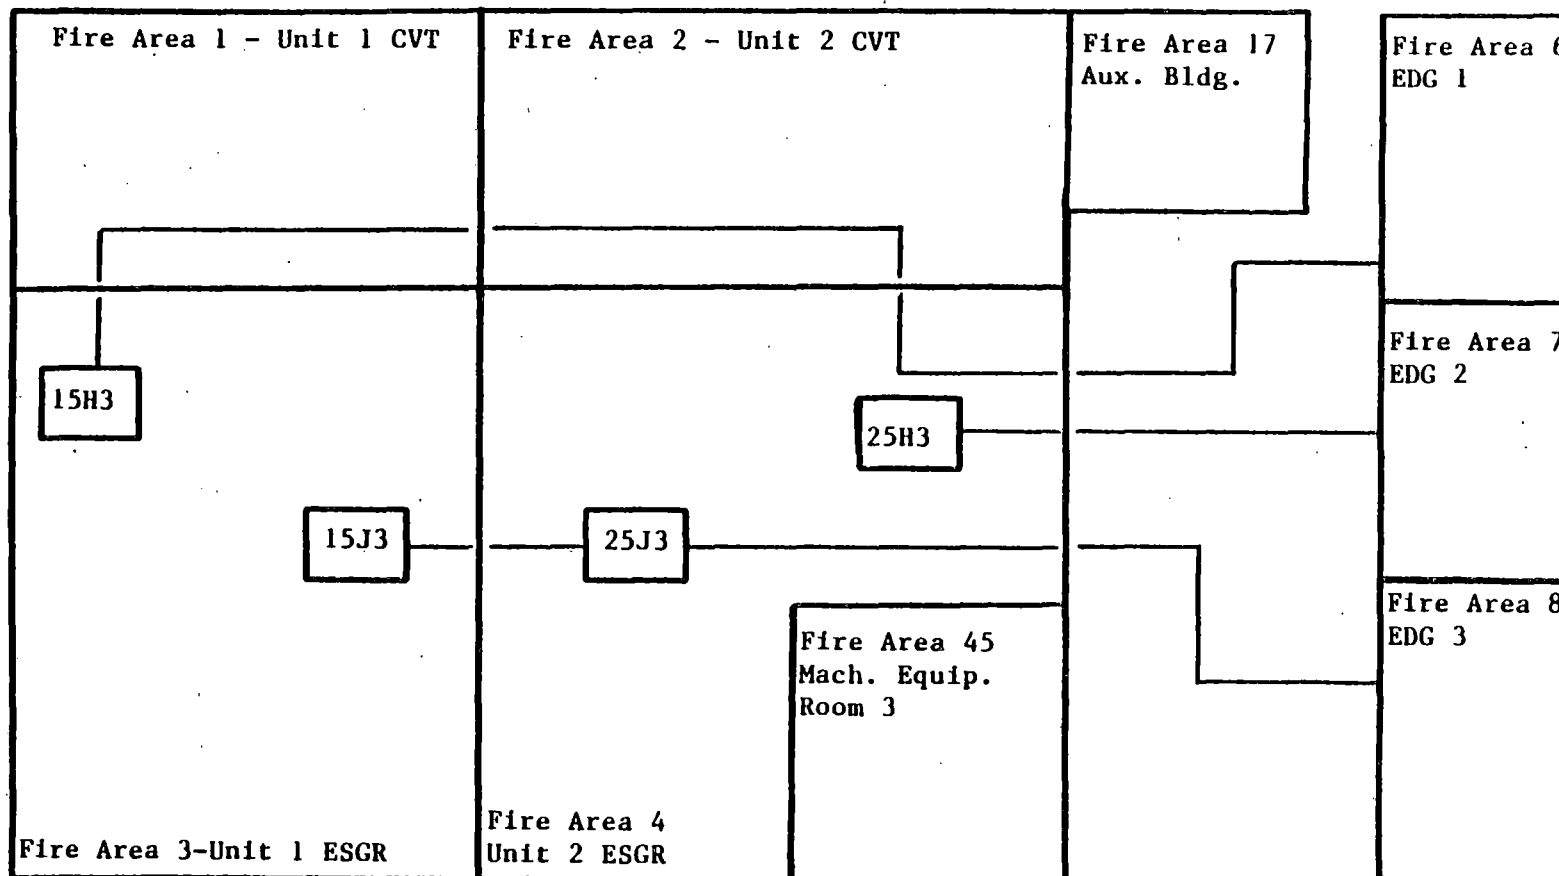
Surry Power Station  
Emergency Diesel Generator  
Main Leads Prior to DC-83-39  
Simplified Cable Block Diagram

This condition was caused by the relocation of the EDG-1 power and control cables through the U-2 CV&T. This rerouting was done as part of Design Change 83-39A "Diesel Generator No. 1 Power Cable Protection". DC-83-39A did not adequately determine the cable routing for EDG-3 to confirm independence from the U-2 CV&T. Appendix R Cable Block Diagrams for EDG-3, recently developed independently of DC-83-39A, indicated that there are 6 cables which are routed through the U-2 CV&T. During the process of the annual update of the 10 CFR 50 Appendix R Report, this information was assembled and the problem was discovered.

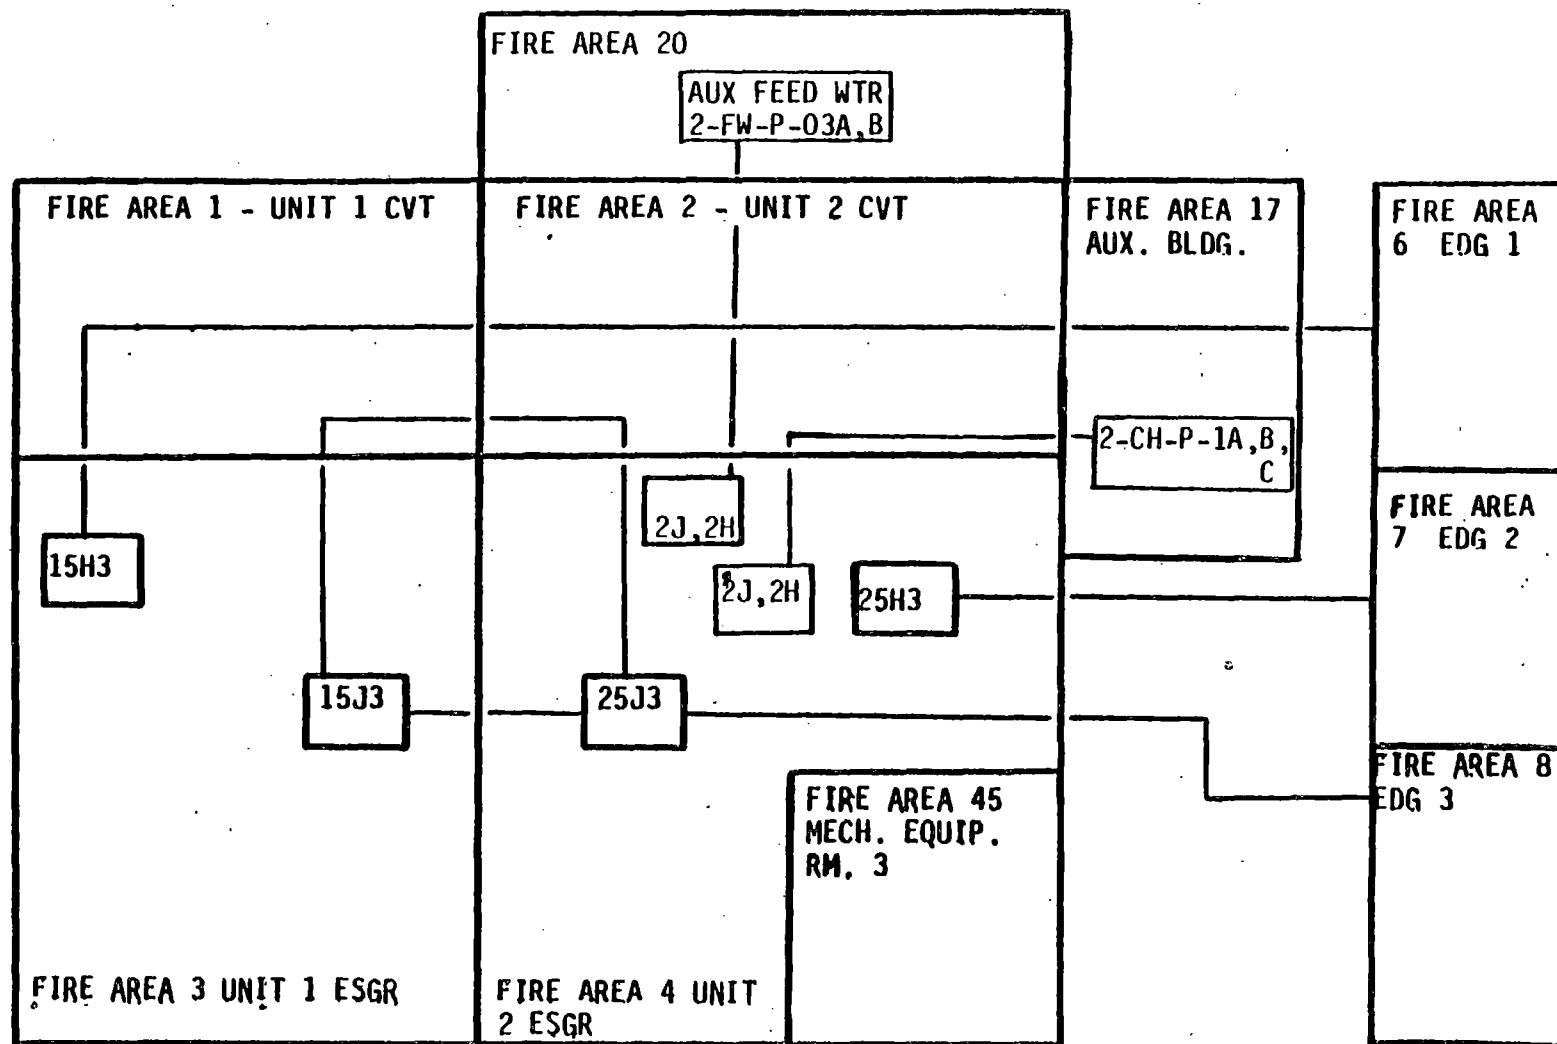
SIMPLIFIED CABLE BLOCK DIAGRAM

- **Design Change 83-39A  
rerouted EDG #1 cables  
through #2 CVT**
- **Recent review revealed  
EDG 3 control cables in #2  
CVT**
- **A fire in #2 CVT could  
disable cables for both EDG 1  
and EDG 3, as well as Unit 2  
safe shutdown equipment**

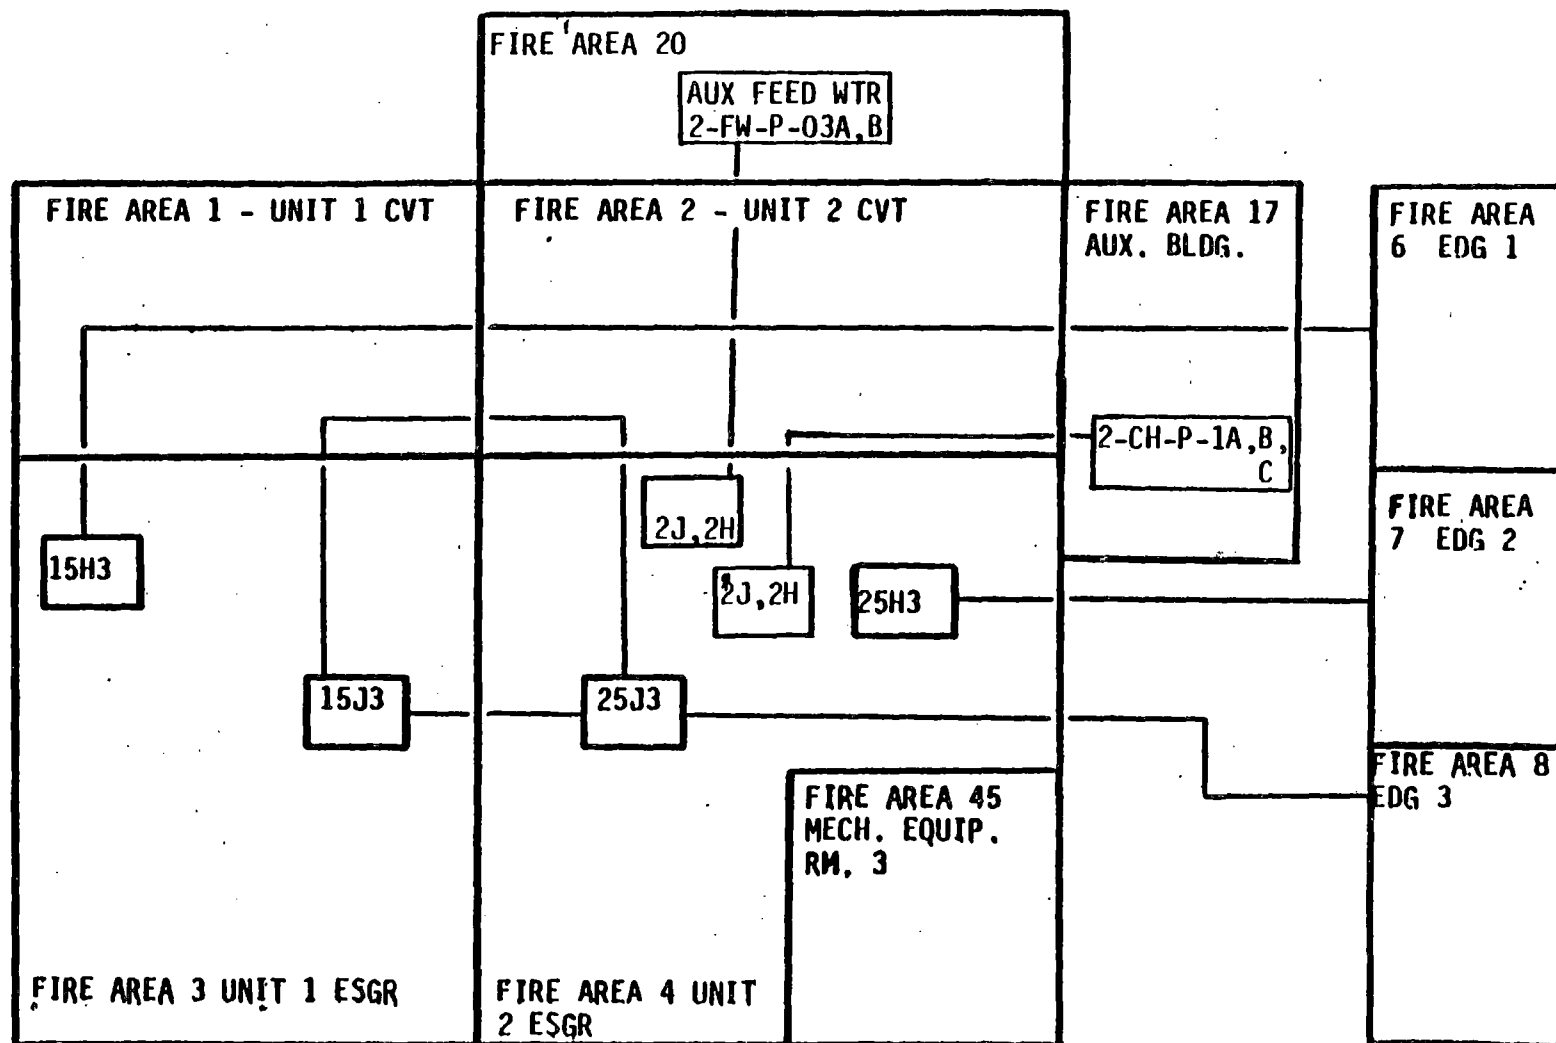
SIMPLIFIED CABLE BLOCK DIAGRAM

On March 13, 1987, with Unit 1 at 100% power and Unit 2 in cold shutdown, it was determined that a fire in the U-2 Cable Vault and Tunnel, could disable Unit 2 safe shutdown equipment as well as EDG-1 {EIIIS-06} and EDG-3, which are the sources to the Unit No. 1 alternative safe shutdown equipment. This condition is not in compliance with 10 CFR 50 Appendix 'R' Section III G.2. The Unit No. 1 alternative safe shutdown equipment (i.e. charging pumps) are cross-connected mechanically with Unit No. 2. The Unit No. 1 equipment can only be powered from EDG-1 or EDG-3.
