Subject: VIRGIL C. SUMMER NUCLEAR STATION (VCSNS) UNIT 1
DOCKET NO. 50-395
OPERATING LICENSE NO. NPF-12
RELIEF REQUEST RR-4-17, REQUEST TO UTILIZE CODE CASE
N-513-3 'EVALUATION CRITERIA FOR TEMPORARY ACCEPTANCE
OF FLAWS IN MODERATE ENERGY CLASS 2 OR 3 PIPING SECTION
XI, DIVISION 1' FOR A SERVICE WATER SYSTEM FLANGE

**South Carolina Electric & Gas Co. (SCE&G)
Virgil C. Summer Nuclear Station Unit 1 (VCSNS)
Relief Request RR-4-17**

**DESIGN CALCULATION SW050/03 REVISION 0 "THROUGH WALL LEAK
EVALUATION"**

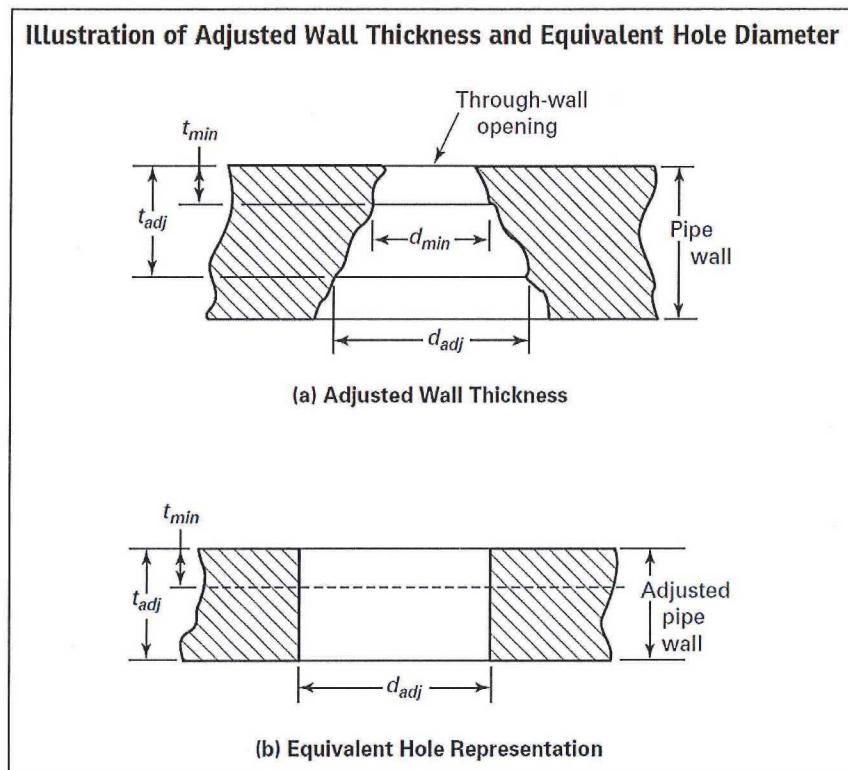
The through wall flaw is acceptable. Further degradation is acceptable as long as the average thickness of the remaining material is greater than 0.046 inches, within a diameter of 2 inches. Note that the average thickness is 0.156 inches as determined from the UT measurements recorded in Attachment 2.

Pressure of 65 psi is used for conservatism, Normal is 16 psi and Upset is 20 psi.

Daily walkdowns of the area are recommended to ensure any spray evaluations are still valid. This calculation is only applicable for the duration up until the next refueling outage (RF24, Fall 2018), where the flaw must be repaired.
