SHEARON HARRIS NUCLEAR POWER PLANT  
FAULT INVESTIGATION

PROGRESS REPORT

EBASCO SERVICES INCORPORATED

VOLUME 1 of 2

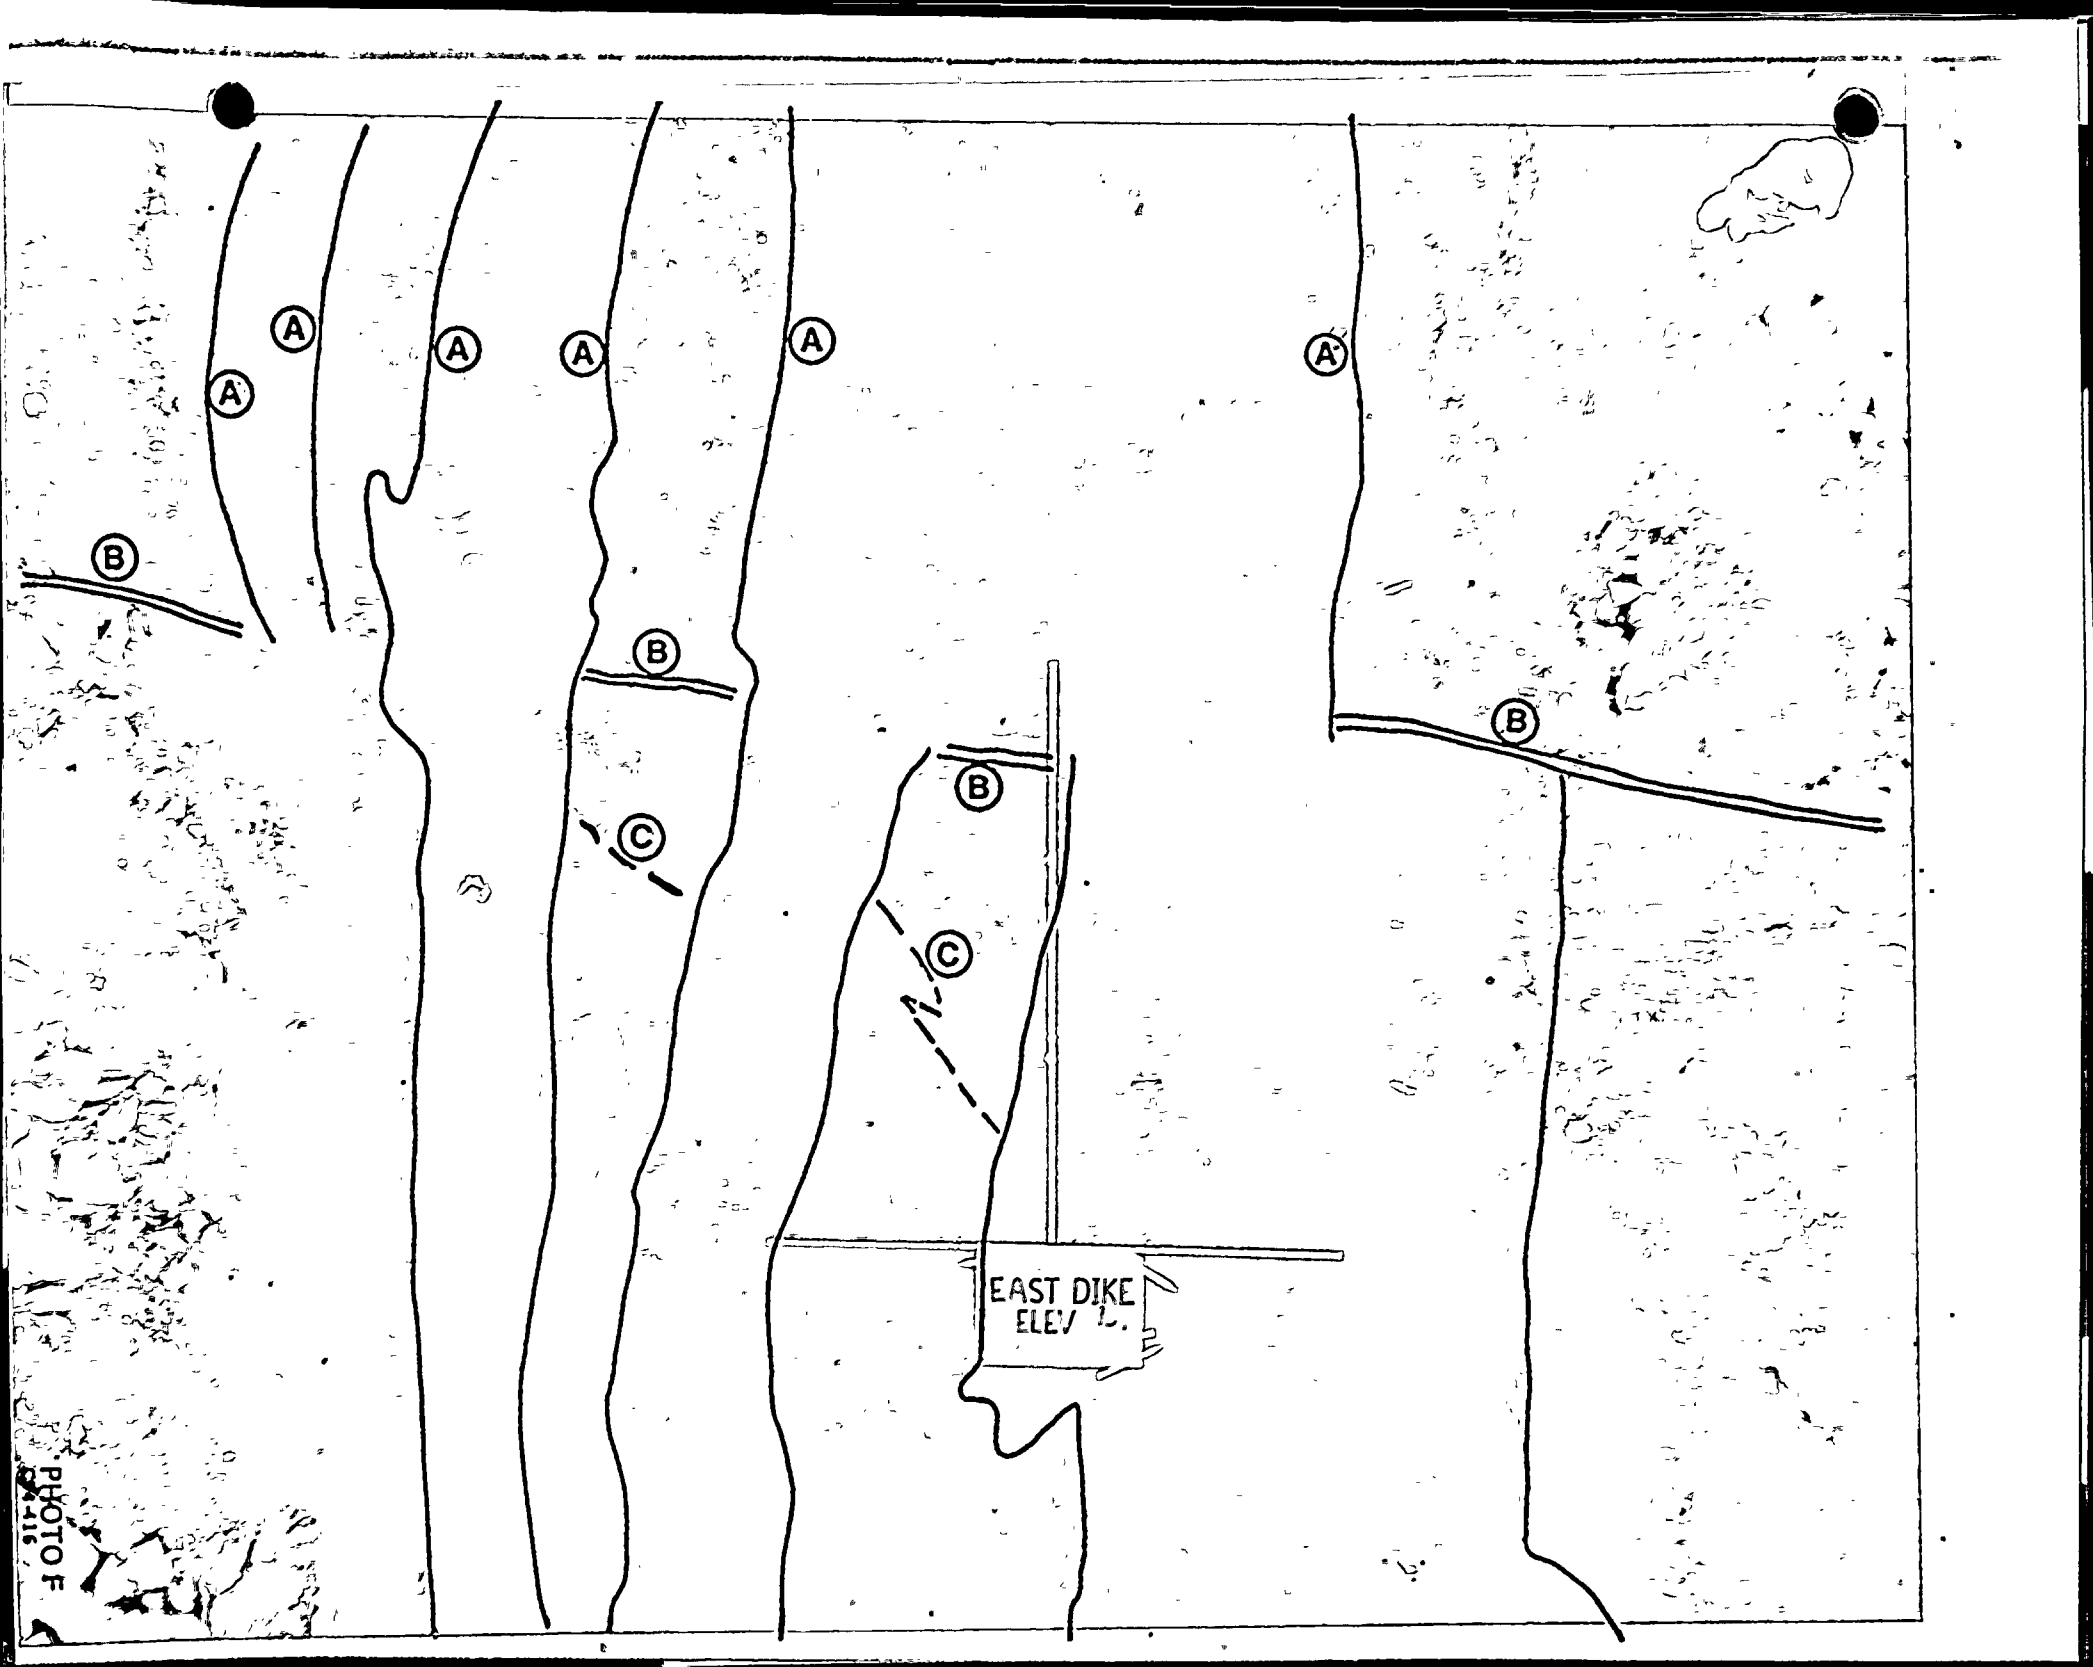
PHOTO F  
116

View north at the intersection of the fault and East Dike 2 at a depth of 13.1 feet below original elevation 247. Line segment (A) represents the limits of diabase. Line segments (B) represent shearing along the trace of the fault. Line segments (C) show the apparent stratigraphic continuity of sedimentary wedges between the diabase segments. Note the fine degree of preservation of cooling fractures and subsequent spheroidal weathering in the diabase. Lack of disturbance of these structures in the weathered diabase indicate the lack of movement along the fault since the initiation of the weathering process. The continuity of sedimentary beds trapped as plates within the diabase, not seen clearly in this photo but demonstrated conclusively in hard rock exposures at greater depth, prove that the diabase segments were not intruded at the same time. Exposures at lower elevations indicate that East Dike 2 is in fact offset by the fault. The maximum sense of left lateral displacement at this elevation is approximately five feet.

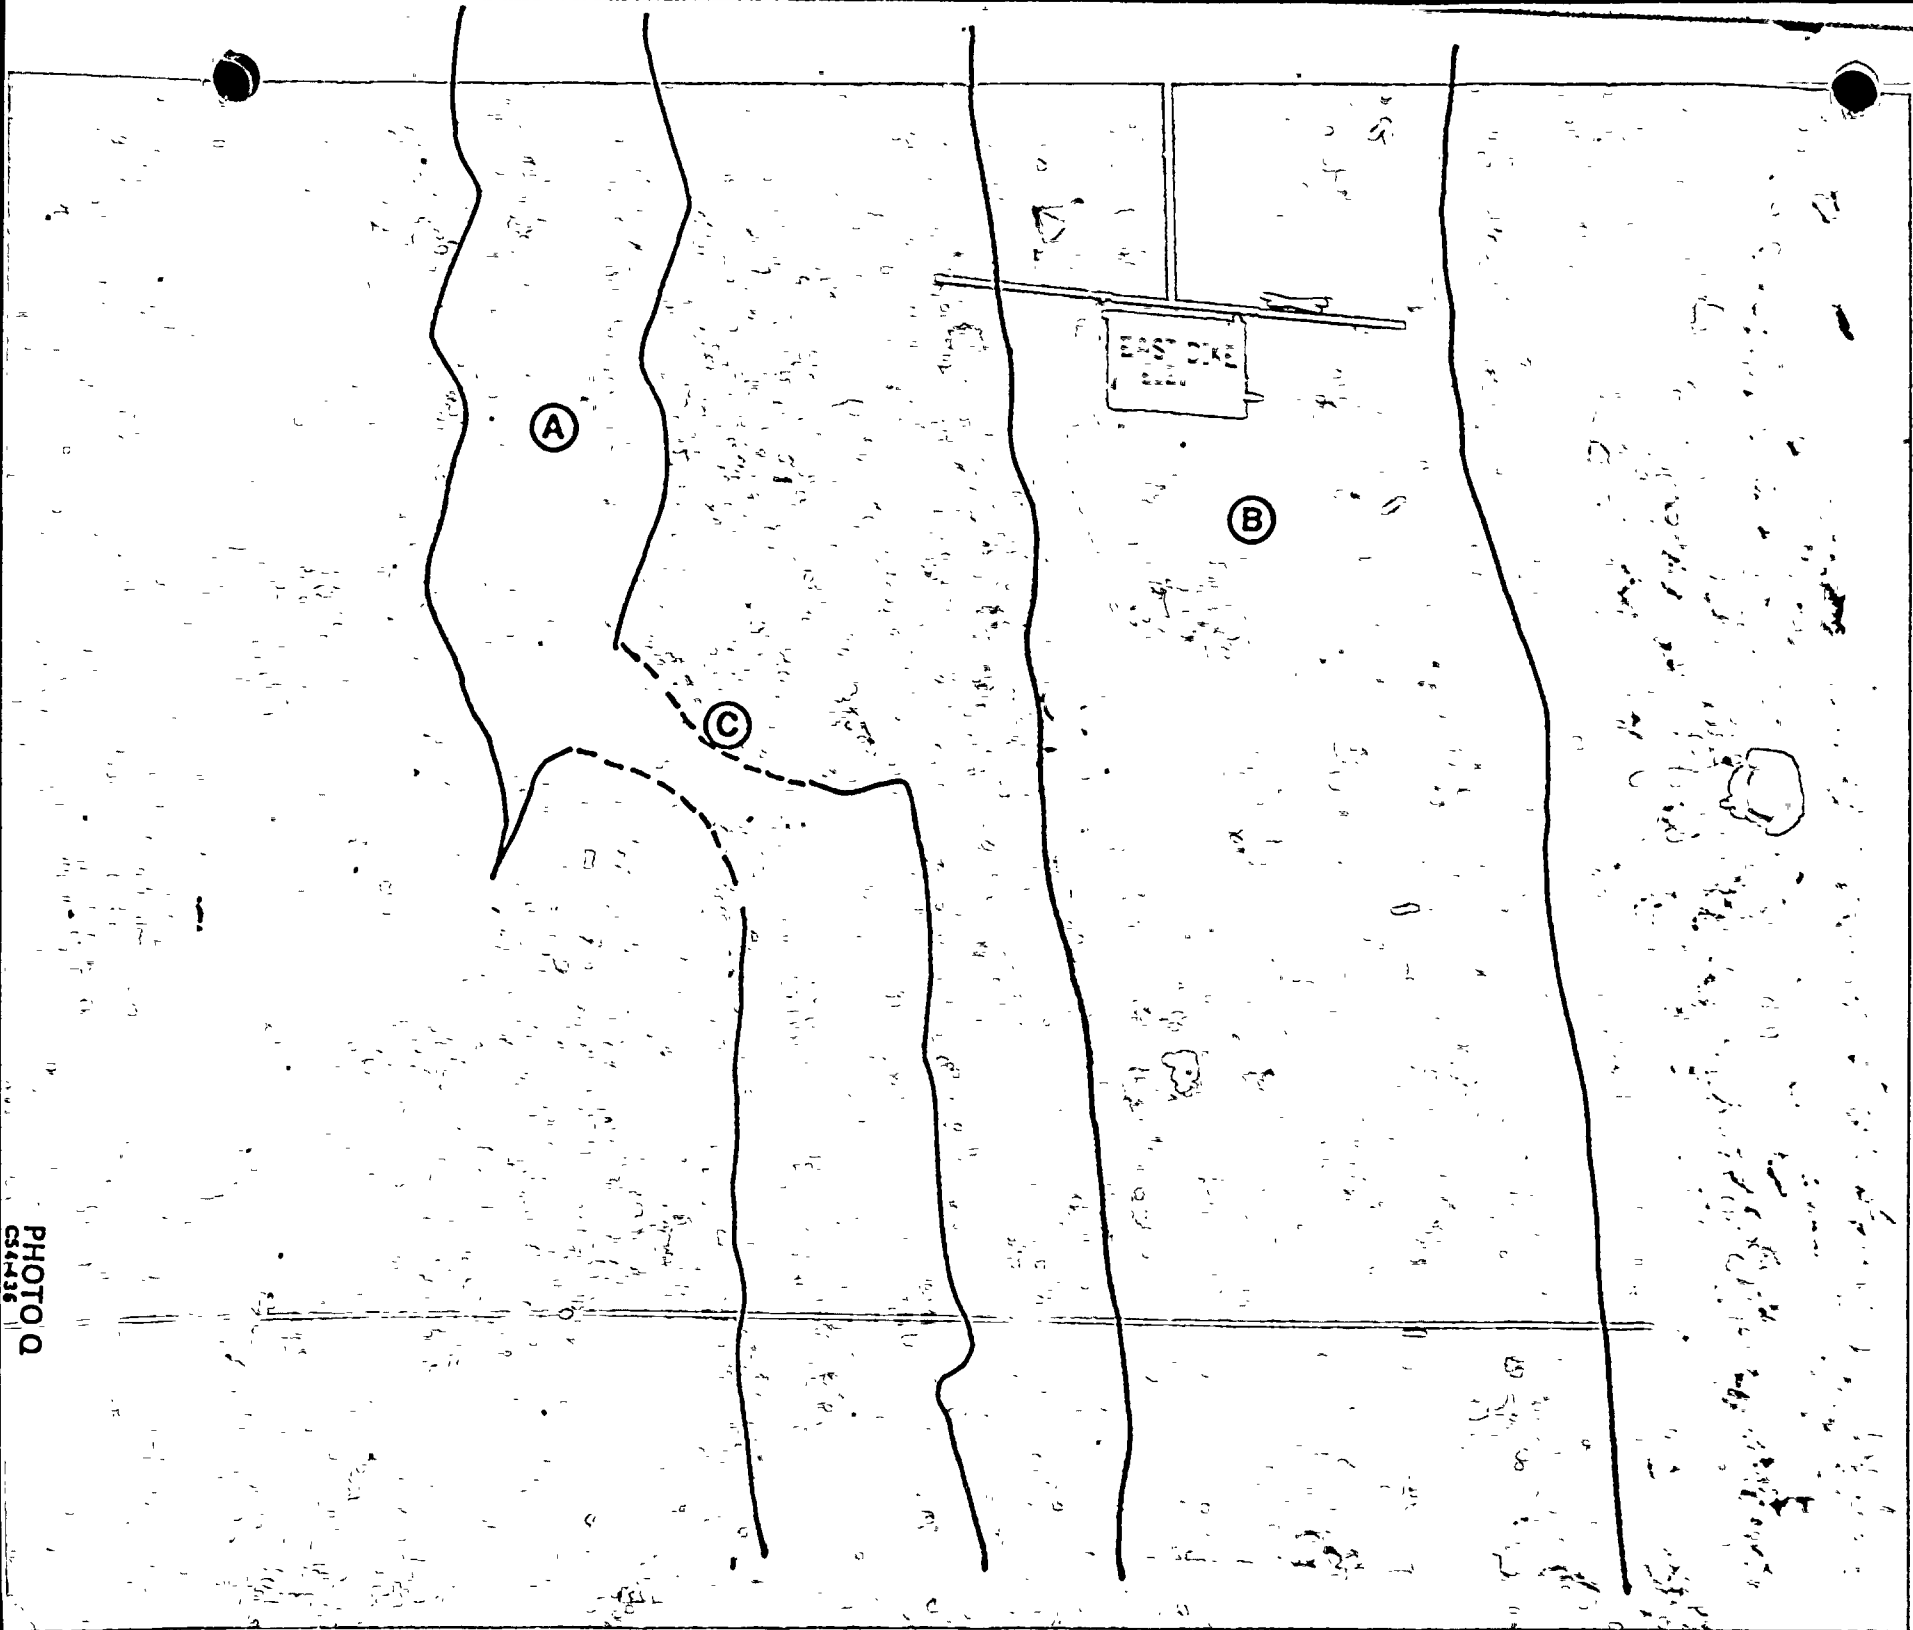
View north at 13.1 feet below beginning elevation 247. This photo is taken of East Dike 2 at a point approximately 90 feet south of the fault crossing. This photo illustrates the precise structural control of the emplacement of the diabase dikes. Dike segments (A), if seen alone and in poorer exposure at higher or lower elevations might be construed to be offset by fault displacement. However, there is no evidence of displacement of the surrounding sedimentary beds and no displacement of diabase dike segment (B). The apophysis at the southern tip of northern part of dike segment (A) conclusively demonstrates that the dike was intruded in this configuration and not offset. Dashed line segment (C) represents a zone of intense alteration and halted or frozen progress of diabase emplacement between the two limbs of diabase segment (A). This situation is analagous to the outcrop exposures at West Dike 3S west of the plant excavation.
