Annual Radioactive Waste Tank Inspection Program – 2017

July 2018

**Savannah River Remediation
Savannah River Site
Aiken, SC 29808**

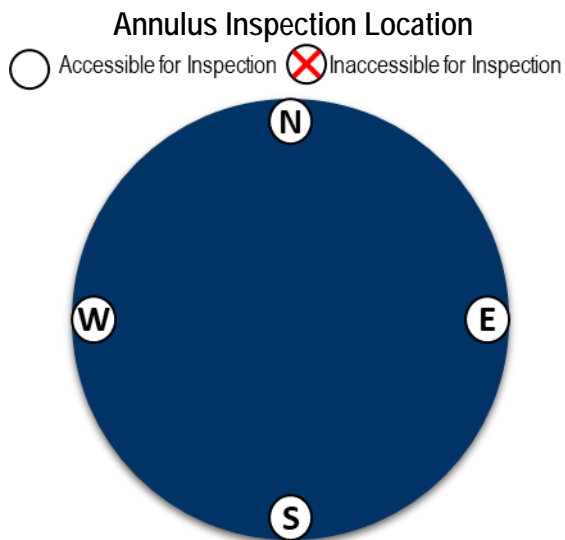
Number of Known Leak Sites	Date of Discovery	Waste on Annulus Floor	Location	Elevation from Tank Bottom
No known leak sites	n/a	n/a	n/a	n/a

Conclusions following 2017 Inspections: No leakage, significant surface corrosion, or other anomalies were noted. The 2017 inspection confirmed the structural integrity and waste confinement capability of Tank 2.

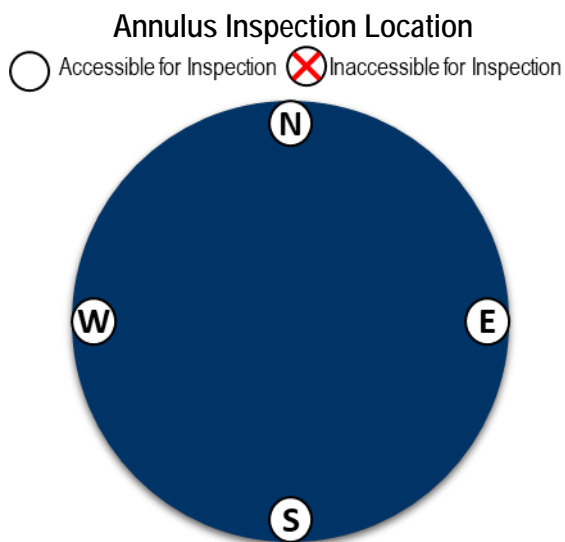
Number of Known Leak Sites	Date of Discovery	Waste on Annulus Floor	Location	Elevation from Tank Bottom
No known leak sites	n/a	n/a	n/a	n/a

Conclusions following 2017 Inspections: No leakage, significant surface corrosion, or other anomalies were noted. The 2017 inspection confirmed the structural integrity and waste confinement capability of Tank 3.

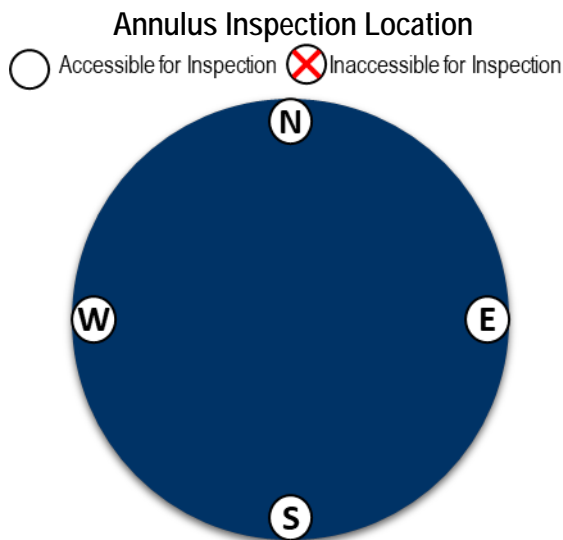
Number of Known Leak Sites	Date of Discovery	Waste on Annulus Floor	Location	Elevation from Tank Bottom
4	Oct 2011	None	South	234 in.
	Sep 2013	None	North	234 in.
	Sep 2013	None	North	234 in.
	Sep 2013	None	North	234 in.

Summary of Visual Inspections: No changes were noted since the inspections in 2016.

Conclusions following 2017 Inspections: No leakage, significant surface corrosion or other anomalies were noted. The 2017 inspection confirmed the structural integrity and waste confinement capability of Tank 4.

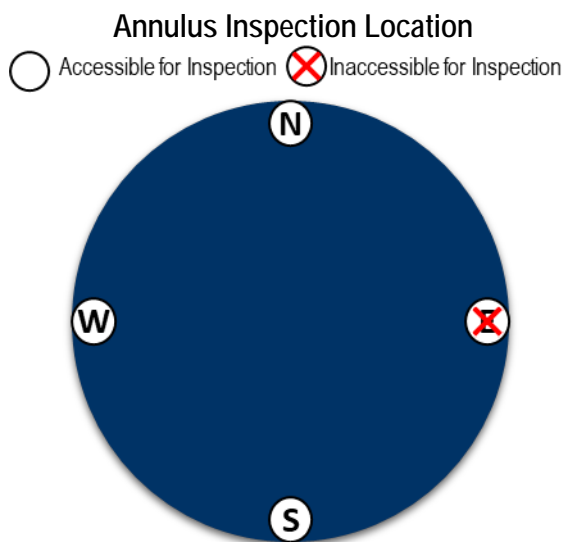
Number of Known Leak Sites	Date of Discovery	Waste on Annulus Floor	Location	Elevation from Tank Bottom
No known leak sites	n/a	n/a	n/a	n/a

Conclusions following 2017 Inspections: No leakage, significant surface corrosion, or other anomalies were noted. The 2017 inspection confirmed the structural integrity and waste confinement capability of Tank 7.

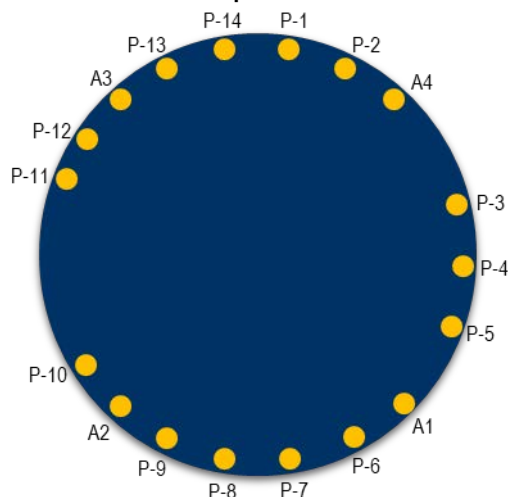
Annulus Inspection Locations

Annulus Inspection Ports Available: 18

Inspection Capability: 100%

Number of Known Leak Sites	Date of Discovery	Waste on Annulus Floor	Location	Elevation from Tank Bottom
No known leak sites	n/a	n/a	n/a	n/a

Ultrasonic Testing Inspections Results: No reportable thinning, pitting or stress corrosion cracking, or evidence of service-induced tank wall thinning on the primary tank wall. Ten incipient pits were documented; however, all of the pits are consistent with pre-service pitting with no evidence of active corrosion or growth. [SRNL-STI-2010-00533]

Conclusions following 2017 Inspections: No leakage, significant surface corrosion, or other anomalies were noted. The 2017 inspection confirmed the structural integrity and waste confinement capability of Tank 30.

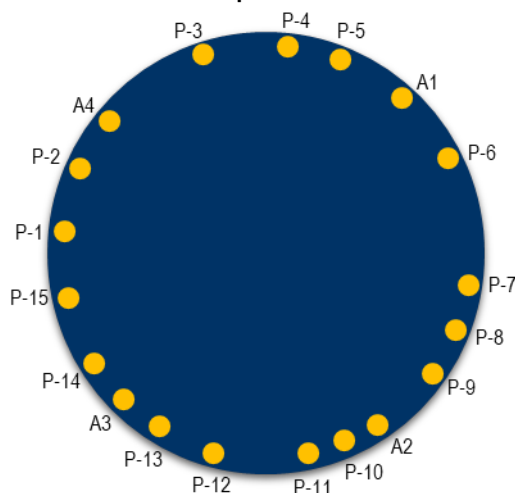
Annulus Inspection Locations

Annulus Inspection Ports Available: 19

Inspection Capability: 100%

Number of Known Leak Sites	Date of Discovery	Waste on Annulus Floor	Location	Elevation from Tank Bottom
No known leak sites	n/a	n/a	n/a	n/a

Ultrasonic Testing Inspections Results: No reportable thinning, pitting or stress corrosion cracking, or evidence of service-induced tank wall thinning on the primary tank wall. Seven incipient pits were documented; however, all of the pits are consistent with pre-service pitting with no evidence of active corrosion or growth. [SRNL-STI-2010-00533]

Conclusions following 2017 Inspections: No leakage, significant surface corrosion, or other anomalies were noted. The 2017 inspection confirmed the structural integrity and waste confinement capability of Tank 32.

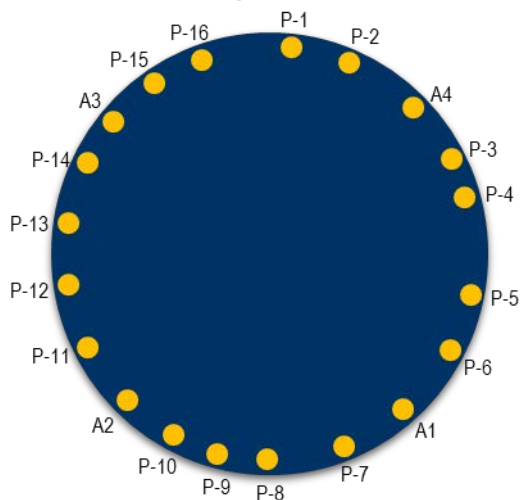
Annulus Inspection Locations

Annulus Inspection Ports Available: 20

Inspection Capability: 100%

Number of Known Leak Sites	Date of Discovery	Waste on Annulus Floor	Location	Elevation from Tank Bottom
No known leak sites	n/a	n/a	n/a	n/a

Ultrasonic Testing Inspections Results: No reportable thinning, pitting or stress corrosion cracking, or evidence of service-induced tank wall thinning on the primary tank wall. [SRNL-STI-2014-00328]

Conclusions following 2017 Inspections: **No leakage, significant surface corrosion, or other anomalies were noted. The 2017 inspection confirmed the structural integrity and waste confinement capability of Tank 33.**

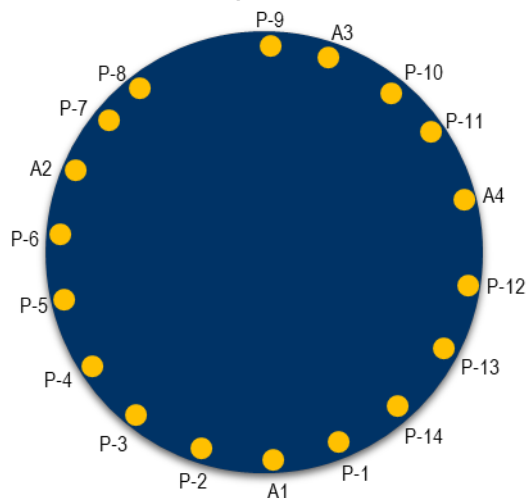
Annulus Inspection Locations

Annulus Inspection Ports Available: 18

Inspection Capability: 100%

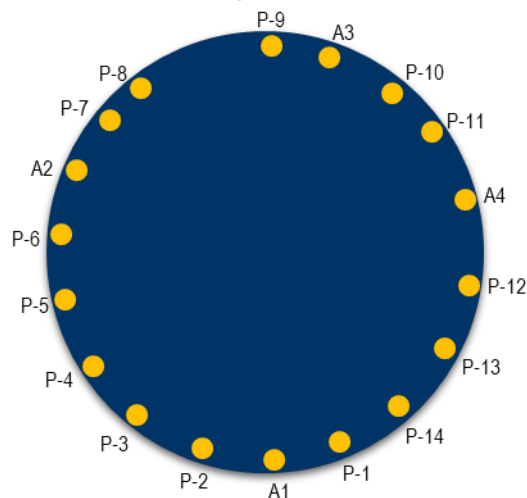
Annulus Inspection Locations

Annulus Inspection Ports Available: 18

Inspection Capability: 100%

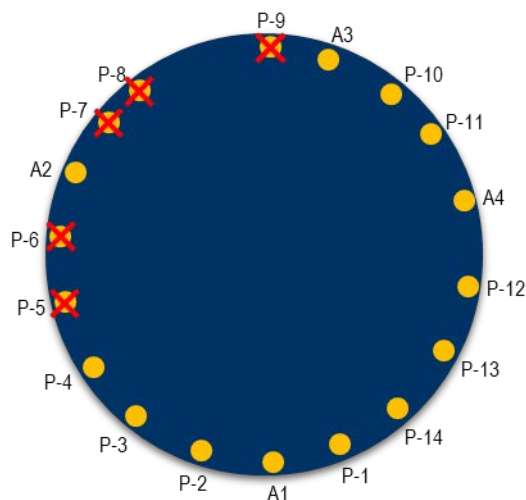
Annulus Inspection Locations

Annulus Inspection Ports Available: 13

Inspection Capability: 75%

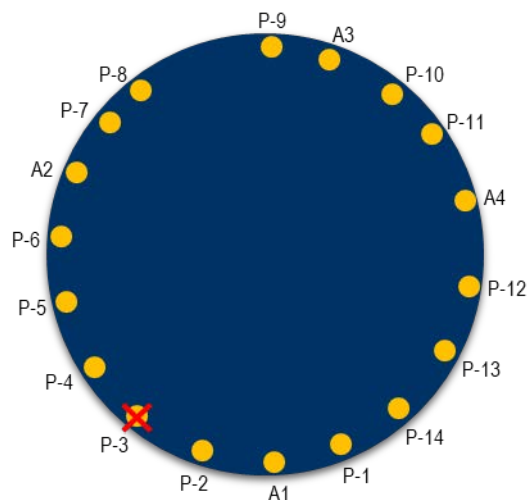
Annulus Inspection Locations

Annulus Inspection Ports Available: 17

Inspection Capability: 100%

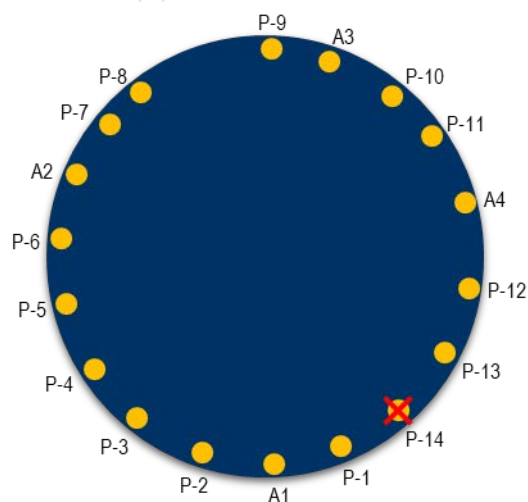
Annulus Inspection Locations

Annulus Inspection Ports Available: 17

Inspection Capability: ~100%
