# LIST OF VARIOUS Inspection Rpt. IN 75

IE Inspection Report No. 50-285/75-06

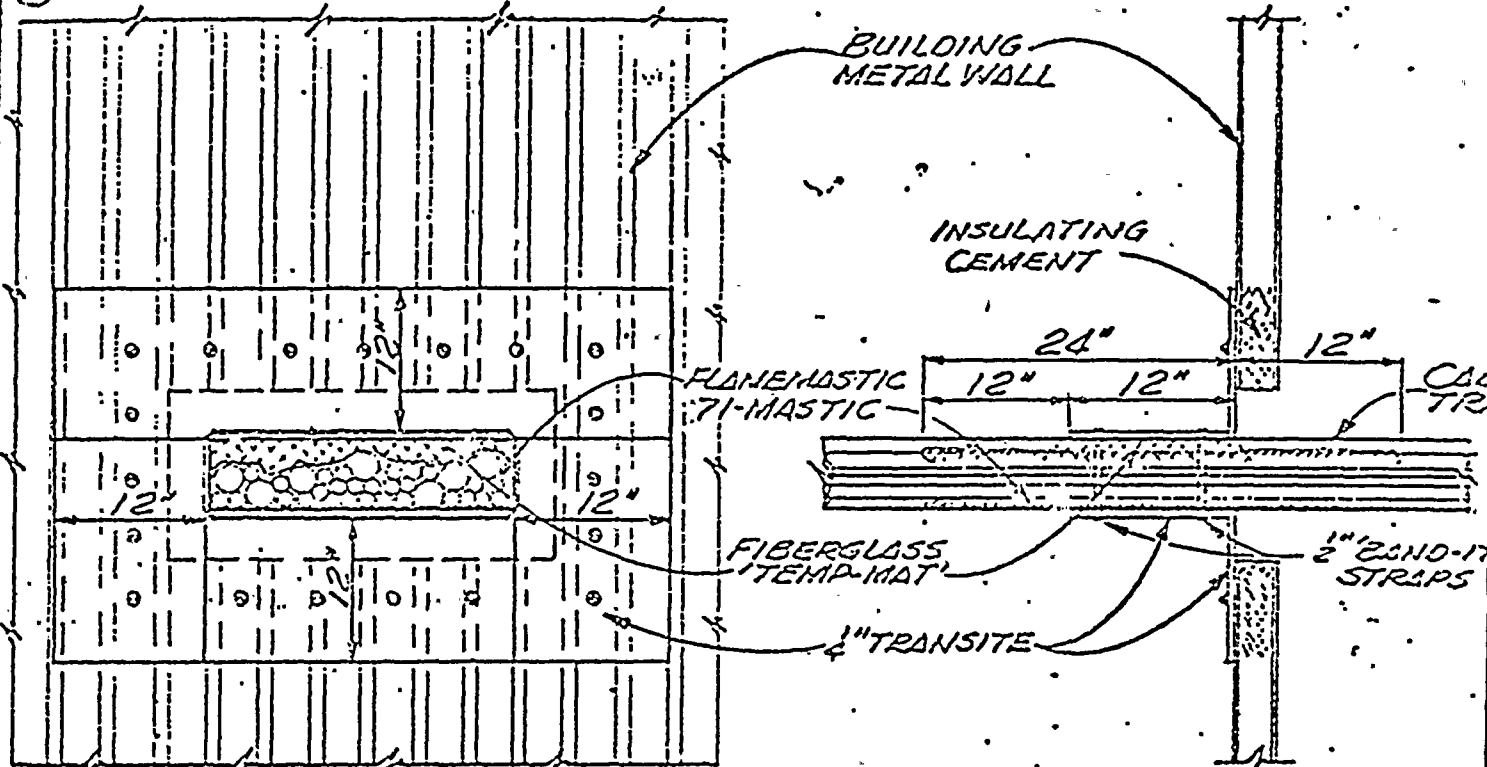
FIGURE - 1

During an inspection of cable tray penetrations, two locations were observed which appeared to deviate from the fire stop installation commitment made in the FPL FSAR, page 8.2-9. (See Details I, paragraph 3d and 3e).

"The Turkey Point FSAR, Section 8, page 8.2-9 states, cable trays passing through walls or floors are provided with fire stops as shown in Figure 8.2-19." (See Figures 1 and 2 attached to this report) "A similar fire stop is provided where cables pass through floor slots, such as under control panels. A thermal resistant coating (such as Flamemastic 71A) is applied to cables in the cable spreading room, and to cables inside and outside the containment in the penetration area".

A construction installation procedure dated 4/10/70 identified as Job No. 5610, Dwg 5610-E-310, states in Section III, "Raceways passing through walls, ceilings, or floors shall have a fire stop such as shown on Florida Power and Light drawing A-GO-4 and A-GO-5." These drawings are the same as shown in the FSAR and are appended as Figures 1 and 2 of this report.

- (a) Fire stops for power cables from the unit auxiliary transformer through the wall of the 4160V switch gear room were examined. Fire stops, as described in Figures 1 and 2 attached, were in place and were in good condition.

The details of examination of the cable trays fire stops are discussed in item 3, above. In discussions with the licensee, the inspector was informed that major program of examining and reworking all firestops was underway. It is the licensee's intent to build fire stops on all entries and exits without regard to safety or non-safety related equipment. The licensee further stated that they intend to replace the transite fire stop material with "Marinite" because of its improved resistance to moisture uptake, and to spray cables with fire retardant a distance of 8 feet where practical rather than the two feet shown on Figures 1 and 2.
