U.S. DEPARTMENT OF  
**ENERGY**

## 2018 Annual Site Inspection and Monitoring Report for Uranium Mill Tailings Radiation Control Act Title II Disposal Sites

December 2018

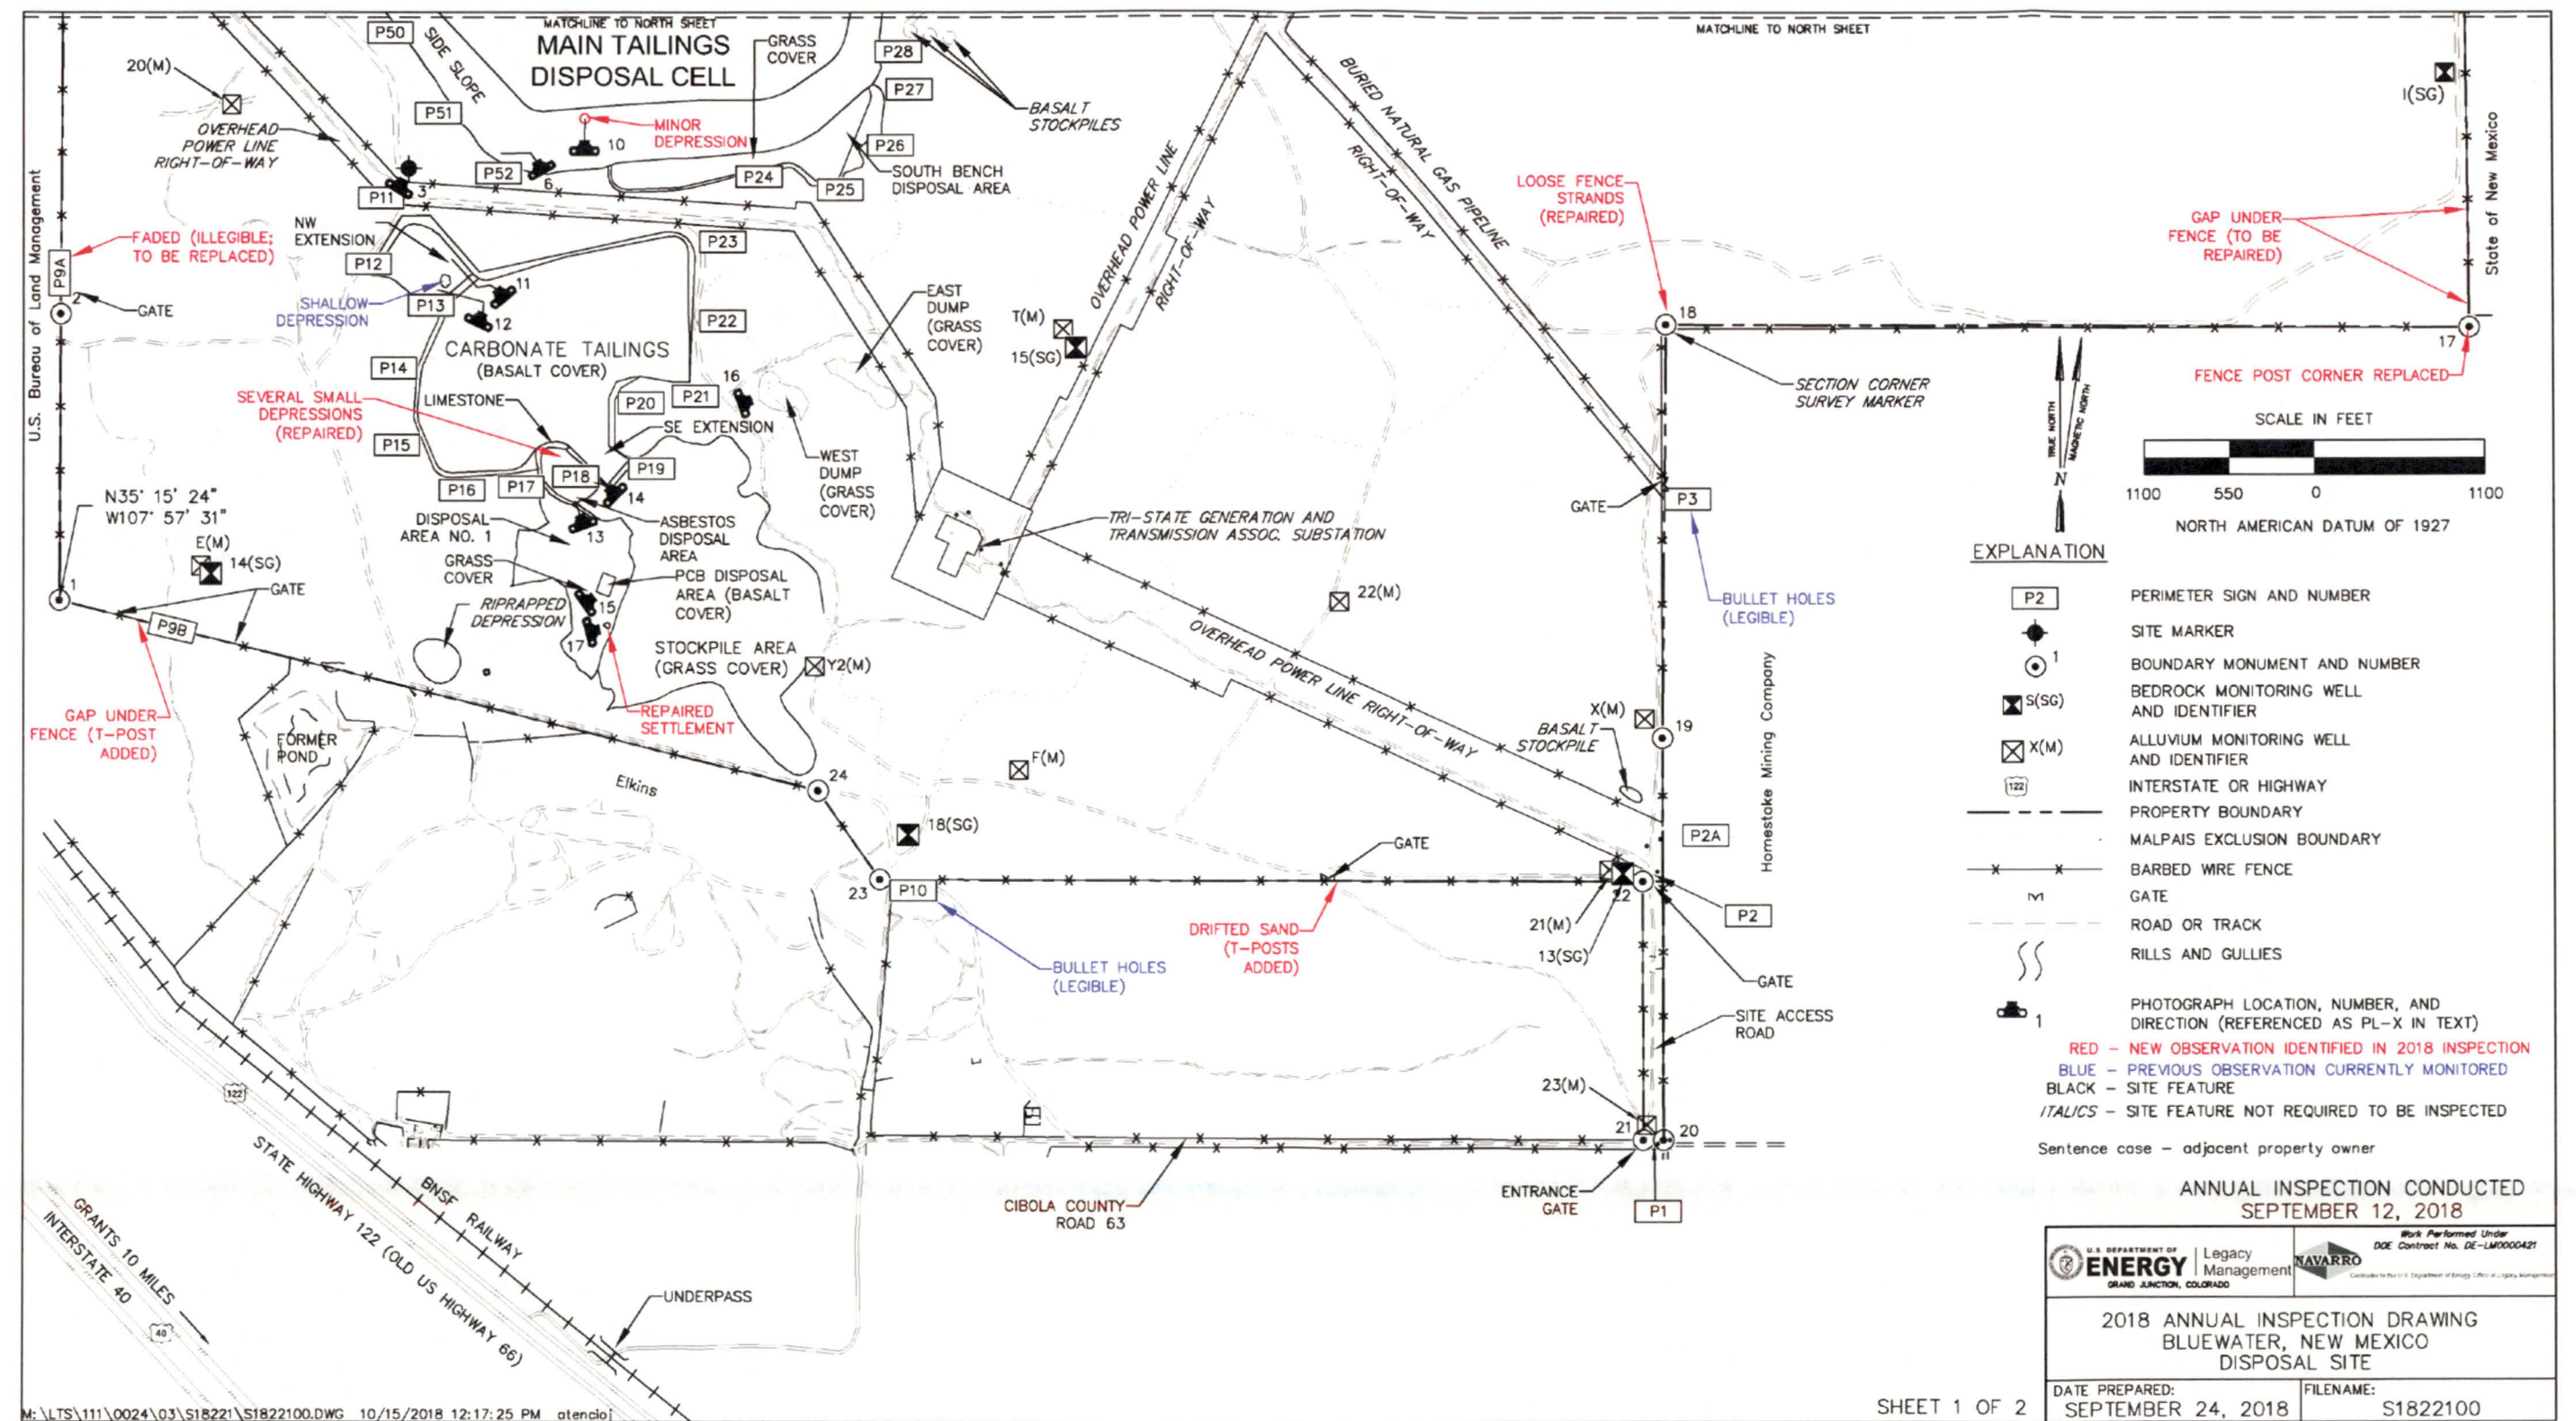
Figure 1-1. 2018 Annual Inspection Drawing for the Bluewater, New Mexico, Disposal Site (South Area)

Interior roads used to access LM assets consist of a dirt track covered at places with crushed basalt. The roads are susceptible to erosion and are repaired when they become impassable. Increased erosion was observed on a road northwest of the main tailings disposal cell (PL-1). A gully intersecting the road at this location required maintenance in the past. Riprap previously was added to repair this section of the road; other repair options will be evaluated in 2019. This portion of road is not necessary to maintain access to the disposal cells; it is used to access the northern portion of the site and monitoring well 11(SG), which can be accessed by utility terrain vehicles when necessary. No other maintenance needs were identified.

A four-strand barbed-wire fence encloses the site to facilitate land management by LM, which retains a local subcontractor to periodically check the site perimeter fence and remove trespassing cattle. Minor fence repairs are conducted as needed. Numerous sections of the fence are in remote areas of the site and cannot be observed from site access roads. The entire perimeter fence was inspected on April 25, 2018. Before the inspection, on April 23–25, 2018, a south section of the perimeter fence was repaired by adding additional T-posts and wire to eliminate gaps caused at some locations by erosion and deposition. At the corner where boundary monument BM-17 is located, the old wooden-post corner was replaced with an angle-iron corner post and braces set in concrete. Additional fence repair needs and a damaged lock on a perimeter gate are noted in Figure 1-1 and Figure 1-2; repairs are planned for 2019.

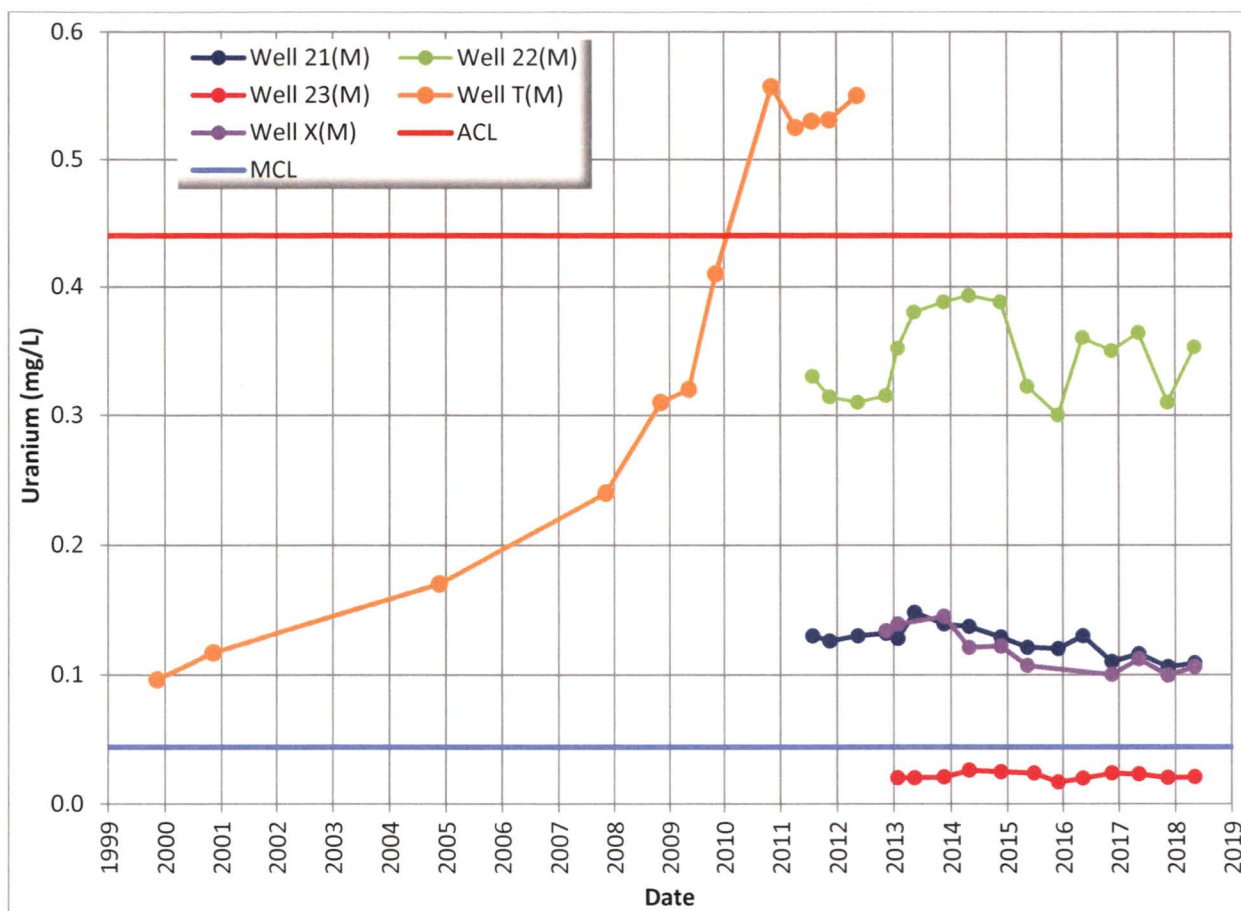
Figure 1-4. Uranium Concentrations in Alluvial Aquifer POC Well T(M) and Downgradient Wells at the Bluewater, New Mexico, Disposal Site

Figure 1-4 shows historical uranium concentrations measured at POC well T(M) and five additional wells screened in the alluvial aquifer. As this figure shows, the uranium concentration at well T(M) trended upward since LM began monitoring the well in 1999, and the November 2010 concentration of 0.557 mg/L was the first of five uranium concentrations that exceeded the ACL of 0.44 mg/L. LM notified NRC of the exceedance upon receiving the 2010 results from the laboratory. Well T(M) dried up following a May 2012 sampling as a result of drought and continuing declines of water levels in the well, and the well has since remained dry. Well 21(M) in the southeast corner of the site and POE well X(M) near the site's east boundary show a slightly decreasing trend in uranium concentration since 2013 (Figure 1-4). However, the elevated uranium concentrations at these two wells in recent years indicate that alluvial groundwater with uranium concentrations exceeding the New Mexico groundwater standard (0.03 mg/L) is discharging from the site toward the southeast.

NRC requested that LM evaluate the performance of the main tailings disposal cell to assess whether seepage losses from the cell between 2005 and 2010 had increased above previous losses to the extent they were responsible for the elevated uranium concentrations measured at POC well T(M) (see Figure 1-4) before it dried up. An assessment of the disposal cell cover and an accompanying evaluation of the water balance for the main tailings disposal cell (including the 2013 radon study referred to in Section 1.4.2.1) concluded that the increase in uranium concentrations in well T(M) could not be attributed to a compromise of the disposal cell's performance and that there was no surge of tailings-fluid seepage from the main tailings cell since it was closed (DOE 2014). It was further concluded that water levels in well T(M) decreased so much during the early 2000s that they were at or below the contact between the alluvium and underlying Chinle Formation from 2008 to 2012. The simultaneous increase in uranium concentration was attributed to the declining water level and the influence of contaminated groundwater migrating through and interacting with weathered Chinle Formation materials, with the resulting fluids obscuring the water chemistry of groundwater in nearby portions of the alluvial aquifer that remained saturated (DOE 2014).

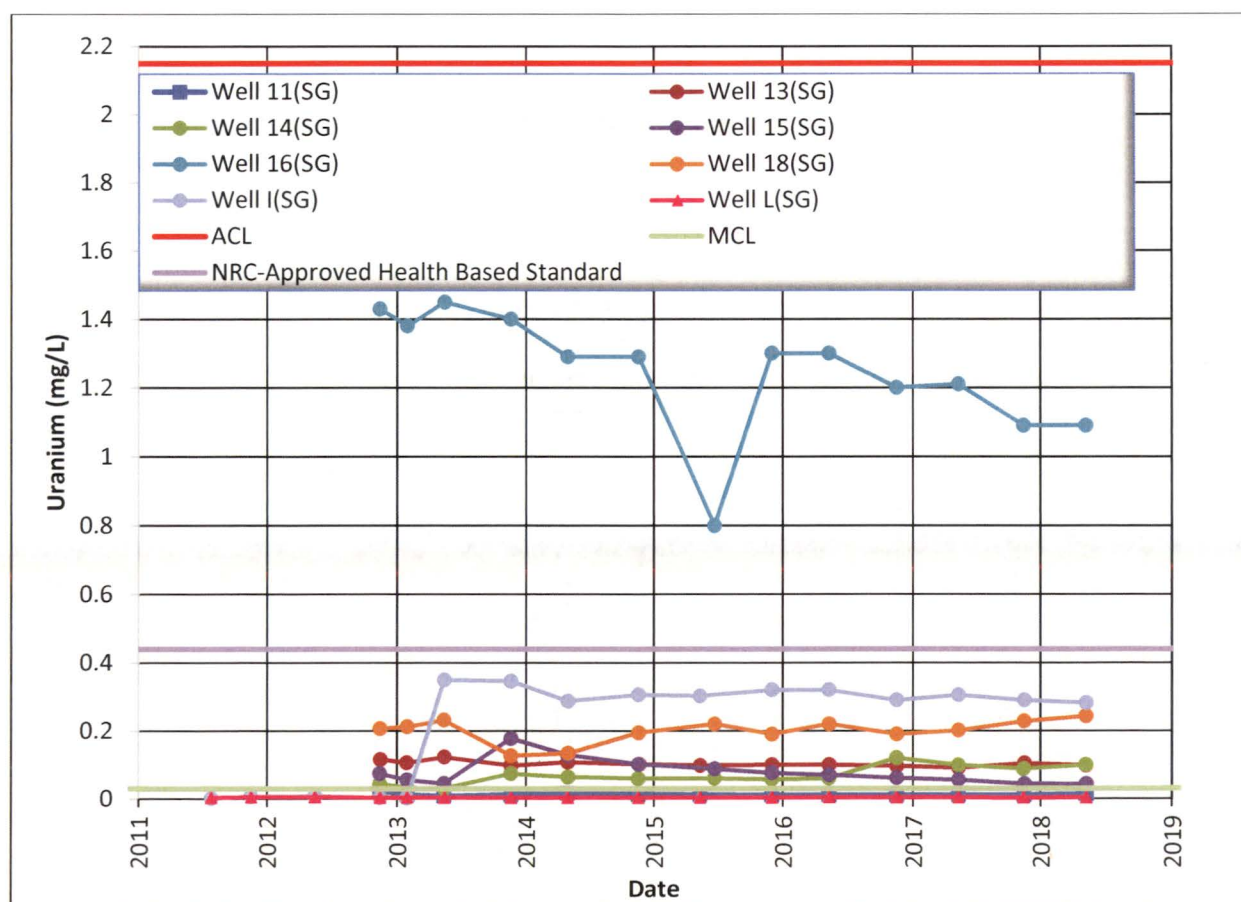
Figure 1-5. Uranium Concentrations in the San Andres/Glorieta Aquifer  
at the Bluewater, New Mexico, Disposal Site

Uranium concentrations in the SAG aquifer are shown in Figure 1-5. Uranium concentrations in well I(SG) before 2013 are not shown because they were erroneously low due to an incorrect sampling depth in the well. Uranium concentrations at POC wells OBS-3 and S(SG) are not shown in Figure 1-5 because the well screens are encrusted with iron scale that has resulted in erroneously low uranium concentrations since LM began sampling the wells.

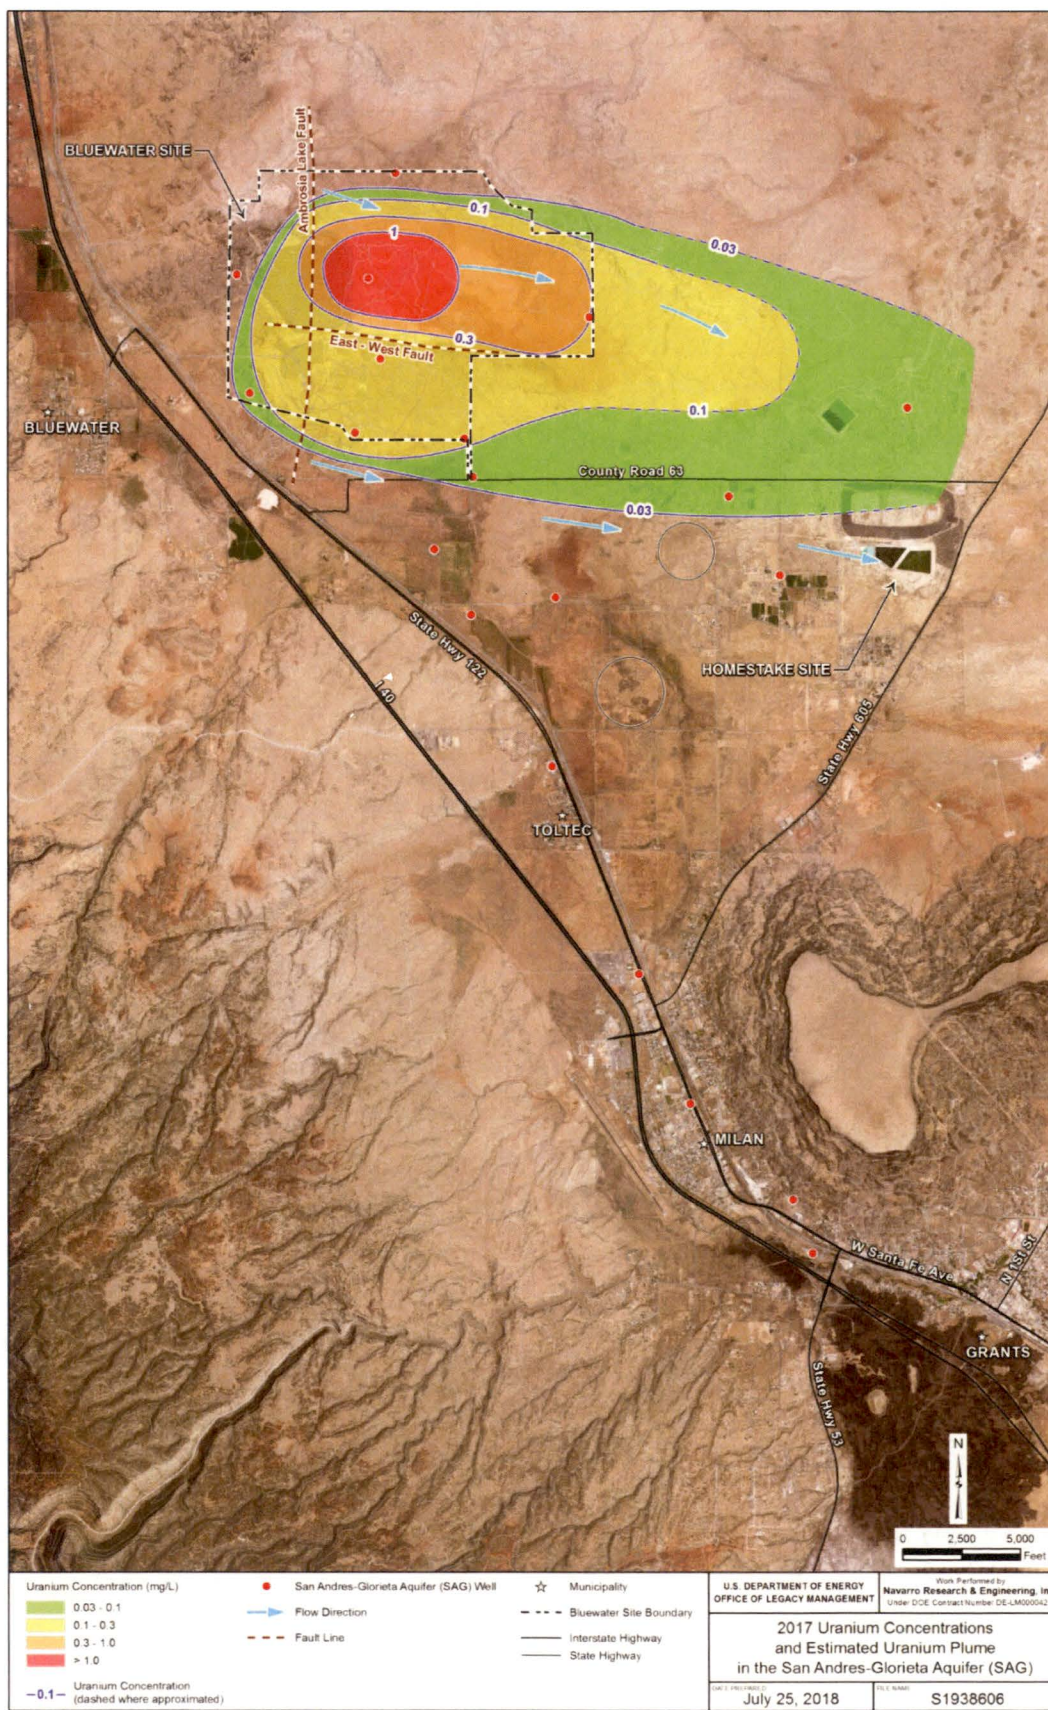
Figure 1-7. 2017 Estimated Uranium Plume in the San Andres/Glorieta Aquifer (DOE 2018)

The estimated extent of the uranium plume, described in the updated groundwater model (DOE 2018), is shown in Figure 1-7. The uranium plume follows the groundwater flow path, and the leading portion is near the Homestake site. Groundwater monitoring results obtained by various entities over the last several decades indicate that uranium contamination from Bluewater mill operations reached the Homestake site by 1980 and that the plume has essentially stabilized (i.e., it is not continuing to migrate to the east). Uranium concentrations attenuate with distance from the site primarily through dispersion instead of chemical reduction because of the absence of a reducing environment in the aquifer formations (DOE 2014). No known drinking water wells are completed within the uranium plume, and site-derived uranium contamination in the SAG aquifer is not expected to impact the Milan or Grants municipal water supplies that are pumped from SAG aquifer wells.

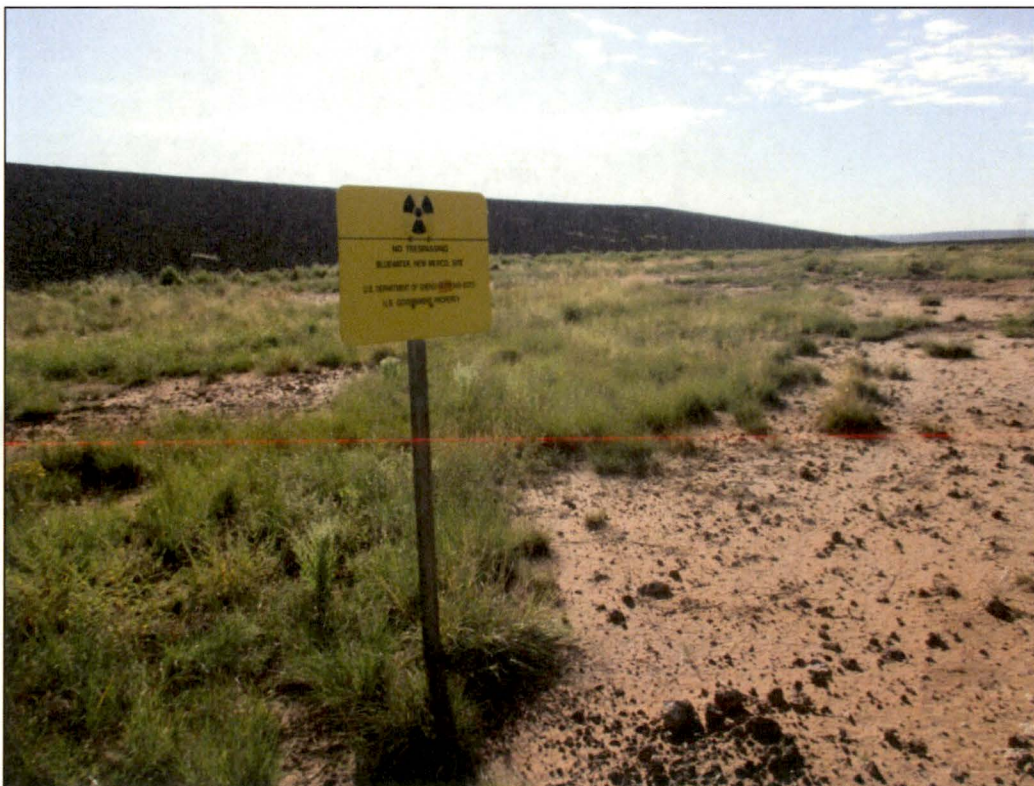
Fifty-five perimeter signs (warning and no-trespassing signs) are mounted on steel posts along the site boundary and around the main and carbonate tailings disposal cells (PL-2). Perimeter signs P3 and P10 have gunshot damage but are legible. Perimeter sign P9A is faded and will be replaced. No other maintenance needs were identified.

*PL-2. Perimeter Sign 49; Southwestern Side Slope in Background*

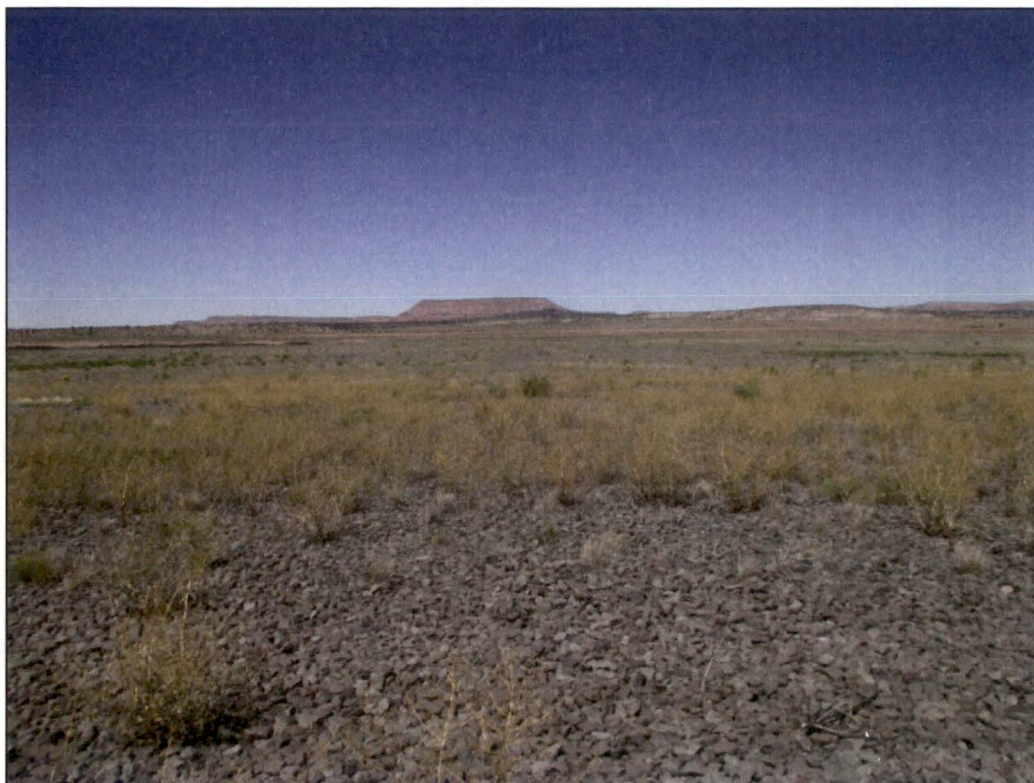
Plant encroachment (by annual weeds, perennial grasses and forbs, and scattered perennial shrubs) continues on the main tailings disposal cell top and side slopes (PL-5, PL-6). Siberian elm saplings on the top slope are managed to prevent the establishment of trees that could damage the main tailings disposal cell cover materials; none were observed during the inspection.

*PL-5. Vegetation on Main Tailings Disposal Cell Top Slope*

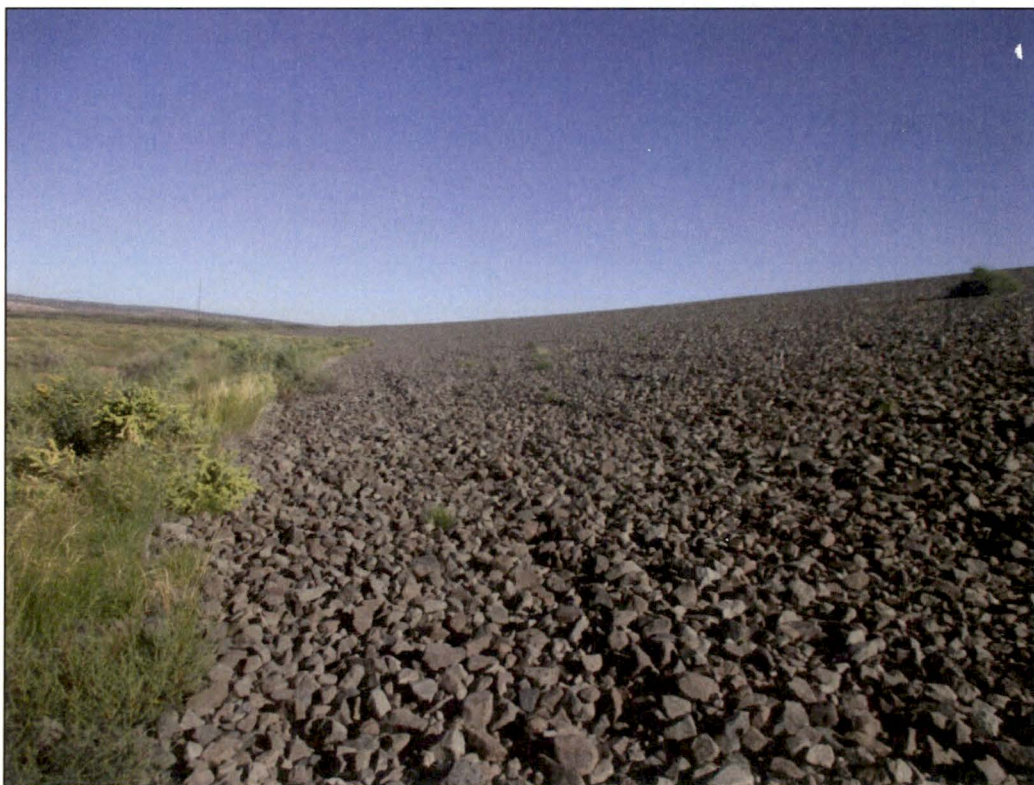
*PL-6. South West Side Slope of the Main Tailings Disposal Cell*

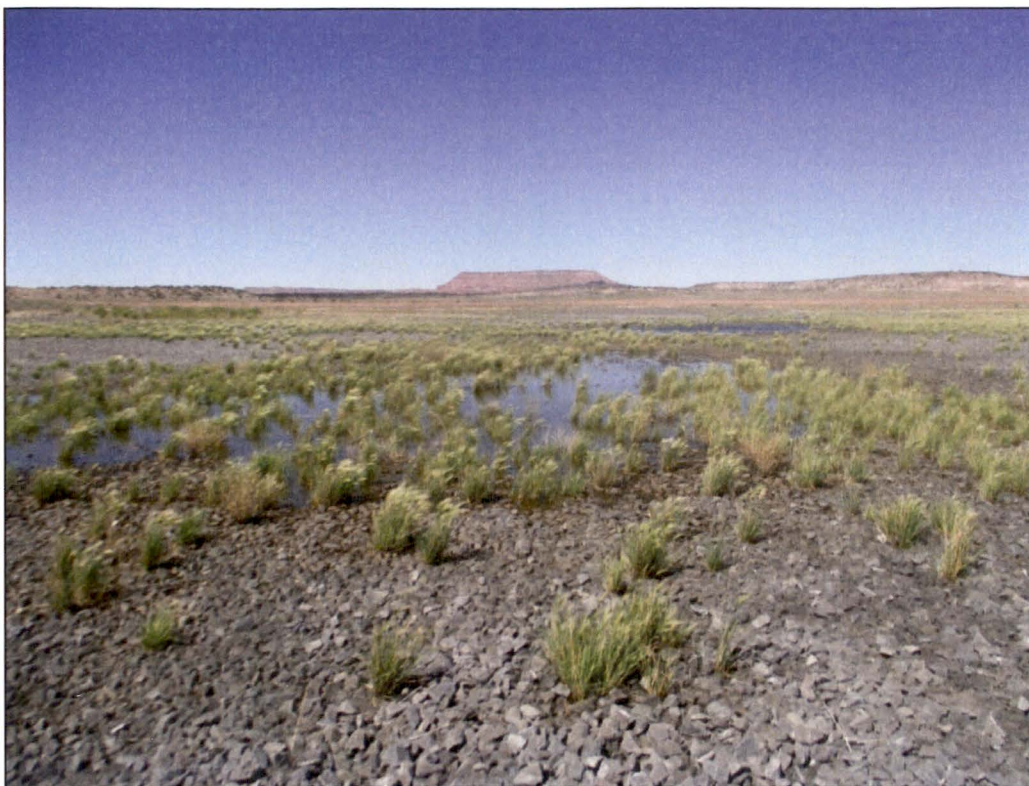
materials if the pond surface reaches an elevation high enough to spill over the north side slope of the disposal cell. Water would start to spill at the lowest point along the north edge of the top slope, and that could initiate erosion at that location. In 2018 LM developed a conceptual design to repair the depressions, regrade the north portion of the top slope, and construct a spillway on the north side slope to ensure positive drainage. In 2019, LM will continue to work on the design and coordinate with NRC regarding its concurrence.

*PL-7. Ponded Water on Main Tailings Disposal Cell Top Slope*

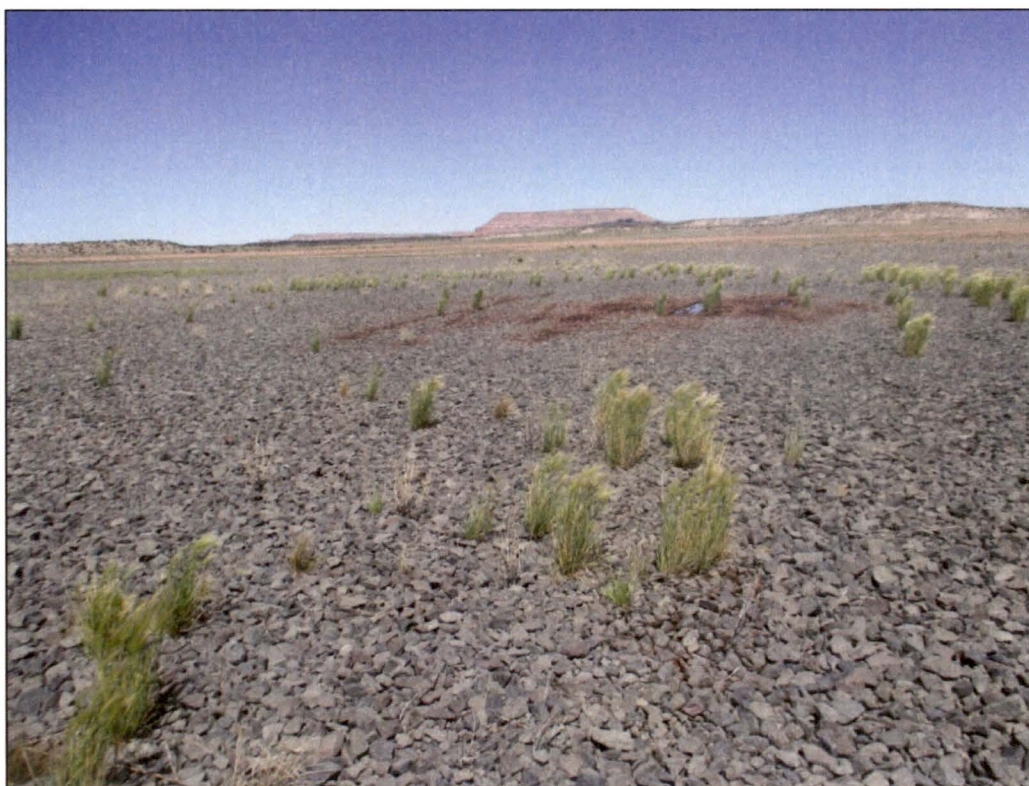
*PL-8. Ponded Water on Main Tailings Disposal Cell Top Slope*

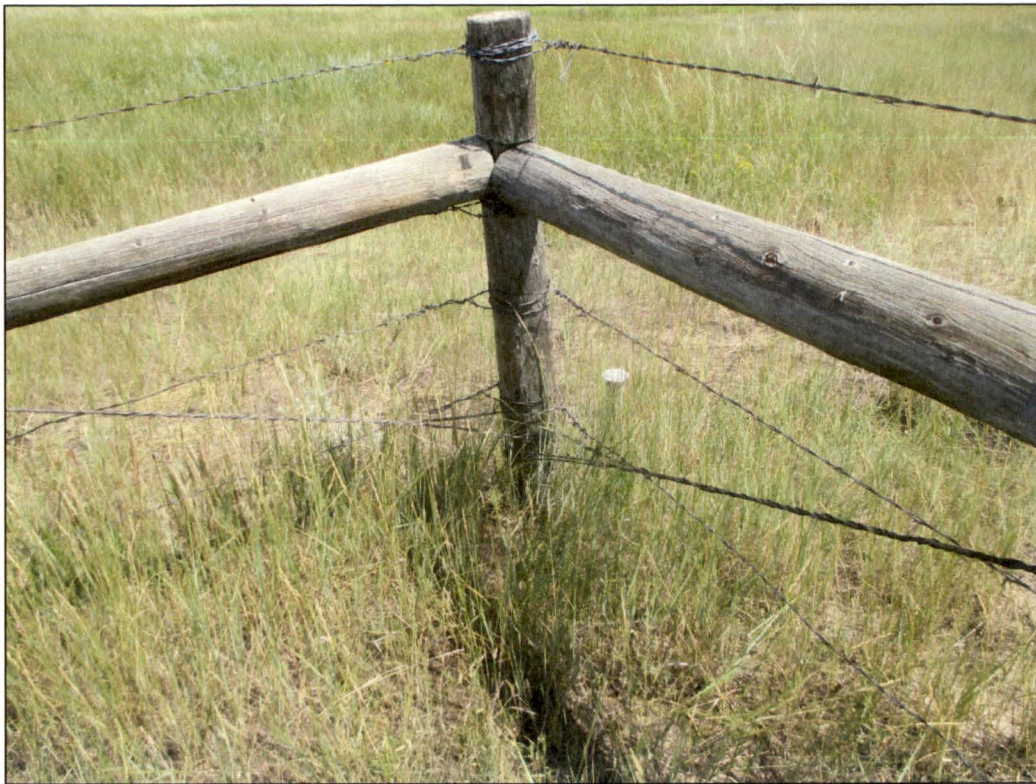
There are four boundary monuments, each at a corner of the property (PL-7). All boundary monuments were inspected, and no maintenance needs were identified.

*PL-7. Boundary Monument BM-2*

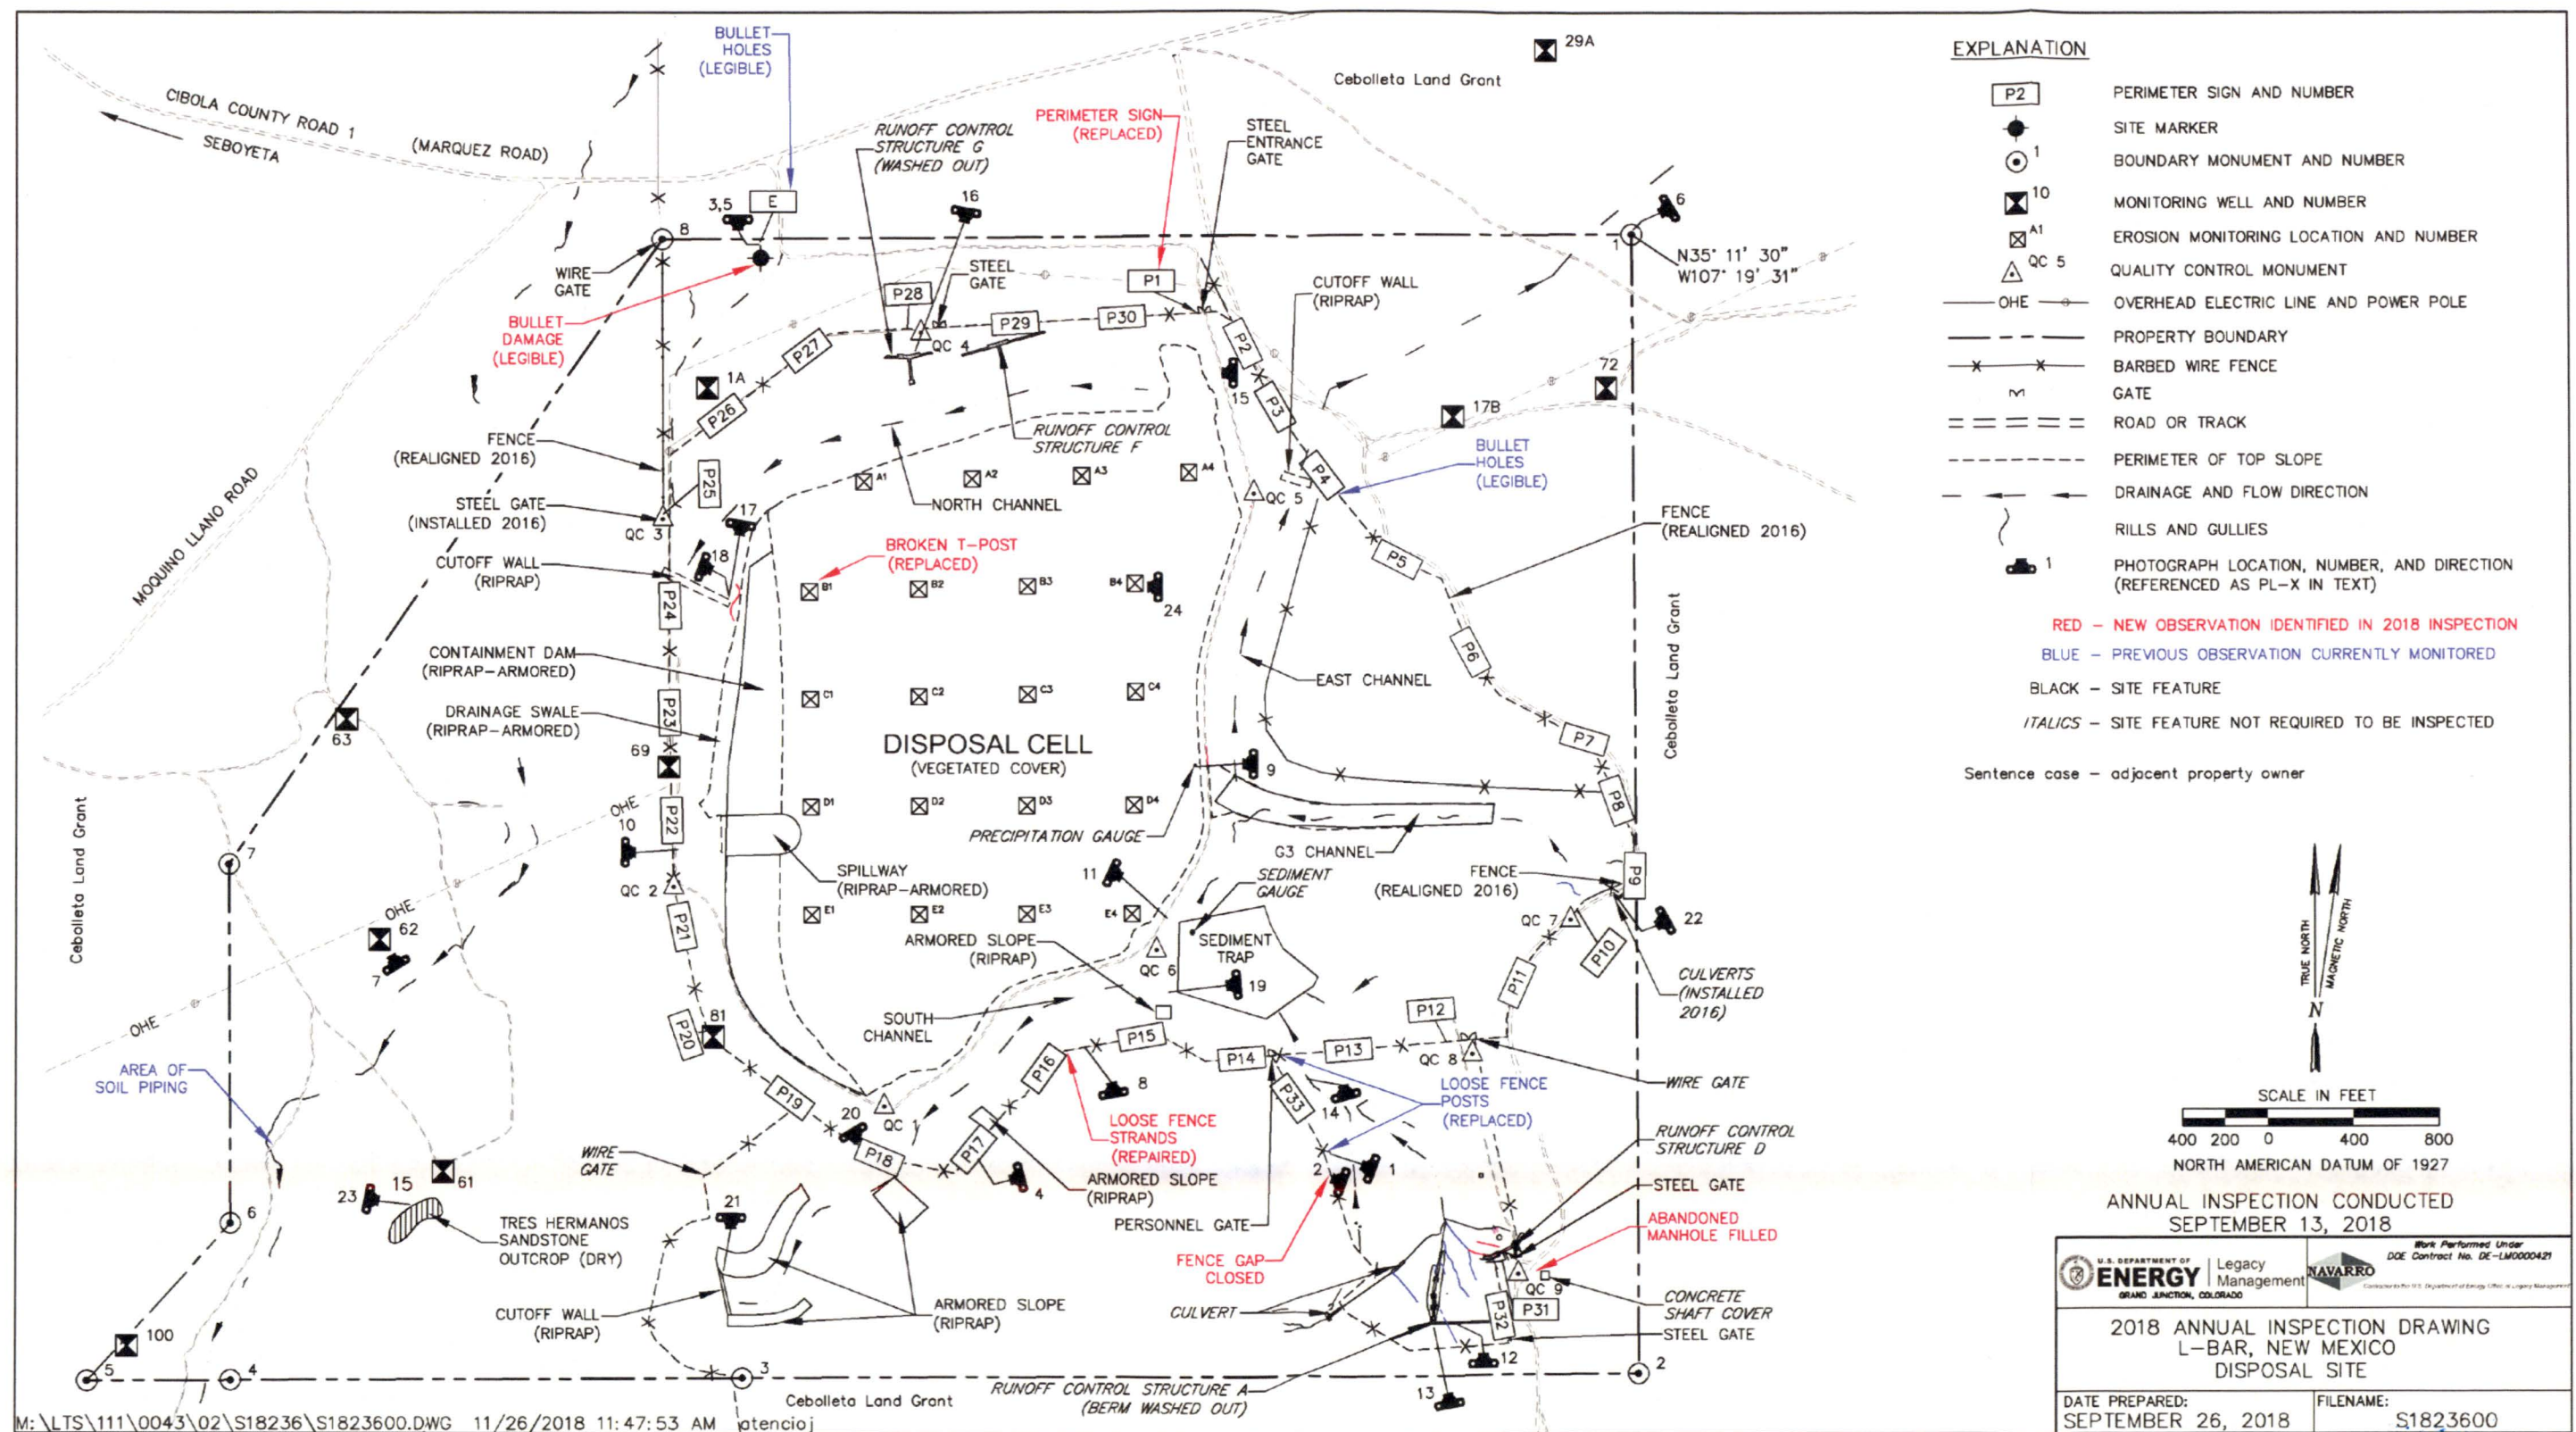
Figure 3-1. 2018 Annual Inspection Drawing for the L-Bar, New Mexico, Disposal Site

A tributary channel (G3) was constructed to divert runoff from a smaller watershed into the east channel (Figure 3-1). Gullies have formed along the side slopes of the G3 channel. The erosion and sediment deposition are not impairing the function of the channel.

A Tres Hermanos Sandstone unit of the Mancos Shale crops out in the southwest corner of the site (Figure 3-1). This unit is reported to be hydraulically connected to contaminated groundwater under the disposal cell, and the outcrop is considered a potential evapotranspiration area. The outcrop was dry at the time of the inspection (PL-23), and there is no evidence that seepage has occurred. This location will continue to be monitored for seepage and recommended for sampling if seep water is present.

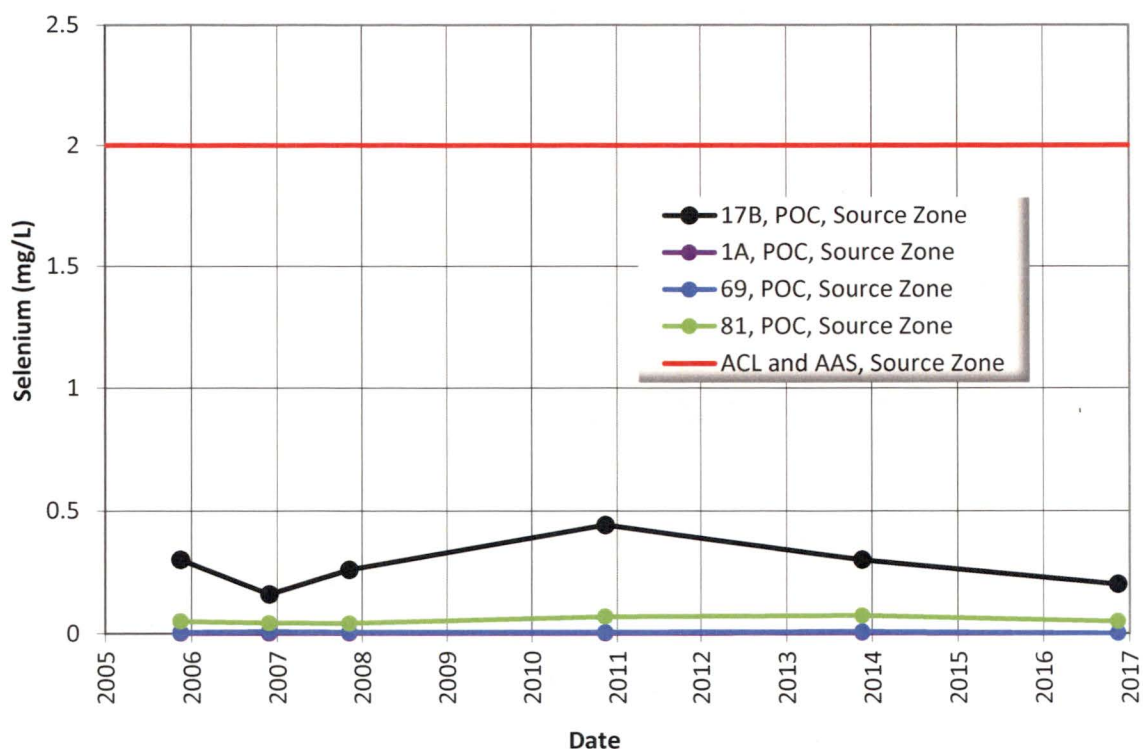
Figure 3-5. Time Concentration Plots of Selenium in Groundwater at the L-Bar Disposal Site

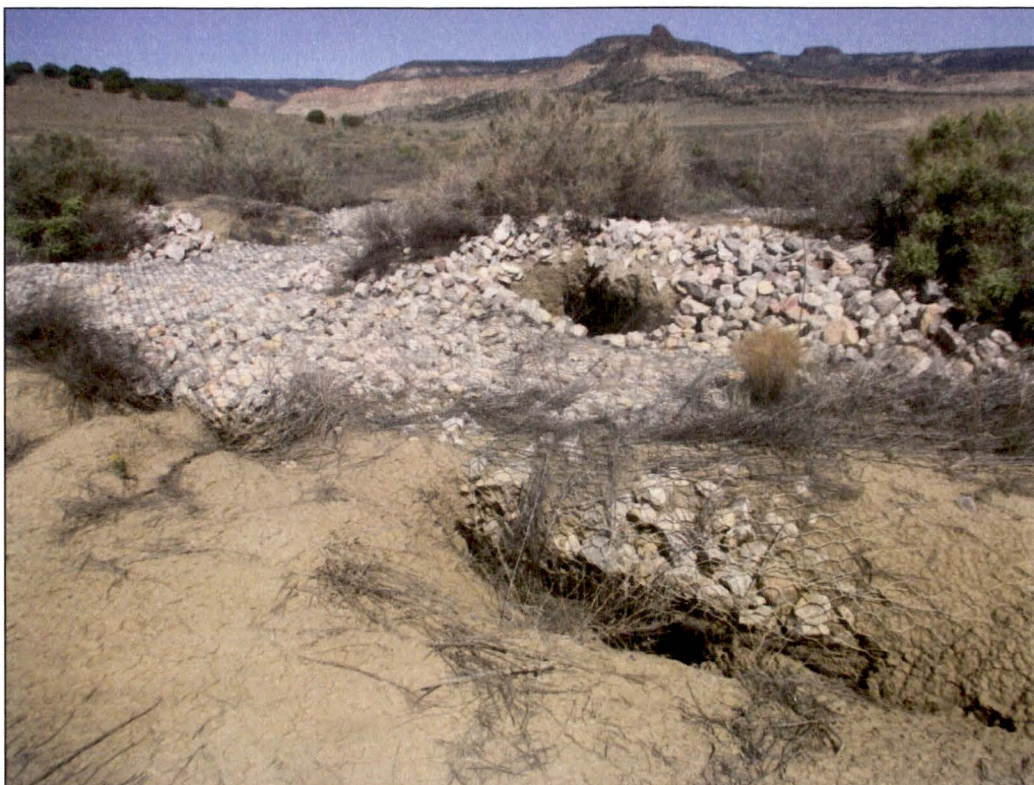
*PL-13. Soil Piping Along Inlet of Runoff Control Structure A*

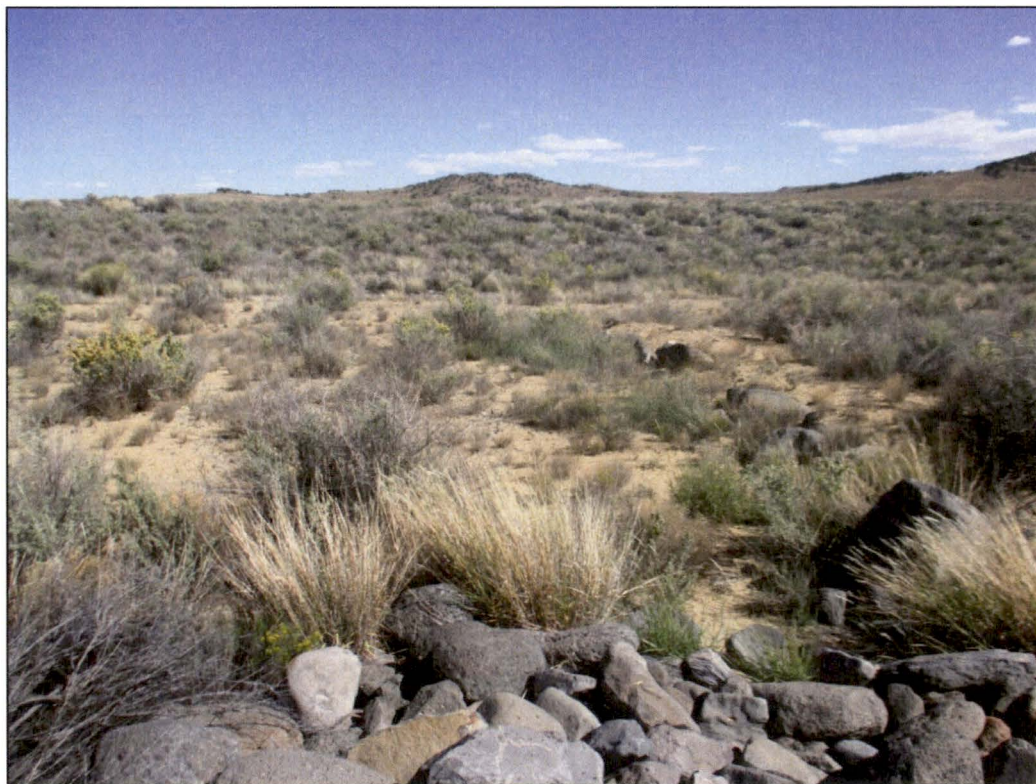
*PL-18. Riprap Cutoff Wall at Outlet of North Channel and Disposal Cell Western Side Slope*
