U.S. DEPARTMENT OF  
**ENERGY**

## 2018 Annual Site Inspection and Monitoring Report for Uranium Mill Tailings Radiation Control Act Title II Disposal Sites

December 2018

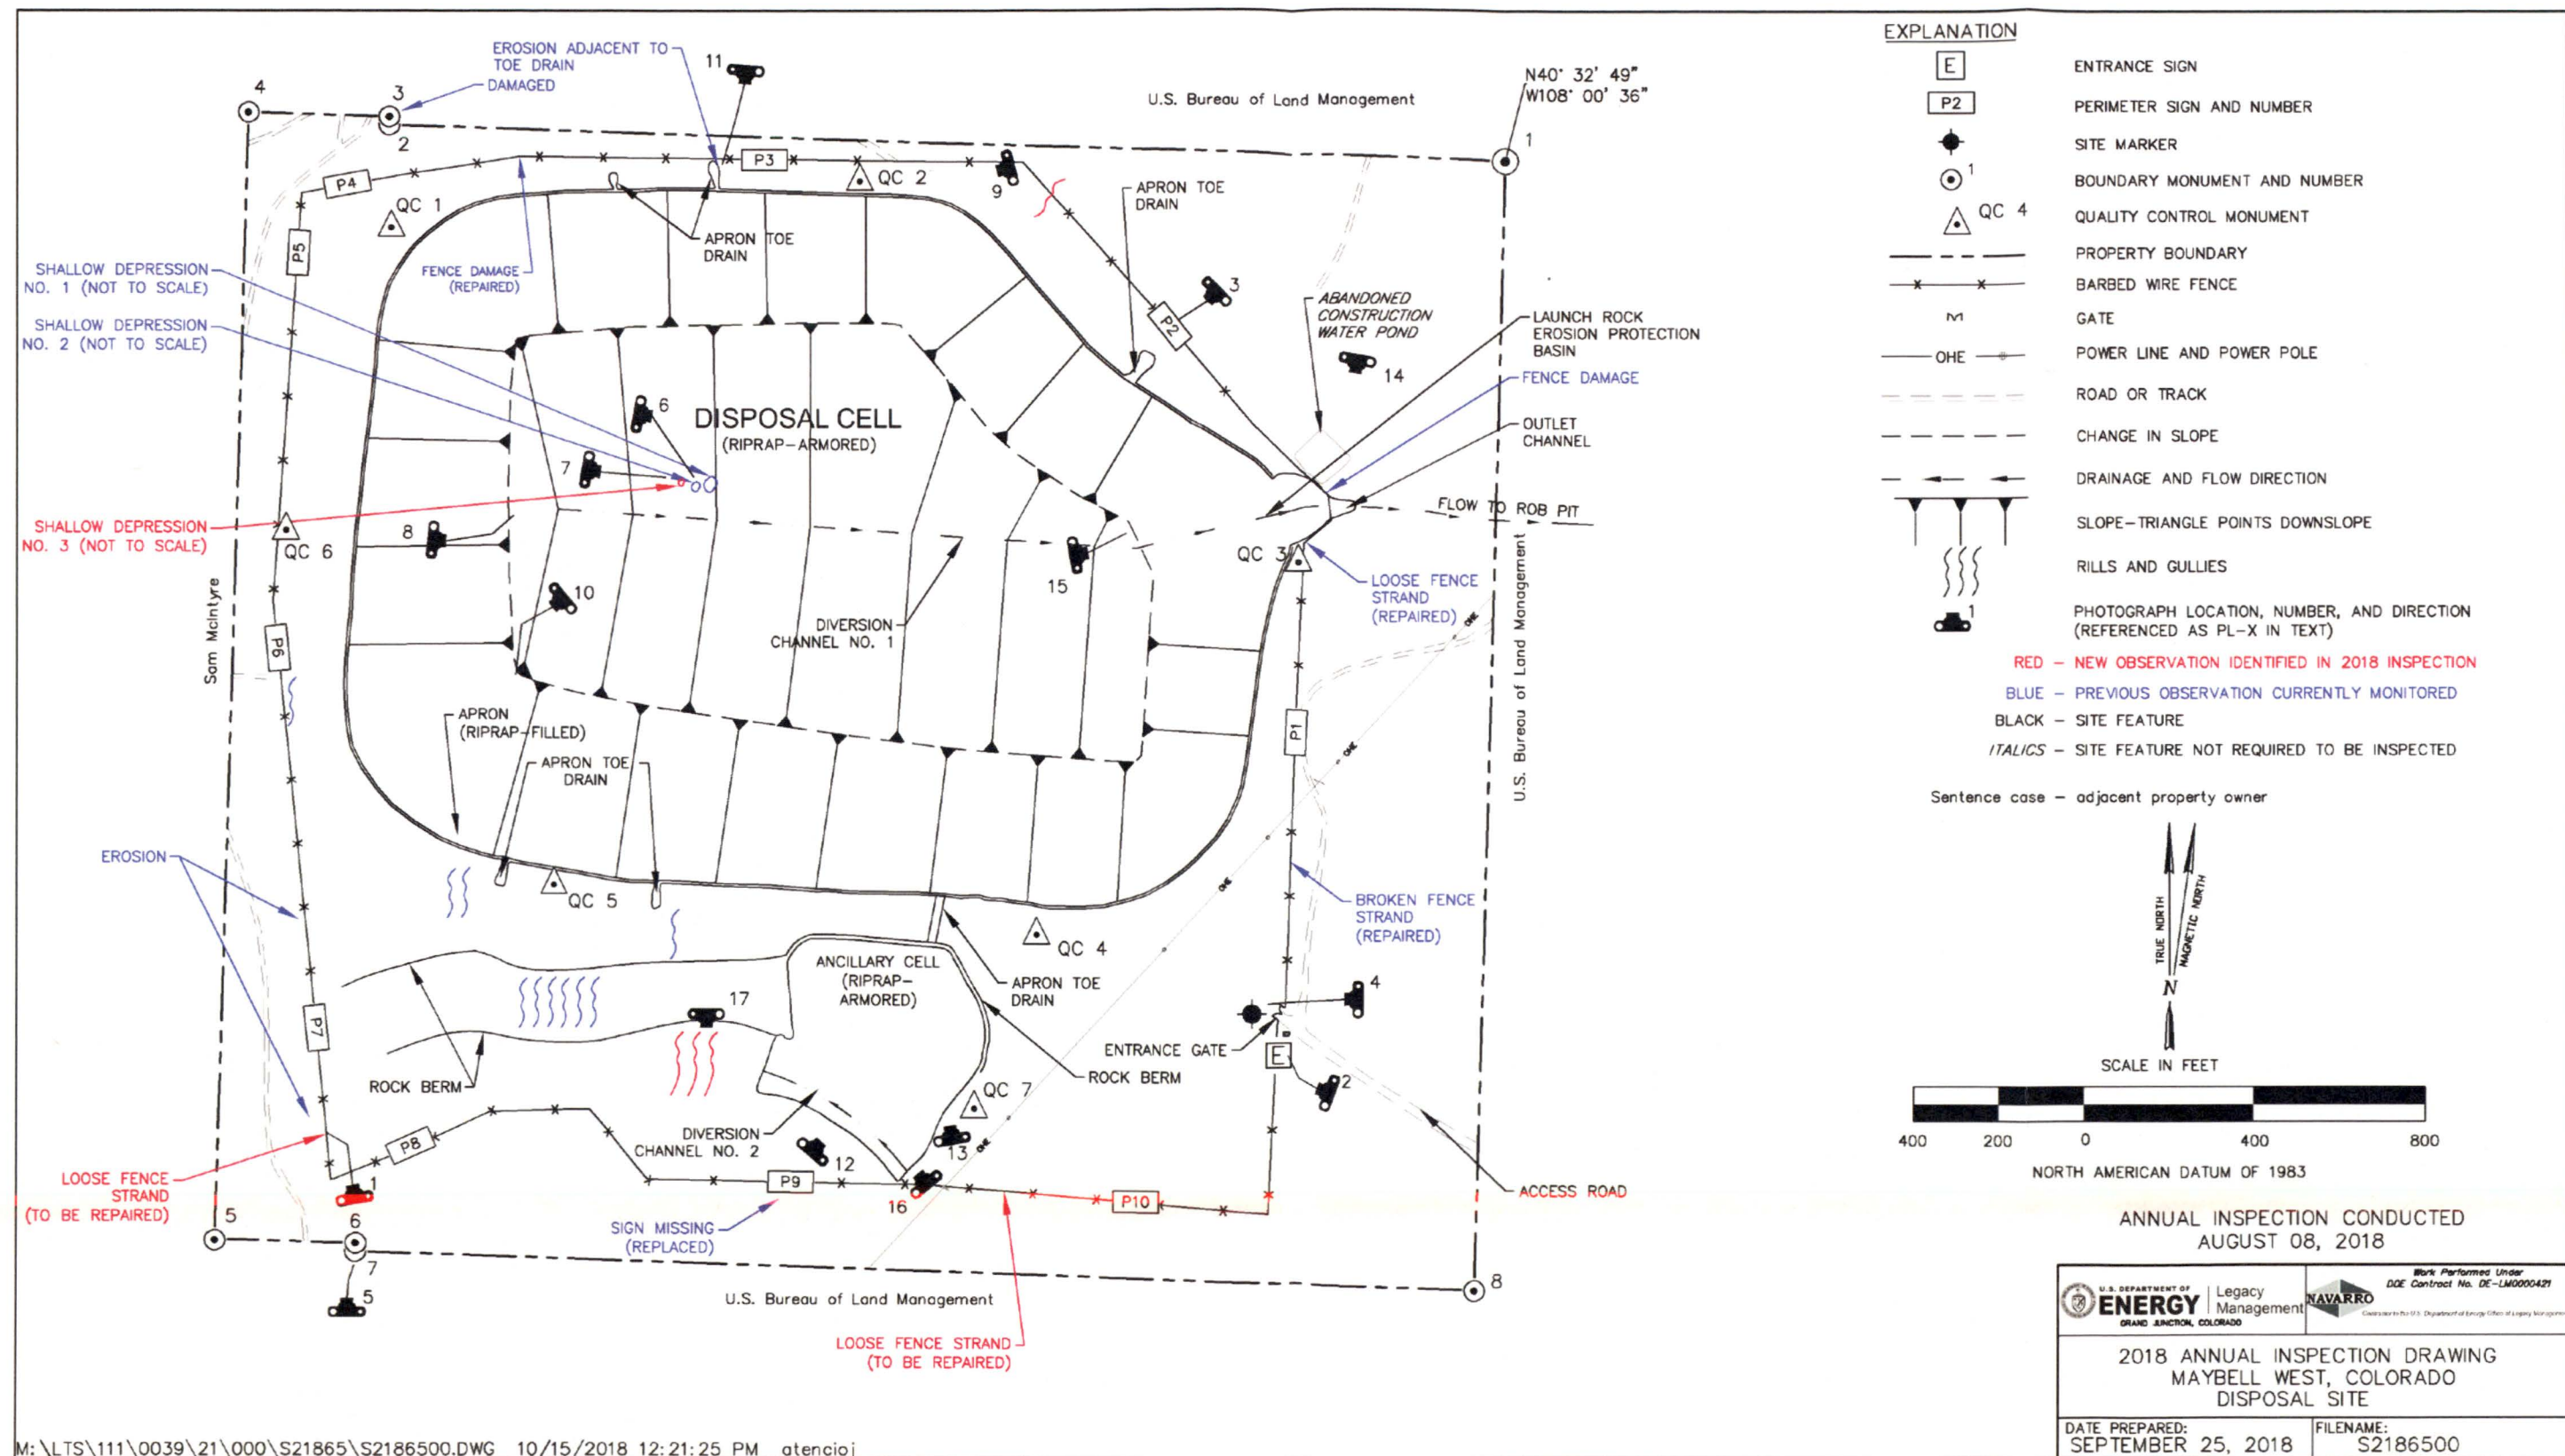
Figure 4-1. 2018 Annual Inspection Drawing for the Maybell West, Colorado, Disposal Site

Figure 4-1 shows the locations of site features in black, including site surveillance features and inspection areas. Site features that are present but not required to be inspected are shown in italic font. Observations from previous inspections that are currently monitored are shown in blue text, and new observations identified in the 2018 annual inspection are shown in red. Inspection results and recommended maintenance activities associated with site surveillance features are included in the following subsections. Photographs to support specific observations are identified in the text and in Figure 4-1 by photograph location (PL) numbers. The photographs and photograph log are presented in Section 4.9.

The access road was passable, and no maintenance needs were identified. The entrance gate, a standard tubular metal stock gate, is near the southeast corner of the site. The gate was locked, and no maintenance needs were identified.

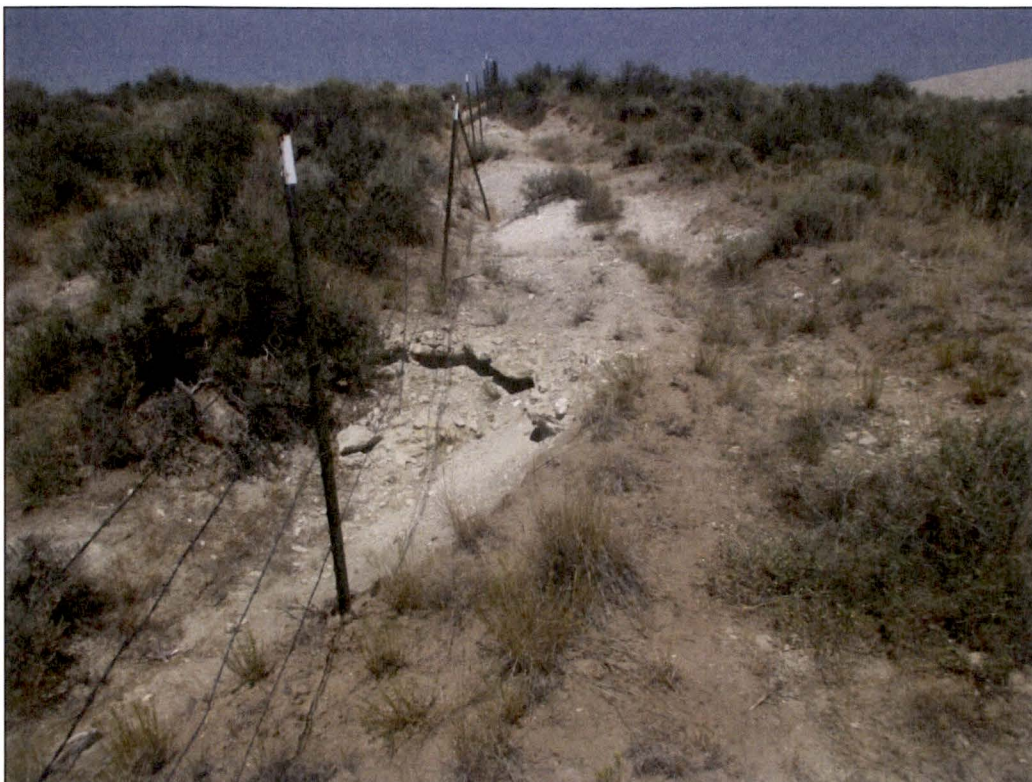
*PL-1. Erosion Near Southwest Corner of Perimeter Fence*

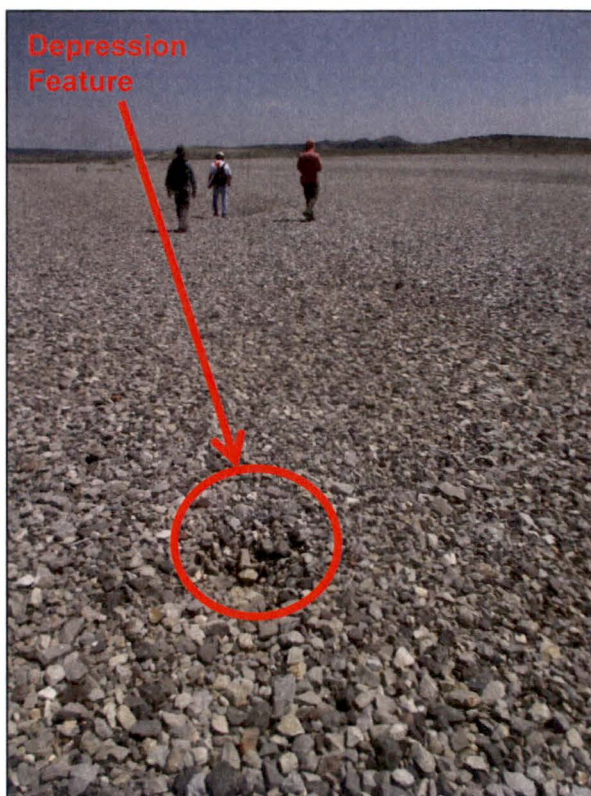
*PL-7. Depression No. 3 on Top Slope of Disposal Cell*

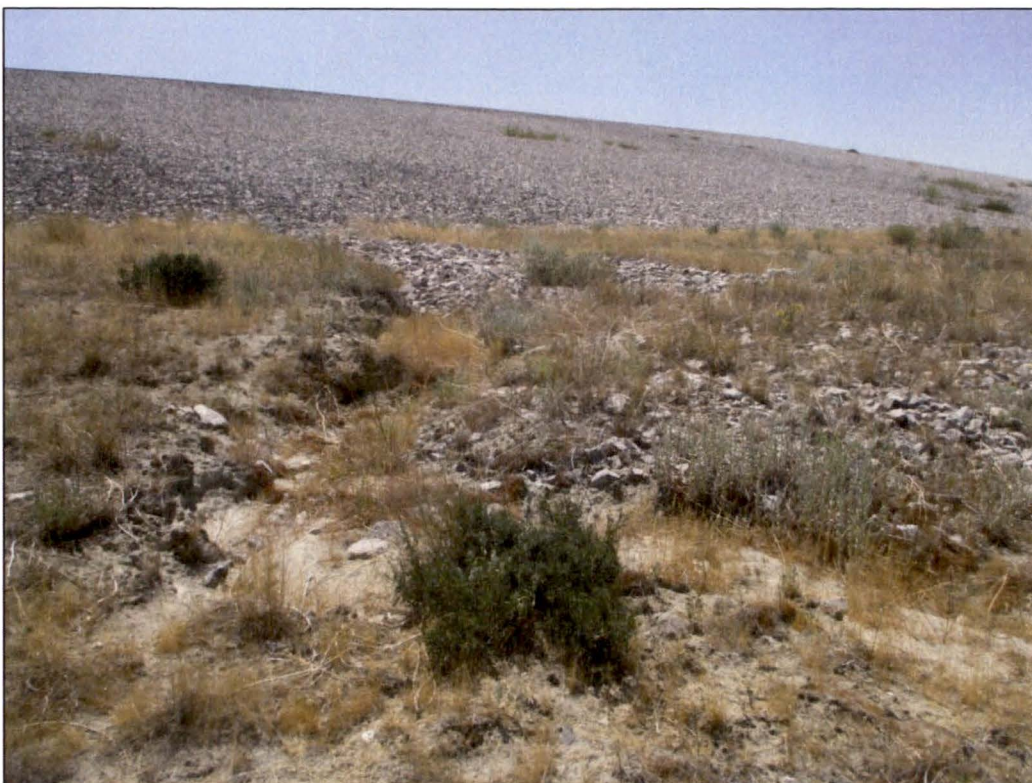
*PL-11. Toe Drain on Disposal Cell North Side Slope and Adjacent Erosion*

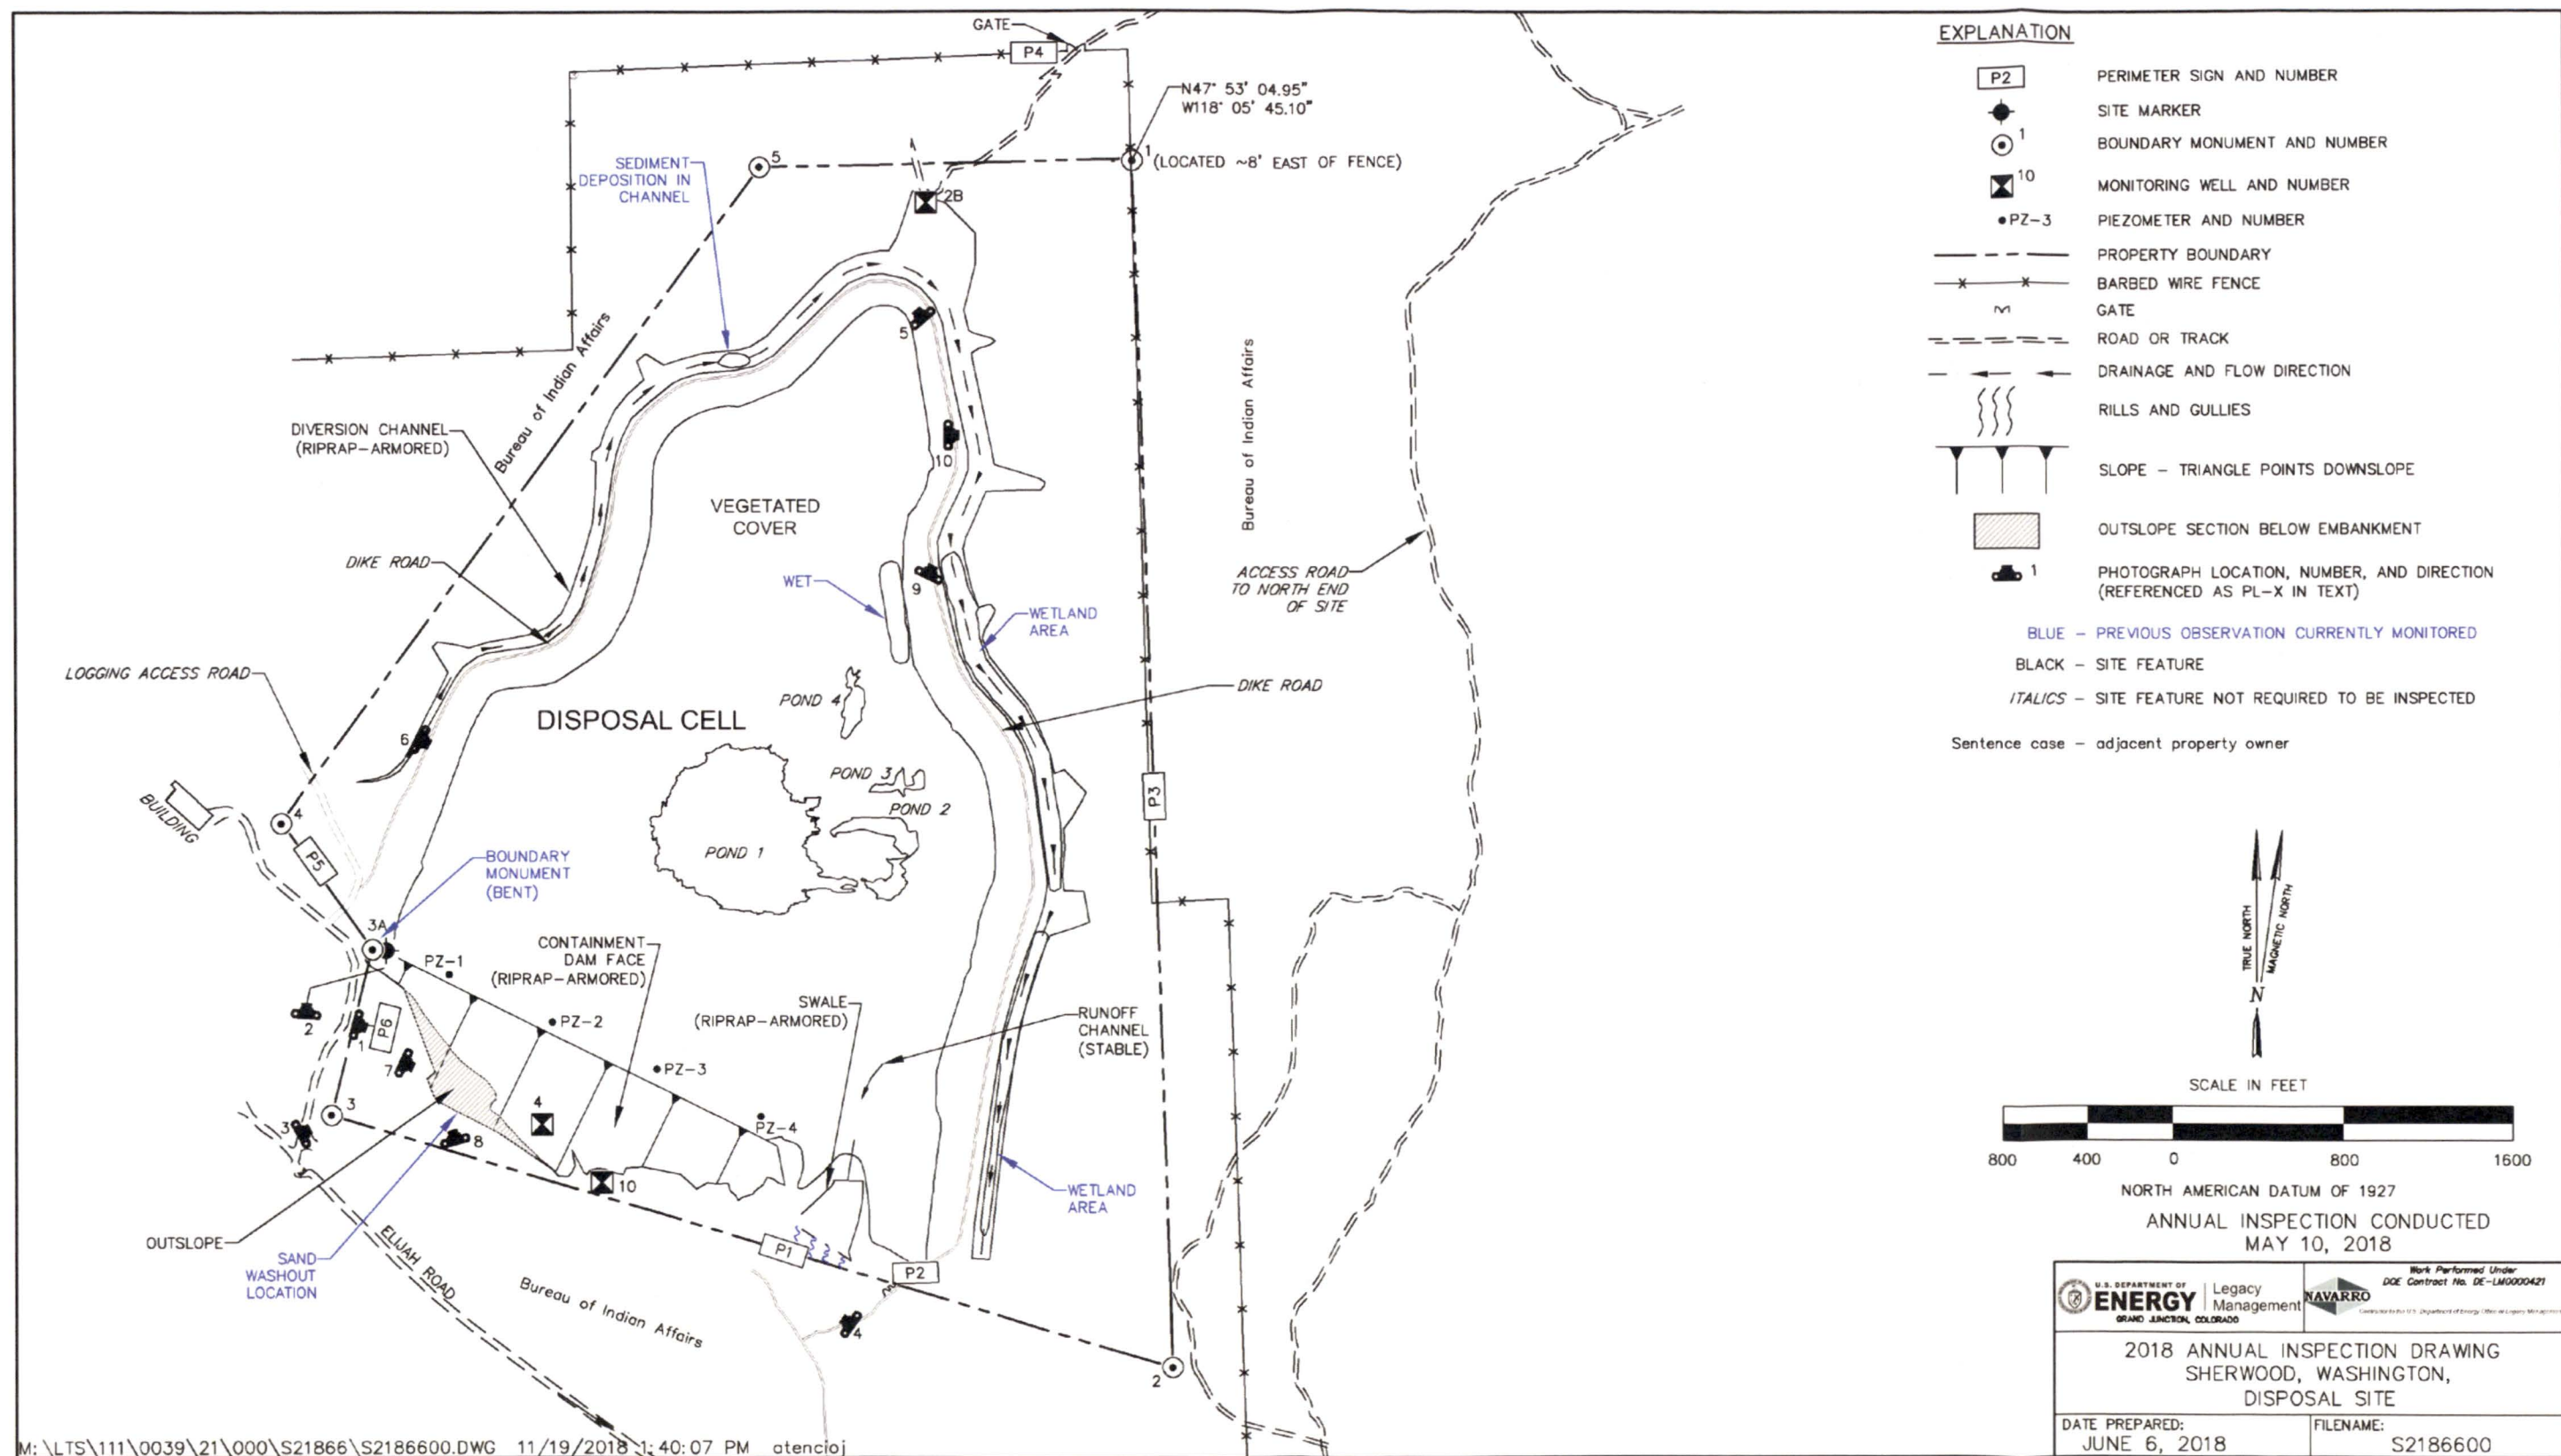
Figure 5-1. 2018 Annual Inspection Drawing for the Sherwood, Washington, Disposal Site

Figure 5-1 shows the locations of site features in black, including site surveillance features and inspection areas. Site features that are present but not required to be inspected are shown in italic font. Observations from previous inspections that are currently monitored are shown in blue text. There were no new observations in 2018. Inspection results and recommended maintenance activities associated with site surveillance features are included in the following subsections. Photographs to support specific observations are identified in the text and in Figure 5-1 by photograph location (PL) numbers. The photographs and photograph log are presented in Section 5.9.

During the 2016 annual inspection, one area at the base of the rock-covered containment dam face was found to have a fan of sand that had washed out from underneath the rock cover (PL-8). A follow-up inspection of the erosion feature was performed on October 4 and 5, 2016. The protective rock cover adjacent to the area of erosion was removed, and the underlying material was examined. The sandy material that was eroded from the embankment was the same as natural undisturbed material nearby. During reclamation, this area of the mill site was used as a source for fill material used to contour the area below the toe of the containment dam. Review of original reclamation and as-built drawings showed that the toe of the containment dam is upslope from the area of erosion. This was confirmed during the investigation conducted before the 2017 annual site inspection and subsequent engineering evaluation, when several small holes were dug upslope to determine the edge of the actual embankment. It was determined that the washout area was in a portion of the dam defined as the outslope in the construction completion report and does not impact the containment dam (Figure 5-1).

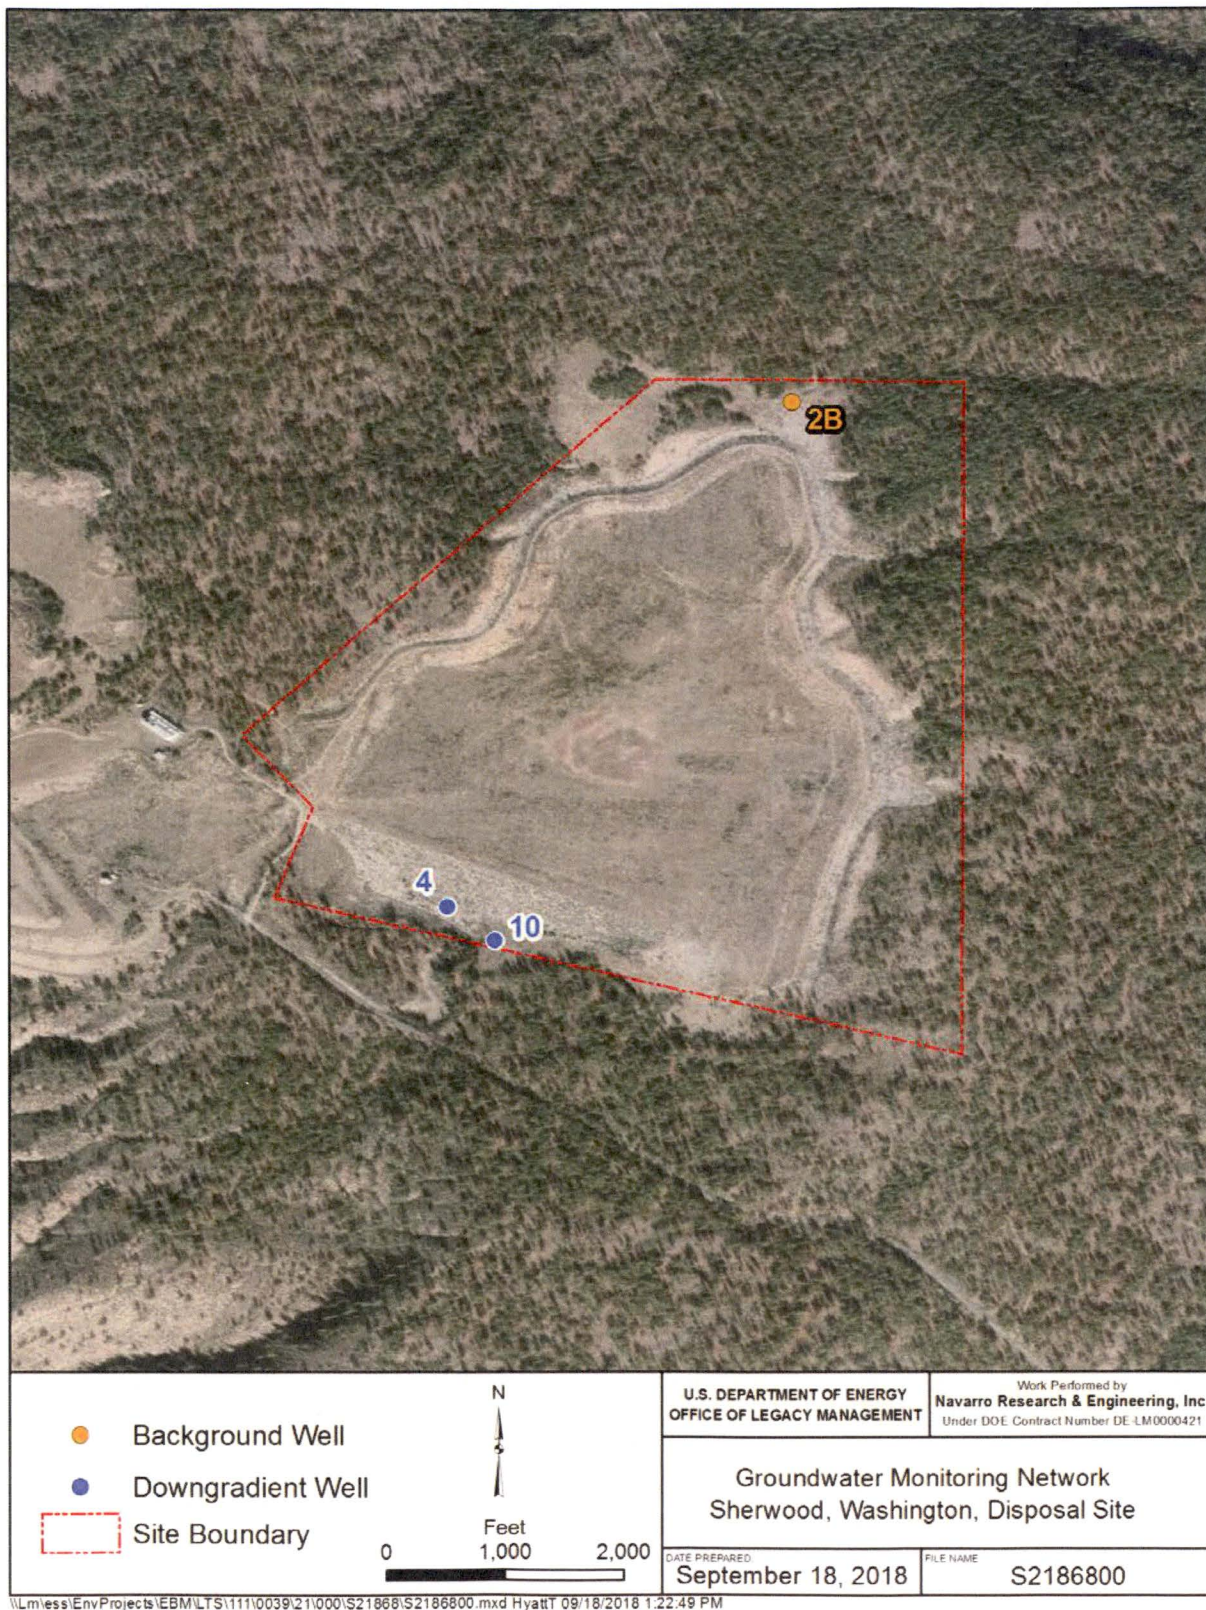
Figure 5-2. Groundwater Monitoring Network at Sherwood, Washington, Disposal Site

A borehole camera was used to evaluate conditions in the three monitoring wells, specifically to determine if there were any well issues that could have caused the exceedance in monitoring well 4. The video showed that the inlet of the dedicated bladder pump used for low-flow sampling was buried in debris at the bottom of the well. The well will be cleaned and redeveloped before sampling in 2019.

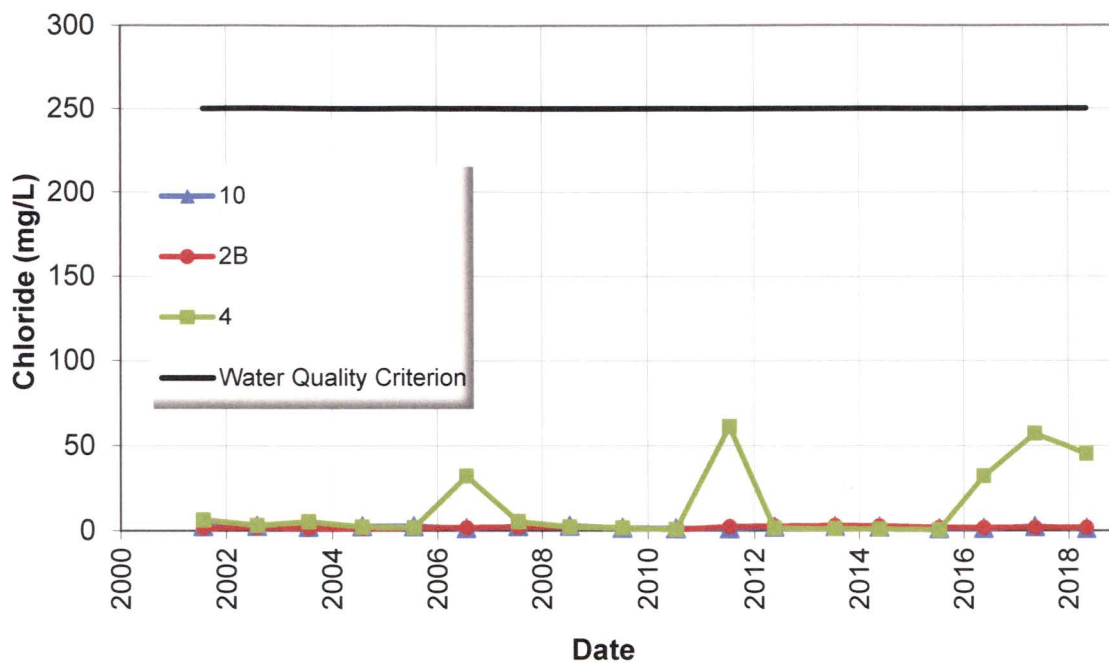
Figure 5-3. Chloride Concentrations at the Sherwood, Washington, Disposal Site

Figure 5-3 and Figure 5-4 show concentrations of chloride and sulfate, respectively, in the three monitoring wells since 2001. Occurrences of slightly elevated chloride levels in well 4 correspond with the higher sulfate levels measured at the same location. Water elevations for each of the monitoring wells are shown in Figure 5-5. These elevations are preliminary and are based on a survey of the elevation of the monitoring wells conducted in August 2018. Groundwater occurs in two hydrostratigraphic units: (1) the alluvium that lies on top of the bedrock surface and (2) the conductive bedrock, including weathered bedrock in the upper portion and unweathered or competent bedrock below. Monitoring well 10 is completed in the alluvium, and wells 2B and 4 are completed in the bedrock.

Increases in water table height in the 2B and 4 wells correspond with the elevated levels of chloride and sulfate measured in well 4 in 2006, 2011, and from 2016 to 2018. As noted by the Washington Department of Health in the February 2000 *Monitoring and Stabilization Plan Supplement*, “One of the downgradient point-of-compliance wells, 4, has seasonal variation in water quality, represented by late spring and summer peaks that are consistent with annual infiltration and the rise in static water levels. This seasonal trend has been evaluated closely and ground water monitoring increased as established by the MSP [Monitoring and Stabilization Plan]” (WDOH 2000). Annual precipitation totals measured in Spokane, Washington, show a correlation with the increased sulfate and chloride concentrations. Years with higher precipitation totals are also years with higher sulfate concentrations.

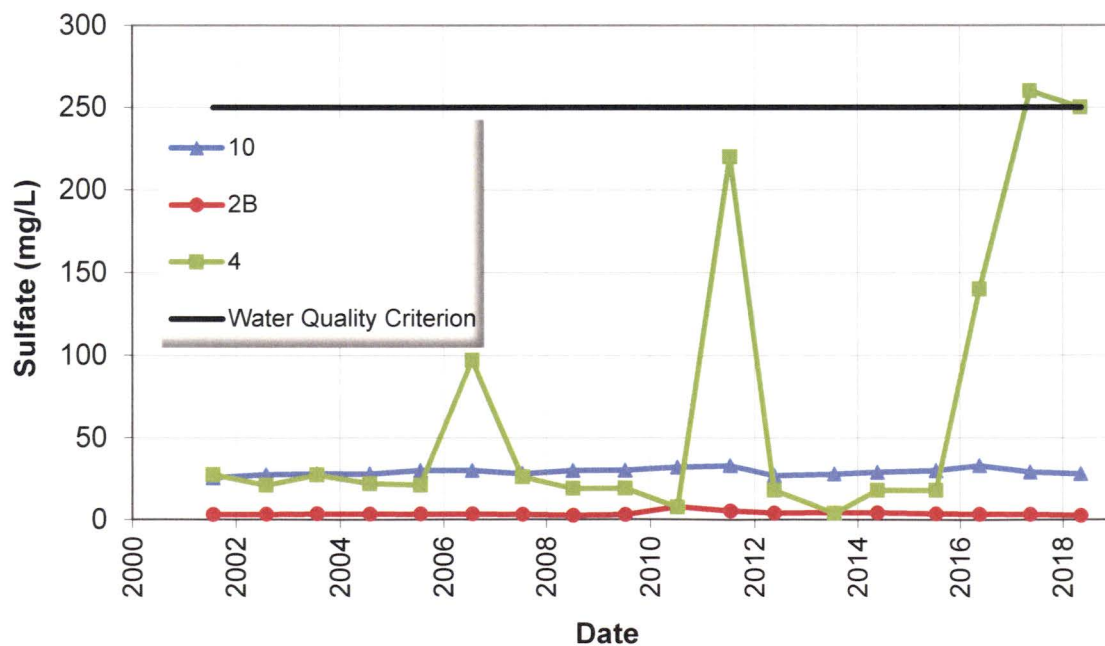
Figure 5-4. Sulfate Concentrations at the Sherwood, Washington, Disposal Site

Table 5-3 presents the May 2018 sampling results. Groundwater constituent concentrations continue to be less than the action levels for confirmatory sampling in monitoring wells 2B and 10; however, sulfate concentration exceeded the action level in monitoring well 4 in 2017 and met it in 2018.

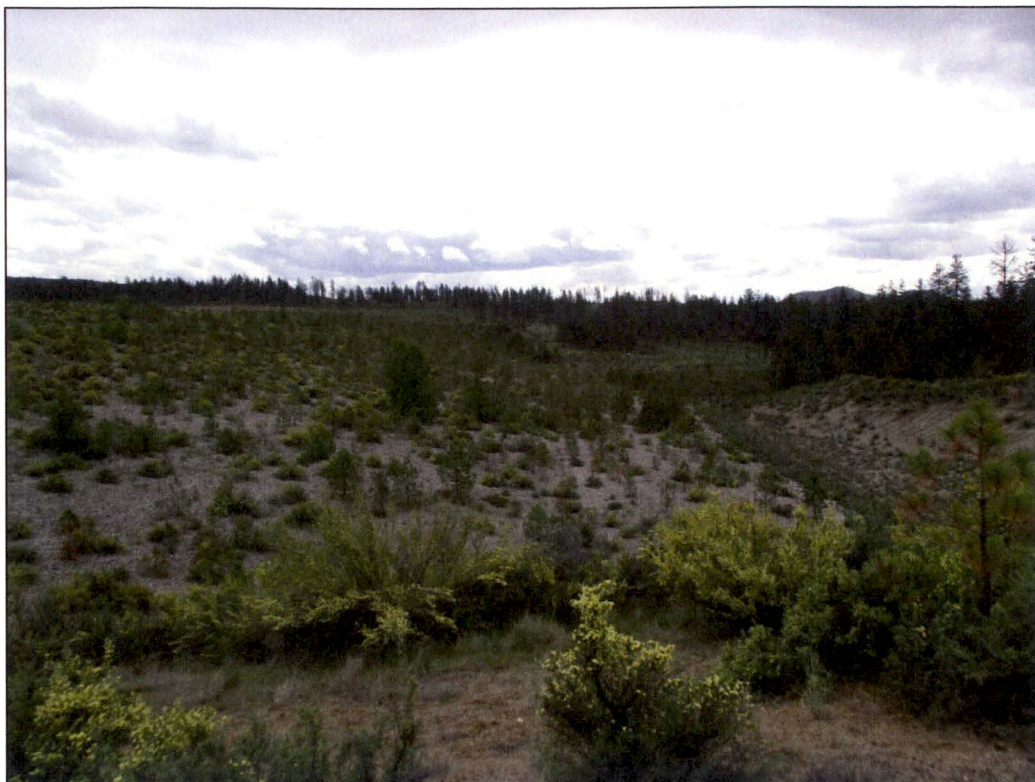
*PL-7. Containment Dam Outslope*

Was evidence of significant erosion observed on the dam? *No, however, minor erosion was observed below the embankment. No erosion was noted on the embankment.*  
If yes discuss in report.

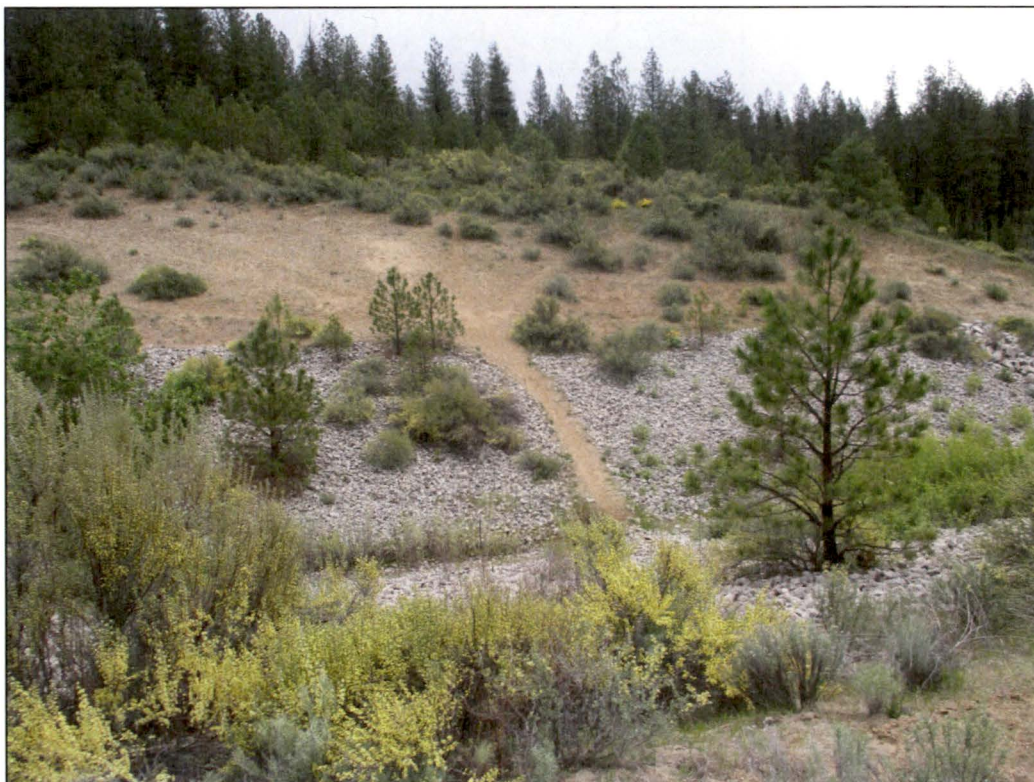
*PL-10. Protective Rock Armor Displaced by Animal Trails*

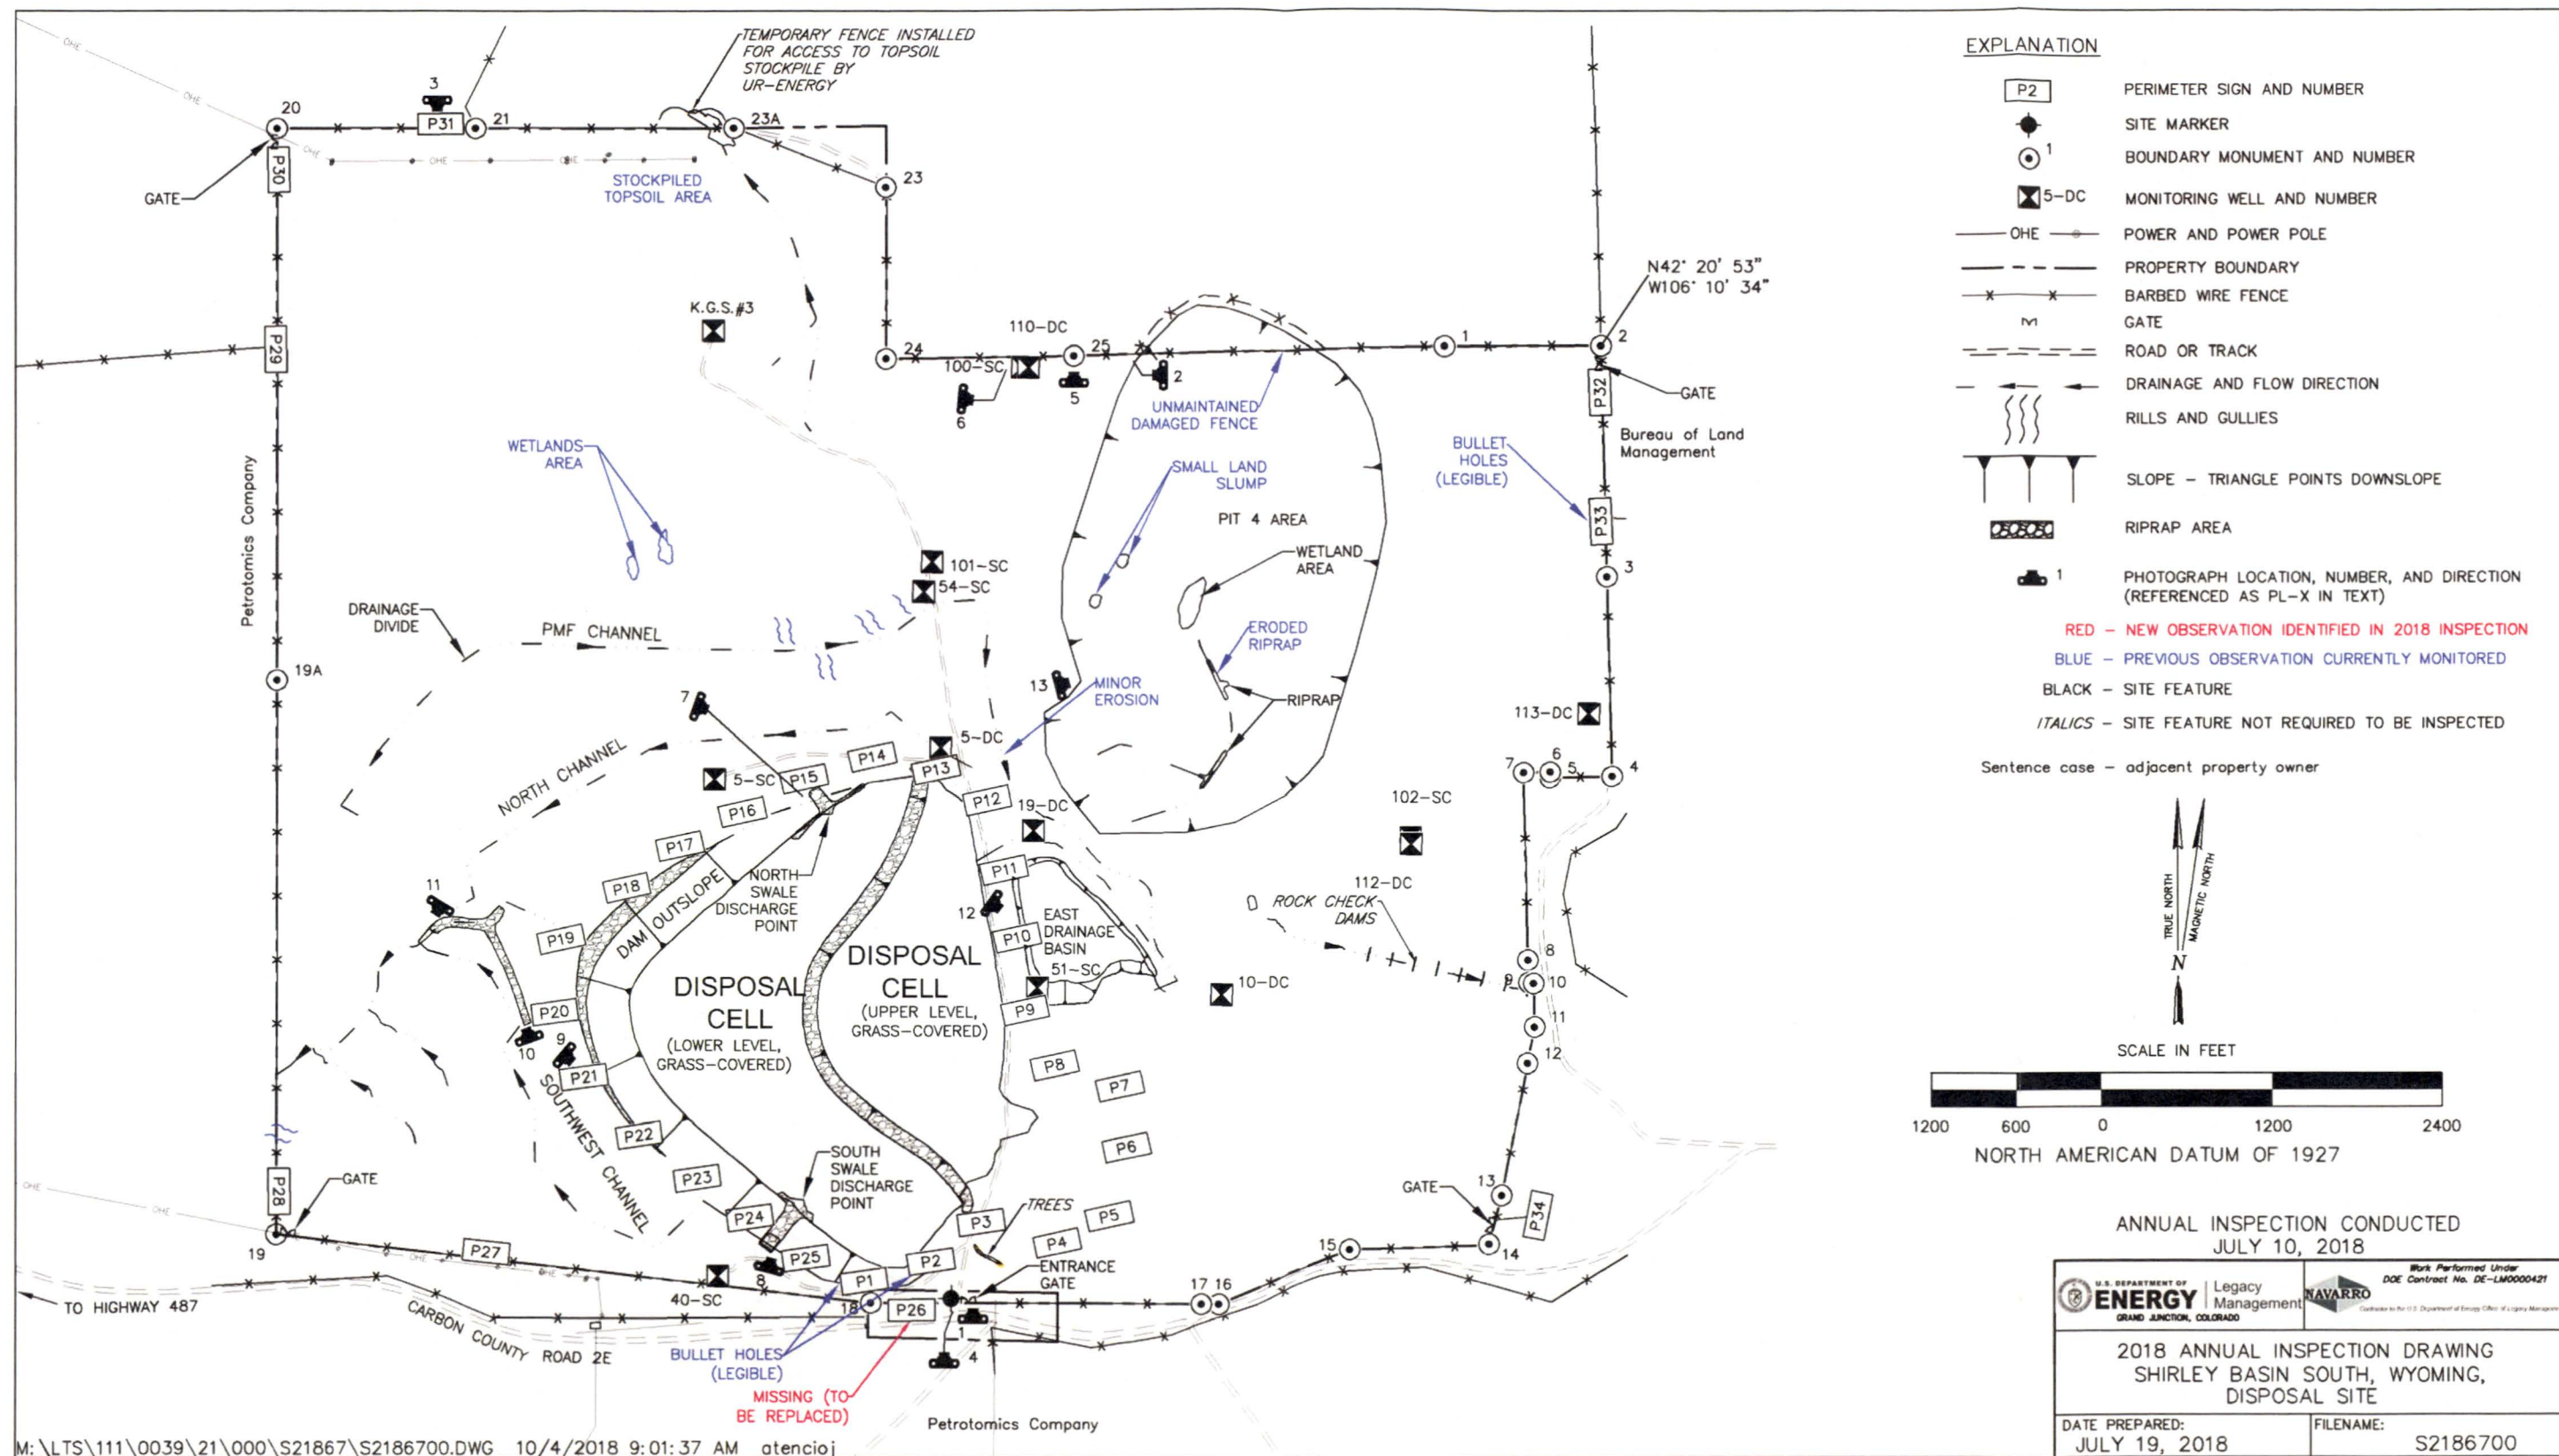
Figure 6-1. 2018 Annual Inspection Drawing for the Shirley Basin South, Wyoming, Disposal Site

The entrance sign is on the main site access road near the site marker. This sign was missing and will be replaced during the 2019 annual site inspection or groundwater sampling. Nine perimeter signs (warning and no-trespassing signs) are posted along the site perimeter at potential points of access, and another 25 signs are positioned around the disposal cell (PL-3). Perimeter signs P1, P2, and P33 have bullet holes in them but remain legible. No other maintenance needs were identified.

The entrance sign (perimeter sign P26) was missing and will be replaced. No other maintenance needs were identified. Emergency measures are corrective actions that LM will take in response to unusual damage or disruption that threatens or compromises site health and safety, security, integrity, or compliance with 40 CFR 192. No emergency measures were identified.

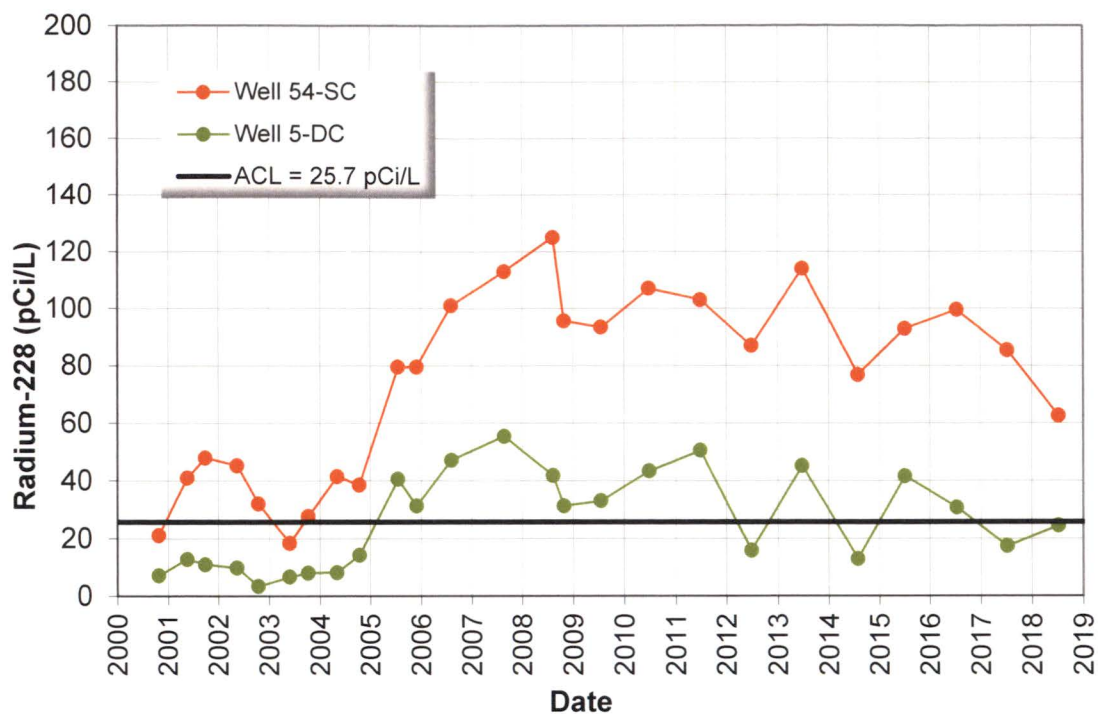
Figure 6-3. Radium-228 Concentrations in Wells 5-DC and 54-SC Since Completion of the Disposal Cell at the Shirley Basin South, Wyoming, Disposal Site

The concentration of cadmium in well 5-SC remained below the ACL since 2005. Radium-228 continued to exceed the ACL in well 54-SC but continues to be below the ACL in well 5-DC (Figure 6-3). Additionally, the ACL for <sup>226</sup>Ra continues to be exceeded in well 110-DC (Figure 6-4).

Although the  $^{228}\text{Ra}$  concentration is elevated in well 54-SC, it is lower than the highest concentration measured in this well in the early 1990s during site groundwater remediation activities. Radium-228 is a decay product of thorium-232 ( $^{232}\text{Th}$ ), which is highly immobile. Because the half-life of  $^{228}\text{Ra}$  is relatively short,  $^{232}\text{Th}$  sources must be near monitoring wells 5-DC and 54-SC. LM attributes the elevated  $^{226}\text{Ra}$  and  $^{228}\text{Ra}$  in the site wells to natural mineralization in the sand units, rather than concluding it is evidence of diminished disposal cell performance or contaminant plumes migrating offsite (DOE 2011). Both the upper and main sand aquifers at the site were dewatered during mining and remediation and are still recovering. Consequently, periodic increases in some constituent concentrations in the groundwater, such as radium-228, may represent a reestablishment of equilibrium of groundwater with naturally occurring constituents in the sand units (Figure 6-3 and Figure 6-4) (DOE 2011).

NRC considers it possible that the elevated radium may represent leakage from the disposal cell. However, NRC has concluded that no additional evaluation of the cause of the elevated radium concentrations by LM is warranted at this time because there is no risk to human health and the environment (Orlando 2012). The groundwater is not a current or potential future source of drinking water due to limited yield and poor ambient conditions resulting from naturally occurring uranium mineralization, and human activities related to uranium exploration and mining that occurred in the area from the late 1950s to the early 1990s. Livestock water at the site is drawn from a separate aquifer, the lower sand aquifer, which is not hydraulically connected to the aquifers of concern and is not impacted by former milling operations.

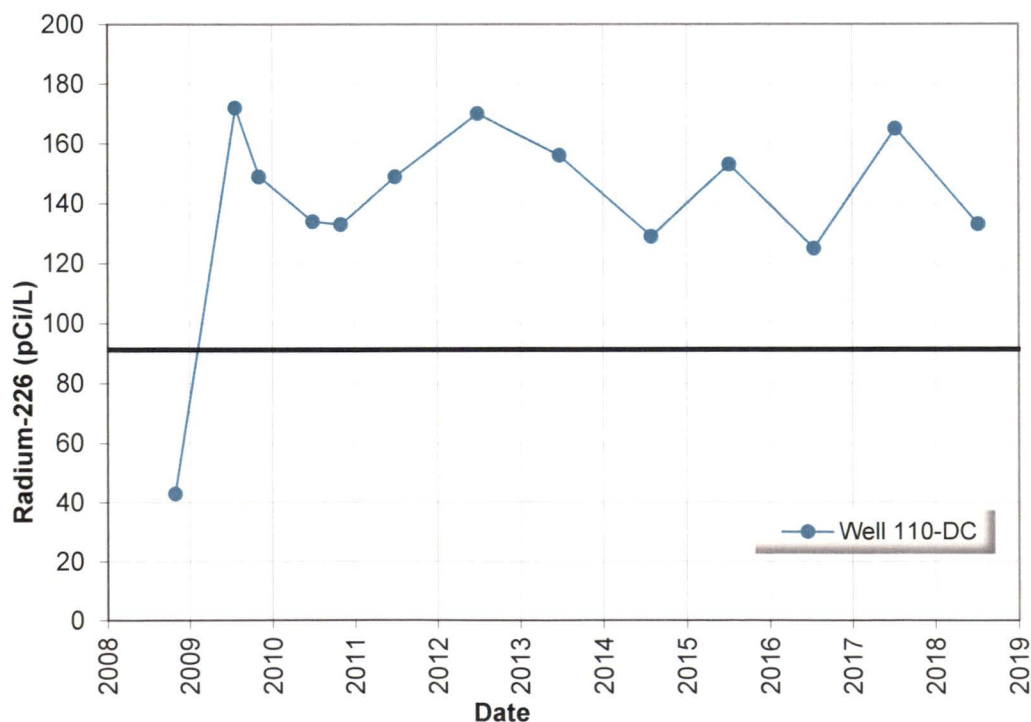
Figure 6-4. Radium-226 Concentrations in Well 110-DC at the Shirley Basin South, Wyoming, Disposal Site

The 2018 water quality results were within the range of historical measurements (Table 6-4 and Table 6-5; Figure 6-3 and Figure 6-4). The exceedances are found in wells near the disposal cell except for the  $^{226}\text{Ra}$  exceedance at well 110-DC. Well 110-DC is near a uranium ore deposit, and the  $^{226}\text{Ra}$  concentration is around 29 times that of the upgradient POC well 5-DC. Therefore, the  $^{226}\text{Ra}$  in well 110-DC is probably naturally occurring (DOE 2011).
